#### DSD CONTRACT NO. DC/2009/13 Construction of Sewage Treatment Works at Yung Shue Wan and Sok Kwu Wan

SOK KWU WAN PORTION AREA MONTHLY ENVIRONMENTAL MONITORING AND AUDIT (EM&A) REPORT (NO.40) – NOVEMBER 2013

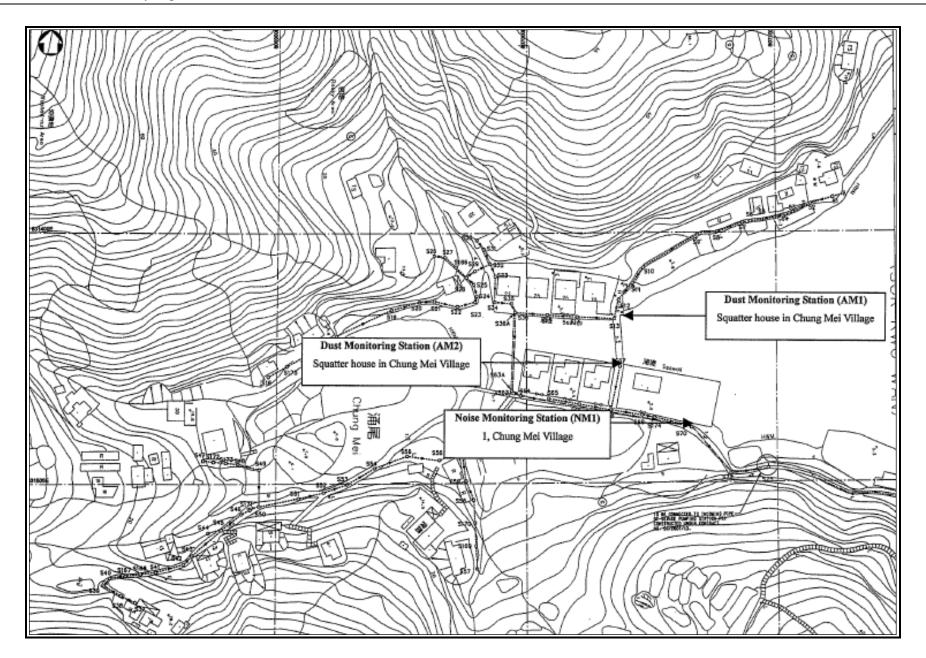
## Location of Monitoring Stations (Air Quality / Construction Noise / Water Quality)

3.05 According to *EM&A Manual Section 3.4*, there were four noise sensitive receivers (NM1-NM4) designated for the construction noise monitoring. NM1, NM2 and NM4 of the three designated monitoring stations were identified and are monitored by the current DSD contract DC/2007/18. However, the premises monitoring station NM3 was rejected by the owner of 1B Sok Kwu Wan and an alternative noise monitoring station RNM3 replacement was proposed by the contract DC/2007/18 ET and accepted by the IEC and EPD before the baseline monitoring commencement in April 2008. The location RNM3 is located at Sok Kwu Wan Sitting-out area which just 3m width footpath away from the original location house 1B. The detailed construction noise monitoring stations to also under the Project is described in *Table 3-3* and graphical is shown in *Appendix D*.

3.06 Three control stations (C1-C3) and three impact stations (W1-W3) were recommended in the *EM&A Manual Section 4.5*. Impact stations W1-W3 identified at the sensitive receivers (FCZ and secondary contact recreation subzone) to monitor the impacts from the construction of the submarine outfall as well as the effluent discharge from the proposed STW on water quality. Three control stations: C1, C2 & C3 were specified at locations representative of the project site in its undisturbed condition and located at upstream and downstream of the works area. Detailed and co-ordnance of marine water quality monitoring stations is described in *Table 3-4* and the graphical is shown in *Appendix D* and would be performed for EM&A programme.

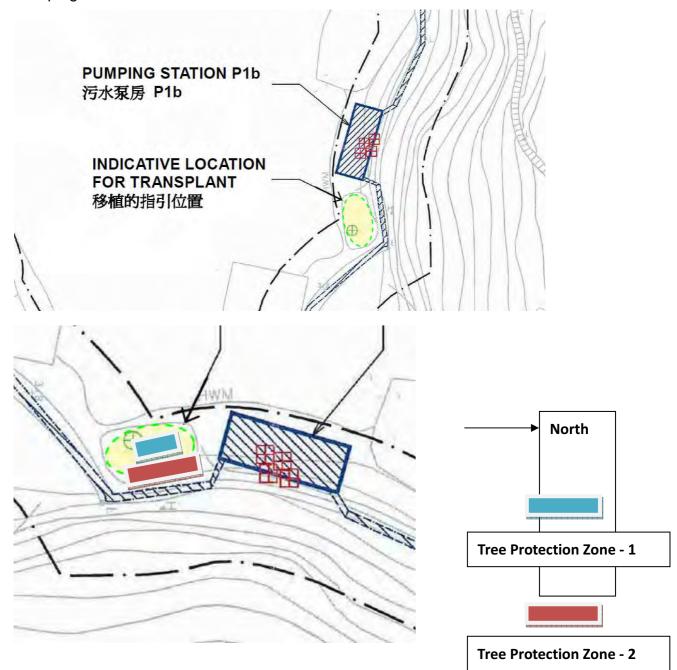
According to the requirement in the Environmental Permit EP-281/2007/A, the uncommon tree species, *Celtis timorensis*, found in the pumping station P1b area as shown in figure below shall be properly transplanted to the area immediately south of the Pumping Station P1b before commencement of construction of the Pumping Station P1b

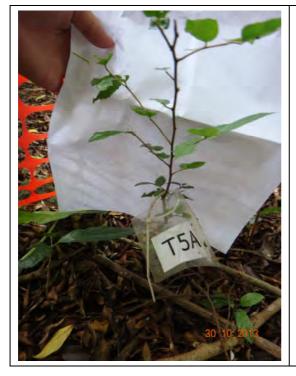
#### 5. Description of Inspection Results: Tree ID: CT\_5A

**Current Status: Good**

Justification: Significant improvement in health. The plant was healthy. Some leaves were damaged by insect.

In the Tree Protection Zone 2, The health of CT\_5A and CT\_6A were found satisfactory. Regular watering and weeding will be carried out during dry weather. They may better recover under this warm and rainy weather. Some newly grown green leaves were found eaten by insects. Remove any insect found on the plant physically to prevent the bud attacked by leaf-feeding insect. No pesticide should be used when the plants are weak.

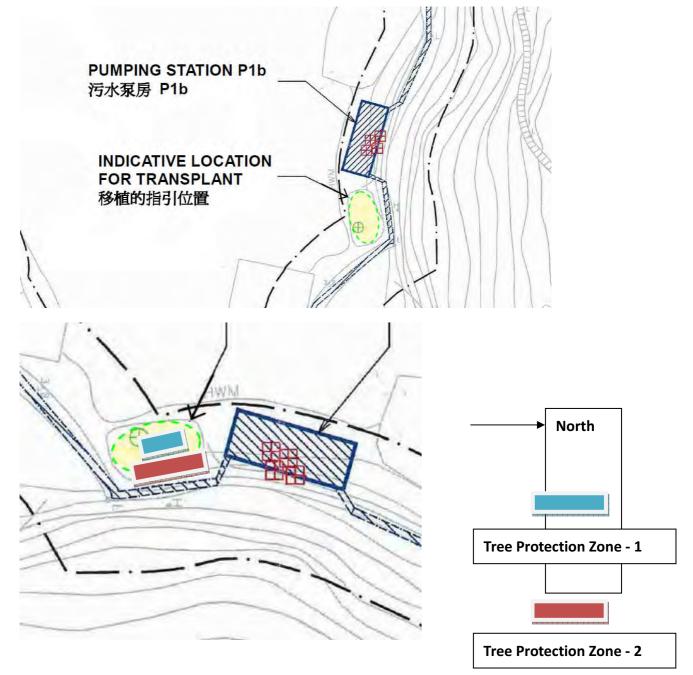
According to the requirement in the Environmental Permit EP-281/2007/A, the uncommon tree species, *Celtis timorensis*, found in the pumping station P1b area as shown in figure below shall be properly transplanted to the area immediately south of the Pumping Station P1b before commencement of construction of the Pumping Station P1b

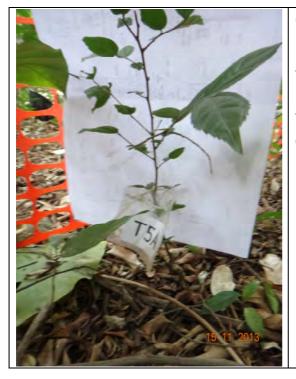
#### 5. Description of Inspection Results: Tree ID: CT\_5A

**Current Status: Good**

Justification: Significant improvement in health. The plant was healthy. Some leaves were damaged by insect.

In the Tree Protection Zone 2, The health of CT\_5A and CT\_6A were found satisfactory. Regular watering and weeding will be carried out during dry weather. They may better recover under this warm and rainy weather. Some newly grown green leaves were found eaten by insects. Remove any insect found on the plant physically to prevent the bud attacked by leaf-feeding insect. No pesticide should be used when the plants are weak.
