DSD CONTRACT No. DC/2009/13 CONSTRUCTION OF SEWAGE TREATMENT WORKS AT YUNG SHUE WAN AND SOK KWU WAN

SOK KWU WAN PORTION AREA MONTHLY ENVIRONMENTAL MONITORING AND AUDIT (EM&A) REPORT (NO.41) – DECEMBER 2013

PREPARED FOR LEADER CIVIL ENGINEERING CORPORATION LIMITED

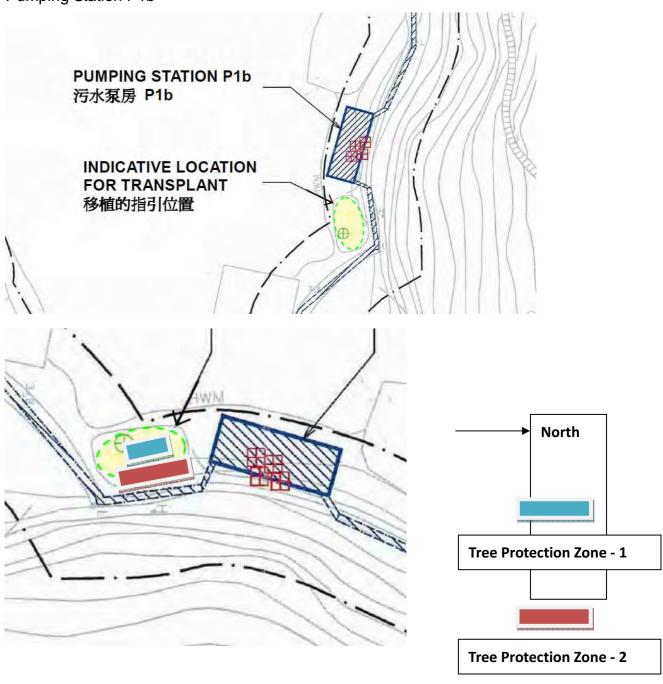
According to the requirement in the Environmental Permit EP-281/2007/A, the uncommon tree species, *Celtis timorensis*, found in the pumping station P1b area as shown in figure below shall be properly transplanted to the area immediately south of the Pumping Station P1b before commencement of construction of the Pumping Station P1b

This Tree Inspection Report describes the bi weekly monitoring result of the *Celtis timorensis*, which were additionally planted as the compensation of previously transplanted Celtis timorensis CT7, CT8, CT9 & CT10.

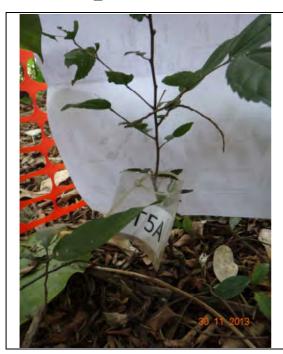
Tree ID: CT_5A

Current Status: Good

Justification: Significant improvement in health. The plant was healthy. Some leaves were damaged by insect.

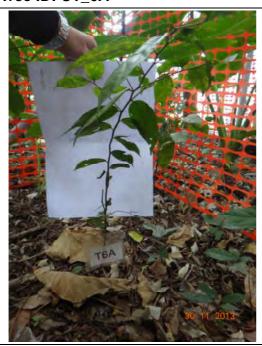
Tree ID: CT_6A

Current Status: Good

Justification: Significant improvement in health. The plant was healthy.

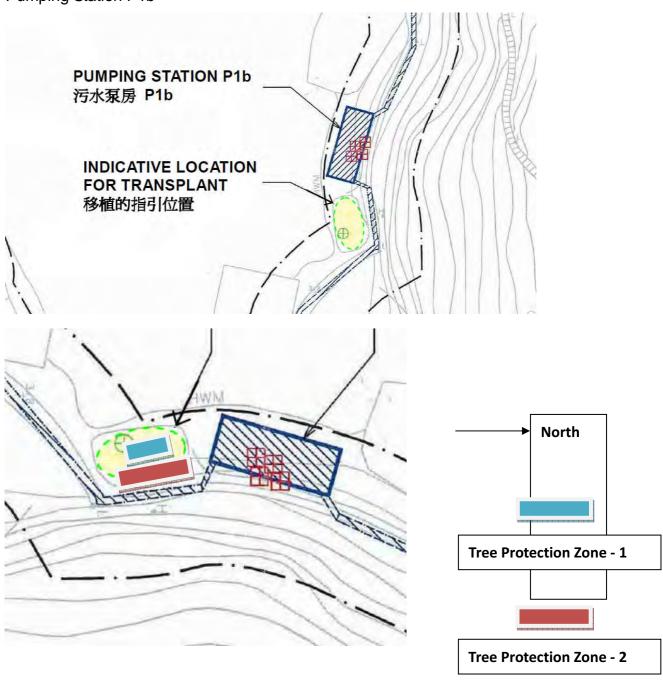
According to the requirement in the Environmental Permit EP-281/2007/A, the uncommon tree species, *Celtis timorensis*, found in the pumping station P1b area as shown in figure below shall be properly transplanted to the area immediately south of the Pumping Station P1b before commencement of construction of the Pumping Station P1b

This Tree Inspection Report describes the bi weekly monitoring result of the *Celtis timorensis*, which were additionally planted as the compensation of previously transplanted Celtis timorensis CT7, CT8, CT9 & CT10.

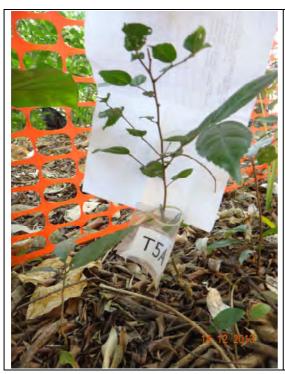
Tree ID: CT_5A

Current Status: Good

Justification: Significant improvement in health. The plant was healthy. Some leaves were damaged by insect.

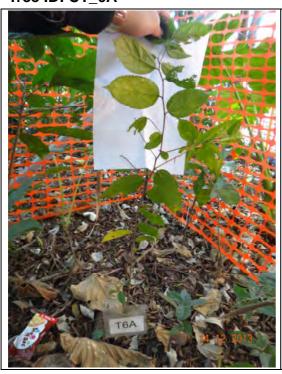
Tree ID: CT_6A

Current Status: Good

Justification: Significant improvement in health. The plant was healthy.
