DSD CONTRACT No. DC/2009/13 CONSTRUCTION OF SEWAGE TREATMENT WORKS AT YUNG SHUE WAN AND SOK KWU WAN

YUNG SHUE WAN PORTION AREA MONTHLY ENVIRONMENTAL MONITORING AND AUDIT (EM&A) REPORT (NO.52) – DECEMBER 2014

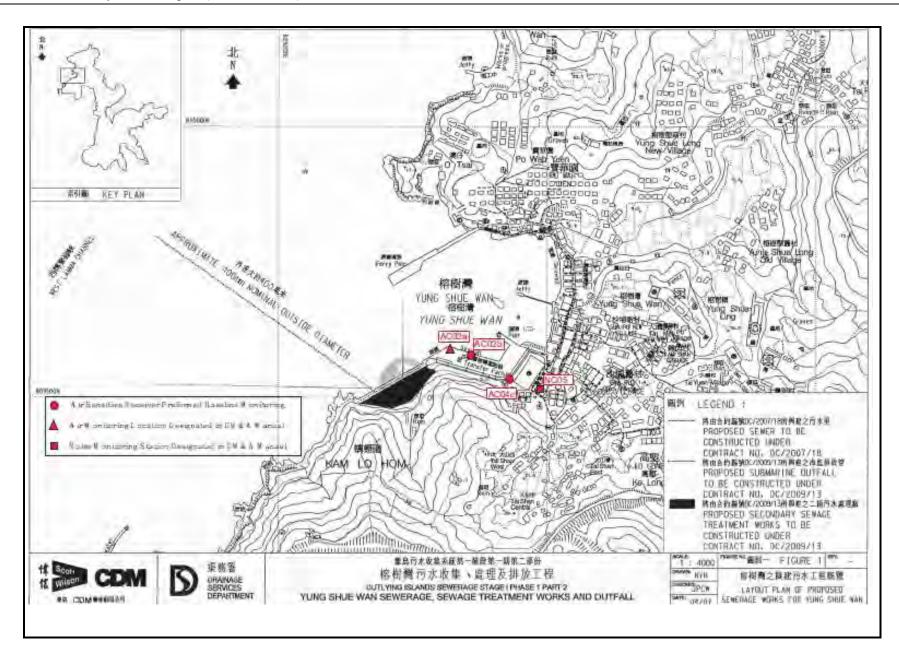
Location of Monitoring Stations
(Air Quality / Construction Noise / Water Quality /
Dive Surveys of Coral)

- 3.04 Two designated monitoring stations, AC02a located at Yung Shue Wan Refuse Transfer Station and AC04 located at residential area nearby Yung Shue Wan football pitch, were recommended in the *EM&A Manual Section 2.5*. In order to identify and seek for the access of the air monitoring locations designated in the EM&A Manual, site visit was conducted by Leader and ET.

3.06 According to *EM&A Manual Section 3.4*, one noise sensitive receivers (NC05) designated for the construction noise monitoring was recommended at Yung Shue Wan Portion Area of the Project. The designated monitoring station is identified and successfully granted the premises. The detailed construction noise monitoring station is described in *Table 3-3* and graphical is shown in *Appendix D*.

3.07 Two control stations (CY1 and CY2) and three impact stations (WY1-WY3) were recommended in the *EM&A Manual Section 4.5*. Impact stations WY1-WY3 were identified close to the sensitive receivers (the coral colonies in the vicinity of Yung Shue Wan, and secondary contact recreation subzone). It is proposed to monitor the impacts from the construction of the submarine outfall as well as the effluent discharge from the proposed STW on water quality. Two control stations: CY1 and CY2 were recommended at locations representative of the project site in its undisturbed condition and located at upstream and downstream of the works area. The marine water quality monitoring stations to be performed under the Project is described in *Table 3-4* and shown in *Appendix D*.

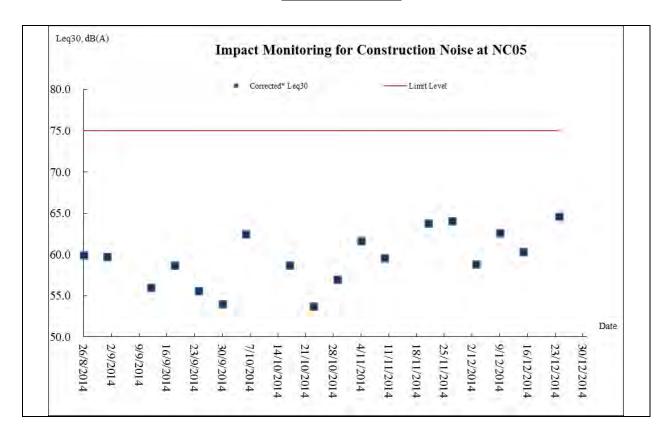
Noise Monitoring

5.03 It was noted that no noise complaint (which is an Action Level exceedance) was received. In view of the results shown in *Table 5-1*, all the values are well below 75dB(A), therefore, no Action or Limit Level exceedance was triggered during this Reporting Period.
