**JOINT USER COMPLEX AND  
WHOLESALE FISH MARKET AT  
AREA 44, TUEN MUN**

**ENVIRONMENTAL MONITORING  
& AUDIT REPORT  
(SEPTEMBER 2008)**

**ALLIED ENVIRONMENTAL CONSULTANTS LTD.**

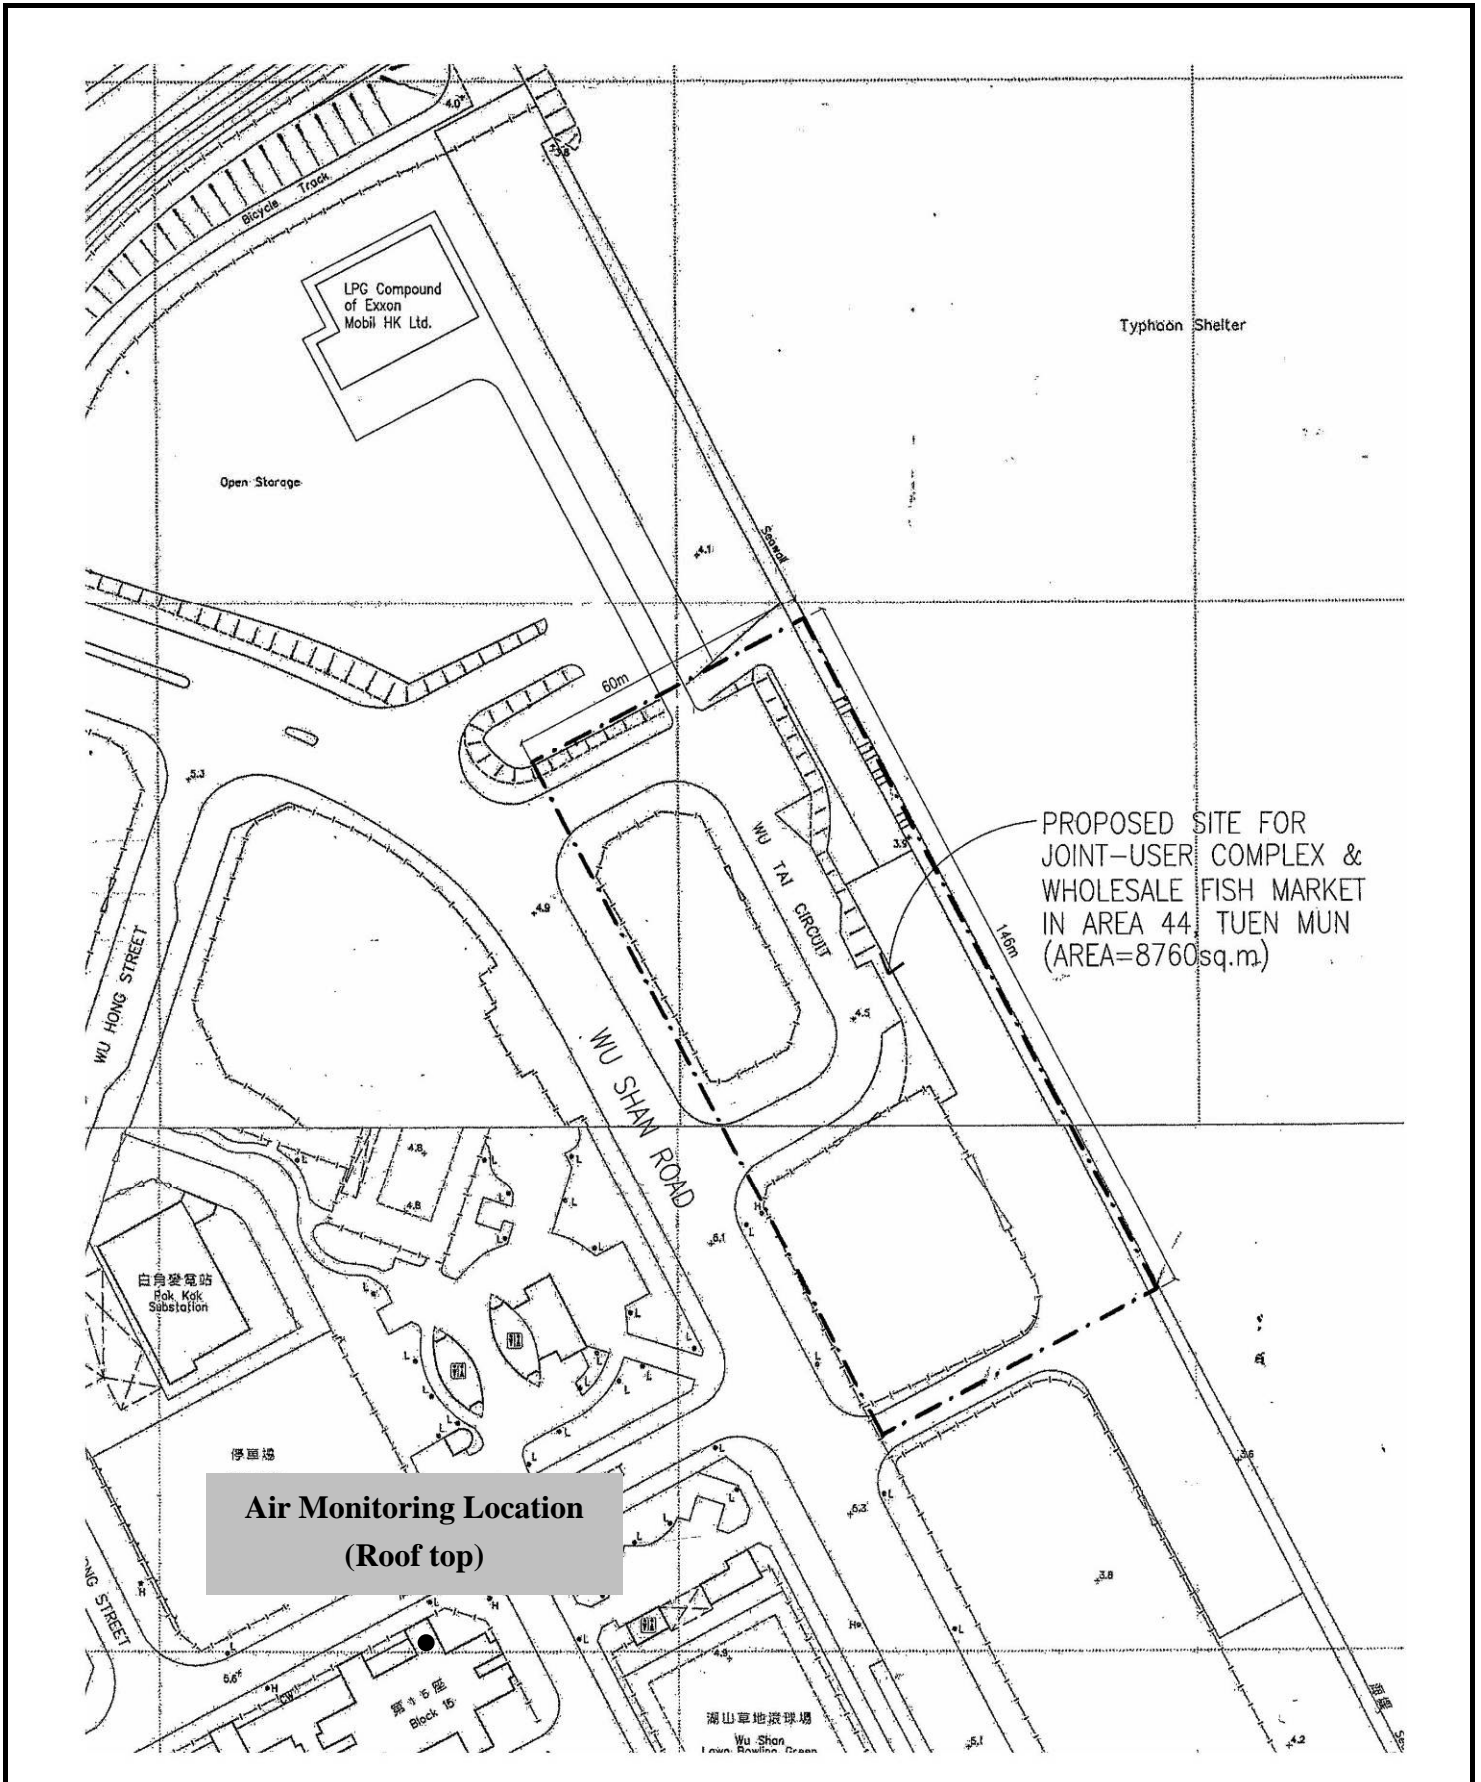
Figure No.	Rev.:
2	0
Scale	Date
NTS	10/08

**LOCATION OF AIR QUALITY MONITORING STATION**

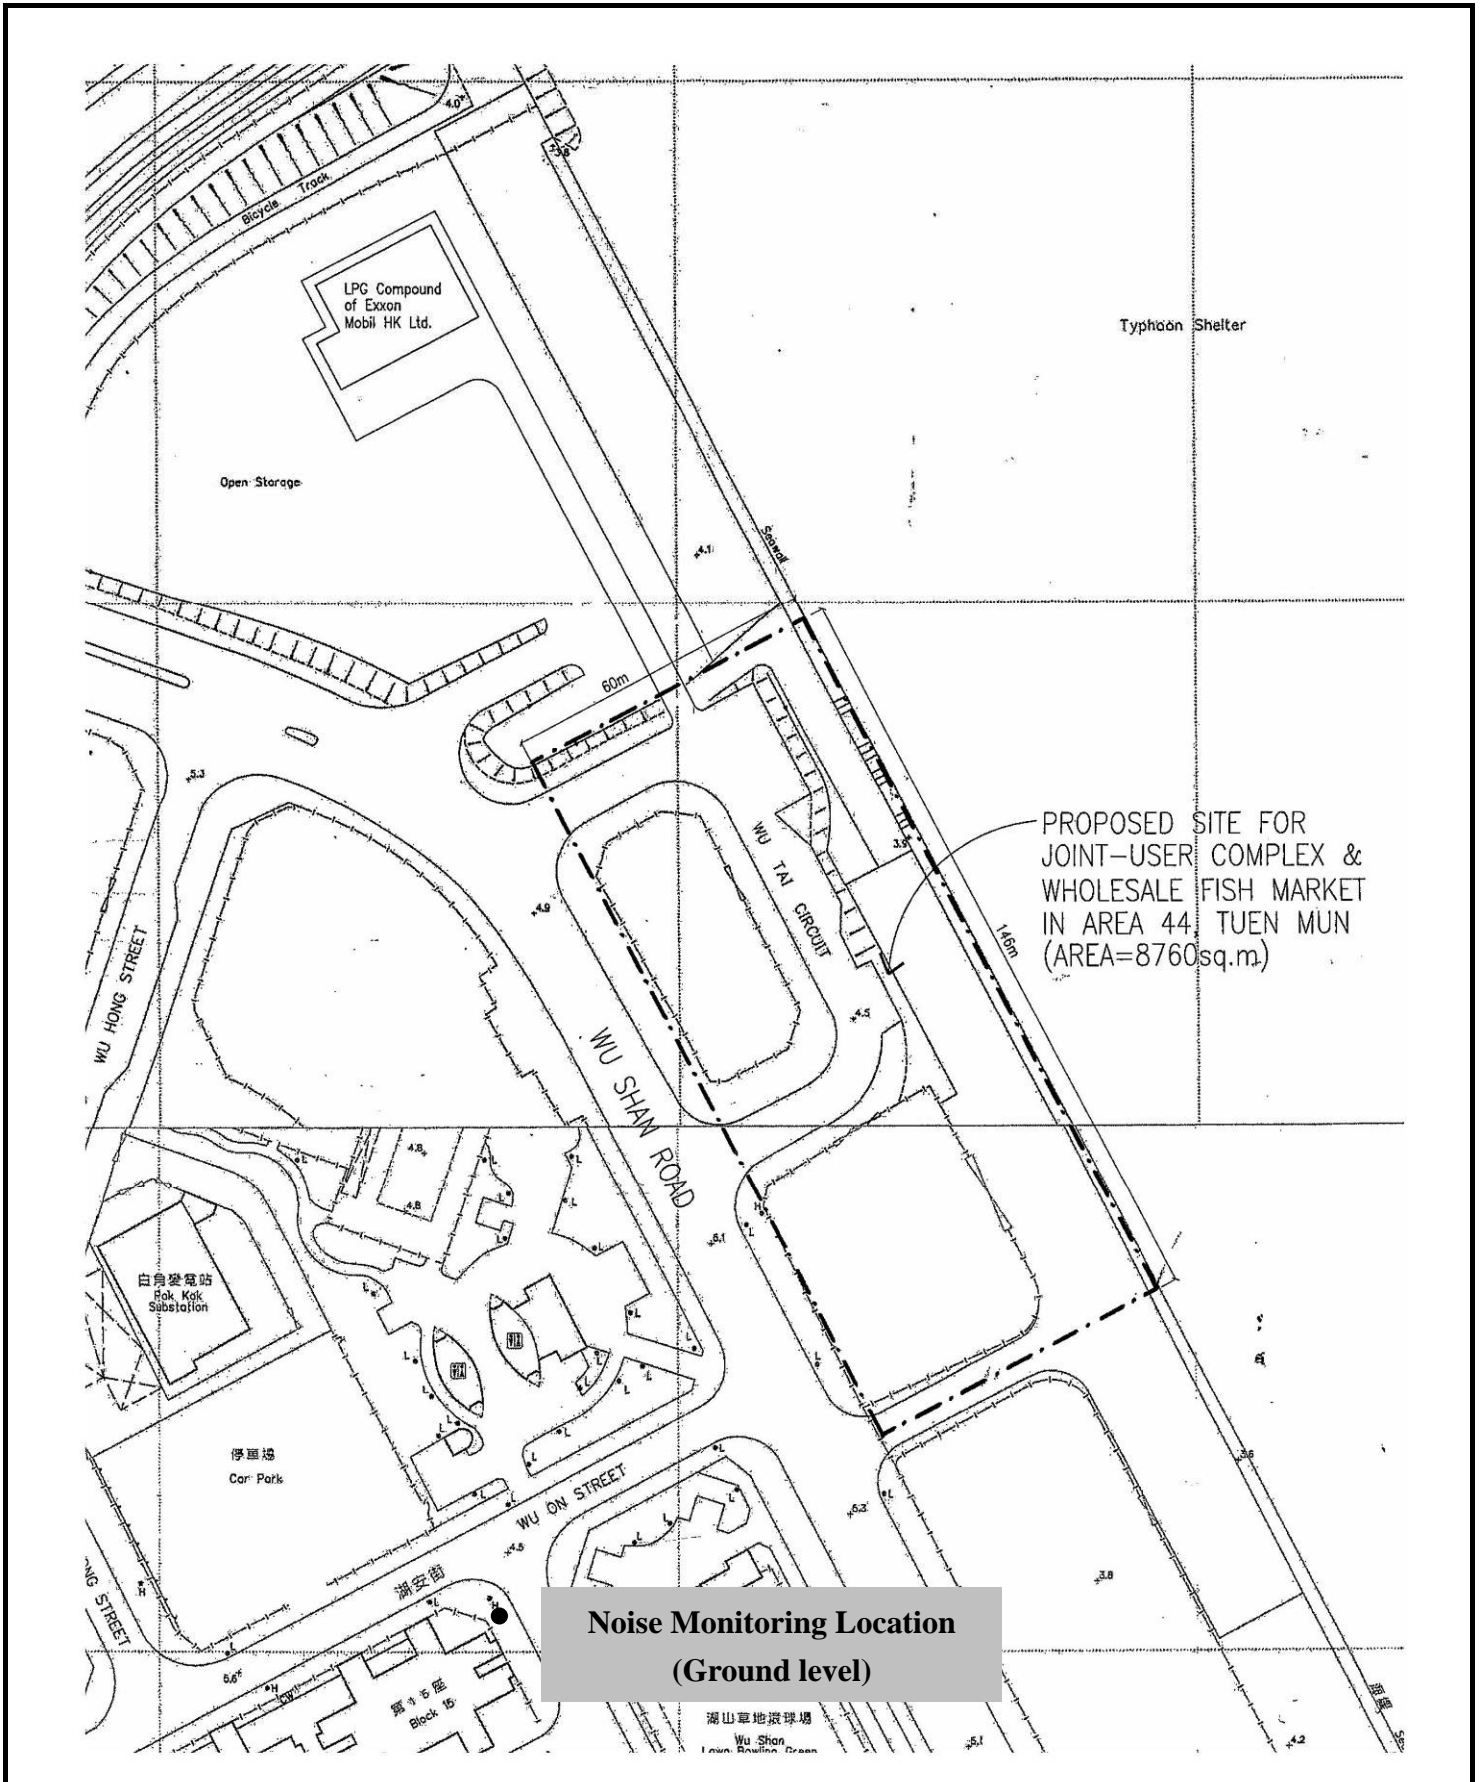
Figure No.	3	Rev.:	0
Scale	NTS	Date	10/08

**LOCATION OF NOISE MONITORING STATION**

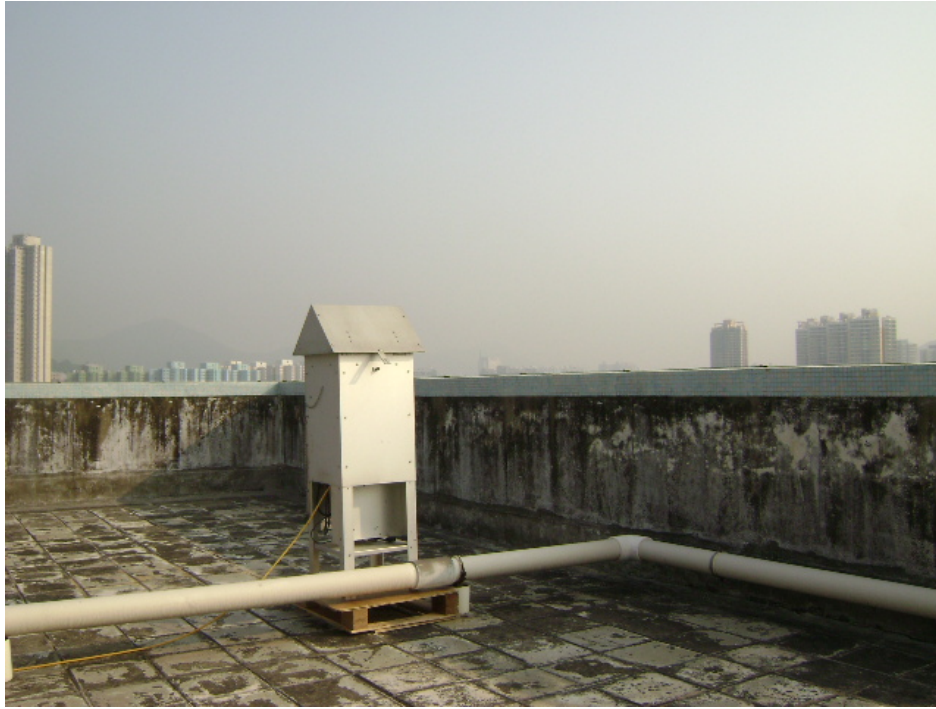
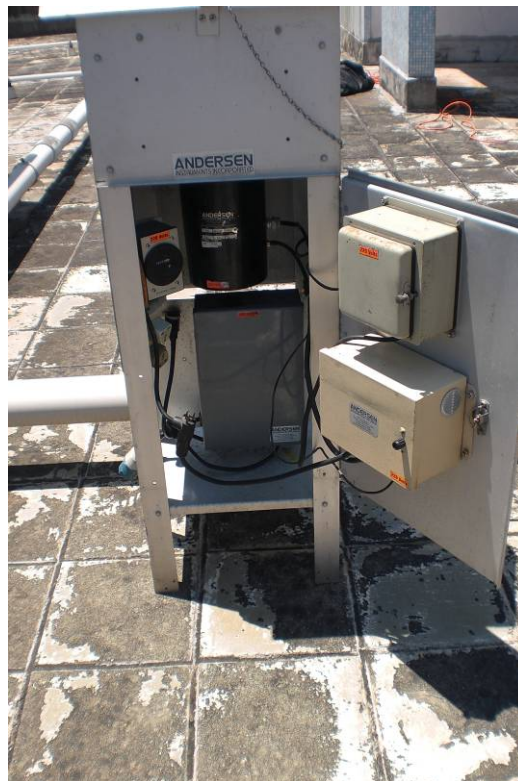
4

1-hour and 24-hour TSP air quality monitoring was conducted at the designated air quality monitoring location using a High Volume TSP Sampler (Model No: Anderson GMWS-2310 ACCU-VOL) at the designated location. The Calibration Record of the High-Volume TSP Sampler is given in [Appendix A](#). 24-hour TSP samples were taken every six days. 1-hour TSP samples were taken three times a day between 0700-1900 hours.

*Roof top of Block 15, Yuet Wu Villa*

*High-Volume Dust Sampler*

**JOINT USER COMPLEX AND WHOLESALE FISH MARKET AT AREA 44,  
TUEN MUN  
PHOTOS OF AIR QUALITY MONITORING STATION**

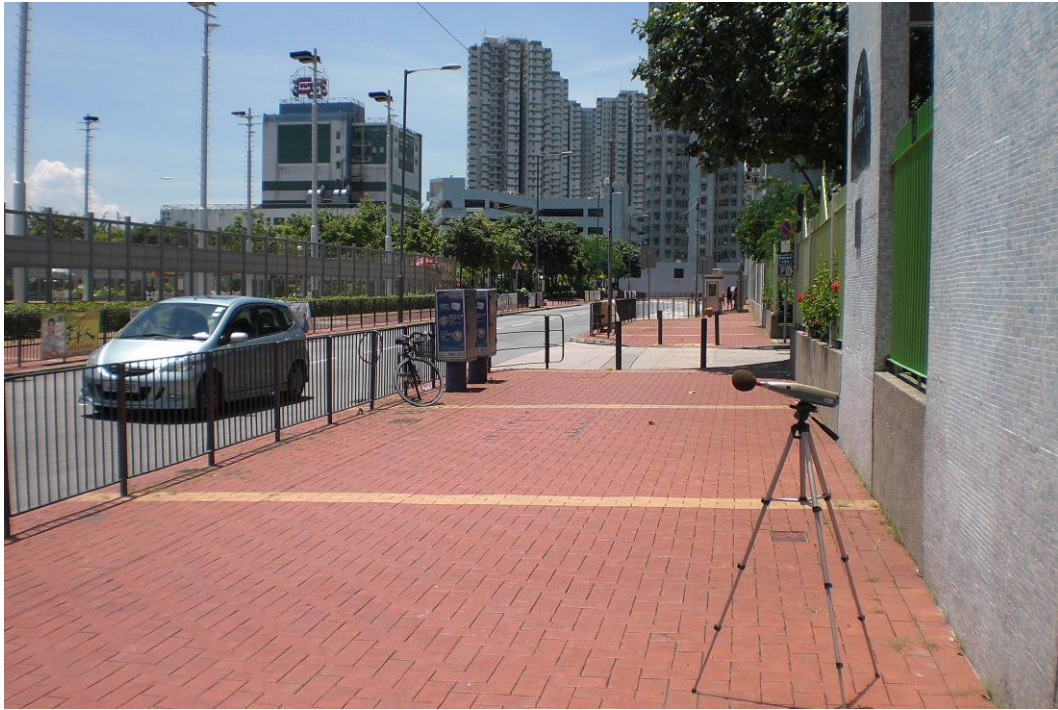
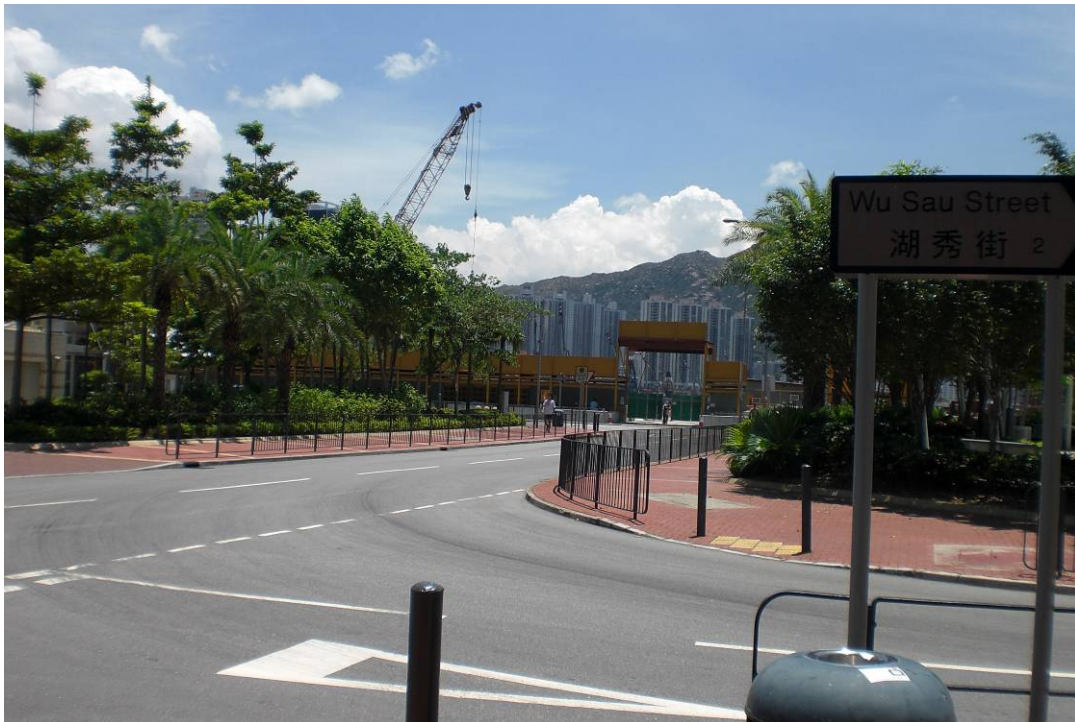
5

Noise levels measurements were recorded in terms of thirty minutes A-weighted equivalent continuous sound pressure level (Leq(30min)) on a daily basis. The sound level meter was calibrated immediately prior to and following each noise measurement. The meter was mounted on a tripod at a height of 1.2m and the microphone was positioned at 1m away the building facade of the noise monitoring station facing the construction site.

*Noise monitoring station*

*View from the noise monitoring station*

**JOINT USER COMPLEX AND WHOLESAL FISH MARKET AT AREA 44,  
TUEN MUN  
PHOTOS OF NOISE MONITORING STATION**

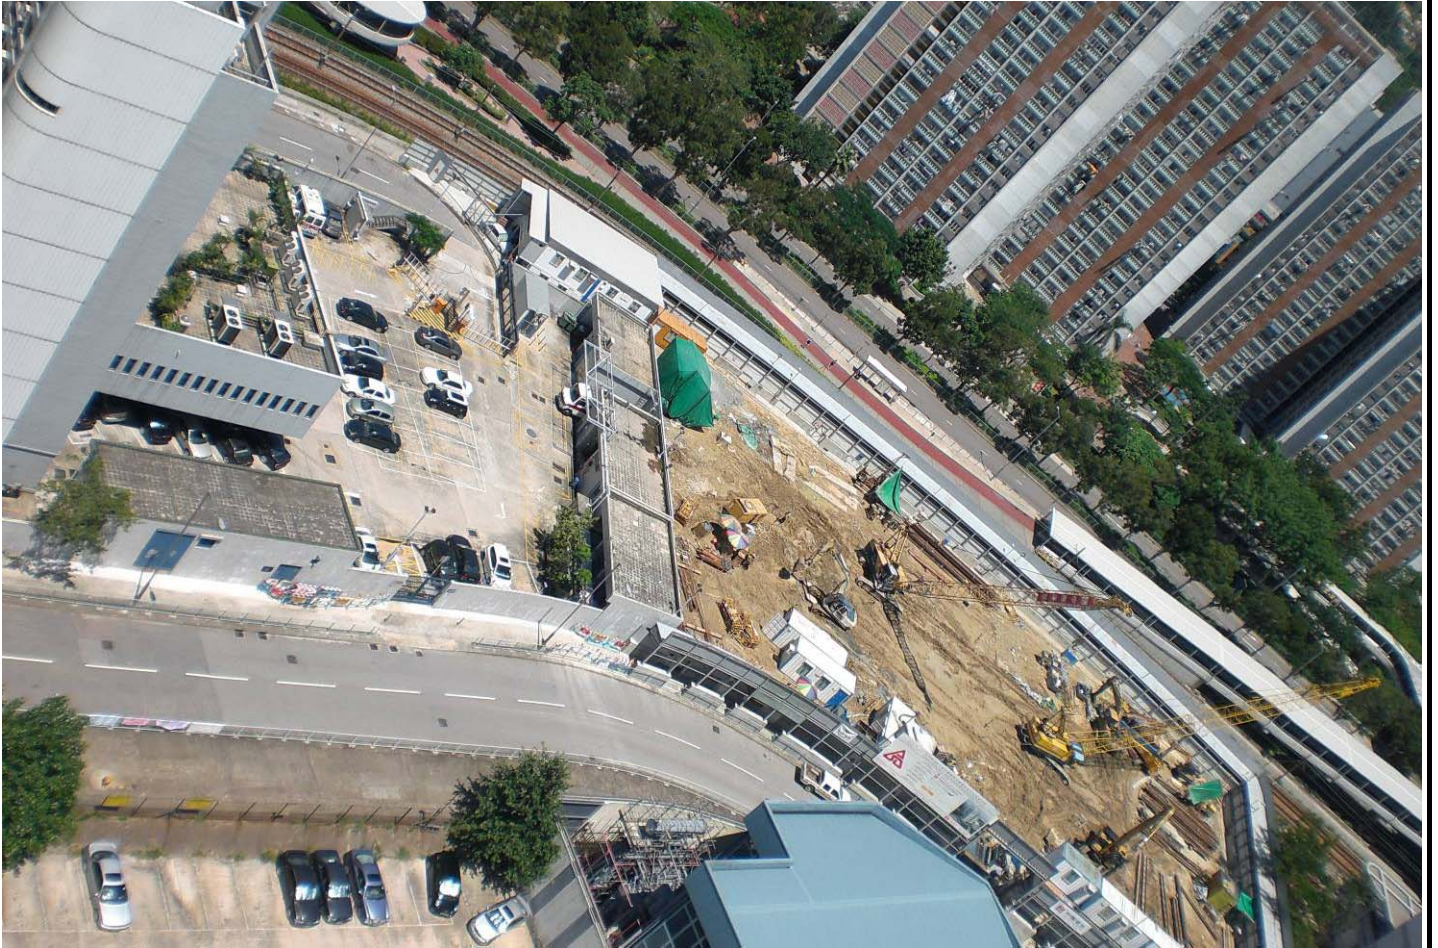
Figure No.	Rev.:
6	0
Scale	Date
NTS	10/08

A construction site for the proposed Junior Police Officers' Married Quarters is located at 110m away from the monitoring location, which can be a major source of the noise and TSP generation during the monitoring period. [Figure 6](#) shows the photos of the construction site.

**PHOTOS OF CONSTRUCTION SITE FOR JUNIOR POLICE OFFICERS' MARRIED QUARTERS**

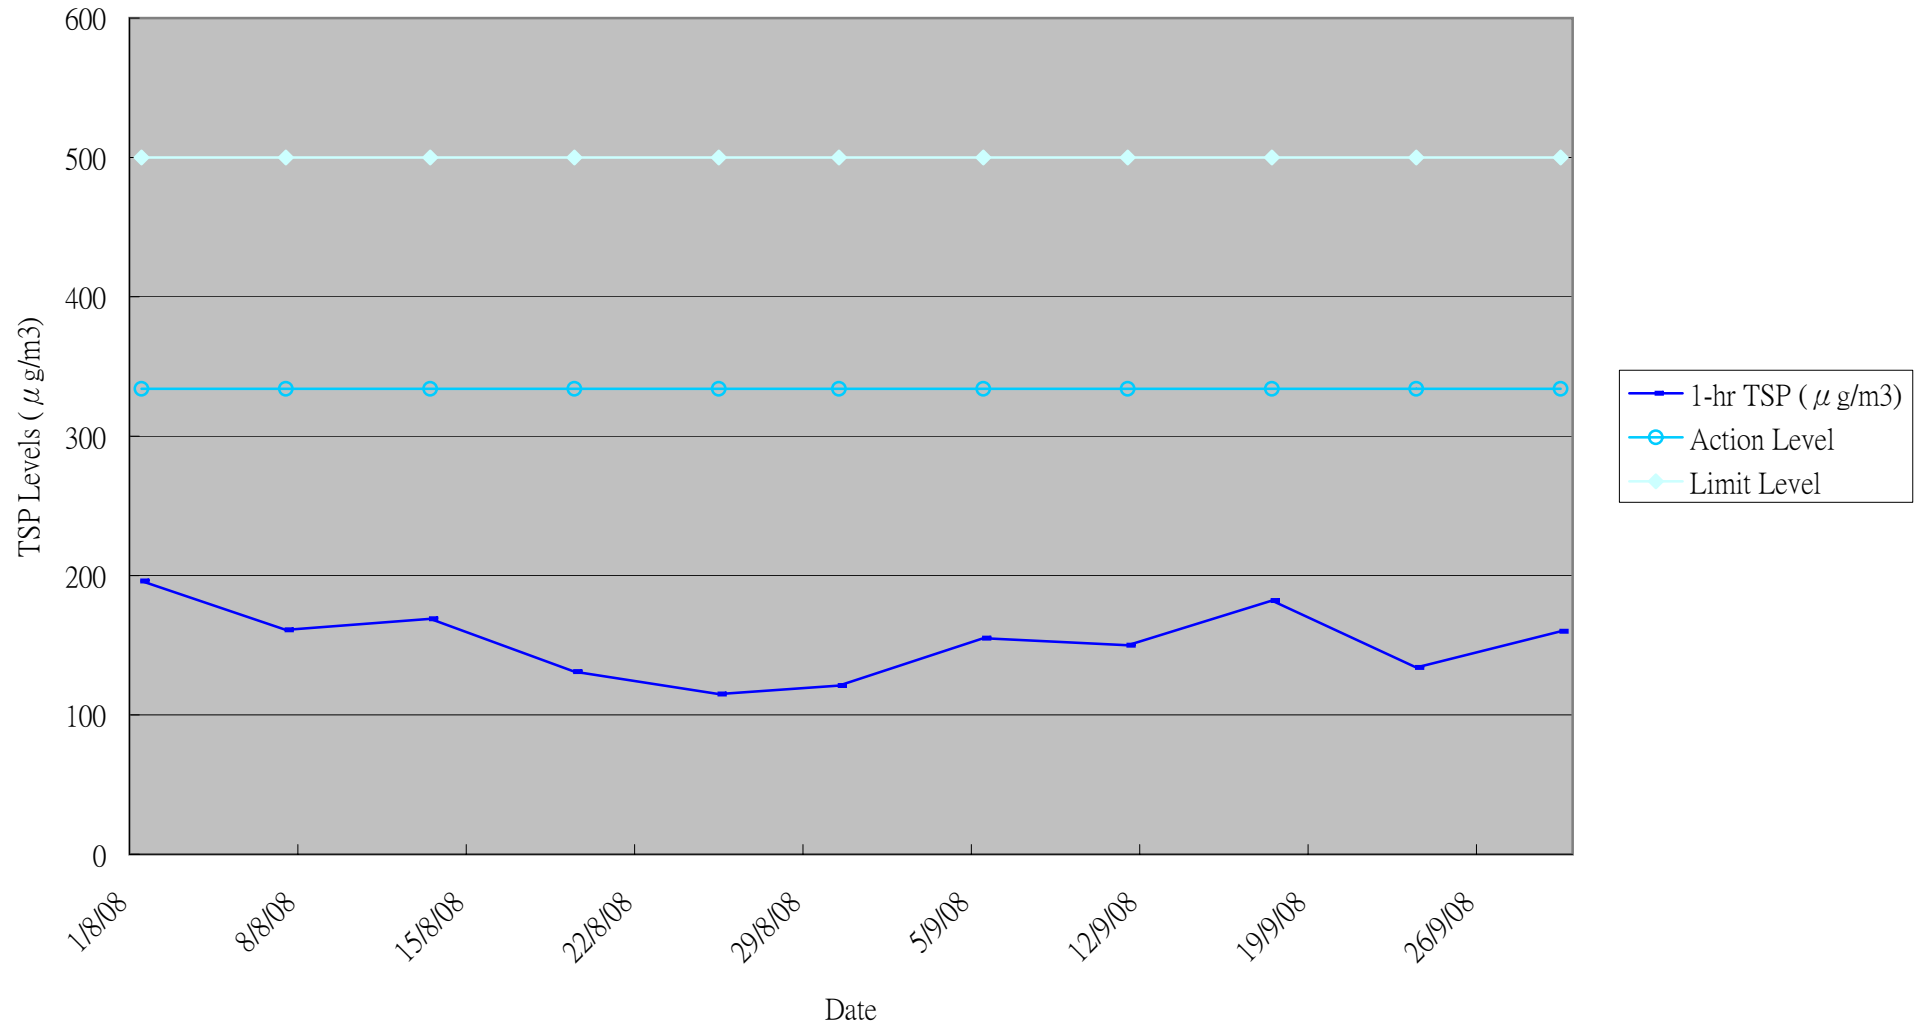
1-hour TSP Monitoring Record

*Summary and Graphical Plot of 1-Hour TSP  
Monitoring Record*

Date	Time	1-hr TSP ( $\mu\text{g}/\text{m}^3$ )	Average
5-Sep-08	08:35 - 09:35	152	155
	09:37 - 10:37	177	
	10:39 - 11:39	136	
11-Sep-08	08:00 - 09:00	133	150
	09:02 - 10:02	181	
	10:04 - 11:04	136	
17-Sep-08	08:05 - 09:05	213	182
	09:07 - 10:07	116	
	10:09 - 11:09	217	
23-Sep-08	13:10 - 14:10	129	134
	14:12 - 15:12	132	
	15:14 - 16:14	142	
29-Sep-08	08:00 - 09:00	174	160
	09:02 - 10:02	146	
	10:04 - 11:04	159	
		Average	156

1-hour and 24-hour TSP monitoring results are summarized in Table 7 and 8 and serve as the basis for determining the action and limit levels. The minimum and maximum 1-hour TSP measured at Yuet Wu Villa was 116 $\mu\text{g}/\text{m}^3$  and 217 $\mu\text{g}/\text{m}^3$  respectively with an average of 156 $\mu\text{g}/\text{m}^3$ . The minimum and maximum 24-hour TSP measured was 55 $\mu\text{g}/\text{m}^3$  and 91 $\mu\text{g}/\text{m}^3$  respectively with an average of 78 $\mu\text{g}/\text{m}^3$ . Summary of air quality monitoring record will be provided in Appendix C and D.

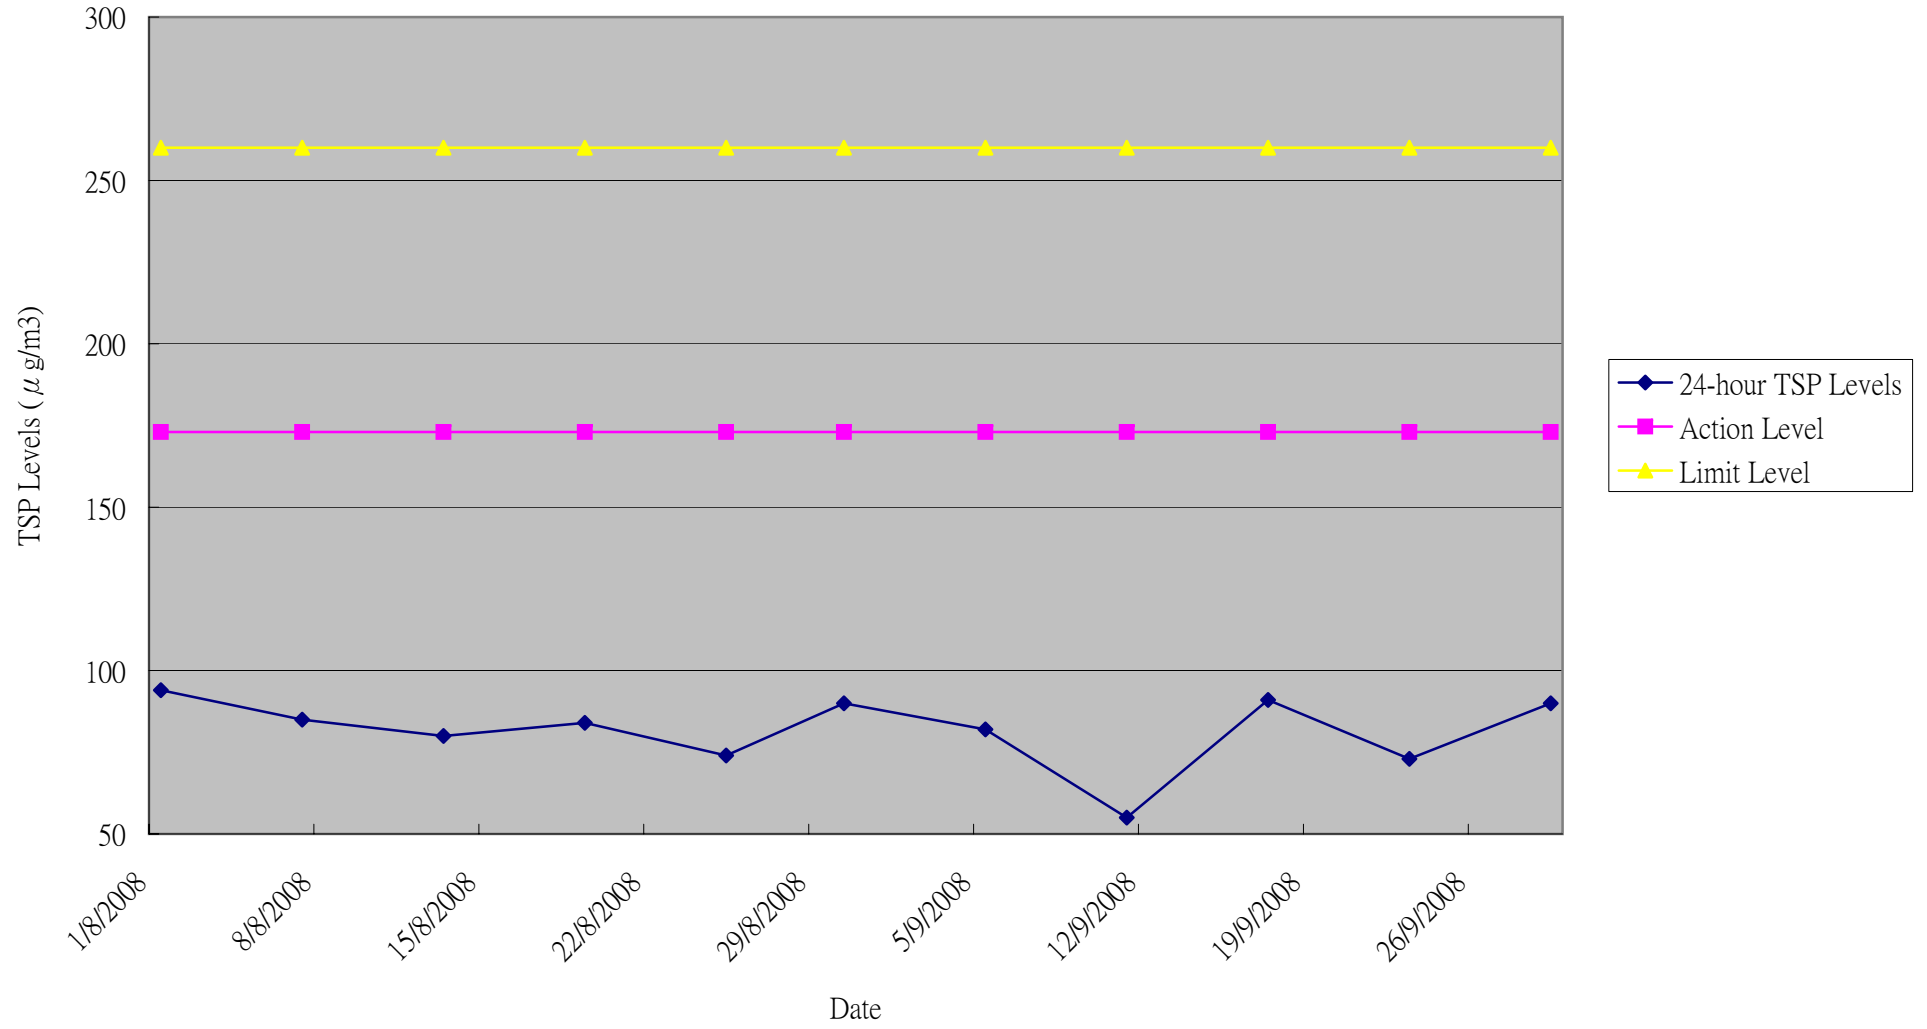
24-Hour TSP Monitoring Record

*Summary and Graphical Plot of 24-Hour TSP  
Monitoring Record*

Date	Start time	24-hr TSP ( $\mu\text{g}/\text{m}^3$ )
5-Sep-08	11:41	82
11-Sep-08	11:06	55
17-Sep-08	11:11	91
23-Sep-08	16:16	73
29-Sep-08	11:06	90
Average		78

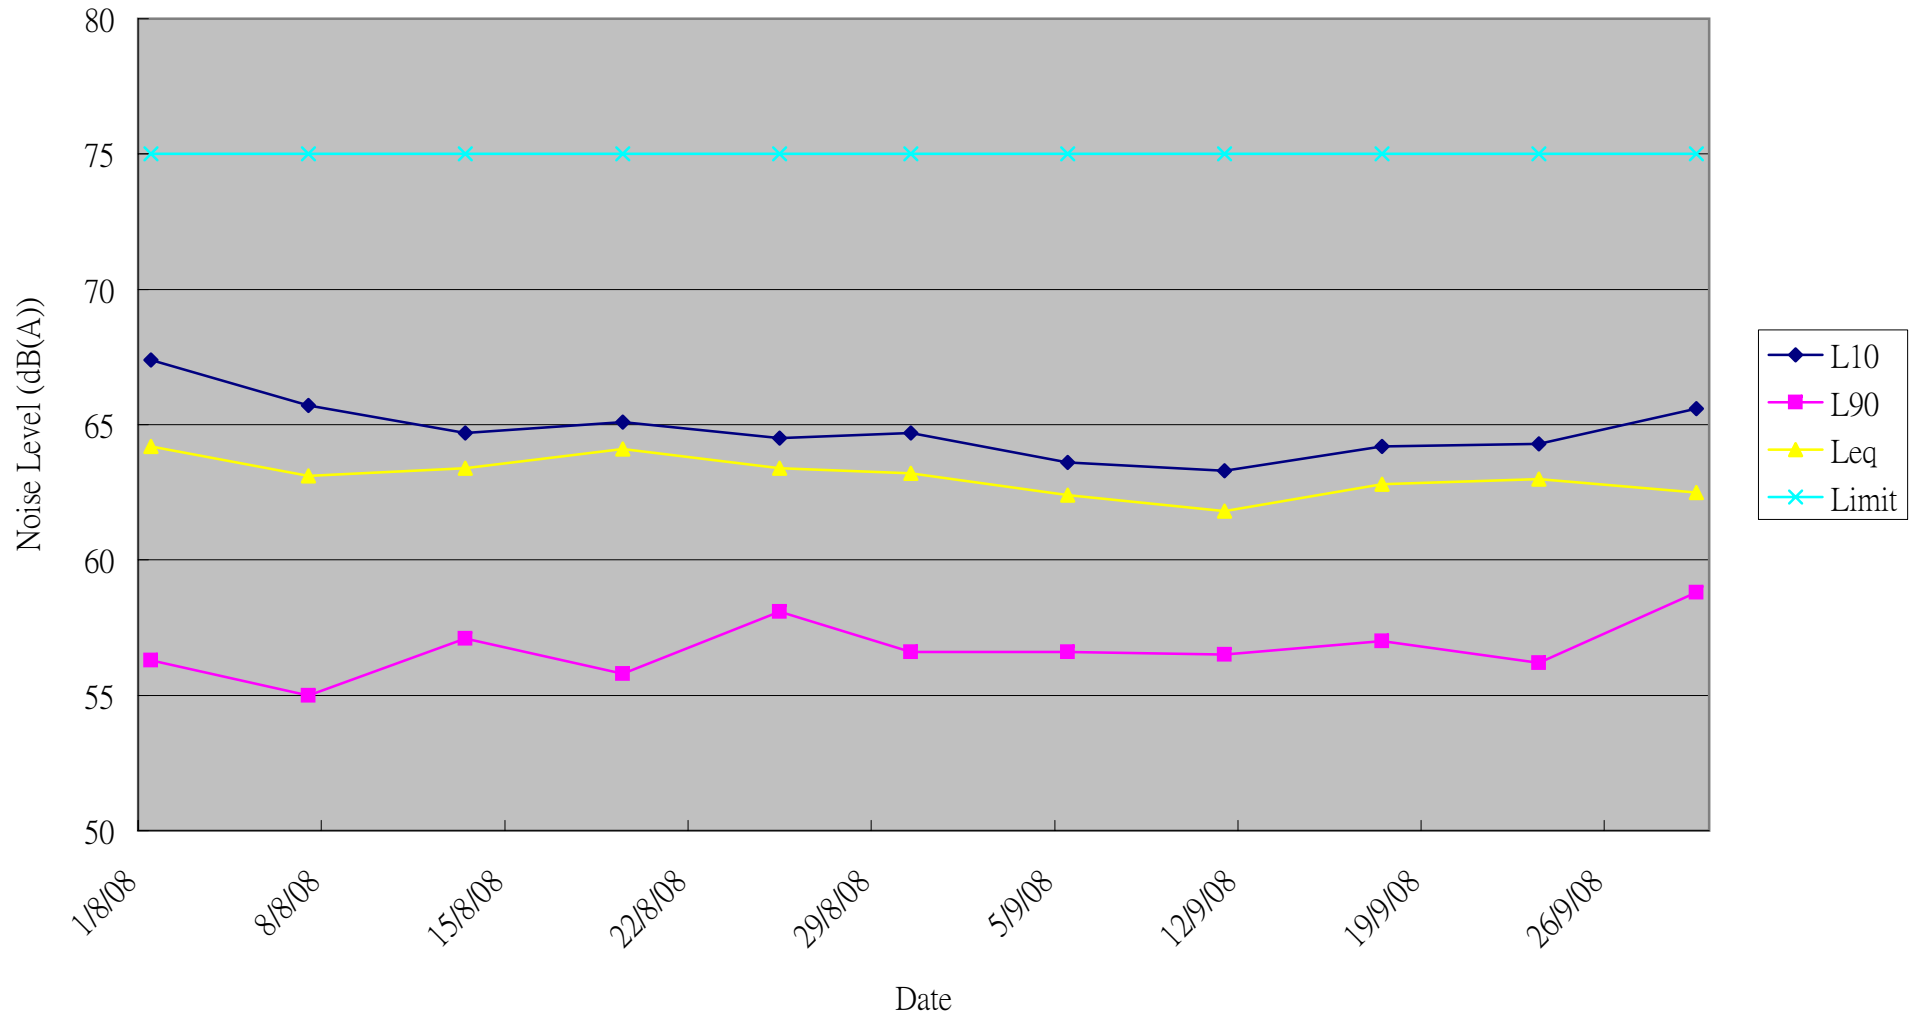
Graphical Plot of Noise Monitoring Record

*Summary and Graphical Plot of Noise Monitoring  
Record*

Date	Time	L10(30mins) (dB(A))	L90(30mins) (dB(A))	Leq(30mins) (dB(A))
5-Sep-08	10:55- 11:25	63.6	56.6	62.4
11-Sep-08	09:10 - 09:40	63.3	56.5	61.8
17-Sep-08	09:15 - 09:45	64.2	57.0	62.8
23-Sep-08	13:15 - 13:45	64.3	56.2	63.0
29-Sep-08	09:40 - 10:10	65.6	58.8	62.5
Average		64.2	56.6	62.5

Noise monitoring results in terms of  $L_{\text{eq}(30\text{min})}$ ,  $L_{10(30\text{min})}$   $L_{90(30\text{min})}$  measured at the designated noise monitoring location are summarized in Table 9.  $L_{10}$  and  $L_{90}$  represent sound levels that are exceeded 10% and 90% of the time respectively. Normally,  $L_{10}$  measurements can be considered as the average peak levels, whilst  $L_{90}$  levels can be considered as the average background noise levels.

During the reporting month, the minimum and maximum noise level measured at Yuet Wu Villa was 61.8dB(A)  $L_{\text{eq}(30\text{min})}$  and 63.0dB(A)  $L_{\text{eq}(30\text{min})}$  respectively with an average of 62.5dB(A)  $L_{\text{eq}(30\text{min})}$ . No exceedance was recorded in this reporting period. Summary of noise monitoring record will be provided in Appendix E.
