JOINT USER COMPLEX AND WHOLESALE FISH MARKET AT AREA 44, TUEN MUN

ENVIRONMENTAL MONITORING & AUDIT REPORT (MAY 2009)

ALLIED ENVIRONMENTAL CONSULTANTS LTD.

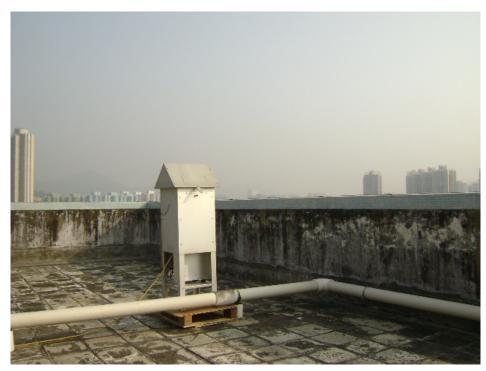
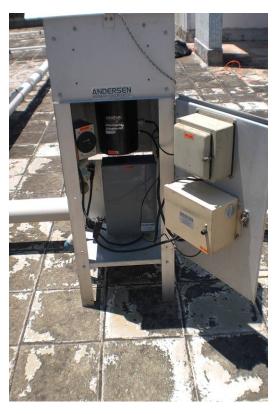
JOINT USER COMPLEX AND WHOLESALE FISH MARKET AT AREA 44,	Figure No. 4	Rev.: 0	6
TUEN MUN	Scale	Date	AEC
Photos of Air Quality Monitoring Station	NTS	6/09

Air quality monitoring and noise monitoring were conducted at Block 15, Yuet Wu Villa on 4th, 9th, 15th, 21st and 27th May 2009. Air quality monitoring station was set up at the roof top of the residential block and noise monitoring was conducted at 1.2m above ground level at the junction of Wu Sau Street and Wu On Street as given in Figure 2 and 3. Figure 4 and 5 show photos taken during monitoring at the two locations.

Roof top of Block 15, Yuet Wu Villa

High-Volume Dust Sampler

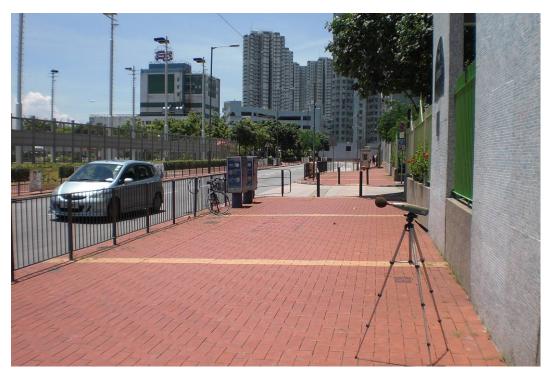
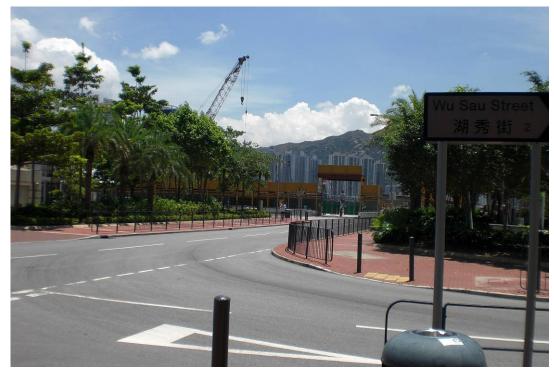
JOINT USER COMPLEX AND WHOLESALE FISH MARKET AT AREA 44,	Figure No. 5	Rev.: 0	
TUEN MUN	Scale	Date	AEC
Photos of Noise Monitoring Station	NTS	6/09

Noise level measurements were recorded in terms of thirty minutes A-weighted equivalent continuous sound pressure level (Leq(30min)) on a daily basis. The sound level meter was calibrated immediately prior to and following each noise measurement. The meter was mounted on a tripod at a height of 1.2m and the microphone was positioned at 1m away the building façade of the noise monitoring station facing the construction site.

Noise monitoring station

View from the noise monitoring station

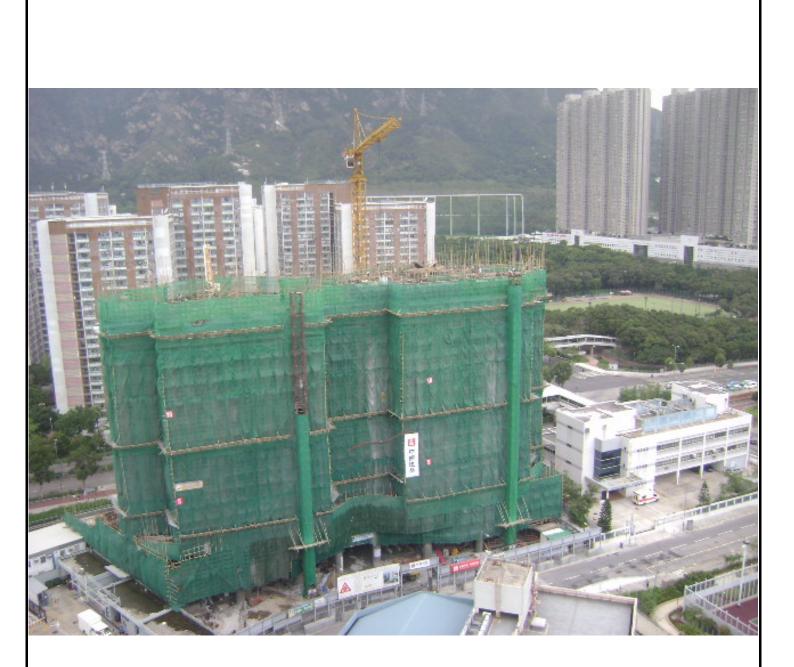
JOINT USER COMPLEX AND WHOLESALE FISH MARKET AT AREA 44,	Figure No. 6	Rev.: 0	6
TUEN MUN	Scale	Date	AEC
Photo of Construction Site for Junior Police Officers' Married Quarters	NTS	6/09

A construction site for the proposed Junior Police Officers' Married Quarters is located at Wu Hong Street which is 110m away from the monitoring location, which can be a major source of the noise and TSP generation during the monitoring period. Figure 6 shows the photo of the construction site.

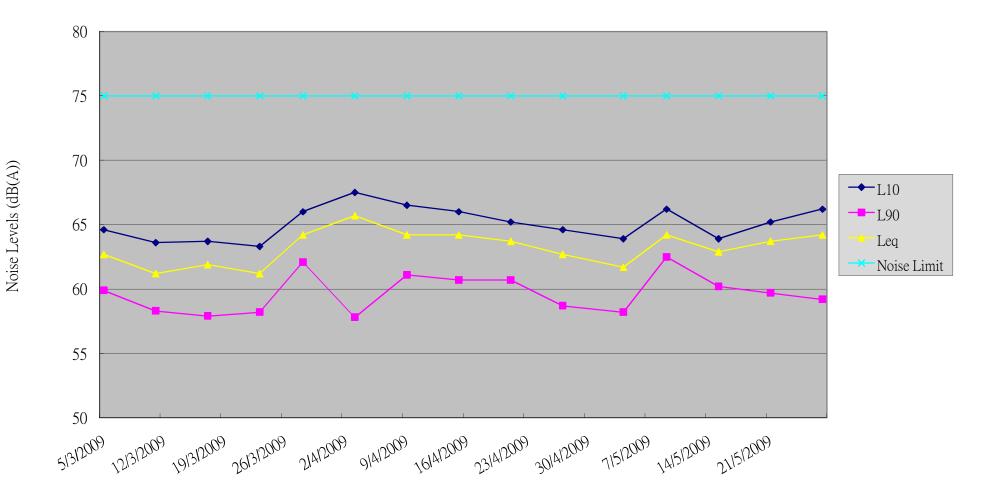
Noise Monitoring Record

Date	Time	L10(30mins) (dB(A))	L90(30mins) (dB(A))	Leq(30mins) (dB(A))
4-May-09	09:05 - 09:35	63.9	58.2	61.7
9-May-09	09:00 - 09:30	66.2	62.5	64.2
15-May-09	13:10 - 13:40	63.9	60.2	62.9
21-May-09	09:00 - 09:30	65.2	59.7	63.7
27-May-09	09:00 - 09:30	66.2	59.2	64.2
Average		65.1	60.0	63.3
