JOINT USER COMPLEX AND WHOLESALE FISH MARKET AT AREA 44, TUEN MUN

ENVIRONMENTAL MONITORING & AUDIT REPORT (AUGUST 2009)

ALLIED ENVIRONMENTAL CONSULTANTS LTD.

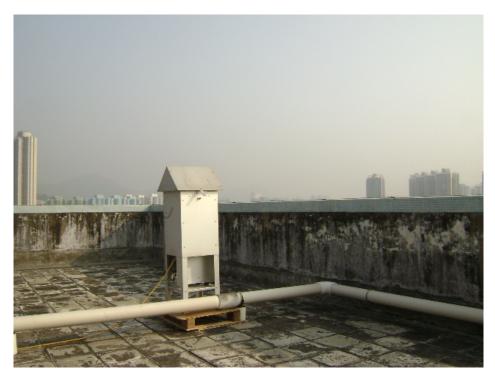
Figure No.	Rev.:
4	0
Scale	Date
NTS	9/09

1-hour and 24-hour TSP air quality monitoring was conducted at the designated air quality monitoring location using a High Volume TSP Sampler (Model No: Anderson GMWS-2310 ACCU-VOL) at the designated location. The Calibration Record of the High-Volume TSP Sampler is given in Appendix B. 24-hour TSP samples were taken every six days. 1-hour TSP samples were taken three times a day between 0700-1900 hours. The weighing of the filter paper used in the monitoring will be undertaken by ASL Laboratory Group Environmental Division.

Roof top of Block 15, Yuet Wu Villa

High-Volume Dust Sampler

PHOTOS OF AIR QUALITY MONITORING STATION

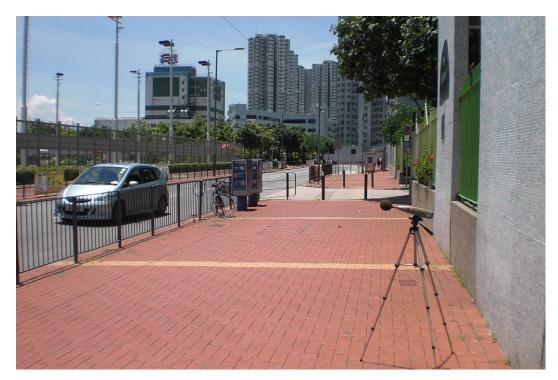
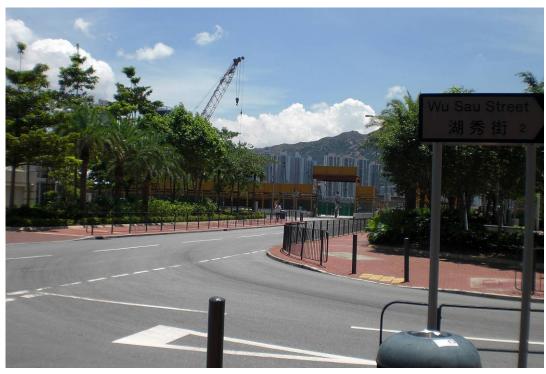
Figure No.	Rev.:
5	0
Scale	Date
NTS	9/09

Noise monitoring was conducted at the designated noise monitoring location between 0700-1900 hours using a sound level meter which complies with the International Electrotechnical Commission Publications 651:1979 (Type 1) and 804:1985 (Type 1). Noise instrumentation details are given in Table 6 and the Calibration Certificate for the sound level meter and calibrator is given in Appendix C.

Noise level measurements were recorded in terms of thirty minutes A-weighted equivalent continuous sound pressure level (Leq(30min)) on a daily basis. The sound level meter was calibrated immediately prior to and following each noise measurement. The meter was mounted on a tripod at a height of 1.2m and the microphone was positioned at 1m away the building façade of the noise monitoring station facing the construction site.

Noise monitoring station

View from the noise monitoring station

PHOTOS OF NOISE MONITORING STATION

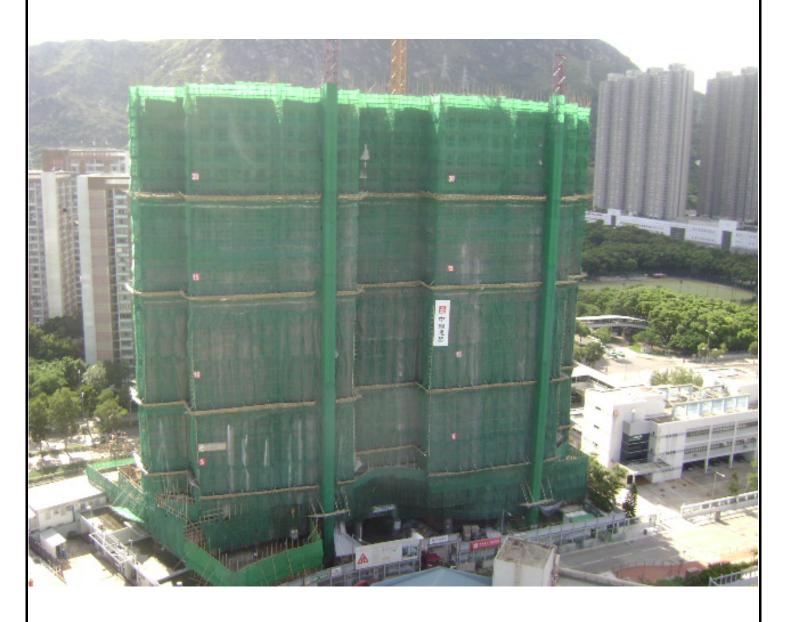
Figure No.	Rev.:
6	0
Scale	Date
NTS	9/09

A construction site for the proposed Junior Police Officers' Married Quarters is located at Wu Hong Street which is 110m away from the monitoring location, which can be a major source of the noise and TSP generation during the monitoring period. Figure 6 shows the photo of the construction site.

${\bf Photo\ of\ Construction\ Site\ for\ Junior\ Police\ Officers'\ Married\ Quarters}$
