**JOINT USER COMPLEX AND  
WHOLESALE FISH MARKET AT  
AREA 44, TUEN MUN**

**ENVIRONMENTAL MONITORING &  
AUDIT REPORT (DECEMBER 2009)**

**ALLIED ENVIRONMENTAL CONSULTANTS LTD.**

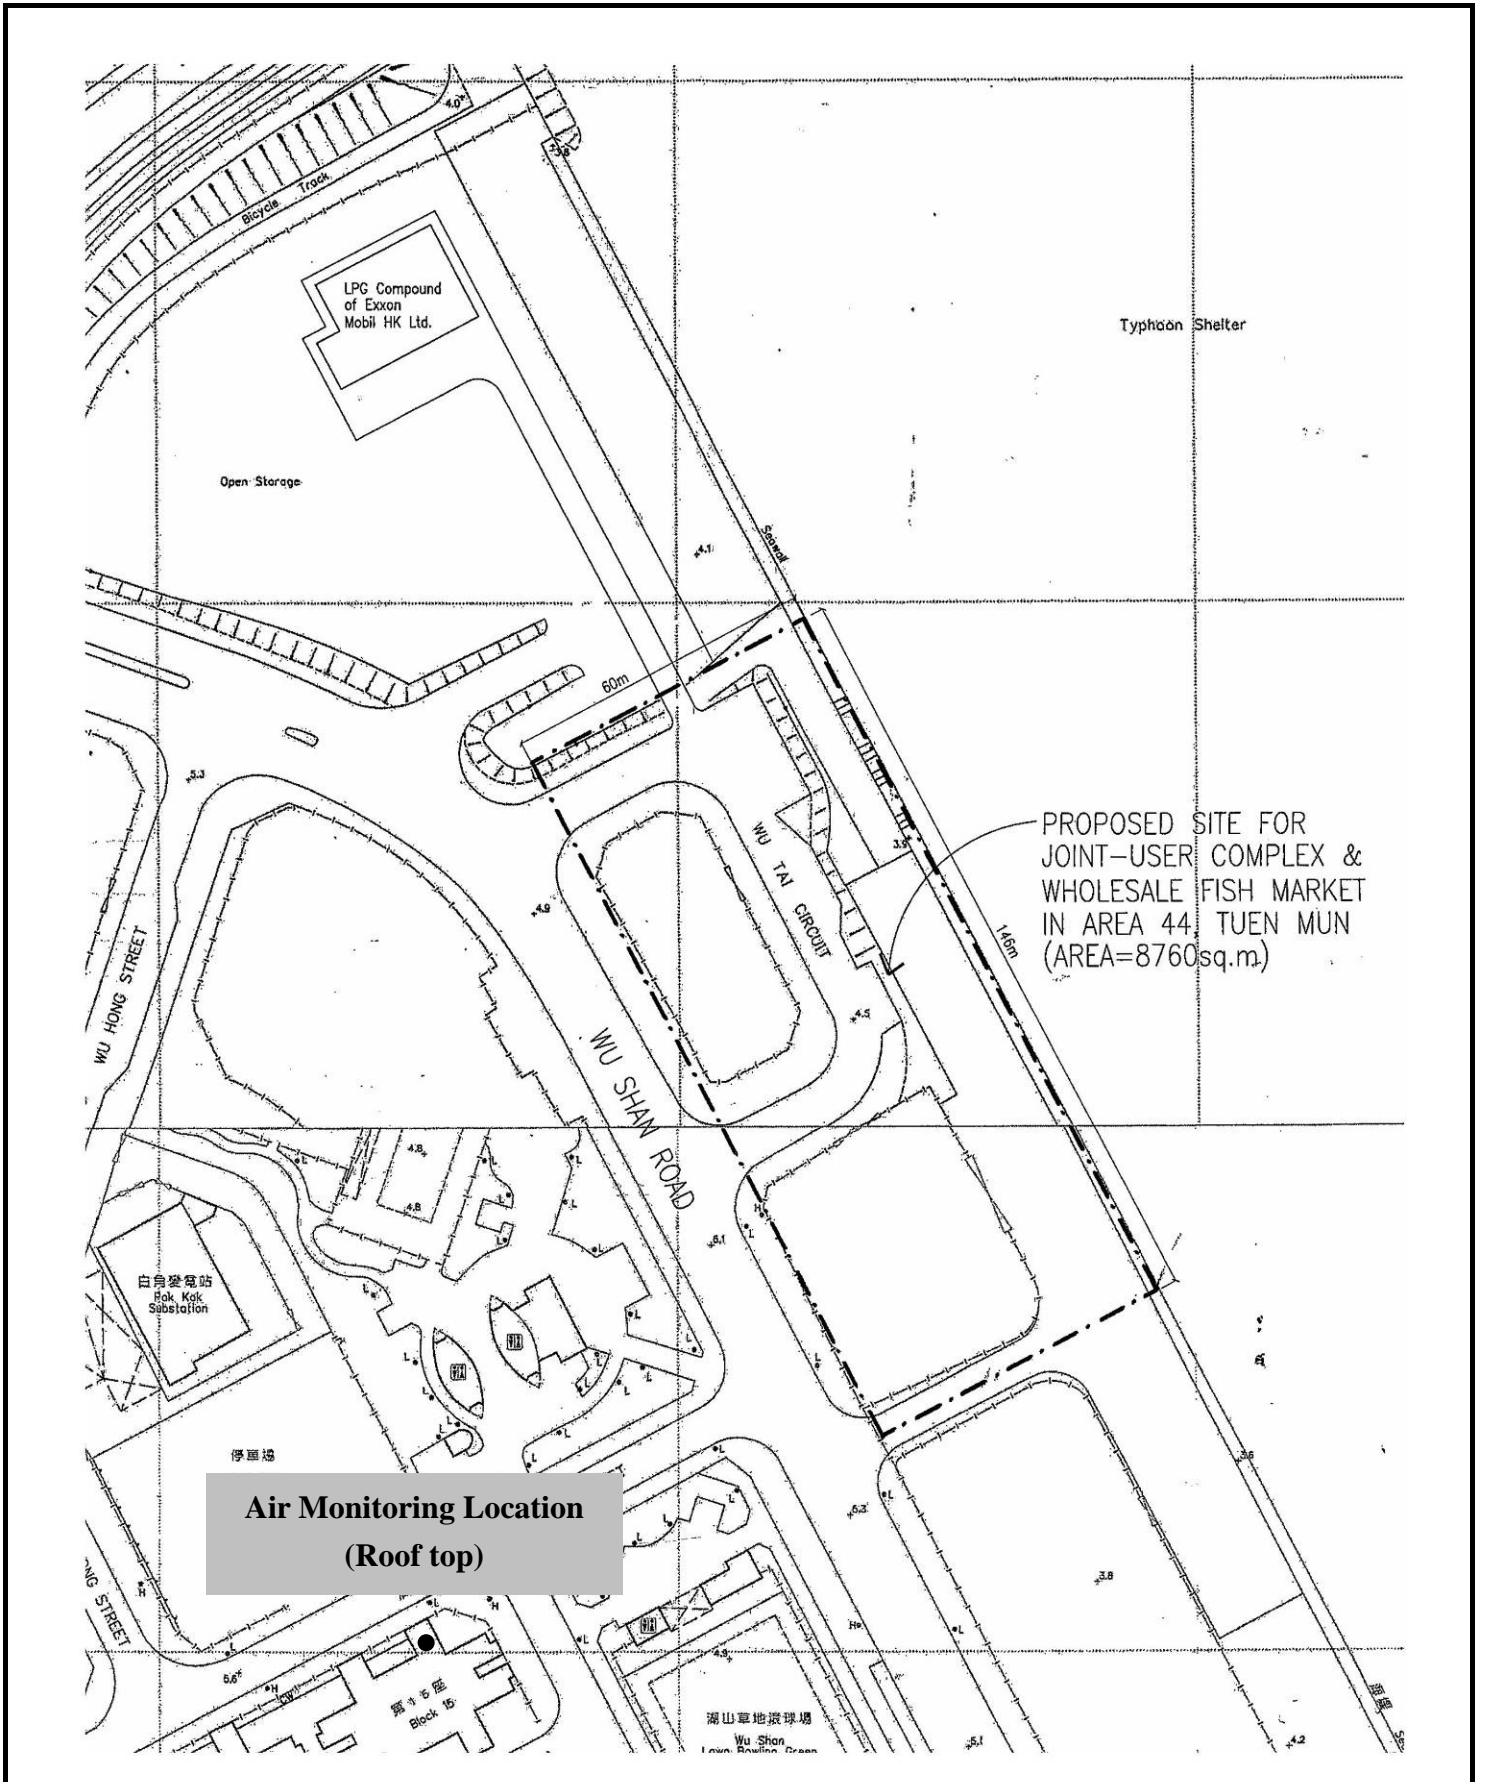
Figure No.	Rev.:
2	0
Scale	Date
NTS	1/10

1-hour and 24-hour TSP air quality monitoring was conducted at the designated air quality monitoring location using a High Volume TSP Sampler (Model No: Anderson GMWS-2310 ACCU-VOL) at the designated location. The Calibration Record of the High-Volume TSP Sampler is given in Appendix B. 24-hour TSP samples were taken every six days. 1-hour TSP samples were taken three times a day between 0700-1900 hours. The weighing of the filter paper used in the monitoring will be undertaken by ALS Laboratory Group Environmental Division. (HOKLAS Registration No.: 066)

**LOCATION OF AIR QUALITY MONITORING STATION**

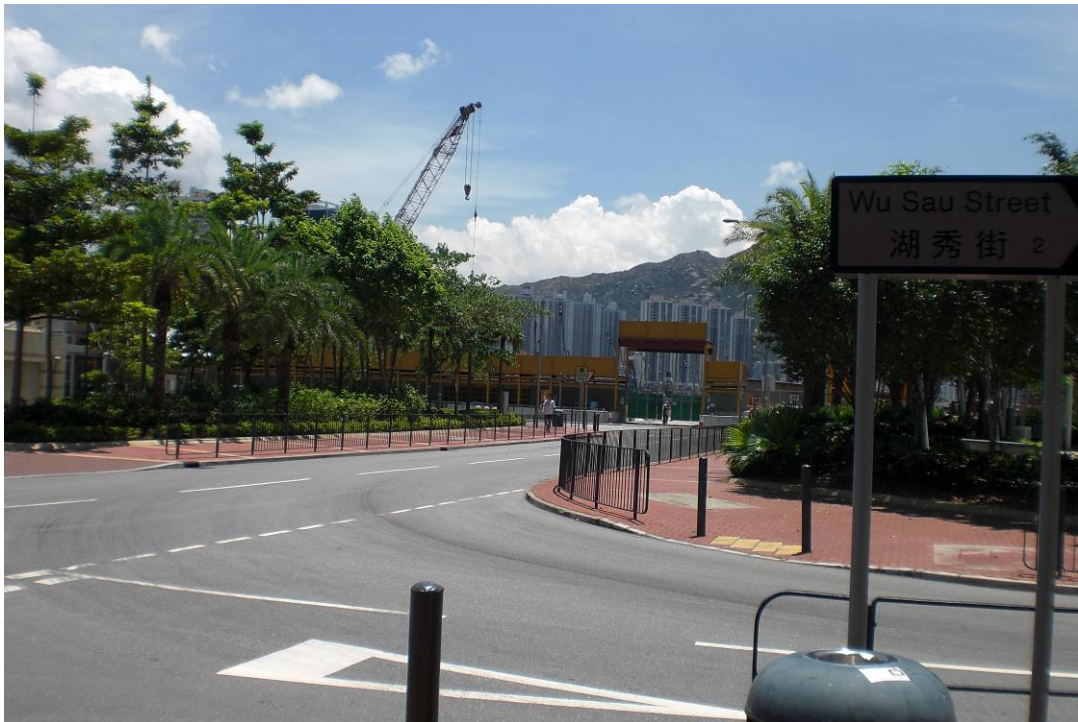
Figure No.

*Noise monitoring station*

*View from the noise monitoring station*

**JOINT USER COMPLEX AND WHOLESALE FISH MARKET AT AREA 44,  
TUEN MUN  
PHOTOS OF NOISE MONITORING STATION**

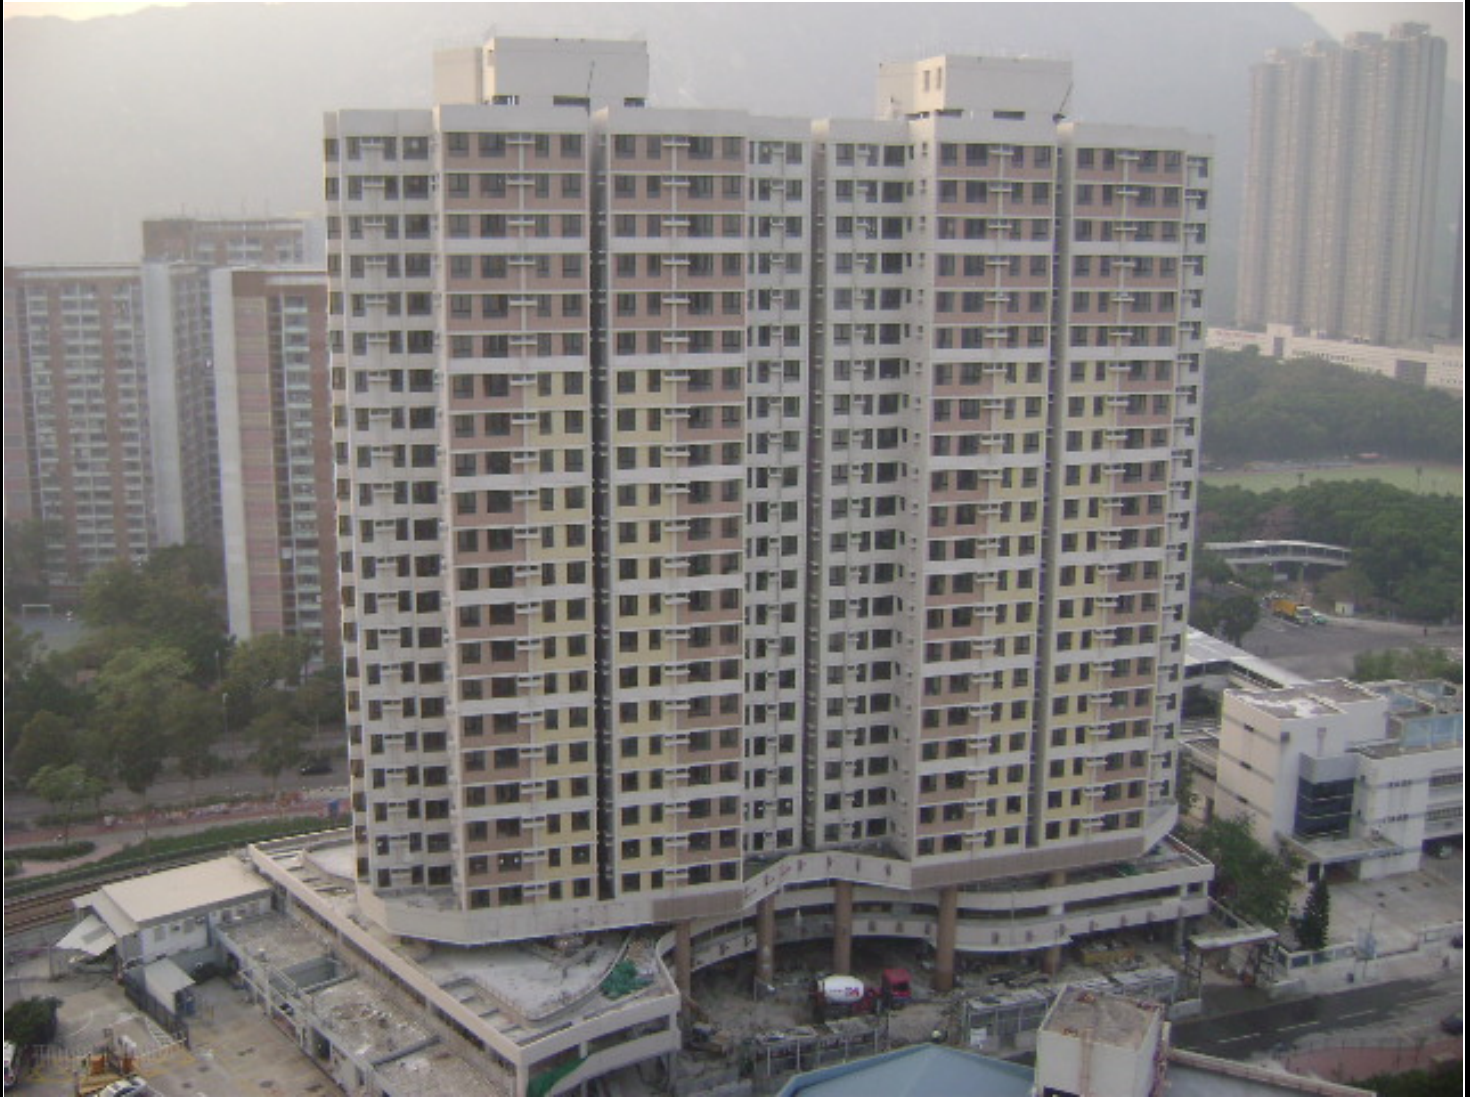
Figure No.

A construction site for the proposed Junior Police Officers' Married Quarters is located at Wu Hong Street which is 110m away from the monitoring location, which can be a major source of the noise and TSP generation during the monitoring period. Figure 6 shows the photo of the construction site.

**PHOTO OF CONSTRUCTION SITE FOR JUNIOR POLICE OFFICERS' MARRIED QUARTERS**

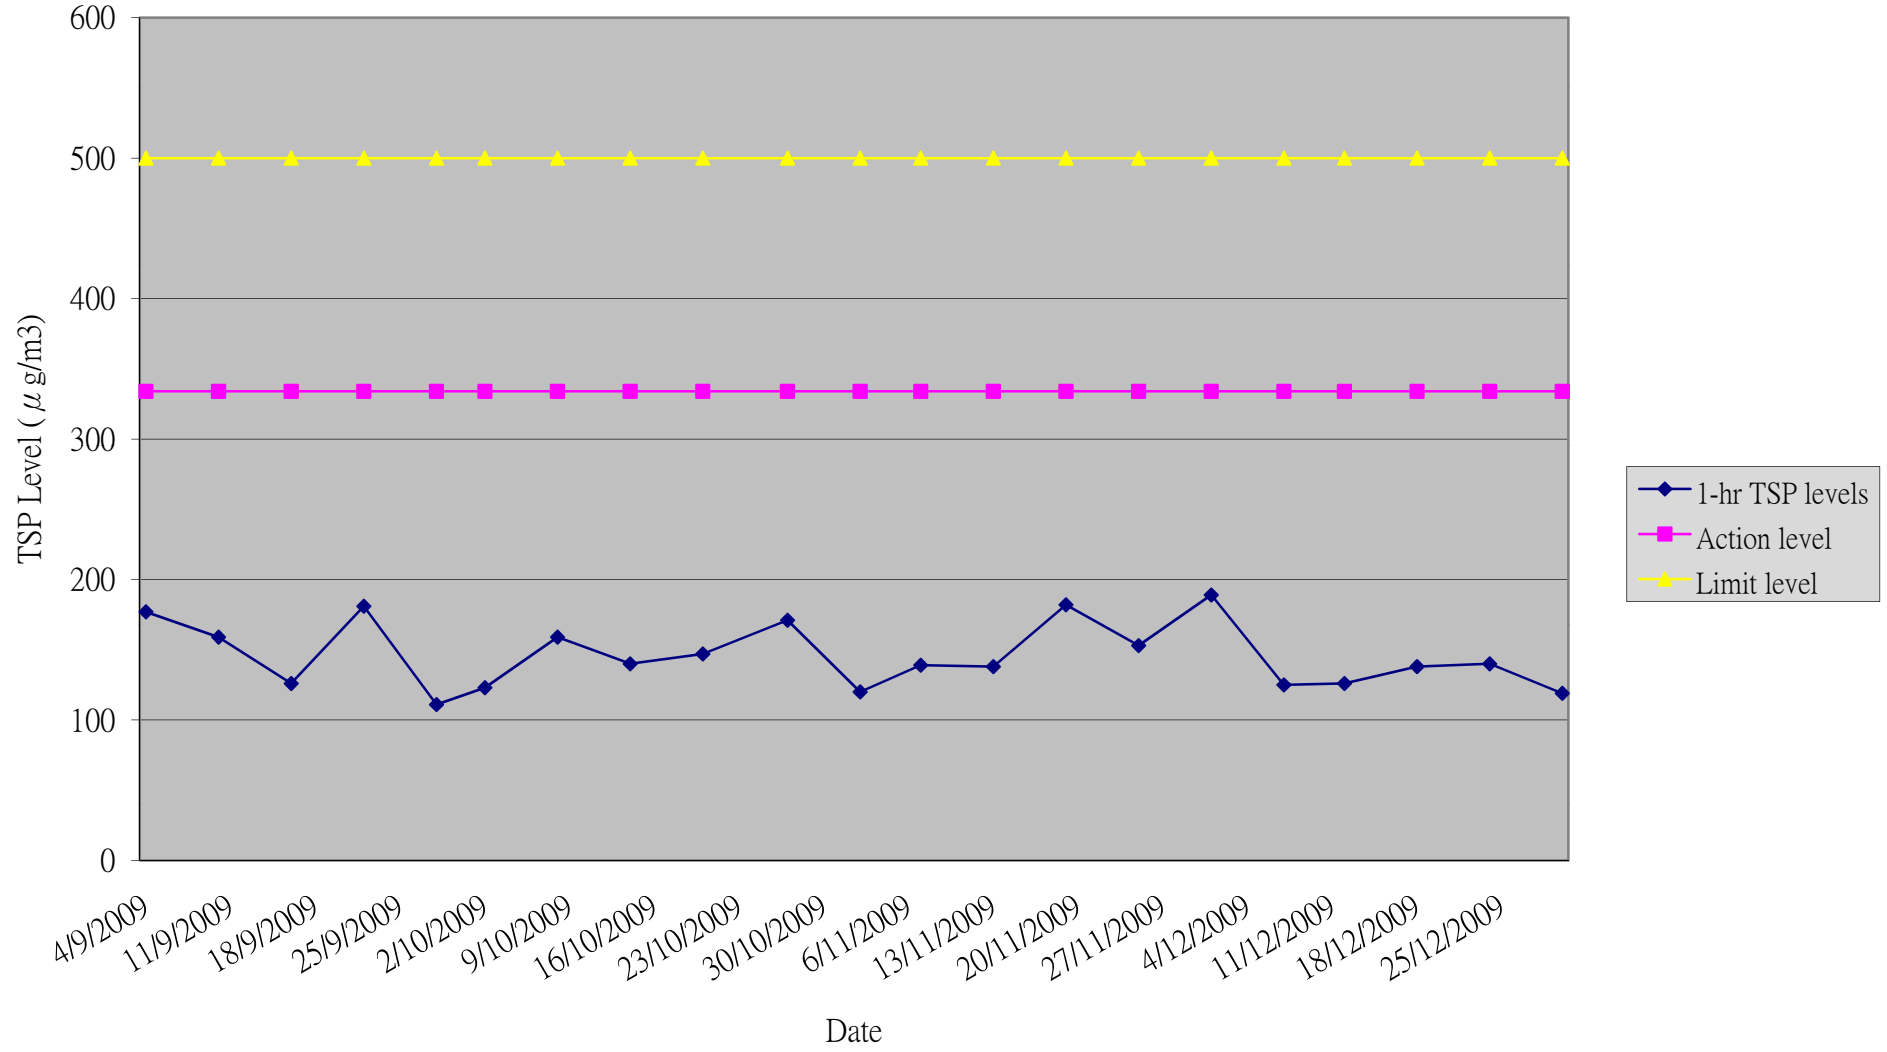
1-hr TSP Levels

*Summary and Graphical Plot of 1-Hour TSP  
Monitoring Record*

Date	Time	1-hr TSP ( $\mu\text{g}/\text{m}^3$ )	Average
1-Dec-09	08:30 - 09:30	175	189
	09:30 - 10:30	181	
	10:30 - 11:30	211	
7-Dec-09	13:00 - 14:00	112	125
	14:00 - 15:00	119	
	15:00 - 16:00	144	
12-Dec-09	08:30 - 09:30	106	126
	09:30 - 10:30	127	
	10:30 - 11:30	144	
18-Dec-09	13:00 - 14:00	105	138
	14:00 - 15:00	153	
	15:00 - 16:00	155	
24-Dec-09	13:00 - 14:00	125	140
	14:00 - 15:00	143	
	15:00 - 16:00	153	
30-Dec-09	13:00 - 14:00	120	119
	14:00 - 15:00	112	
	15:00 - 16:00	125	
		Average	139

1-hour and 24-hour TSP monitoring results are summarized in Table 7 and 8 and serve as the basis for determining the action and limit levels. The minimum and maximum 1-hour TSP measured at Yuet Wu Villa was 105 $\mu\text{g}/\text{m}^3$  and 211 $\mu\text{g}/\text{m}^3$  respectively with an average of 139 $\mu\text{g}/\text{m}^3$ . The minimum and maximum 24-hour TSP measured was 62 $\mu\text{g}/\text{m}^3$  and 110 $\mu\text{g}/\text{m}^3$  respectively with an average of 78 $\mu\text{g}/\text{m}^3$ . Summary of air quality monitoring record is provided in Appendices D and E.

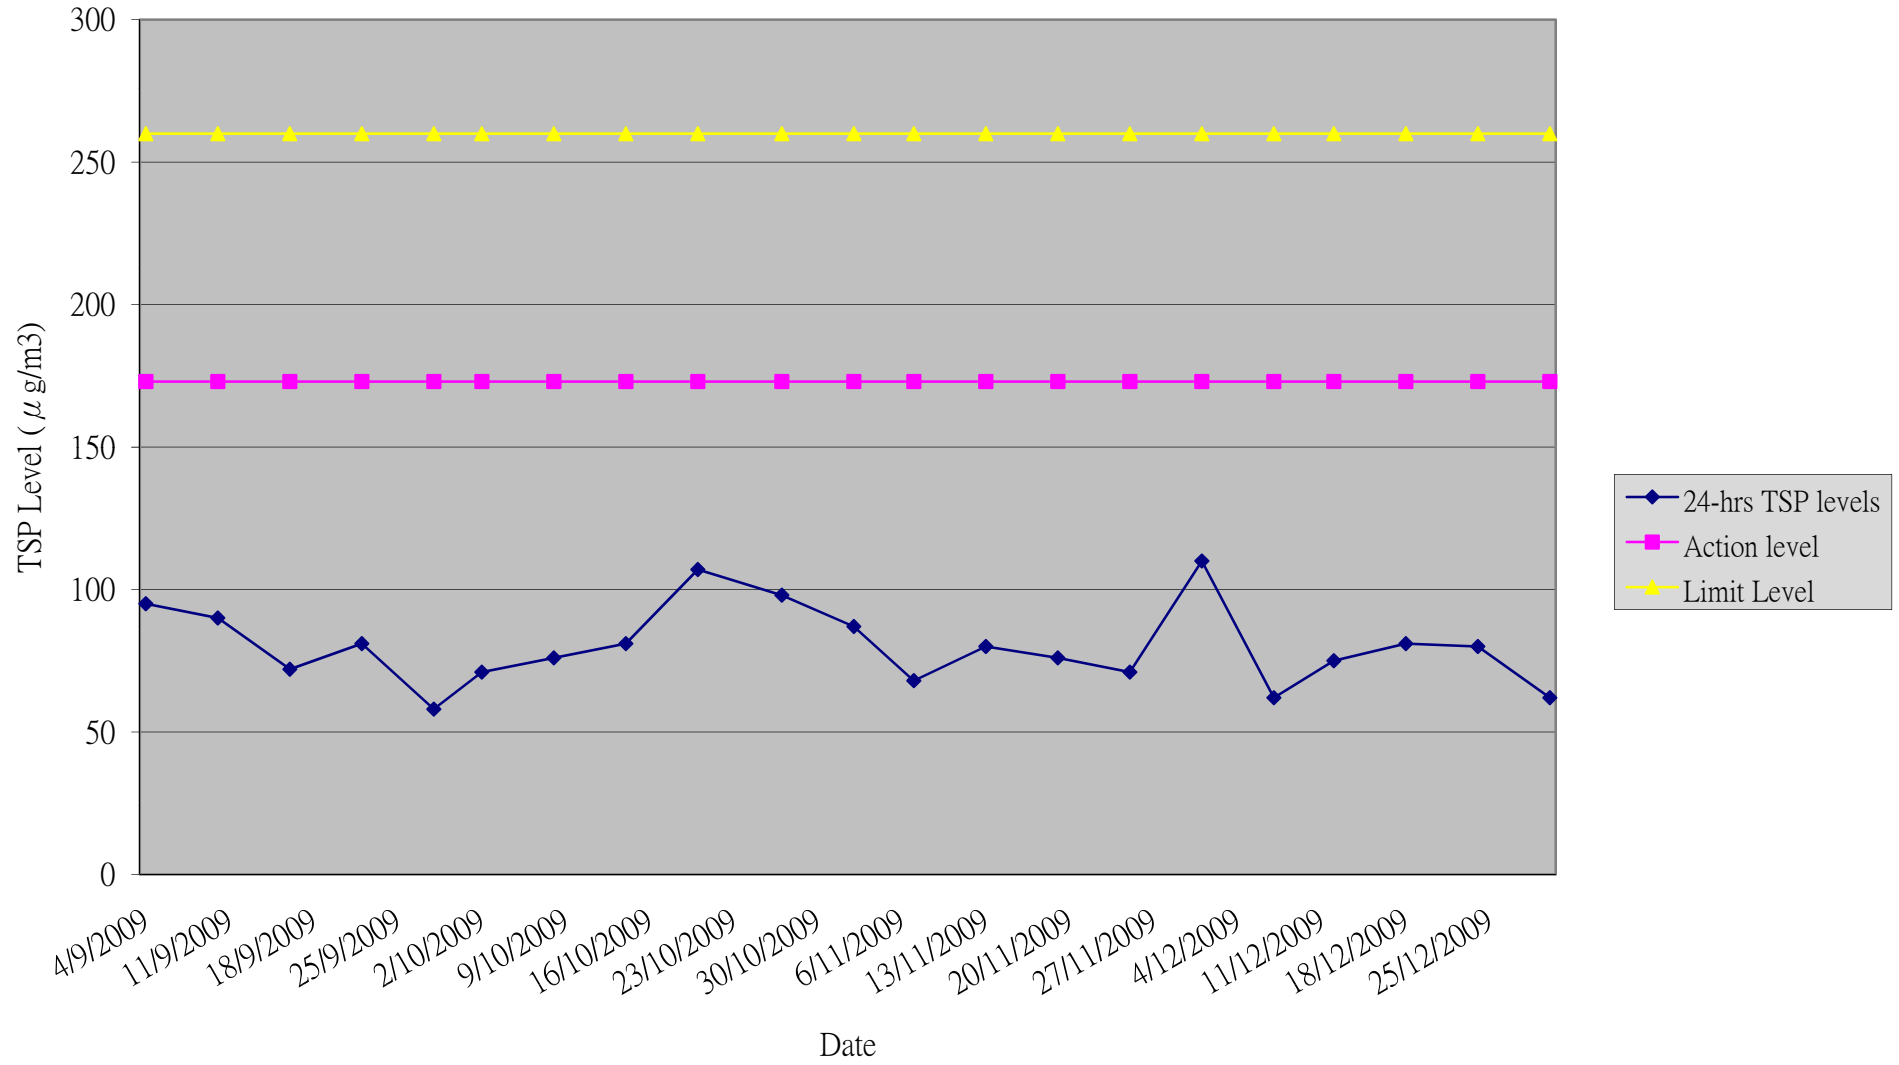
24-hour TSP Levels

*Summary and Graphical Plot of 24-Hour TSP  
Monitoring Record*

Date	Start time	24-hr TSP ( $\mu\text{g}/\text{m}^3$ )
1-Dec-09	11:30	110
7-Dec-09	16:00	62
12-Dec-09	11:30	75
18-Dec-09	16:00	81
24-Dec-09	16:00	80
30-Dec-09	16:00	62
Average		78

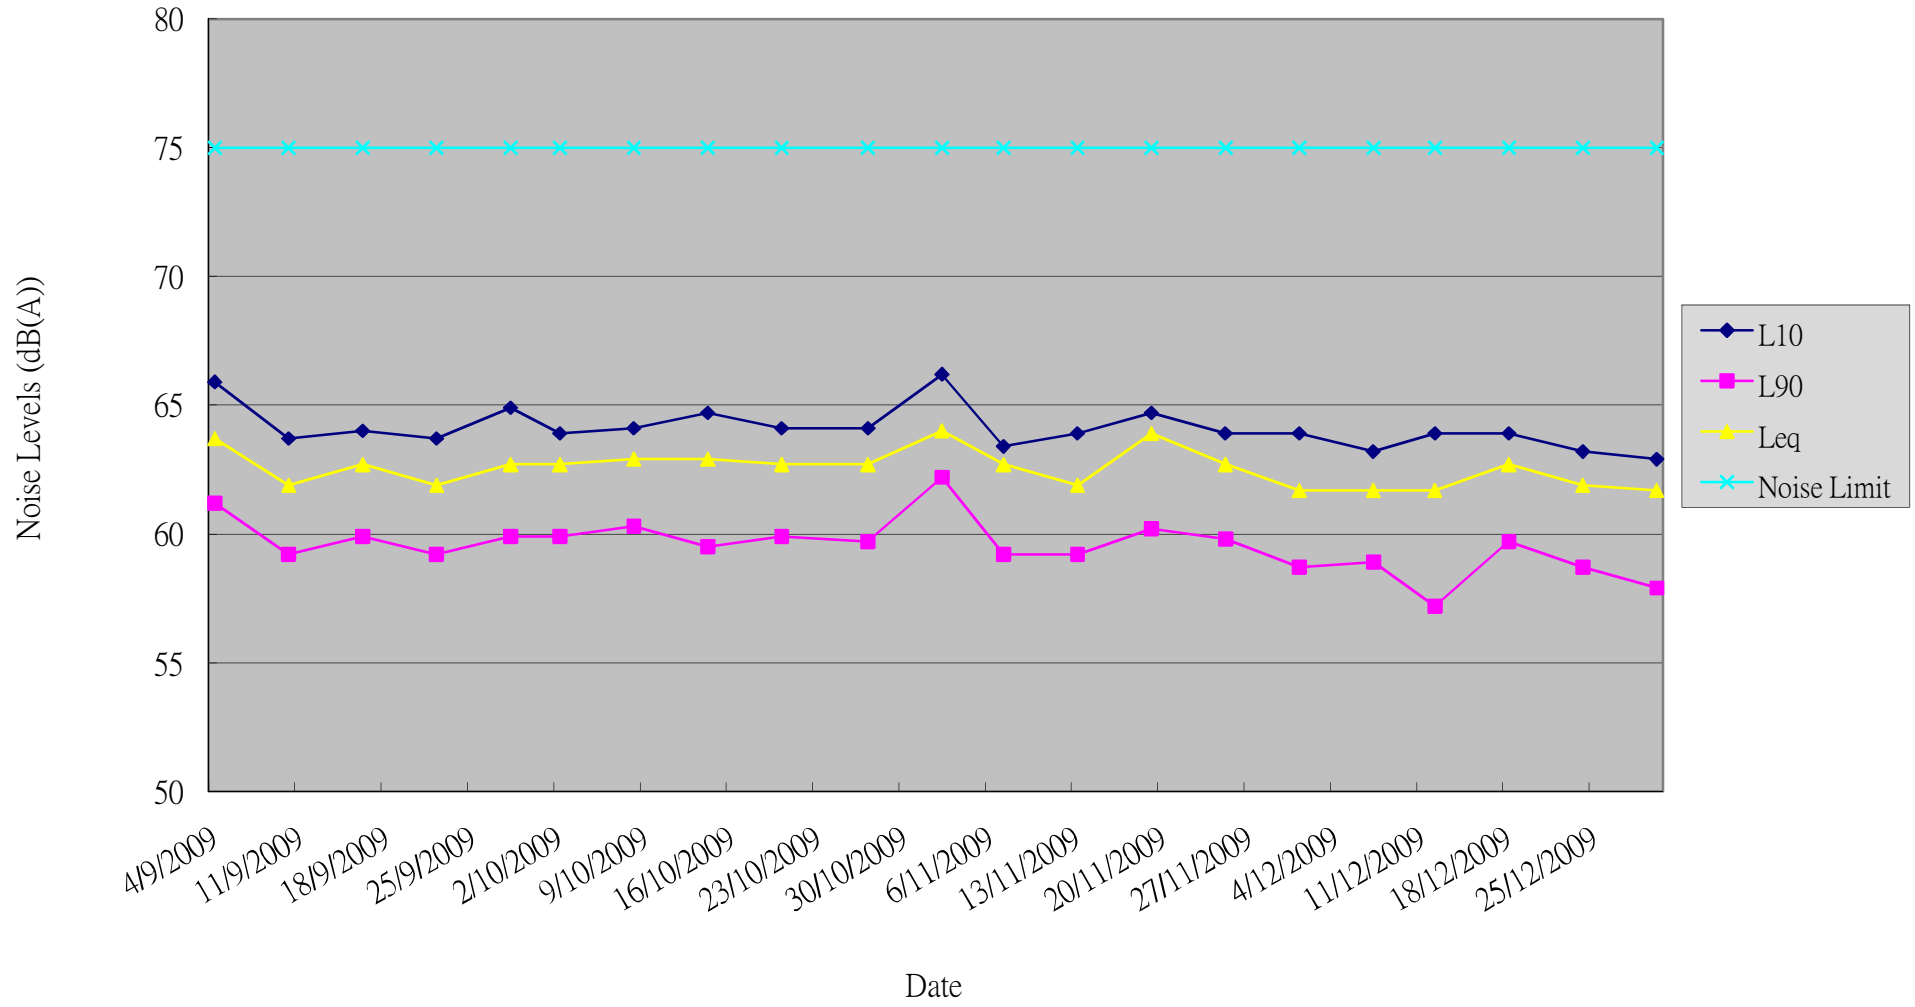
# Noise Monitoring Record

*Summary and Graphical Plot of Noise Monitoring  
Record*

Date	Time	L10(30mins) (dB(A))	L90(30mins) (dB(A))	Leq(30mins) (dB(A))
1-Dec-09	08:50 - 09:20	63.9	58.7	61.7
7-Dec-09	15:15 - 15:45	63.2	58.9	61.7
12-Dec-09	08:50 - 09:20	63.9	57.2	61.7
18-Dec-09	13:10 - 13:40	63.9	59.7	62.7
24-Dec-09	13:10 - 13:40	63.2	58.7	61.9
30-Dec-09	13:10 - 13:40	62.9	57.9	61.7
Average		63.5	58.5	61.9

During the reporting month, the minimum and maximum noise level measured at Yuet Wu Villa was 61.7dB(A)  $L_{eq(30min)}$  and 62.7dB(A)  $L_{eq(30min)}$  respectively with an average of 61.9dB(A)  $L_{eq(30min)}$ . No exceedance was recorded in this reporting period. Summary of noise monitoring record will be provided in Appendix F.
