JOINT USER COMPLEX AND WHOLESALE FISH MARKET AT AREA 44, TUEN MUN

ENVIRONMENTAL MONITORING & AUDIT REPORT (FEBRUARY 2010)

ALLIED ENVIRONMENTAL CONSULTANTS LTD.

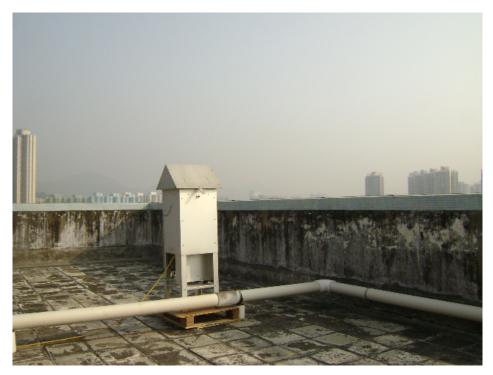
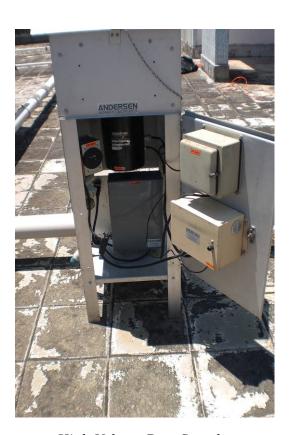
Rev.:
0
Date
3/10

Roof top of Block 15, Yuet Wu Villa

High-Volume Dust Sampler

PHOTOS OF AIR QUALITY MONITORING STATION

1-hour and 24-hour TSP air quality monitoring was conducted at the designated air quality monitoring location using a High Volume TSP Sampler (Model No: Anderson GMWS-2310 ACCU-VOL) at the designated location. The Calibration Record of the High-Volume TSP Sampler is given in Appendix B. 24-hour TSP samples were taken every six days. 1-hour TSP samples were taken three times a day between 0700-1900 hours. The weighing of the filter paper used in the monitoring was undertaken by ALS Laboratory Group Environmental Division. (HOKLAS Registration No.: 066)

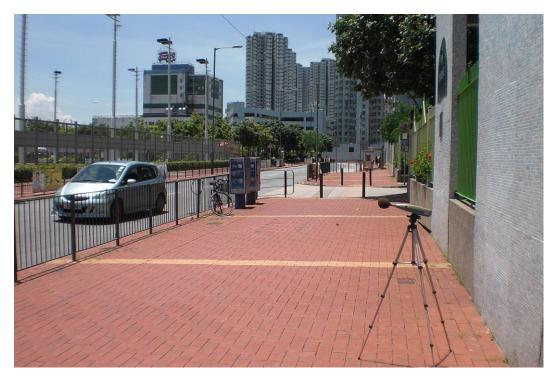
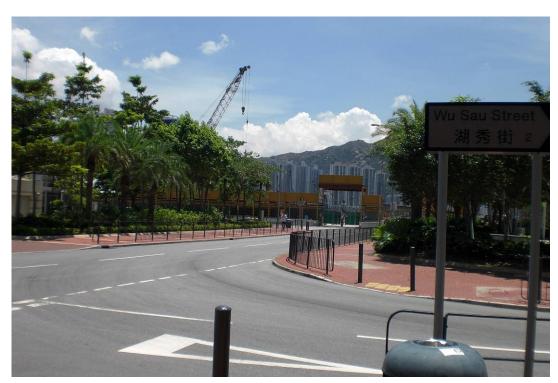
Figure No.	Rev.:
5	0
Scale	Date
NTS	3/10

Noise monitoring station

View from the noise monitoring station

PHOTOS OF NOISE MONITORING STATION

Noise level measurements were recorded in terms of thirty minutes A-weighted equivalent continuous sound pressure level ( $L_{eq(30min)}$ ) on a daily basis. The sound level meter was calibrated immediately prior to and following each noise measurement. The meter was mounted

on a tripod at a height of 1.2m and the microphone was positioned at 1m away the building façade of the noise monitoring station facing the construction site.

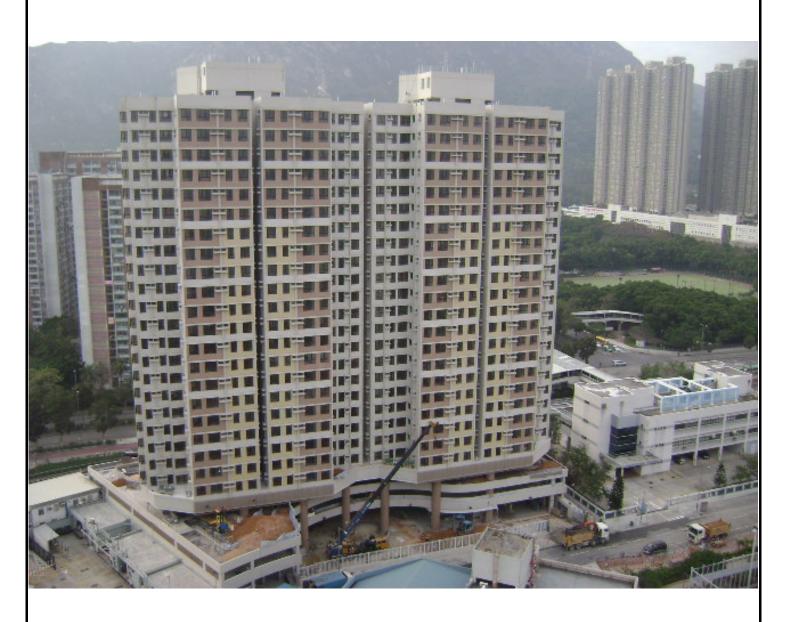
Figure No.	Rev.:
6	0
Scale	Date
NTS	3/10

PHOTO OF CONSTRUCTION SITE FOR JUNIOR POLICE OFFICERS' MARRIED QUARTERS

A construction site for the proposed Junior Police Officers' Married Quarters is located at Wu Hong Street which is 110m away from the monitoring location, which can be a major source of the noise and TSP generation during the monitoring period. Figure 6 shows the photo of the construction site.
