Issue No. : 1  
Issue Date : April 2010  
Project No. : 768

**JOINT USER COMPLEX AND  
WHOLESALE FISH MARKET AT  
AREA 44, TUEN MUN**

**ENVIRONMENTAL MONITORING &  
AUDIT REPORT (MARCH 2010)**

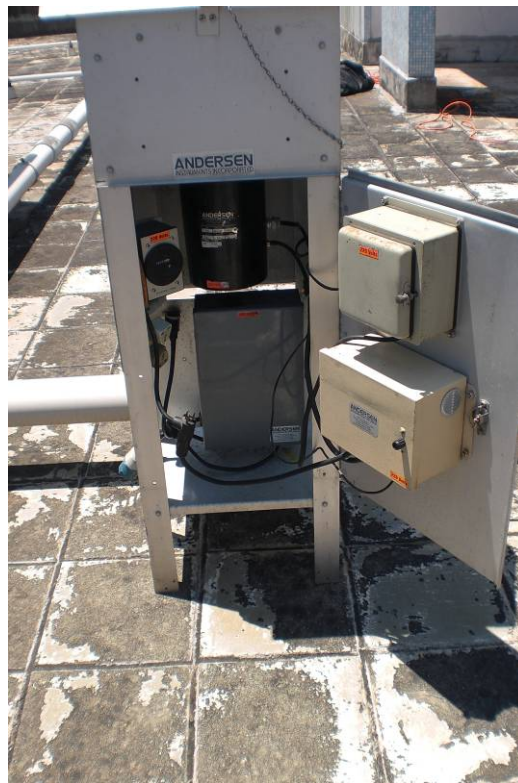
Figure No.

*Roof top of Block 15, Yuet Wu Villa*

*High-Volume Dust Sampler*

**JOINT USER COMPLEX AND WHOLESALE FISH MARKET AT AREA 44,  
TUEN MUN  
PHOTOS OF AIR QUALITY MONITORING STATION**

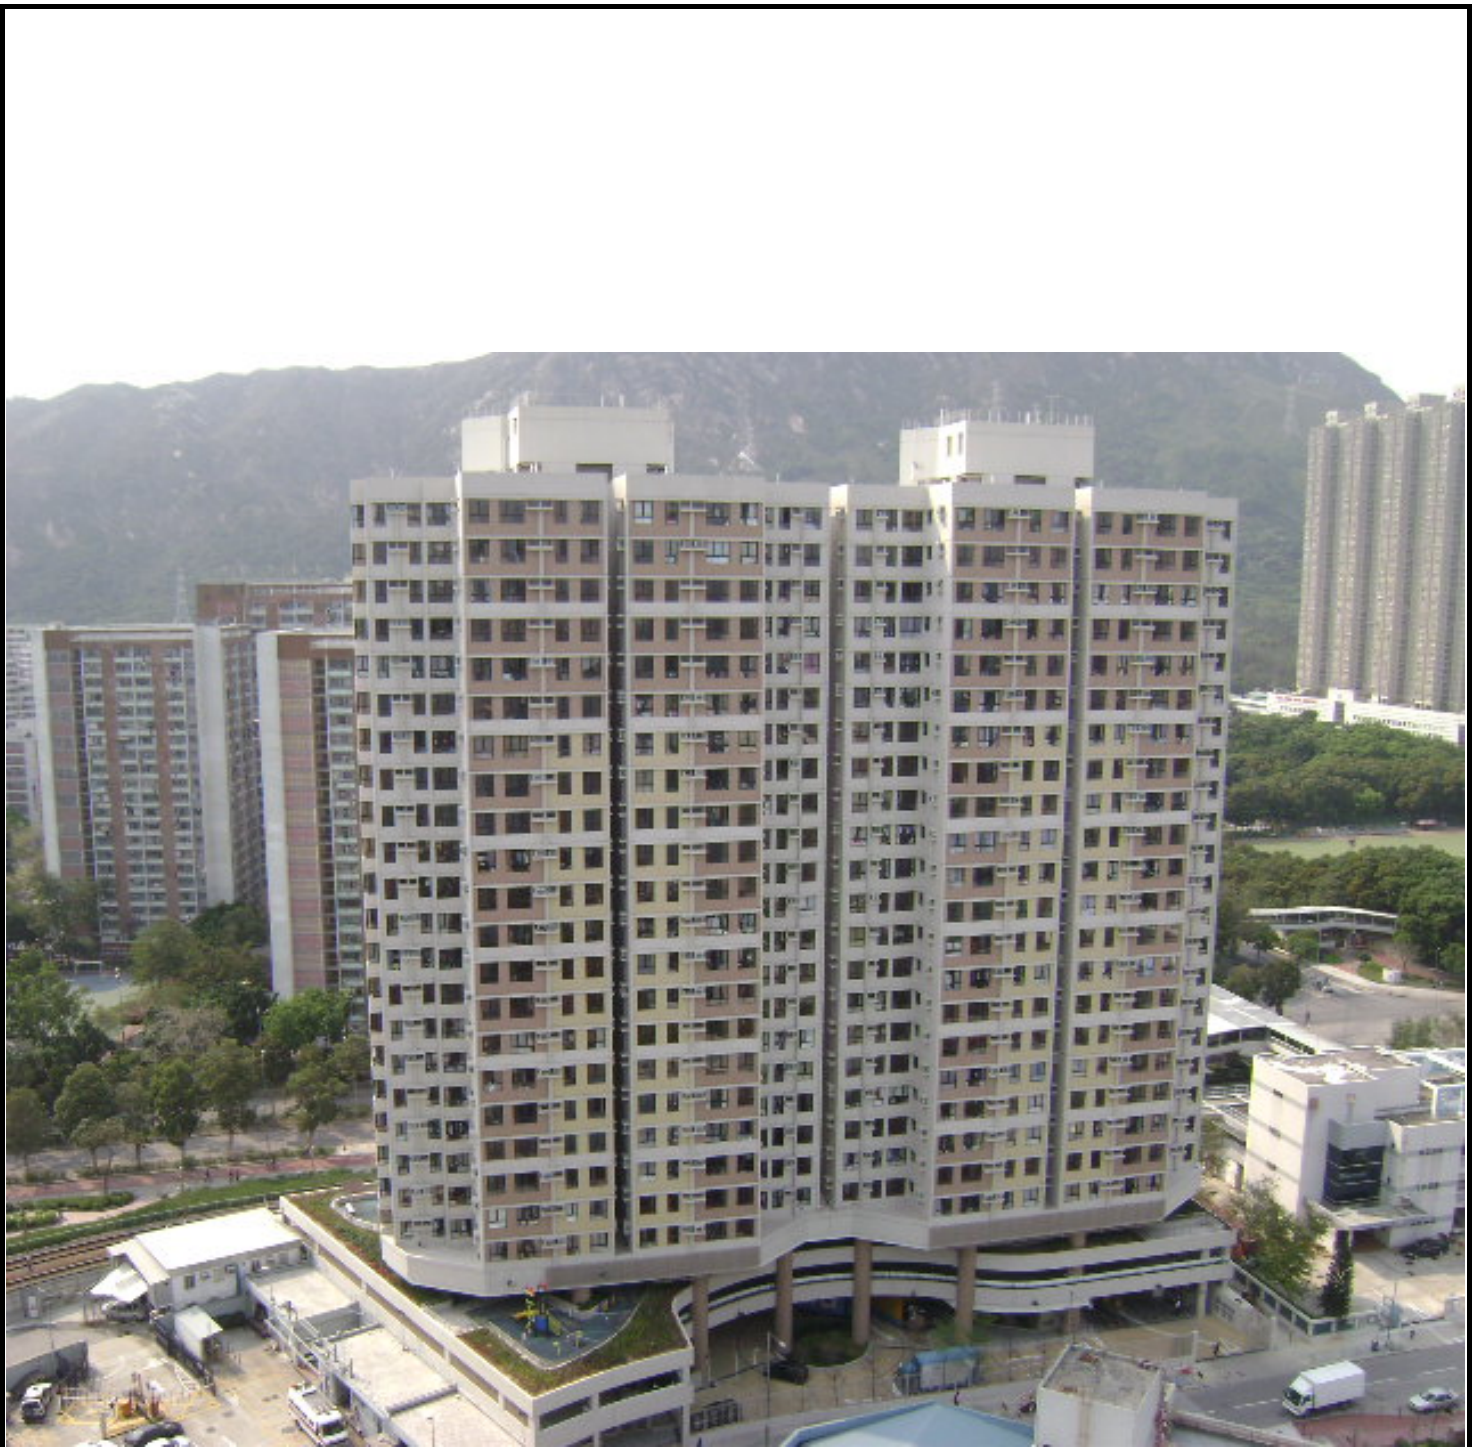
Figure No.

A construction site for the proposed Junior Police Officers' Married Quarters is located at Wu Hong Street which is 110m away from the monitoring location, which can be a major source of the noise and TSP generation during the monitoring period. The construction works of proposed Junior Police Officers' Married Quarters were completed in March 2010. Figure 6 shows the photo of the construction site.

**PHOTO OF CONSTRUCTION SITE FOR JUNIOR POLICE OFFICERS' MARRIED QUARTERS**
