**CONTRACT NO. DC/2010/02 –
DRAINAGE IMPROVEMENT IN SHUEN WAN AND
SHEK WU WAI**

**MONTHLY ENVIRONMENTAL MONITORING AND
AUDIT REPORT (NO.5) – NOVEMBER 2011**

PREPARED FOR
KWAN LEE-KULY JOINT VENTURE

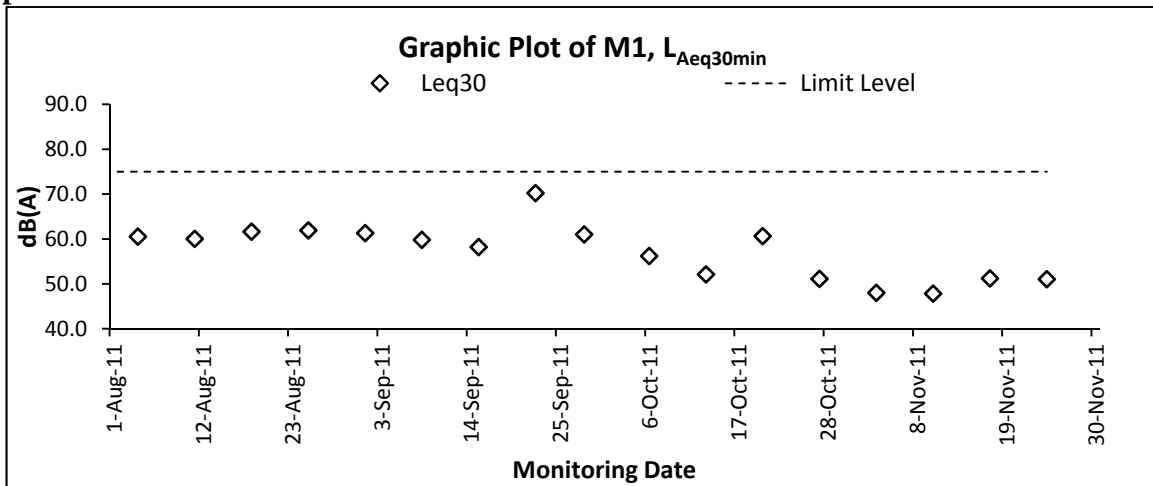
Remark: The monitoring is undertaken under façade situation. No façade correction is added according to acoustical principles and EPD guidelines.

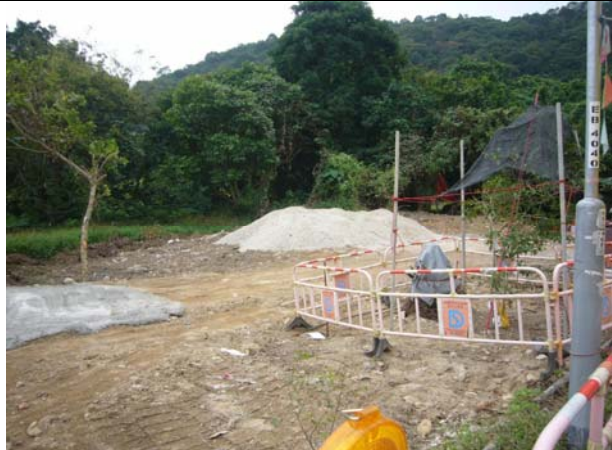
Observations recorded in this Site Inspection (17-11-2011):

<p>1. Open stockpile was observed within the site, the Contractor is reminded to cover any dusty material with tarpaulin sheet under dry and windy conditions.</p>

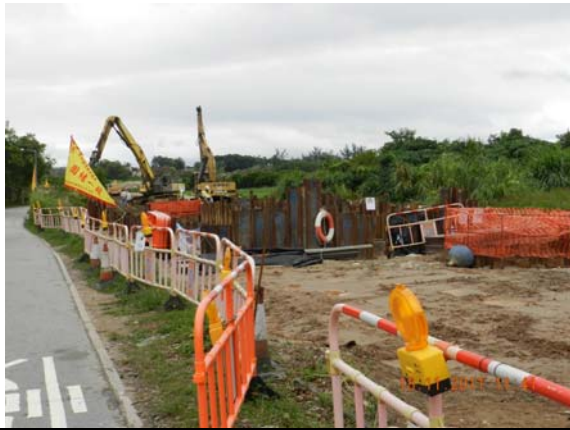
Photo 1 – Temporary hoardings have been erected around the active works area

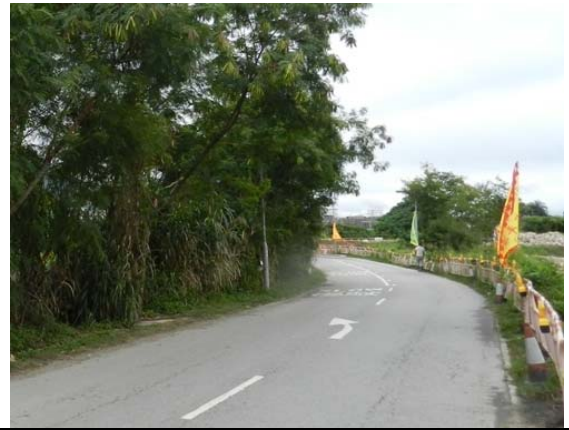
Photo 2 - Temporary hoardings have been erected along Tung Tsz Road

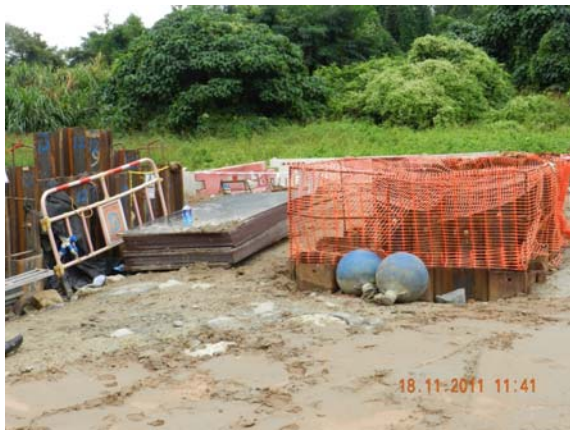
Photo 3 – Sedimentation tank for water drained from the underground

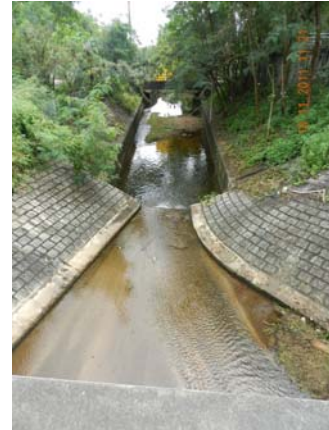
Photo 4 – Upper stream of Wa Ha River. No direct water discharge into the Wai Ha River since no active works area has been commenced adjacent to the River.

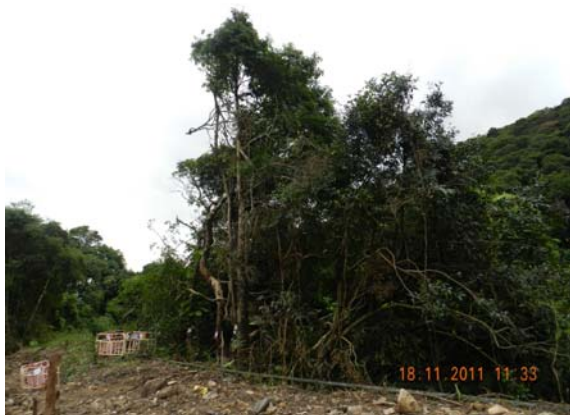
Photo 5 – Tree felling was observed within the active works area.

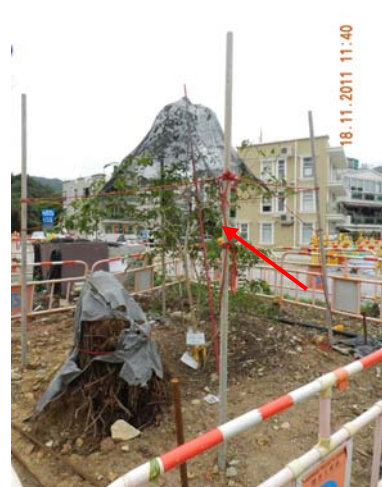
Photo 6 – Protective area and the newly installed shade net for the two young specimens of the protected shrubs *P. hongkongensis*.

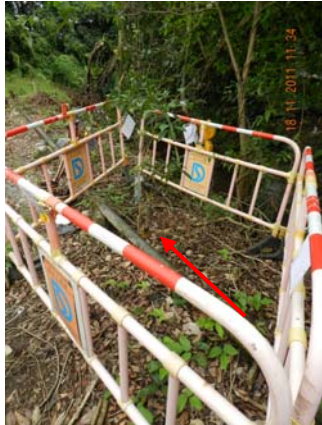
Photo 7 – Protective area for the seedling of the protected shrub of *P. hongkongensis*.

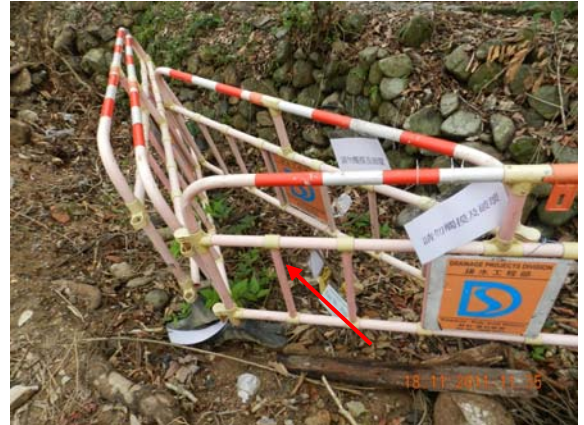
Photo 8 – A fenced-area for the seedling of the protected shrub of *P. hongkongensis*. It is a dead seedling resulting from natural dieback.
