Ref No.: 100440EN131180

Contract No. EP/SP/58/08
Sludge Treatment Facilities
Environmental Monitoring and Audit Report
For
November 2013

09 December 2013

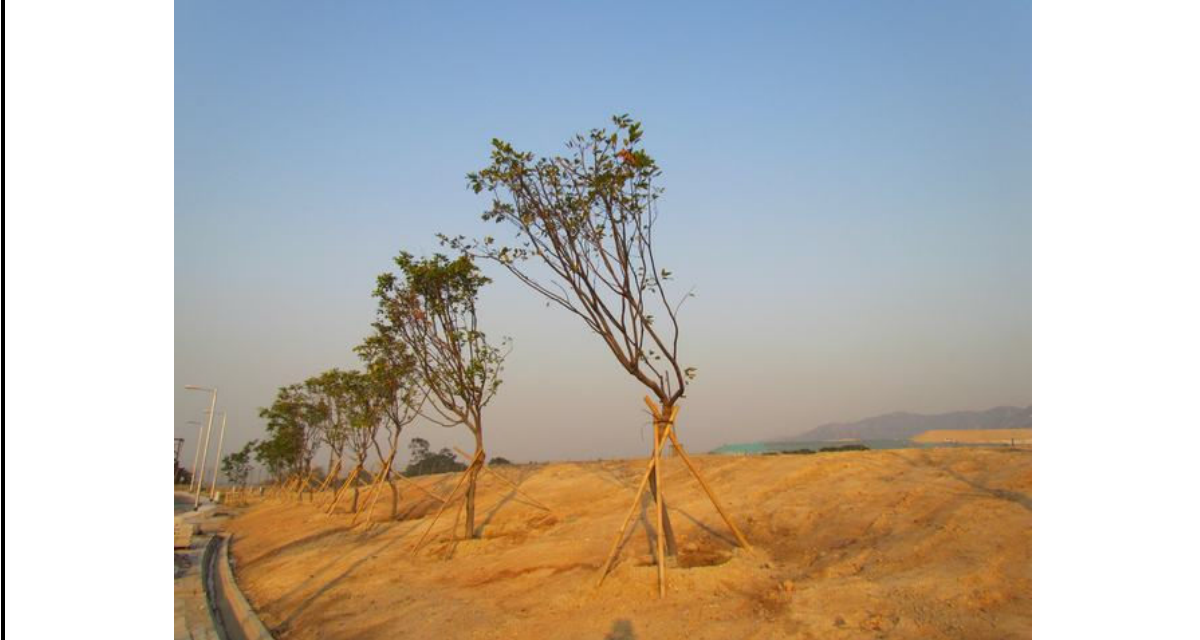
4. Photographic Record of the Compensatory Tree Locations

First batch of compensatory trees has finished.

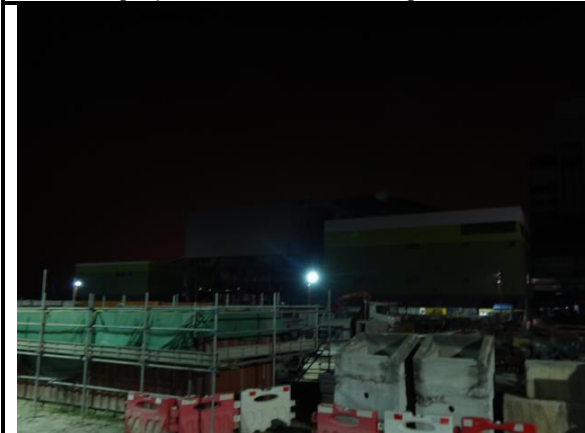
5. Photographic Record of the Night-Time Working

The lighting during night-time working is confined within the working area within the site boundary. Periphery area and the sensitive receivers are not affected by the lighting during night-time working.

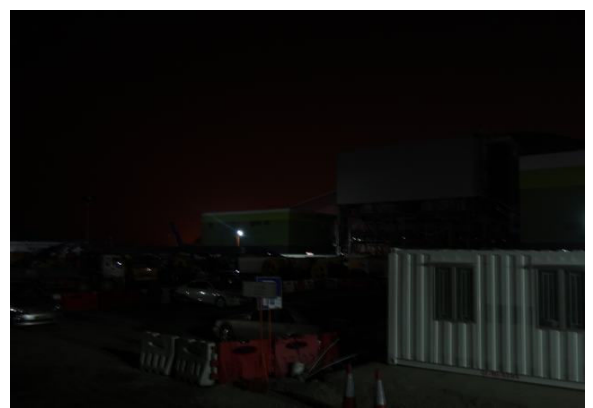
The lighting during night-time working is confined within the working area within the site boundary. Periphery area and the sensitive receivers are not affected by the lighting during night-time working.
