EP-337/2009 – New Distributor Roads Serving the Planned KTD

Contract No. KL/2012/02  
Kai Tak Development – Stage 3A Infrastructure at Former  
North Apron Area

Quarterly EM&A Report

February 2014 to April 2014

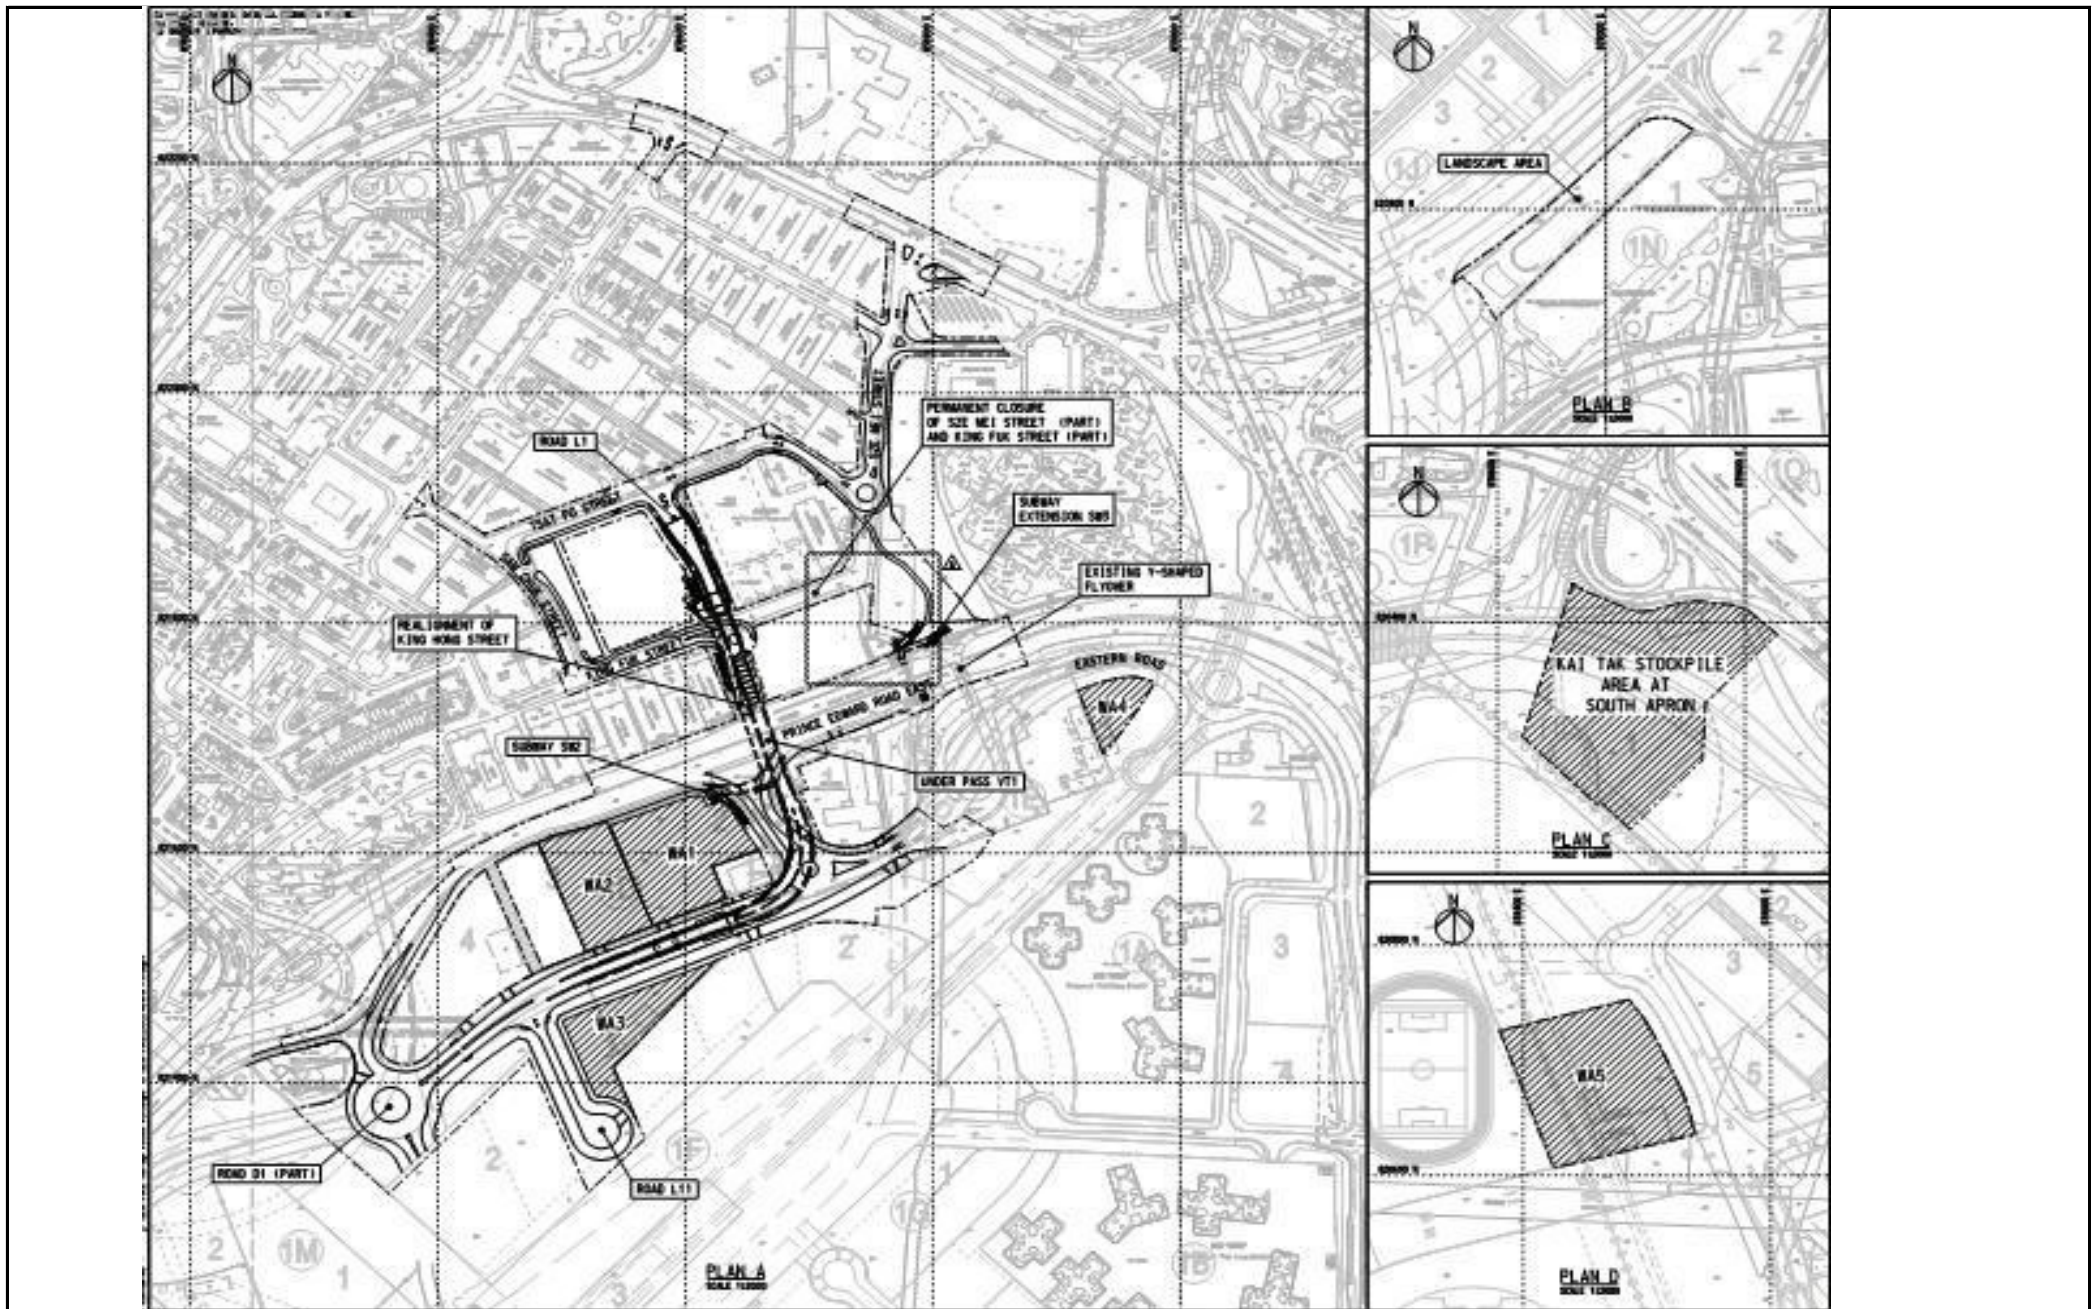
Title	Contract No. KL/2012/02		Scale	Project
	Kai Tak Development –Stage 3A Infrastructure at Former North Apron Area		N.T.S	No. MA13043
Site Layout Plan			Date	Figure
			Aug-13	1

- 1.1 The Kai Tak Development (KTD) is located in the south-eastern part of Kowloon Peninsula, comprising the apron and runway areas of the former Kai Tak Airport and existing waterfront areas at To Kwa Wan, Ma Tau Kok, Kowloon Bay, Kwun Tong and Cha Kwo Ling. It covers a land area of about 328 hectares. Stage 3A Infrastructure at Former North Apron Area is one of the construction stages of KTD. It contains one Schedule 2 DP including new distributor roads serving the planned KTD. The general layout of the Project is shown in **Figure 1**.

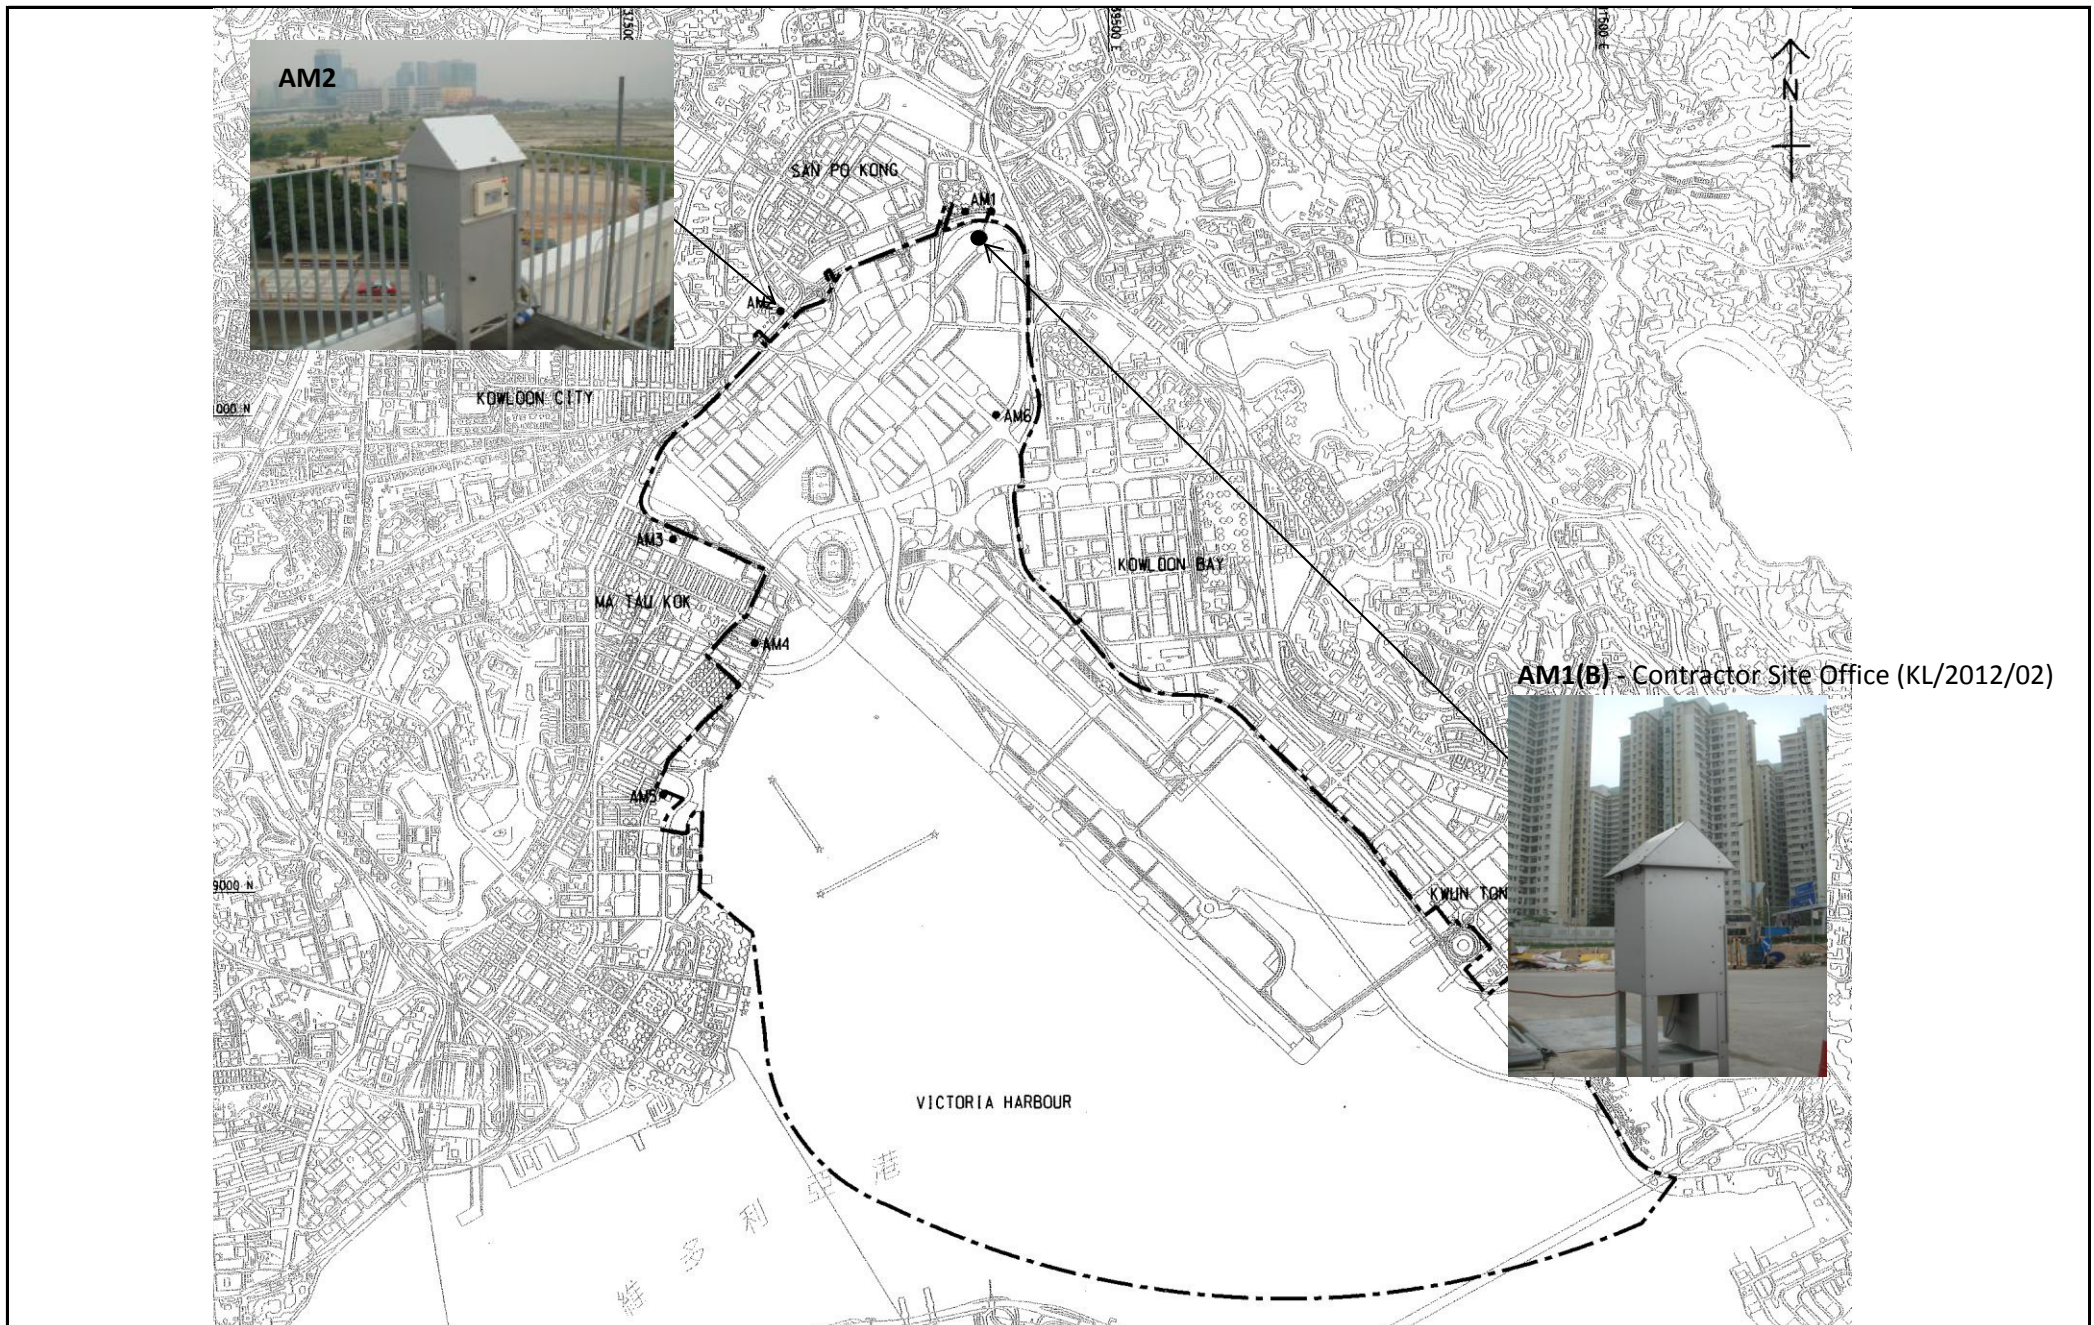
Title	Contract No. KL/2012/02		Scale	Project
	Kai Tak Development –Stage 3A Infrastructure at Former North Apron Area		N.T.S	No. MA13043
Date			Figure	
Air Quality Monitoring Stations under Contract No.: KLN/2010/04		Aug-13	2	CINOTECH

2. With reference to the same principle of EIA report of the Project, air quality monitoring stations within 500m and noise monitoring stations within 300m from the boundary of this Project are considered as relevant monitoring locations. In such regard, the relevant air quality and noise monitoring locations are tabulated in Table I (see **Figure 2** and **3** for their locations).

- 2.1 The EM&A Manual designates locations for the ET to monitor environmental impacts in terms of air quality, noise, landscape and visual due to the Project. The Project area and monitoring locations are depicted in **Figures 2 and 3. Appendix A** gives details of monitoring requirements.

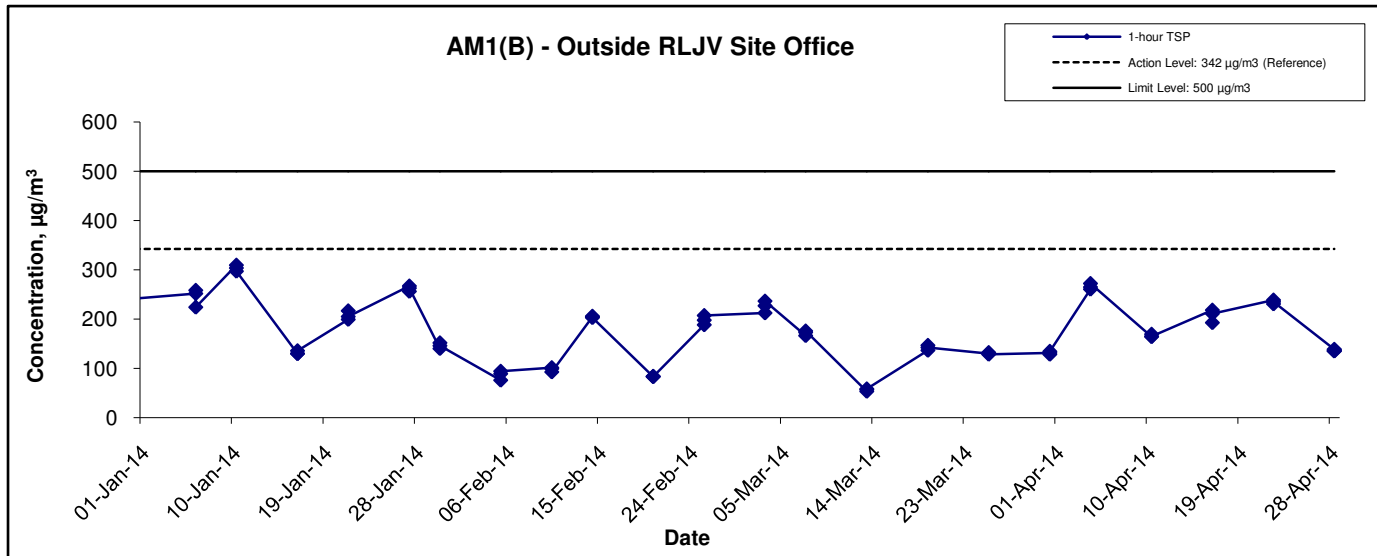
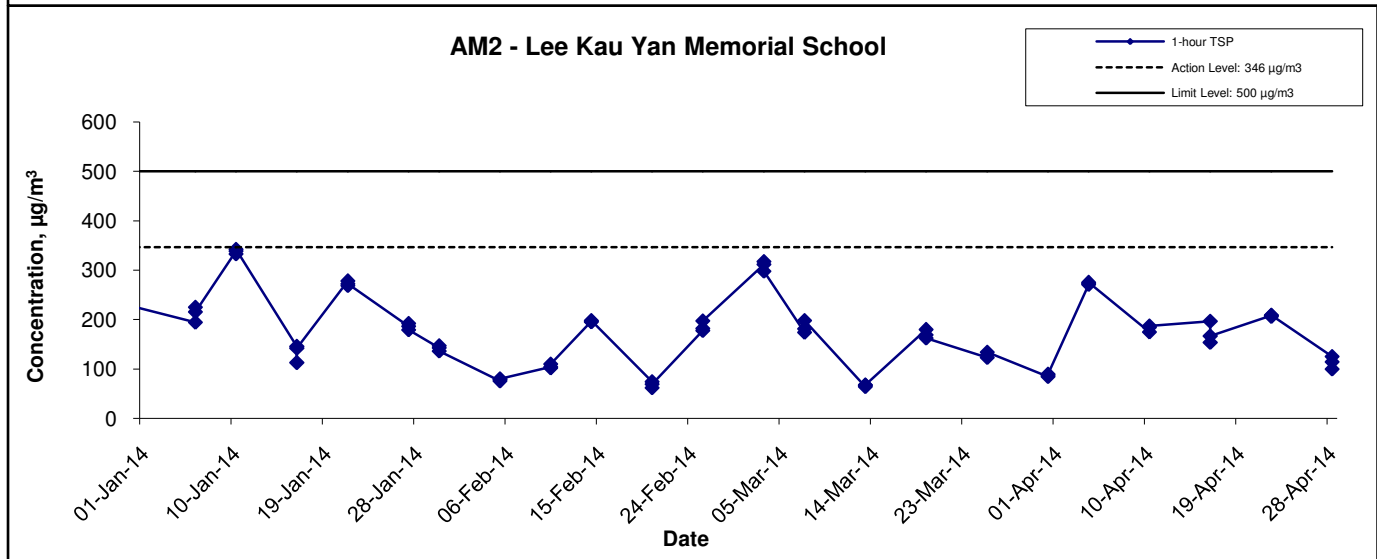
Title Contract No. KL/2012/02 Kai Tak Development - Stage 3A Infrastructure at Former North Apron Area  Graphical Presentation of 1-hour TSP Monitoring Results	Scale	Project	
	N.T.S	No. MA13043	
	Date	Appendix	
	Apr 14	C

3.3 1-hour TSP monitoring at 2 monitoring stations, AM1(B) – Contractor Site Office and AM2 - Lee Kau Yan Memorial School, was conducted as schedule in the reporting period. No Action/Limit Level exceedance was recorded for 1-hr TSP monitoring in the reporting quarter.

3.5 The graphical presentations of the air quality monitoring results are shown in **Appendix C**.

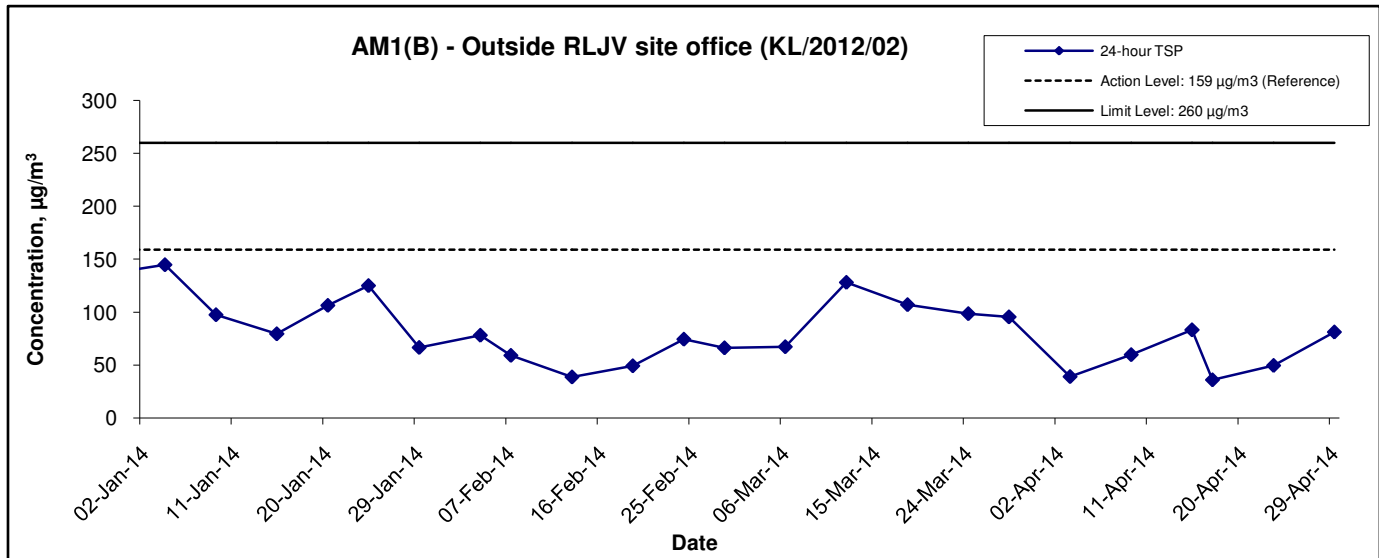
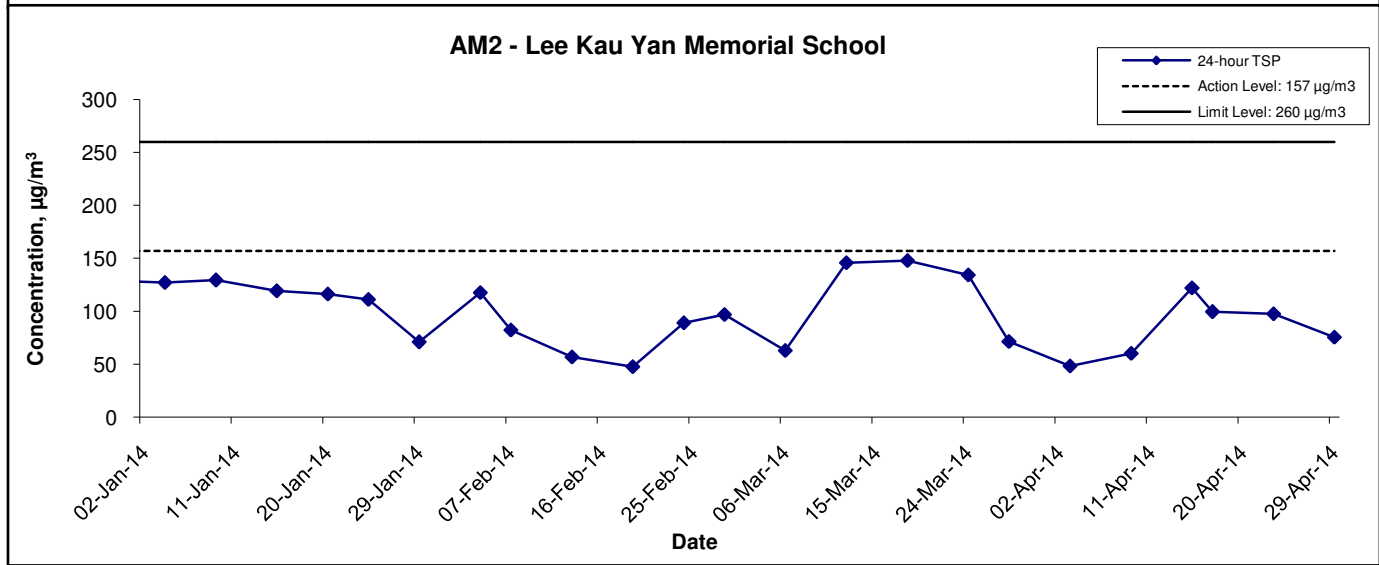
Title Contract No. KL/2012/02 Kai Tak Development - Stage 3A Infrastructure at Former North Apron Area  Graphical Presentation of 24-hour TSP Monitoring Results	Scale N.T.S	Project No. MA13043	
	Date Apr 14	Appendix C

3.4 24-hr TSP monitoring at 2 monitoring stations, AM1(B) and AM2, was also conducted as schedule in the reporting period. No Action/Limit Level exceedance was recorded for 24-hr TSP monitoring in the reporting quarter.

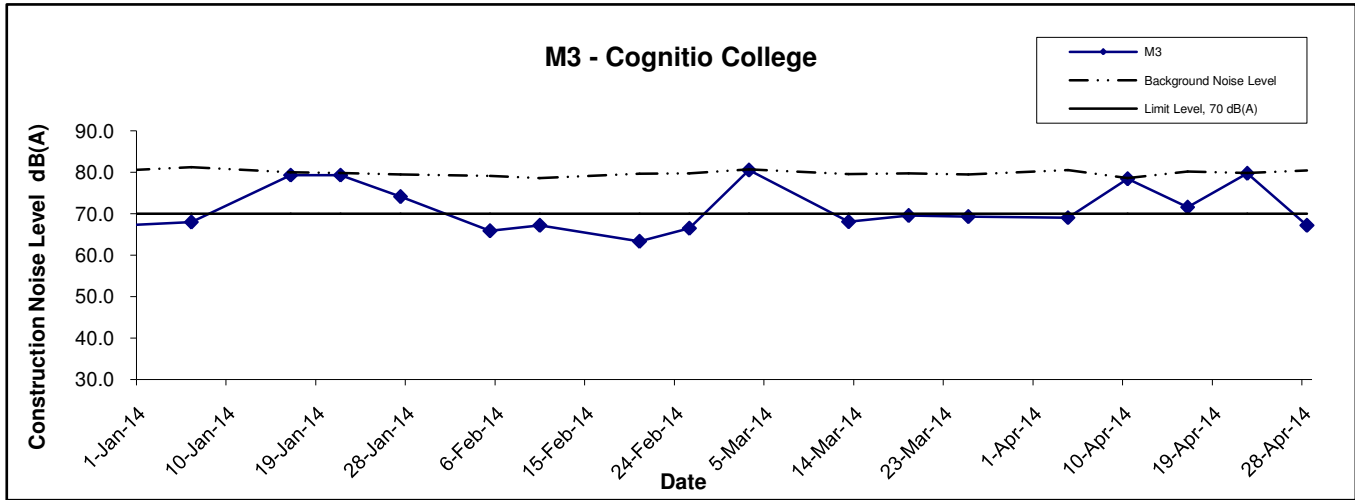
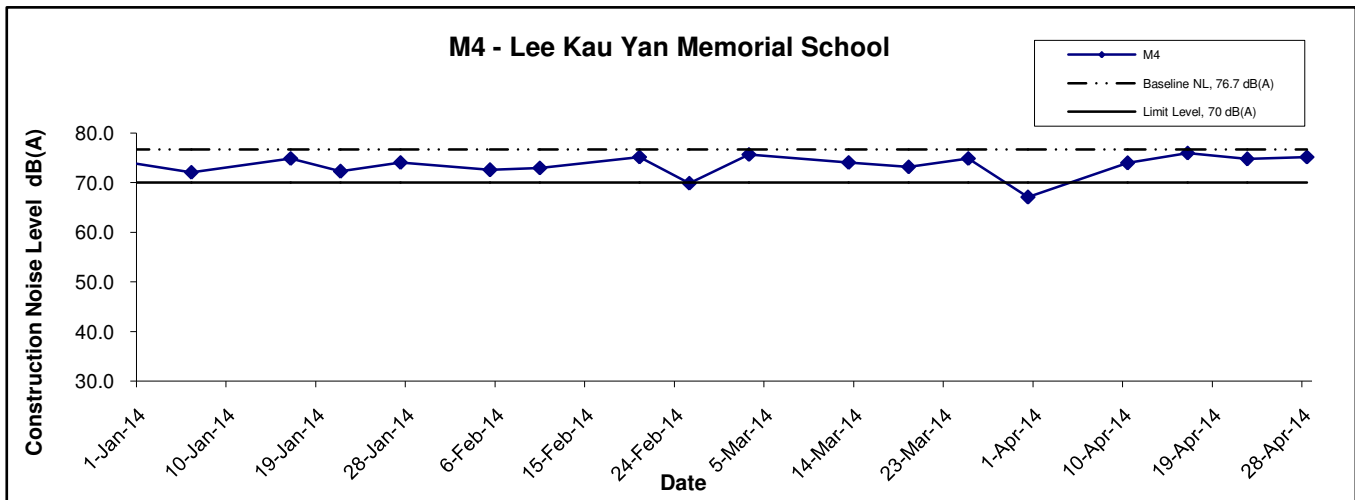
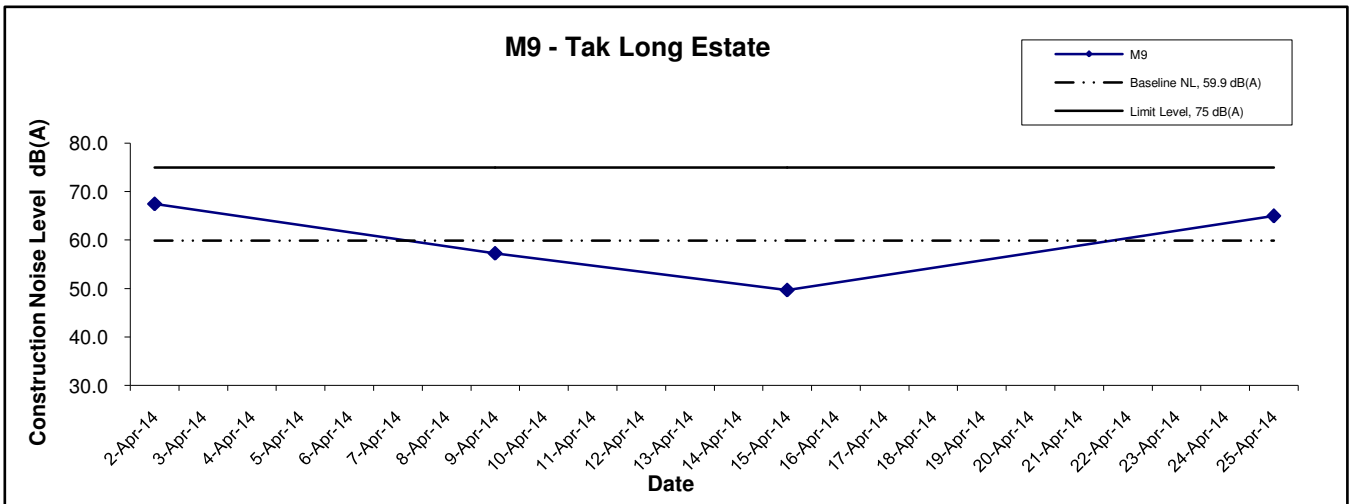
Title  
 Contract No. KL/2012/02  
 Kai Tak Development - Stage 3A Infrastructure at Former North Apron Area  
 Graphical Presentation of Construction Noise Monitoring Results

3.6 Noise monitoring at 2 monitoring stations, M3 – Cognitio College and M4 – Lee Kau Yan Memorial College, was conducted as schedule in the reporting period except 31 March 2014. Noise monitoring at M3 on 31 March 2014 was rescheduled to 3 April 2014 due to heavy rain. Noise monitoring at monitoring station, M9 – Tak Long Estate, had started on 2<sup>nd</sup> April 2014 and conducted as schedule in the reporting period.

3.7 No Action/Limit Level exceedance was recorded for construction noise monitoring in the reporting quarter.

3.8 The graphical presentations of the noise monitoring results are shown in **Appendix D**.
