EP-337/2009 – New Distributor Roads Serving the Planned KTD

Contract No. KL/2012/02

Kai Tak Development –Stage 3A Infrastructure at Former  
North Apron Area

Quarterly EM&A Report

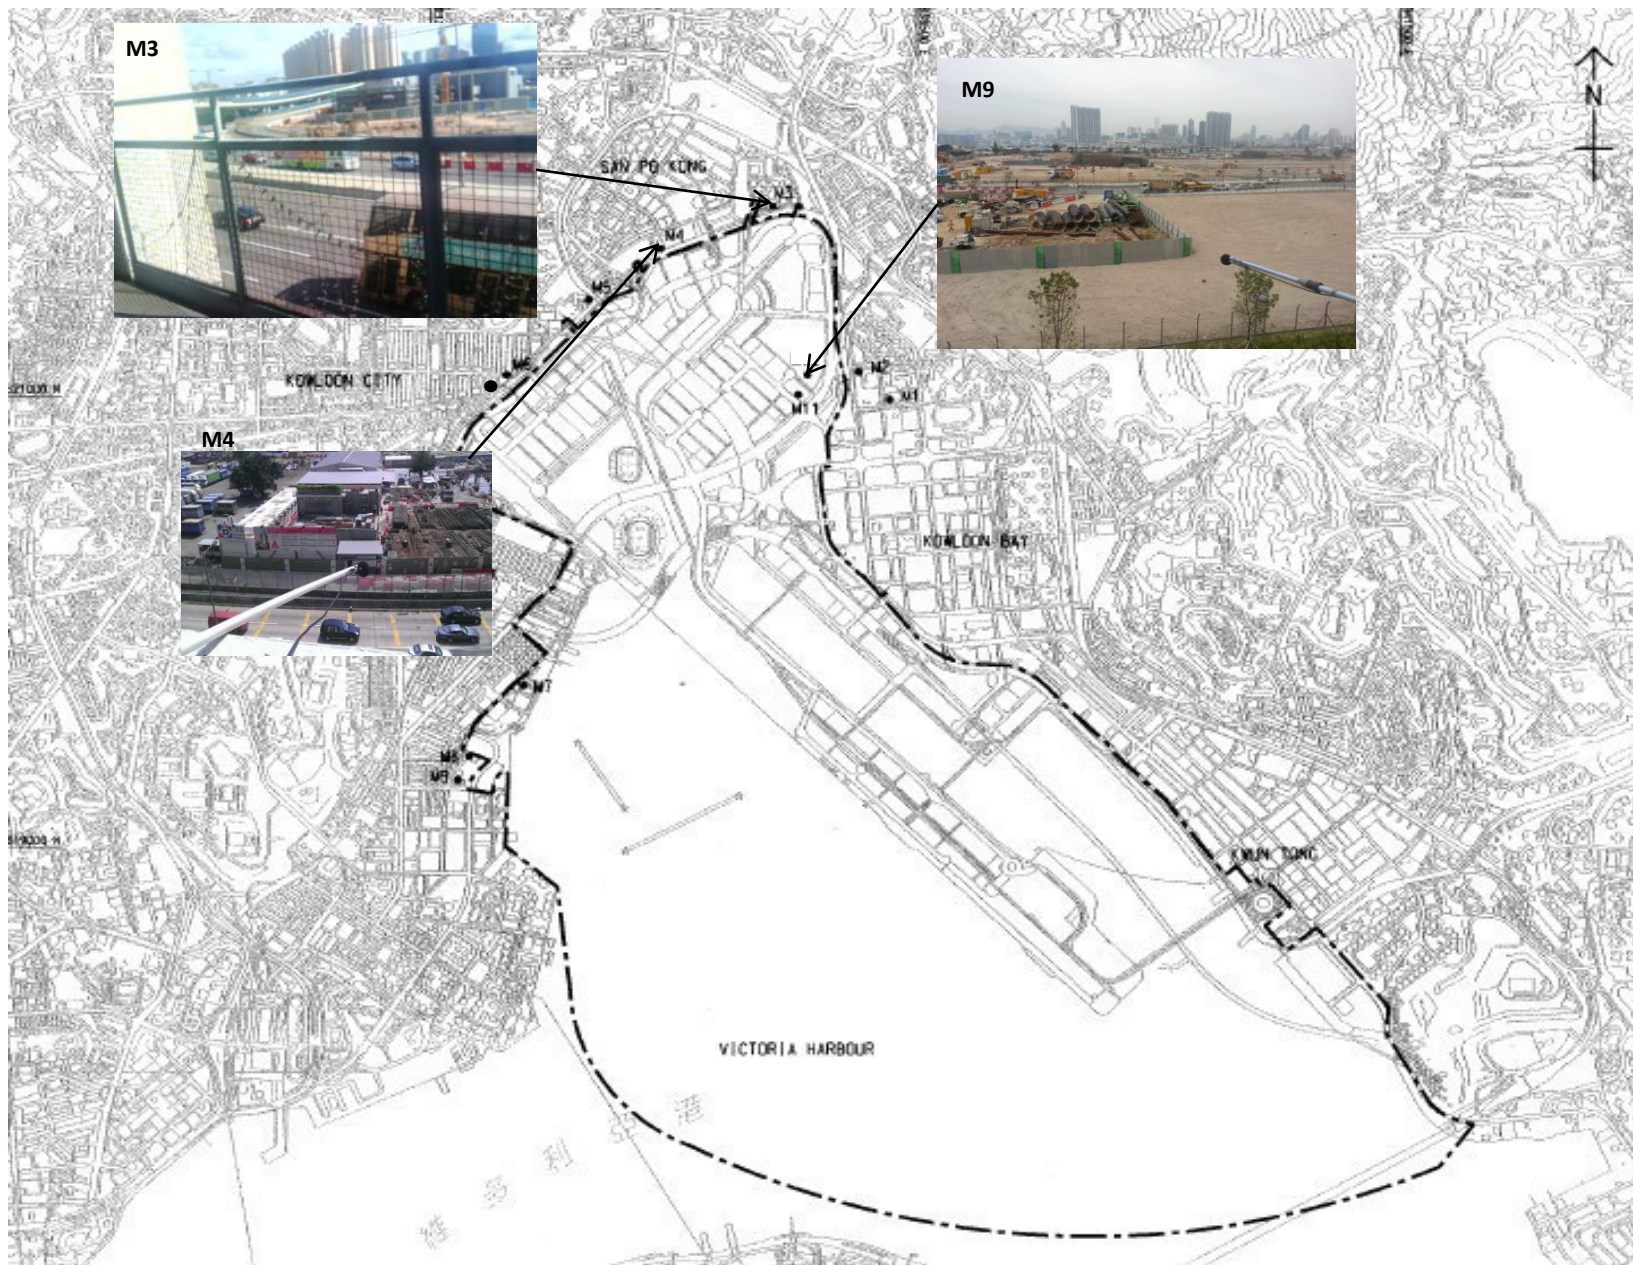
Title Contract No. KL/2012/02 Kai Tak Development –Stage 3A Infrastructure at Former North Apron Area Noise Monitoring Stations under Contract No.: KLN/2013/16	Scale	Project No.

2. With reference to the same principle of EIA report of the Project, air quality monitoring stations within 500m and noise monitoring stations within 300m from the boundary of this Project are considered as relevant monitoring locations. In such regard, the relevant air quality and noise monitoring locations are tabulated in Table I (see **Figure 2** and **3** for their locations).

3.6 Noise monitoring at 3 monitoring stations, M3 – Cognitio College, M4 – Lee Kau Yan Memorial College and M9 – Tak Long Estate, was conducted as schedule in the reporting period. No Action/Limit Level exceedance was recorded for construction noise monitoring in the reporting quarter.

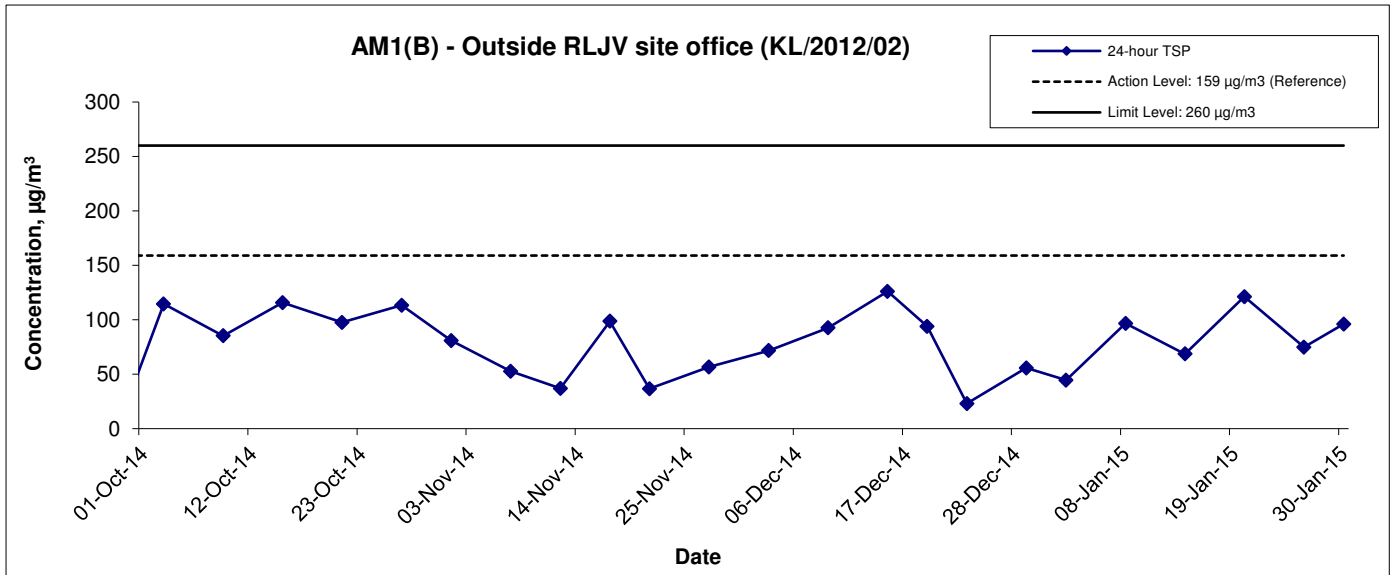
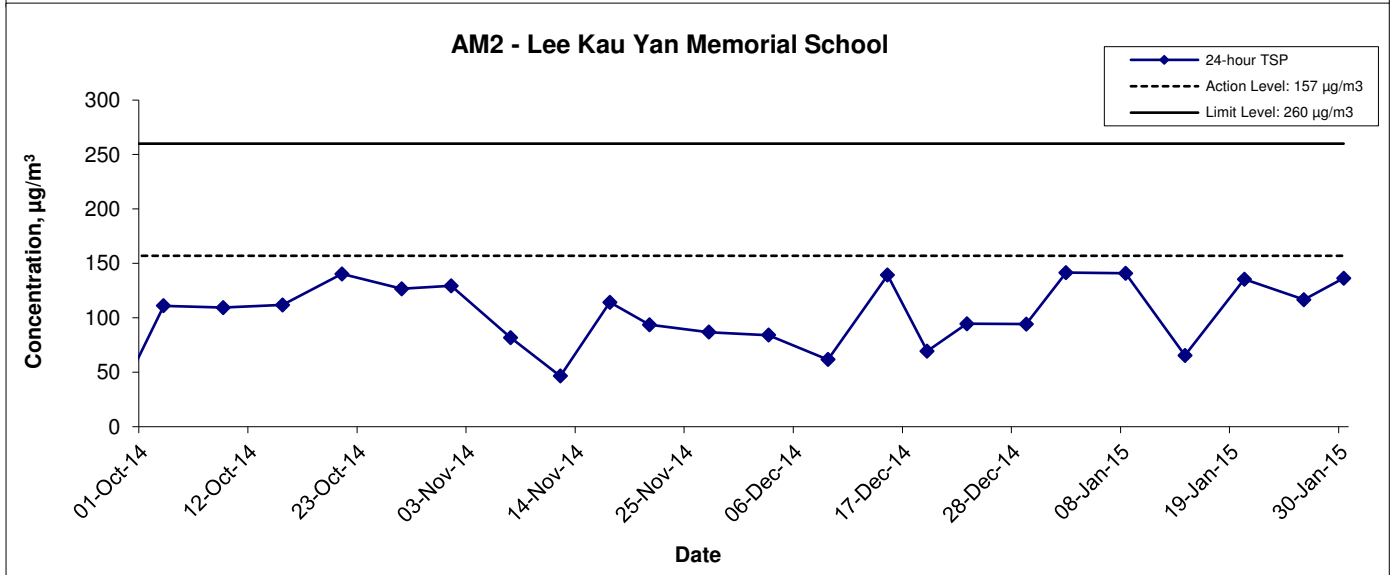
Title Contract No. KL/2012/02 Kai Tak Development - Stage 3A Infrastructure at Former North Apron Area  Graphical Presentation of 24-hour TSP Monitoring Results	Scale N.T.S	Project No. MA13043	CINOTECH
	Date Jan 15	Appendix C

3.4 24-hr TSP monitoring at 2 monitoring stations, AM1(B) and AM2, was also conducted as schedule in the reporting period. No Action/Limit Level exceedance was recorded for 24-hr TSP monitoring in the reporting quarter.

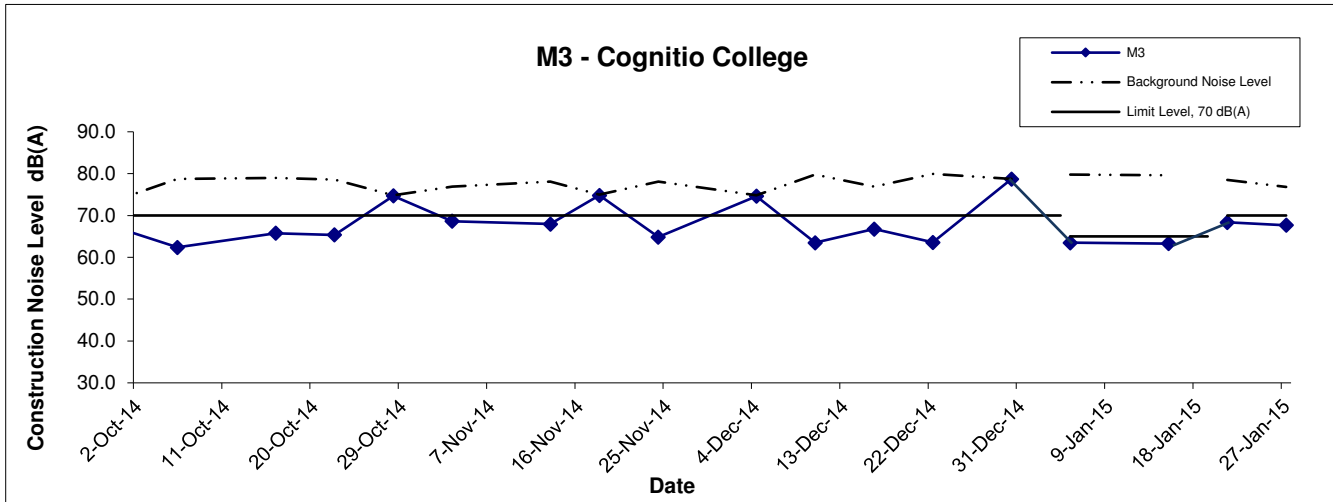
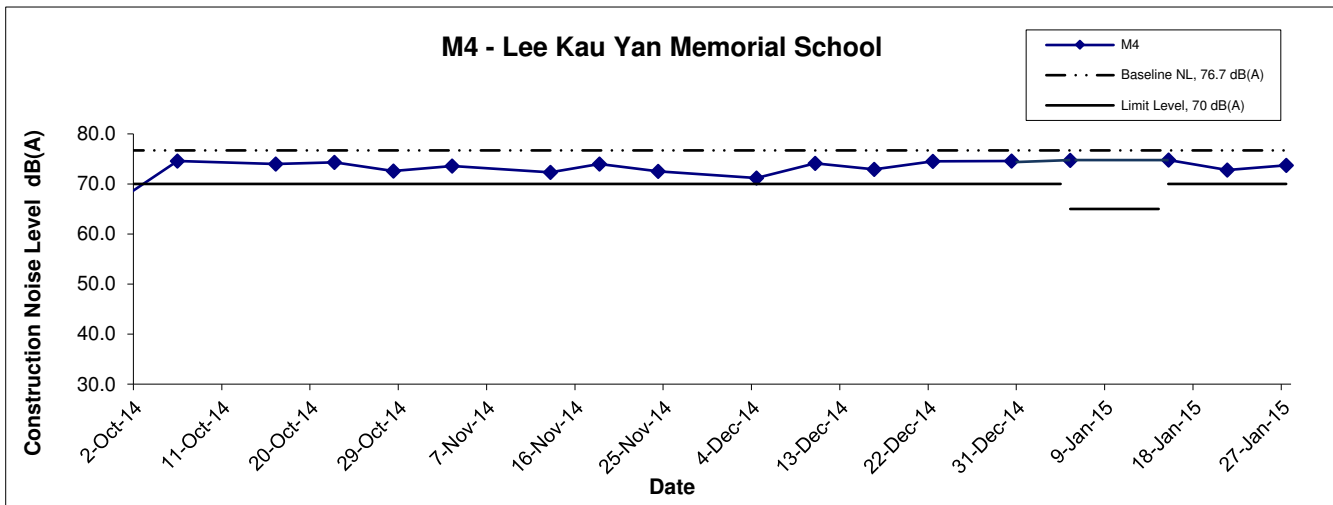
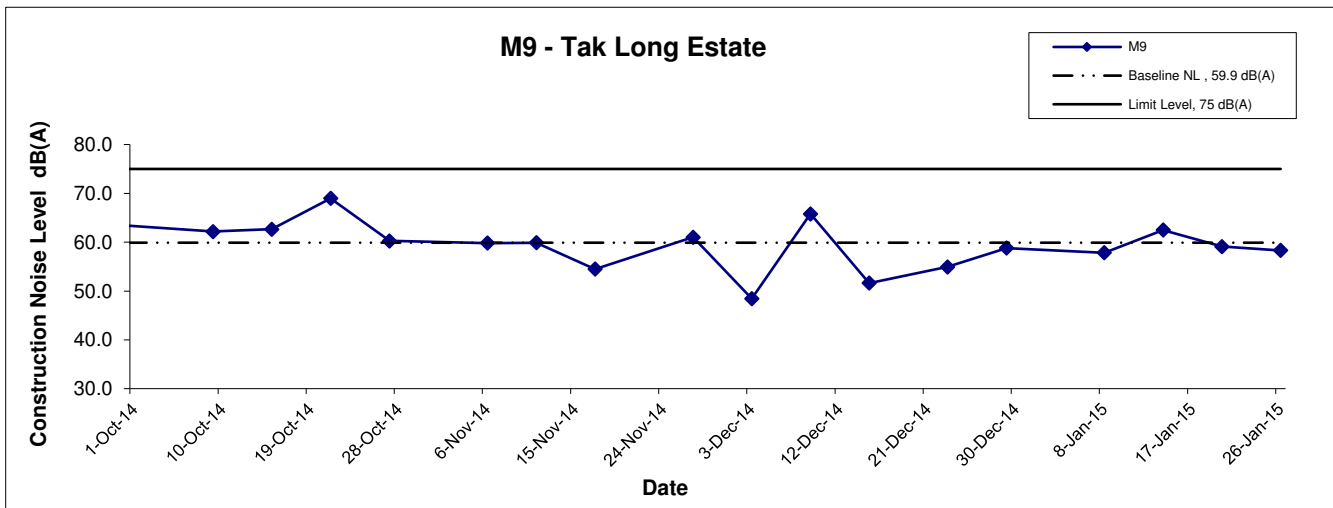
Remarks: The construction noise levels in the Tables in Appendix G were adopted for plotting the graphs
