EP-337/2009 – New Distributor Roads Serving the Planned KTD

Contract No. KL/2012/02
Kai Tak Development –Stage 3A Infrastructure at Former
North Apron Area

Quarterly EM&A Report

August 2015 to October 2015

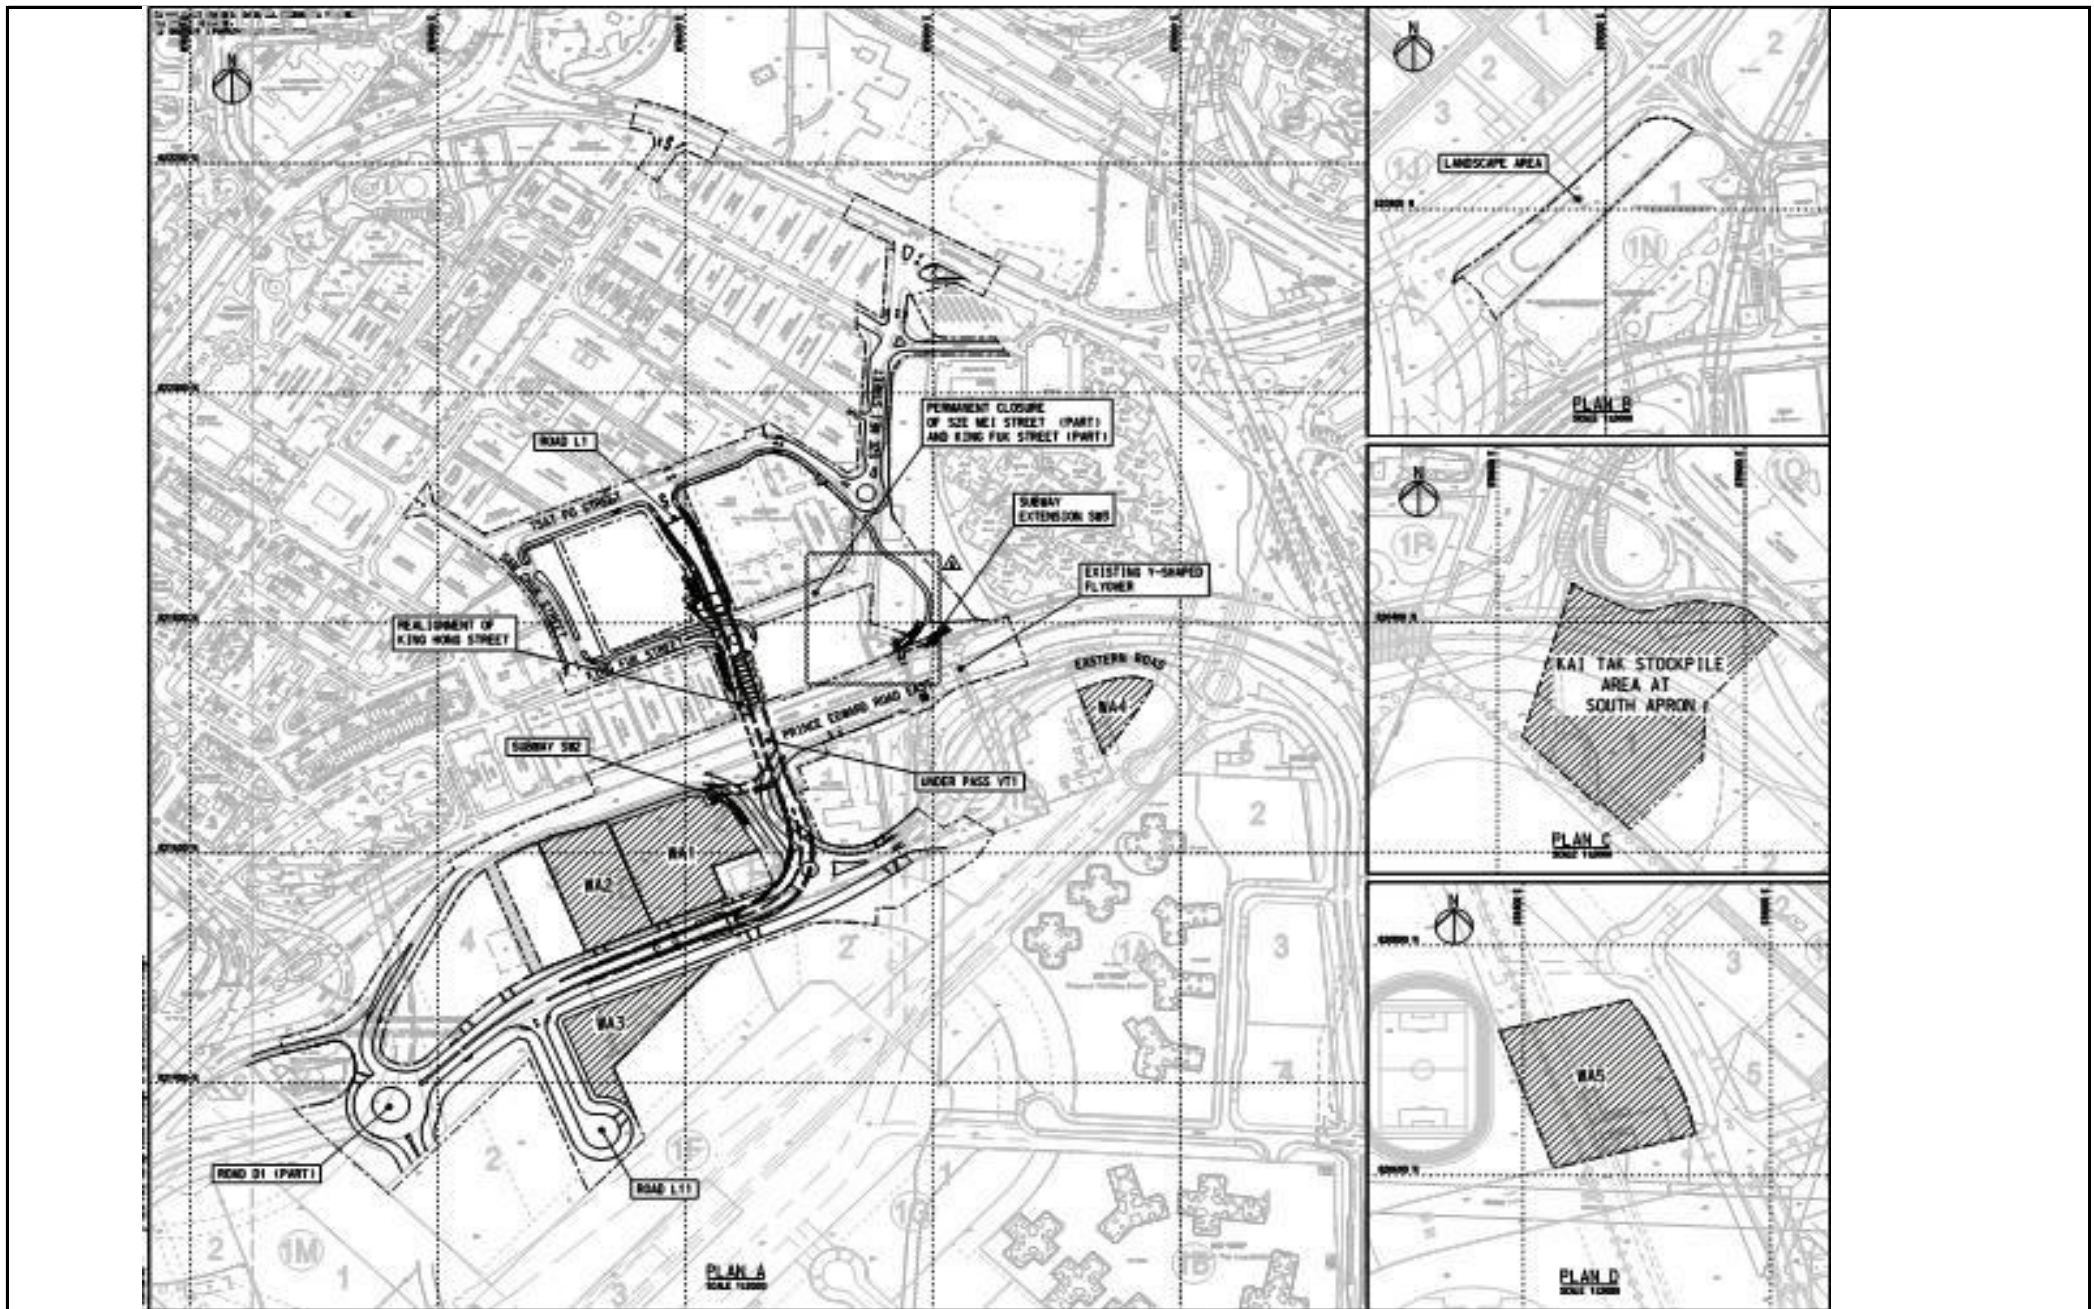
Title	Contract No. KL/2012/02		Scale	Project
	Kai Tak Development –Stage 3A Infrastructure at Former North Apron Area		N.T.S	No. MA13043
Site Layout Plan			Date	Figure
			Aug-13	1

- 1.1 The Kai Tak Development (KTD) is located in the south-eastern part of Kowloon Peninsula, comprising the apron and runway areas of the former Kai Tak Airport and existing waterfront areas at To Kwa Wan, Ma Tau Kok, Kowloon Bay, Kwun Tong and Cha Kwo Ling. It covers a land area of about 328 hectares. Stage 3A Infrastructure at Former North Apron Area is one of the construction stages of KTD. It contains one Schedule 2 DP including new distributor roads serving the planned KTD. The general layout of the Project is shown in **Figure 1**.

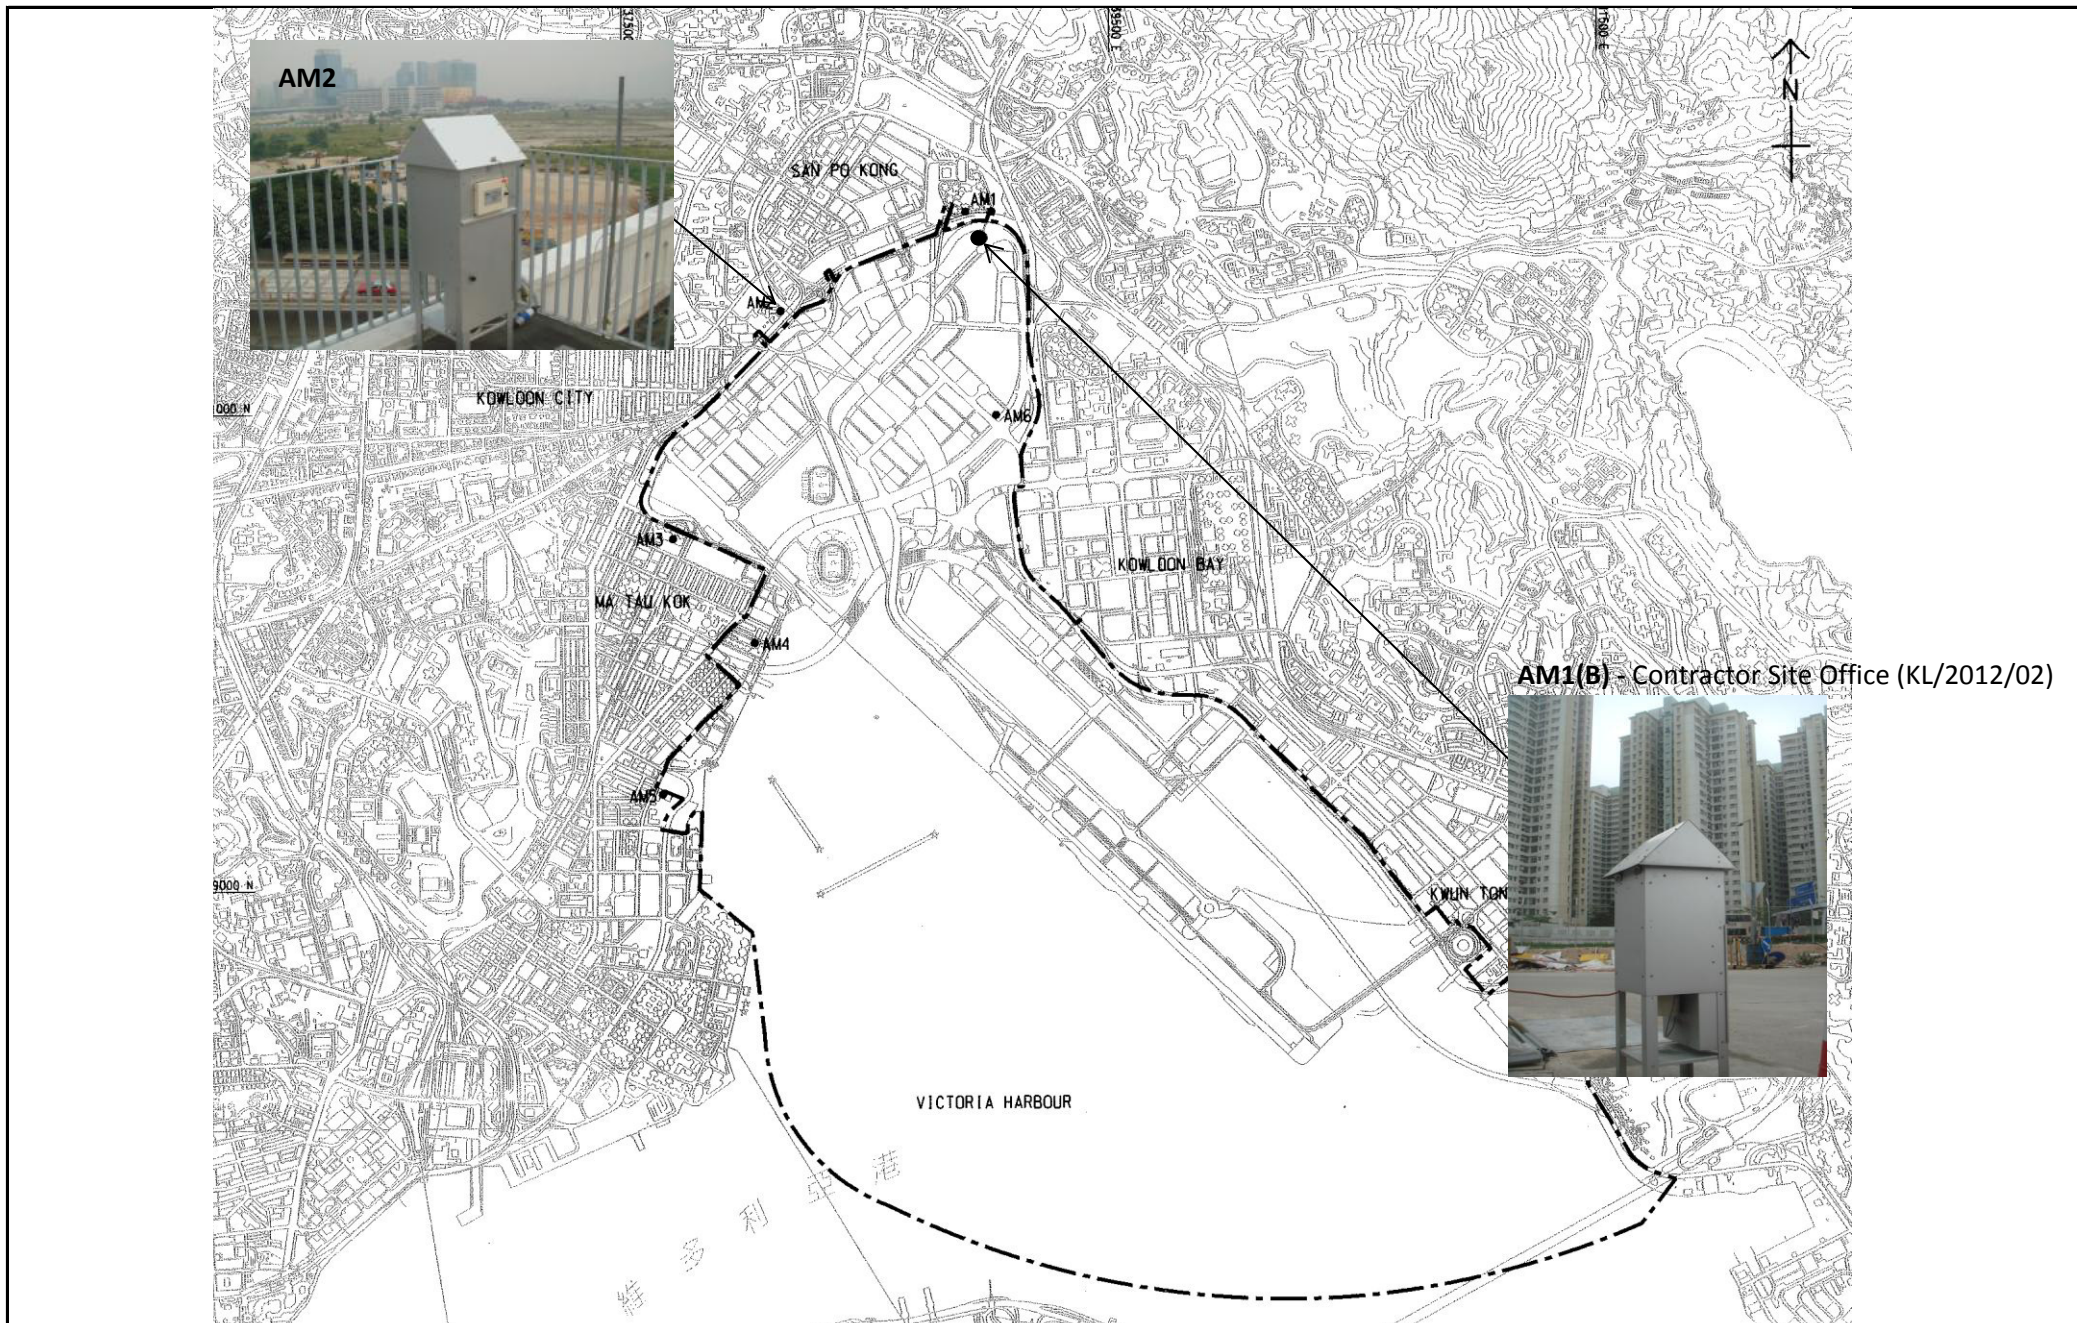
Title	Contract No. KL/2012/02		Scale	Project
	Kai Tak Development –Stage 3A Infrastructure at Former North Apron Area		N.T.S	No. MA13043
Air Quality Monitoring Stations under Contract No.: KLN/2010/04			Date	Figure
		Aug-13	2	CINOTECH

2. With reference to the same principle of EIA report of the Project, air quality monitoring stations within 500m and noise monitoring stations within 300m from the boundary of this Project are considered as relevant monitoring locations. In such regard, the relevant air quality and noise monitoring locations are tabulated in Table I (see **Figure 2** and **3** for their locations).

3.3 1-hour TSP monitoring at 2 monitoring stations, AM1(B) – Contractor Site Office and AM2 - Lee Kau Yan Memorial School, was conducted as schedule in the reporting period. No Action/Limit Level exceedance was recorded for 1-hr TSP monitoring in the reporting quarter.

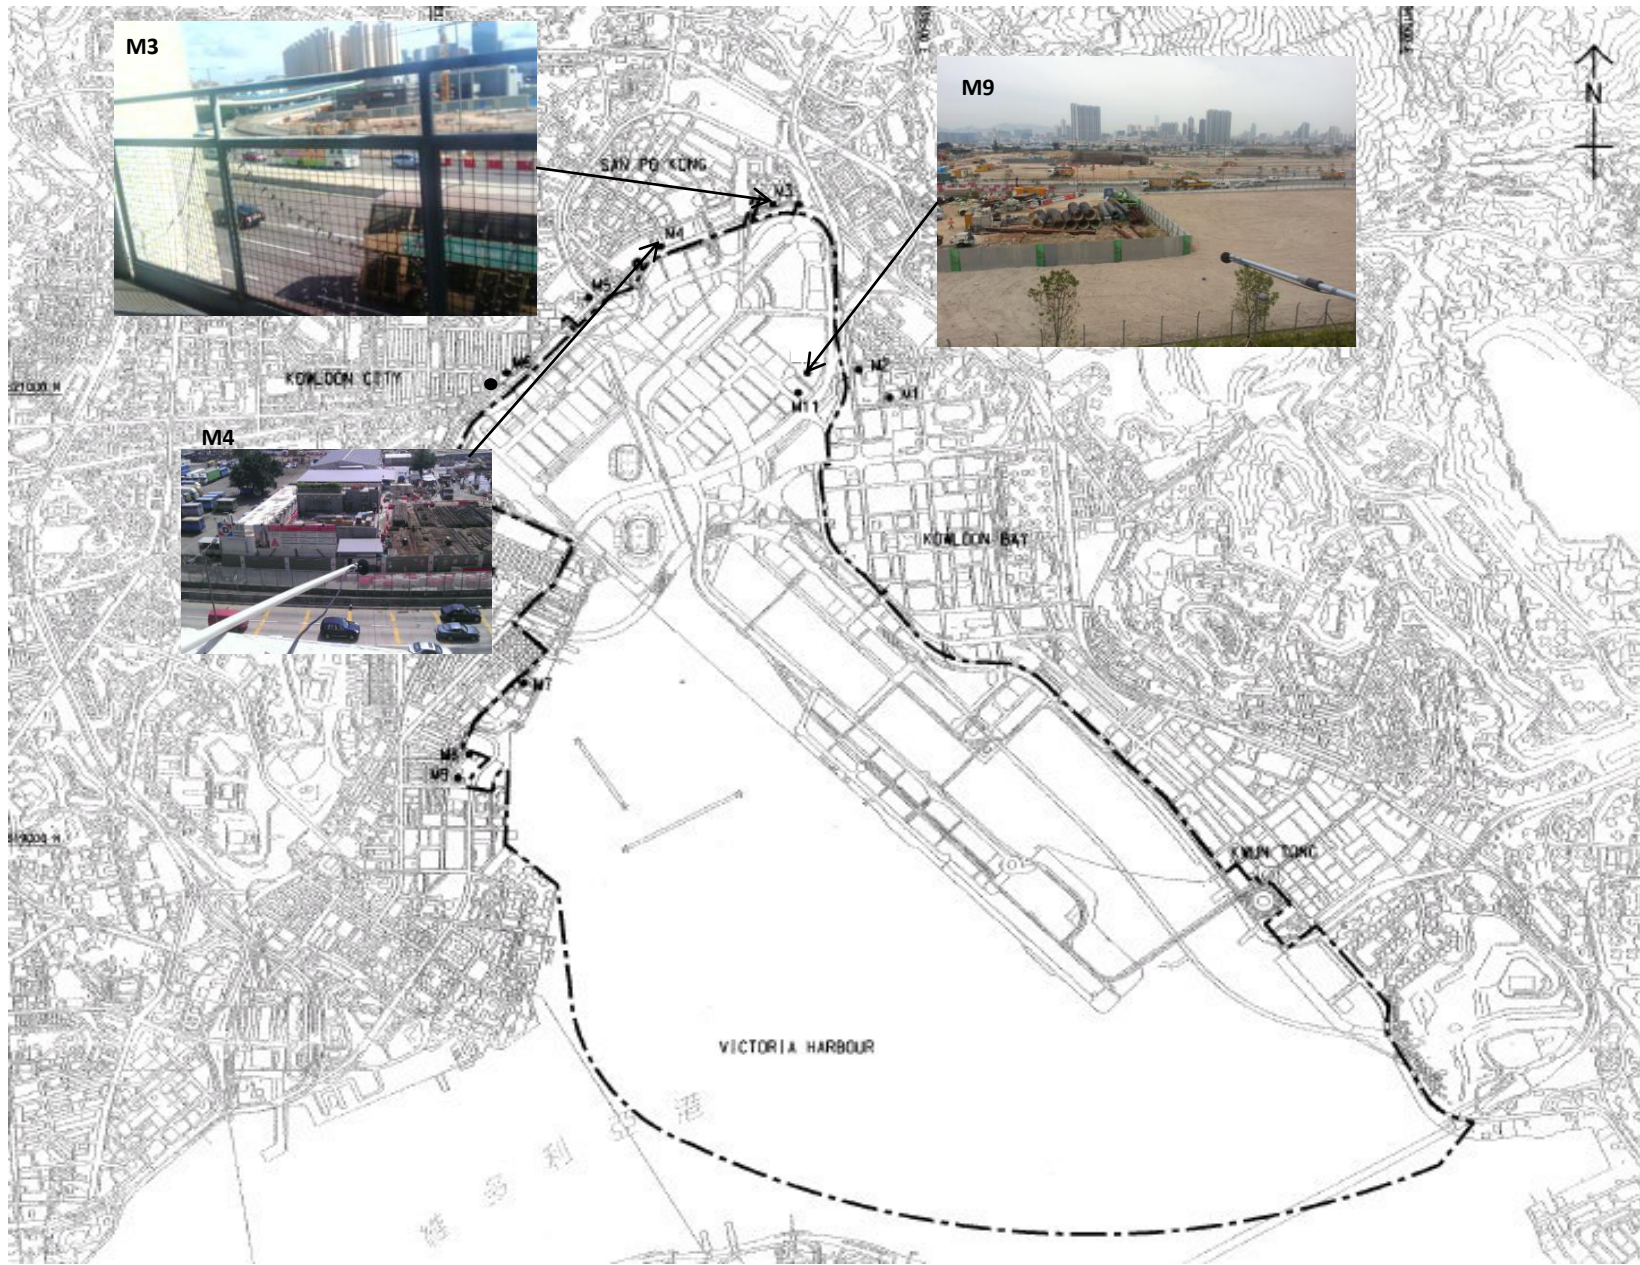
Title Contract No. KL/2012/02 Kai Tak Development –Stage 3A Infrastructure at Former North Apron Area Noise Monitoring Stations under Contract No.: KLN/2013/16	Scale N.T.S	Project No. MA13043

3.6 Noise monitoring at 3 monitoring stations, M3 – Cognitio College, M4 – Lee Kau Yan Memorial College and M9 – Tak Long Estate, was conducted as schedule in the reporting period. No Action/Limit Level exceedance was recorded for construction noise monitoring in the reporting quarter.

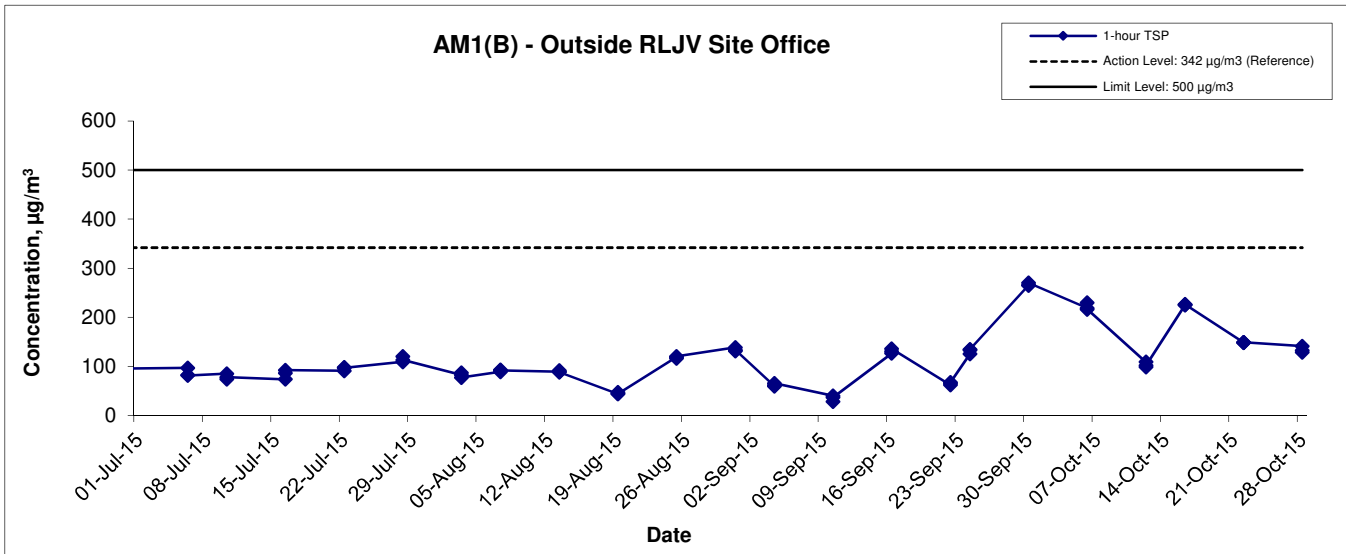
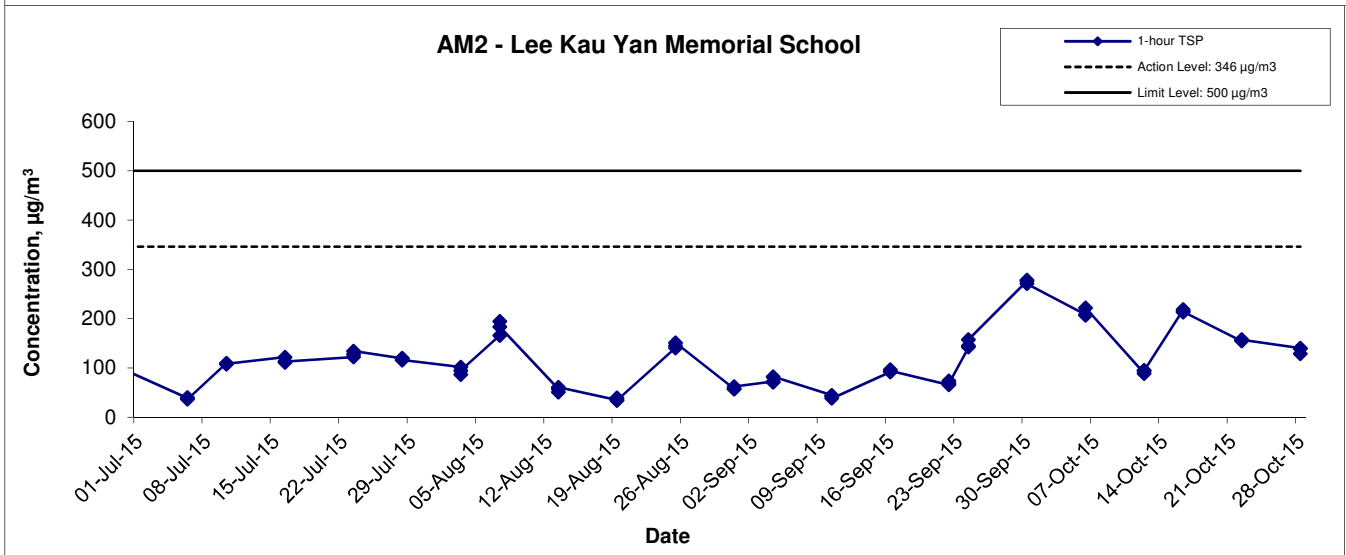
Title Contract No. KL/2012/02 Kai Tak Development - Stage 3A Infrastructure at Former North Apron Area Graphical Presentation of 1-hour TSP Monitoring Results	Scale N.T.S	Project No. MA13043	
	Date Oct 15	Appendix E

1-hr TSP Concentration Levels

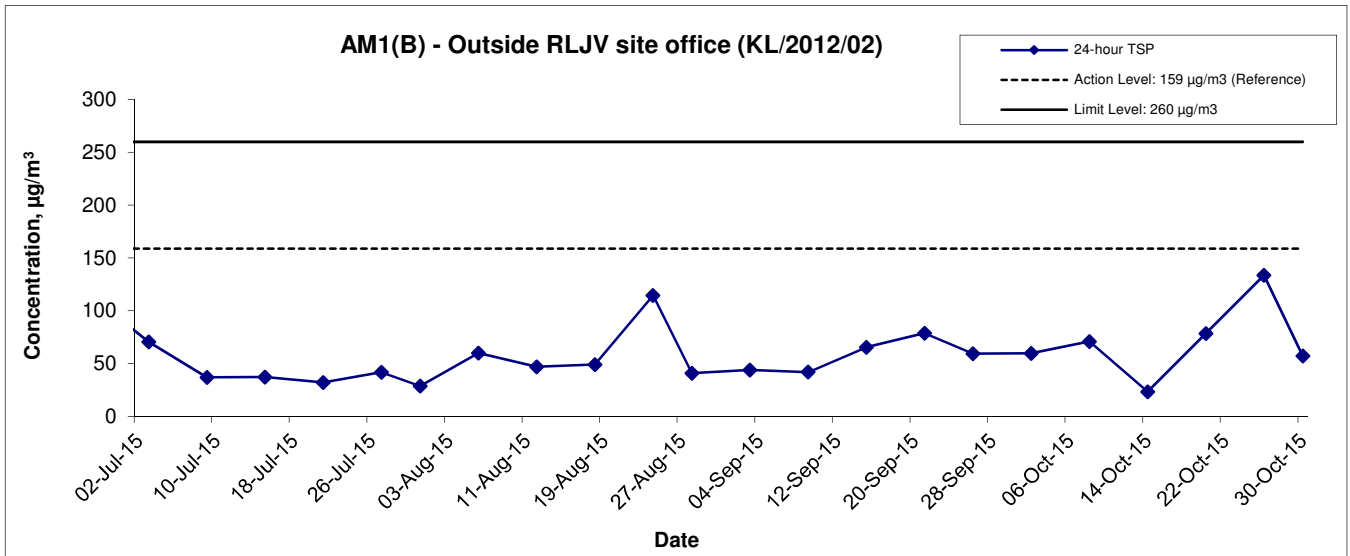
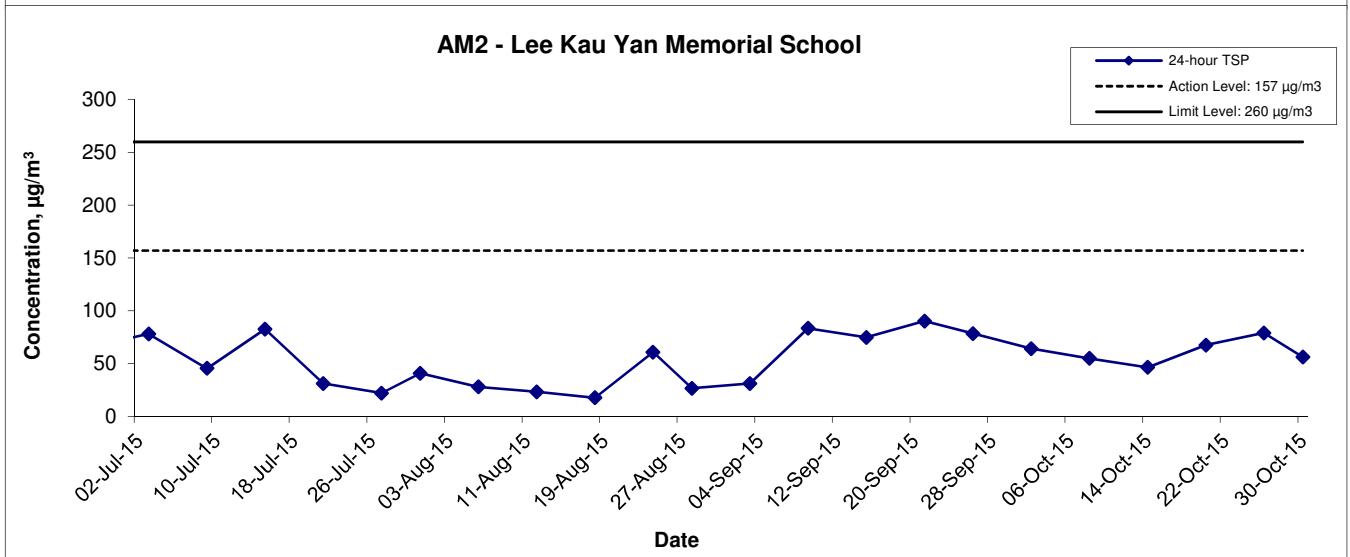
Title Contract No. KL/2012/02 Kai Tak Development - Stage 3A Infrastructure at Former North Apron Area Graphical Presentation of 24-hour TSP Monitoring Results	Scale N.T.S	Project No. MA13043	
	Date Oct 15	Appendix F

3.4 24-hr TSP monitoring at 2 monitoring stations, AM1(B) and AM2, was also conducted as schedule in the reporting period. No Action/Limit Level exceedance was recorded for 24-hr TSP monitoring in the reporting quarter.

24-hr TSP Concentration Levels

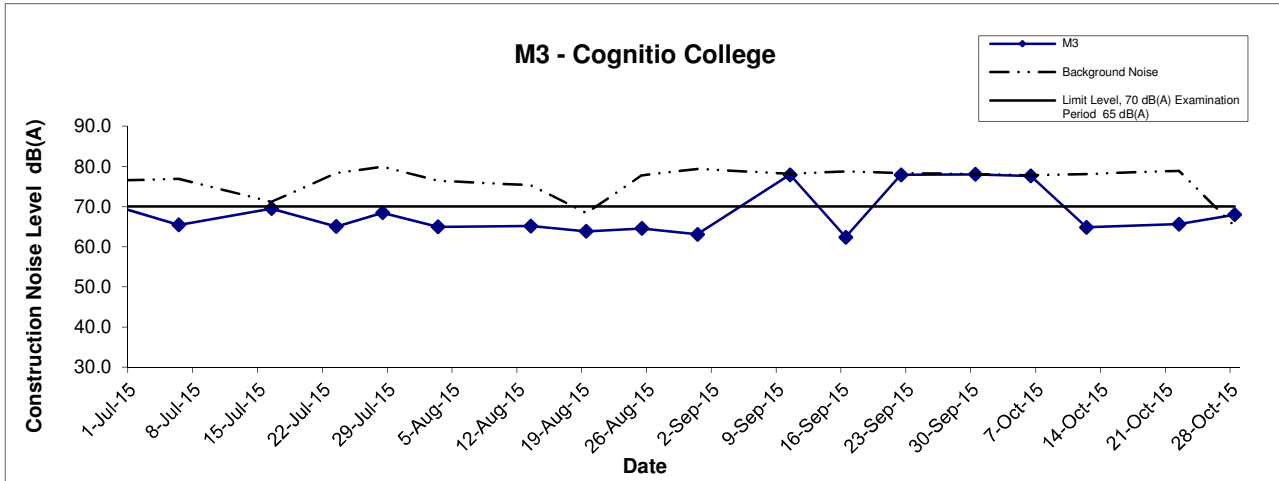
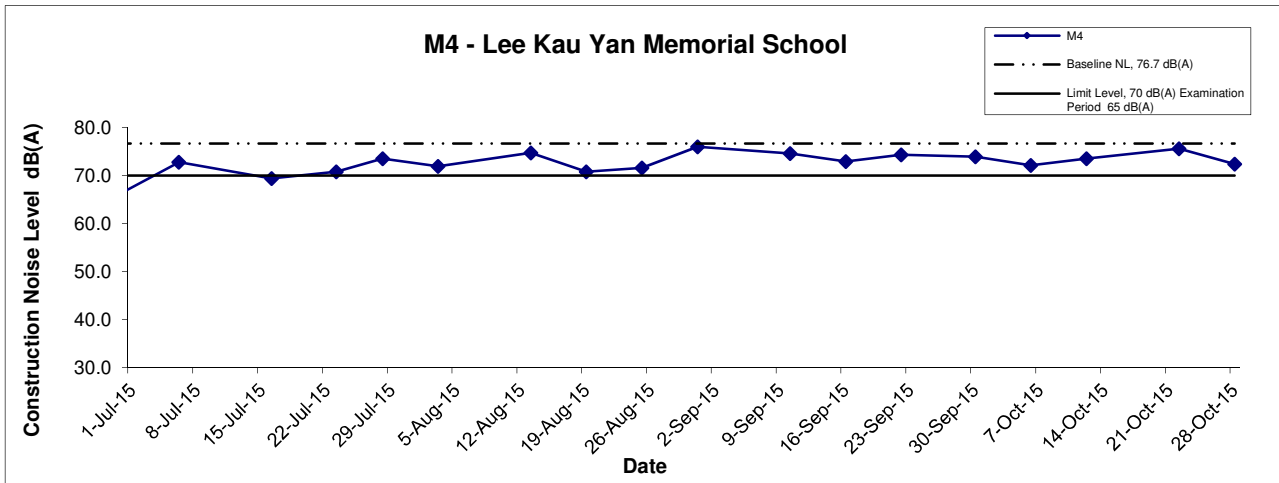
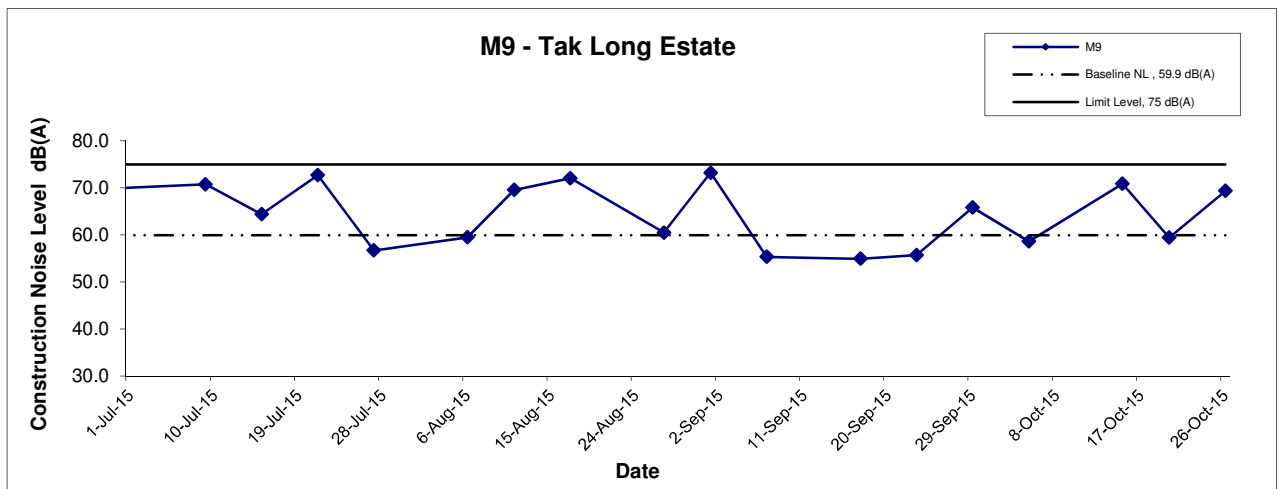
Title Contract No. KL/2012/02 Kai Tak Development - Stage 3A Infrastructure at Former North Apron Area Graphical Presentation of Construction Noise Monitoring Results	Scale N.T.S	Project No. MA13043	CINOTECH
	Date Oct 15	Appendix G

Noise Levels

Remarks: The construction noise levels in the Tables in Appendix G were adopted for plotting the graphs
