Contract No. KL/2012/02

Kai Tak Development – Stage 3A Infrastructure at Former
North Apron Area

Monthly EM&A Report

December 2015

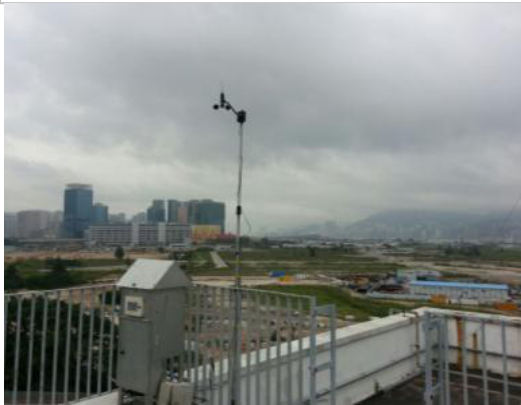
Anemometer Station from The Hong Kong Observatory
