EP-337/2009 – New Distributor Roads Serving the Planned KTD

Contract No. KL/2012/02

Kai Tak Development –Stage 3A Infrastructure at Former  
North Apron Area

Monthly EM&A Report

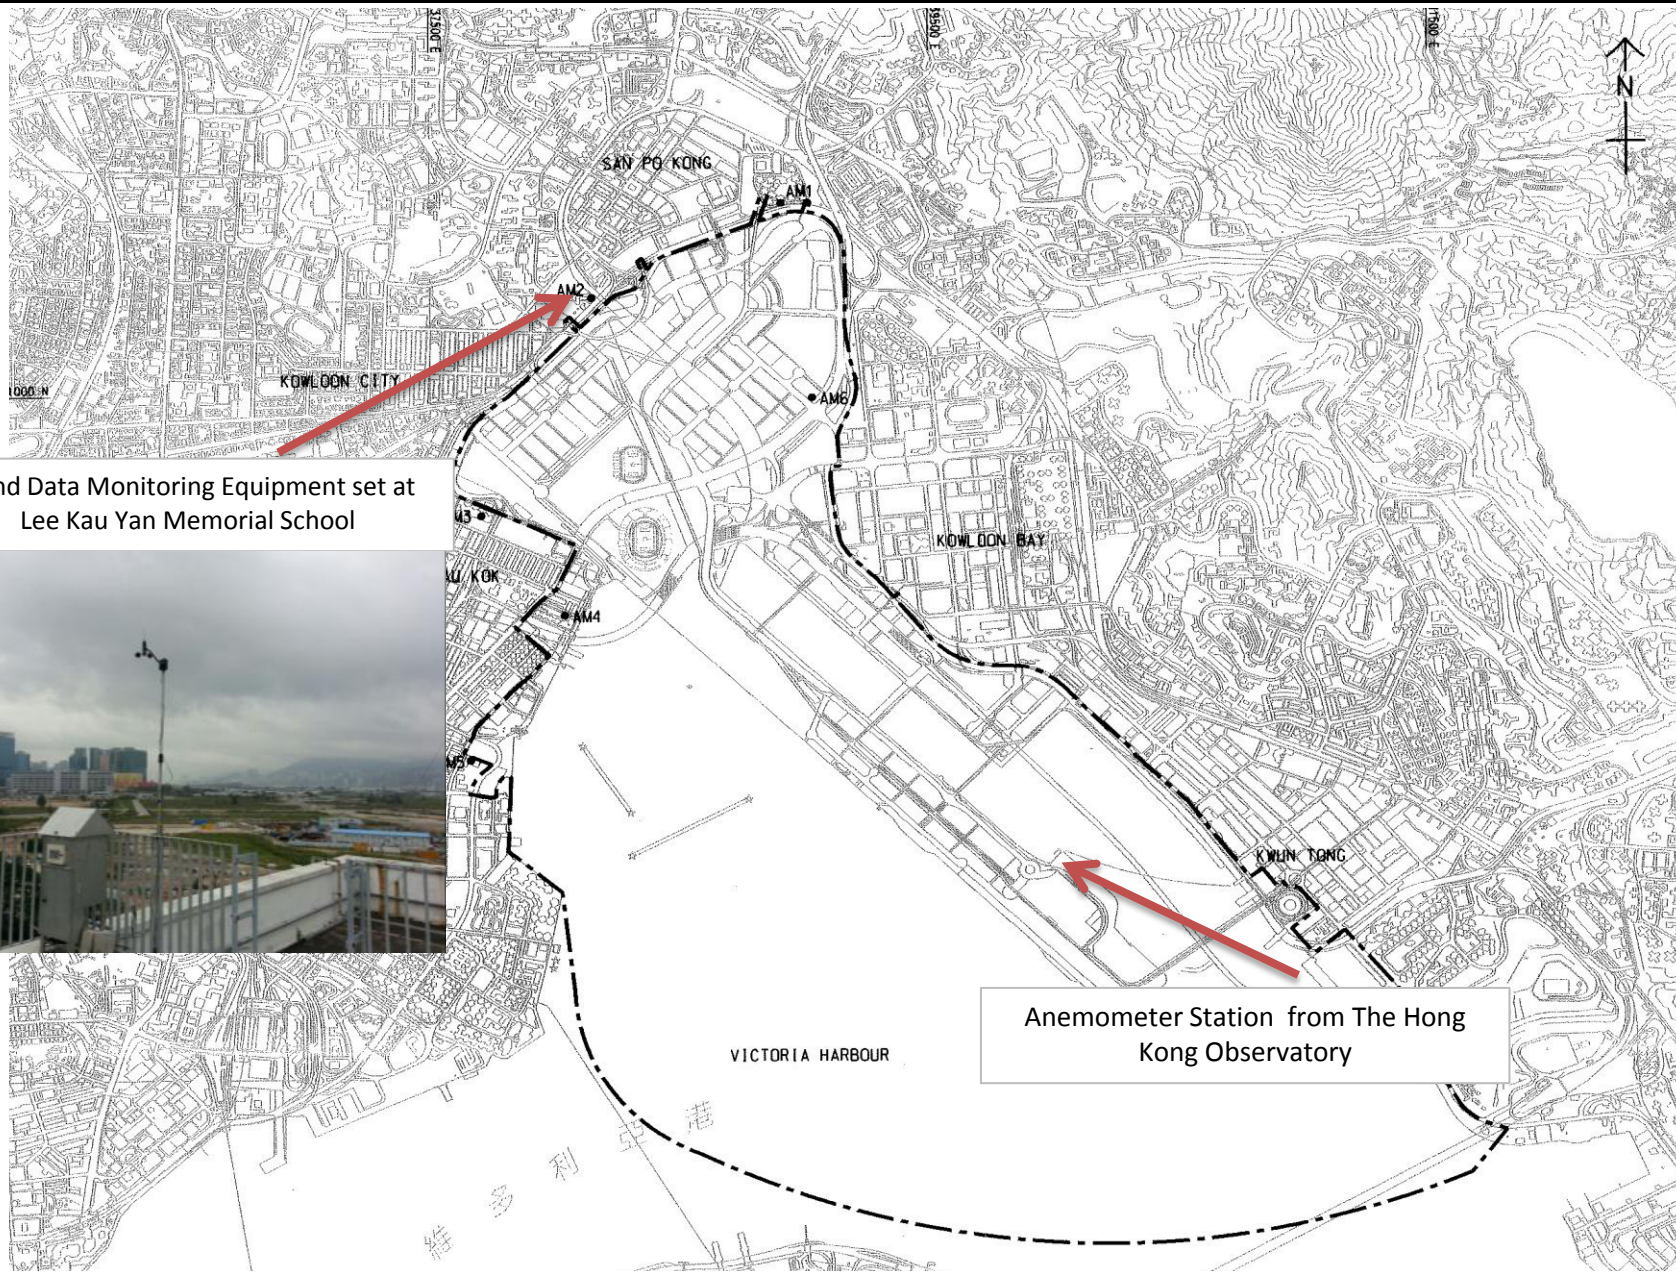
Wind Data Monitoring Equipment set at Lee Kau Yan Memorial School

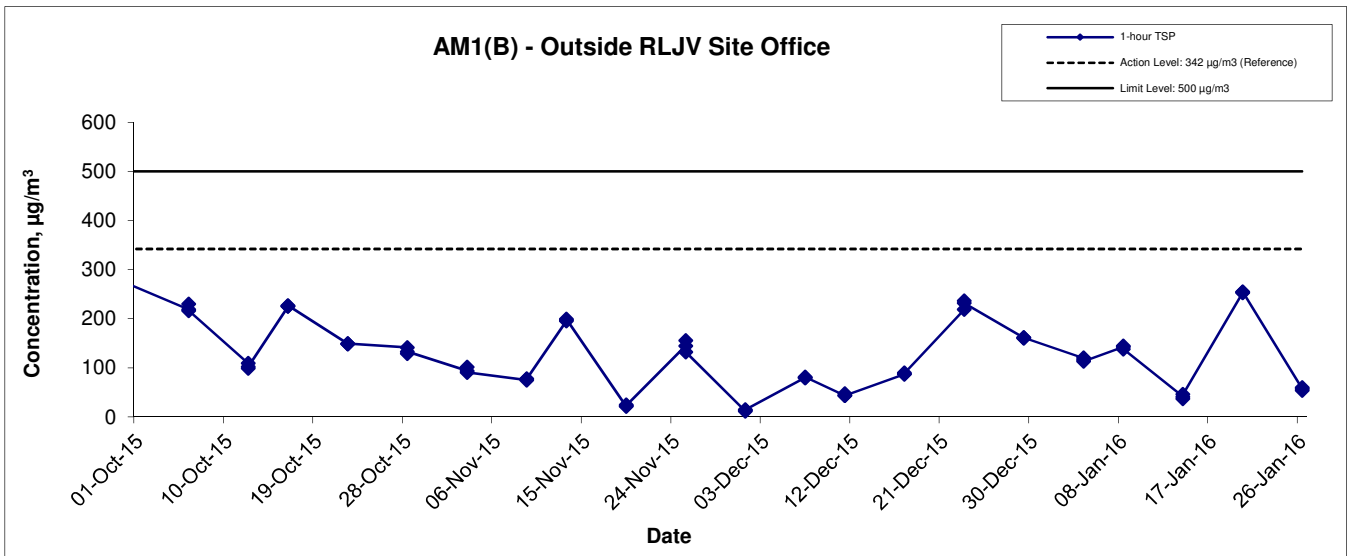
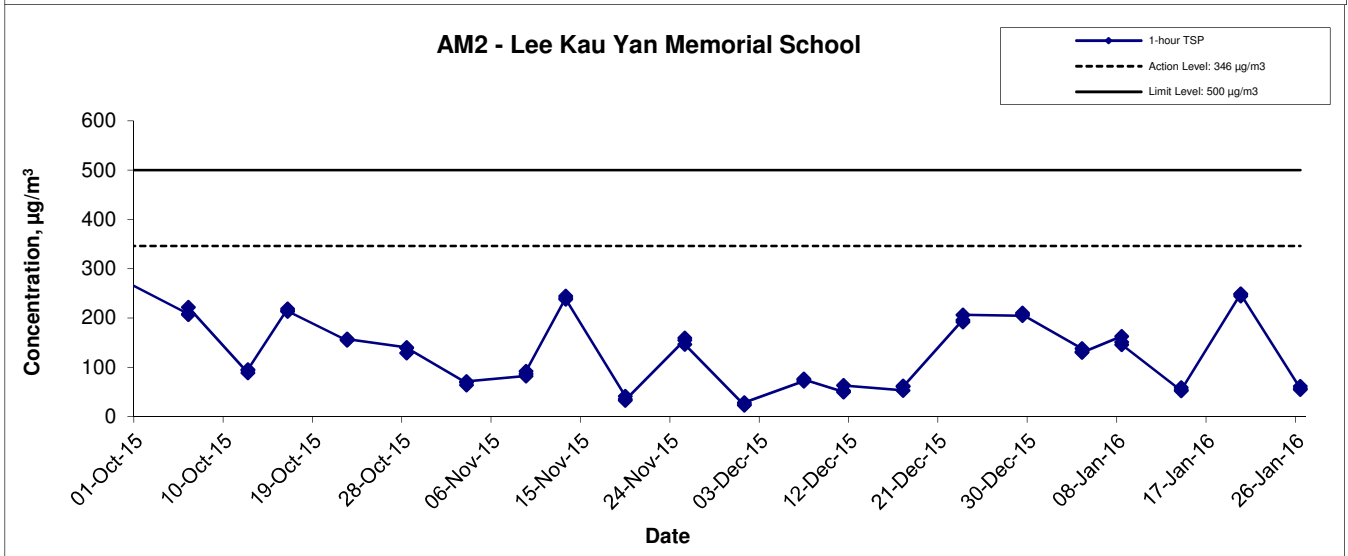
Title Contract No. KL/2012/02 Kai Tak Development - Stage 3A Infrastructure at Former North Apron Area  Graphical Presentation of 1-hour TSP Monitoring Results	Scale N.T.S	Project No. MA13043	
	Date Jan 16	Appendix E

### 1-hr TSP Concentration Levels

- 2.17 All 1-hour TSP monitoring was conducted as scheduled in the reporting month. No Action/Limit Level exceedance was recorded.
- 2.18 All 24-hour TSP monitoring was conducted as scheduled in the reporting month. No Action/Limit Level exceedance was recorded.
- 2.19 The air temperature, precipitation and the relative humidity data was obtained from Hong Kong Observatory where the wind speed and wind direction were recorded by the installed Wind Anemometer set at rooftop (about 8/F) Lee Kau Yan Memorial School. The location is shown in **Figure 4**. This weather information for the reporting month is summarized in **Appendix C**.
- 2.20 The monitoring data and graphical presentations of 1-hour and 24-hour TSP monitoring results are shown in **Appendices E and F** respectively.

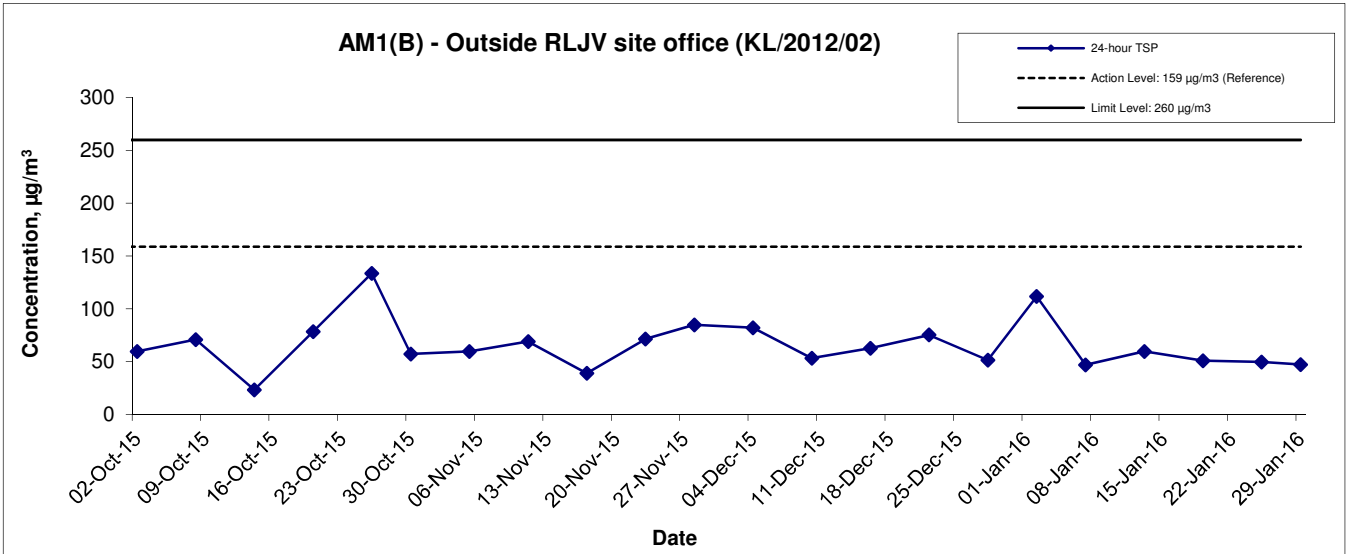
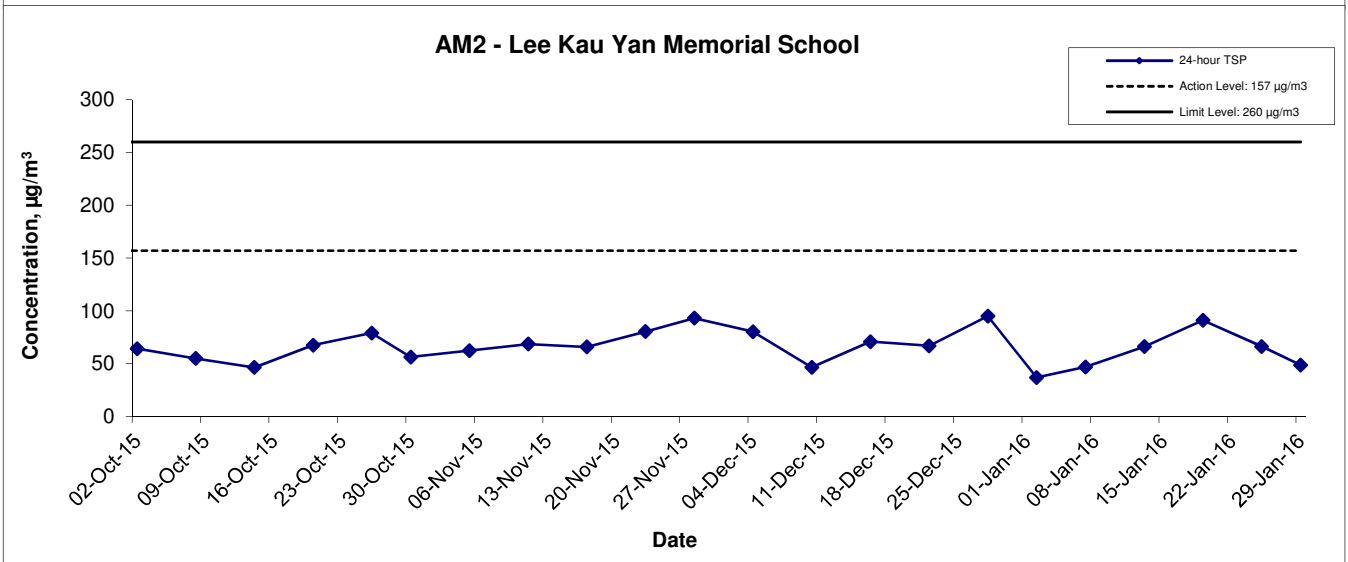
Title Contract No. KL/2012/02 Kai Tak Development - Stage 3A Infrastructure at Former North Apron Area  Graphical Presentation of 24-hour TSP Monitoring Results	Scale N.T.S	Project No. MA13043	
	Date Jan 16	Appendix F

### 24-hr TSP Concentration Levels

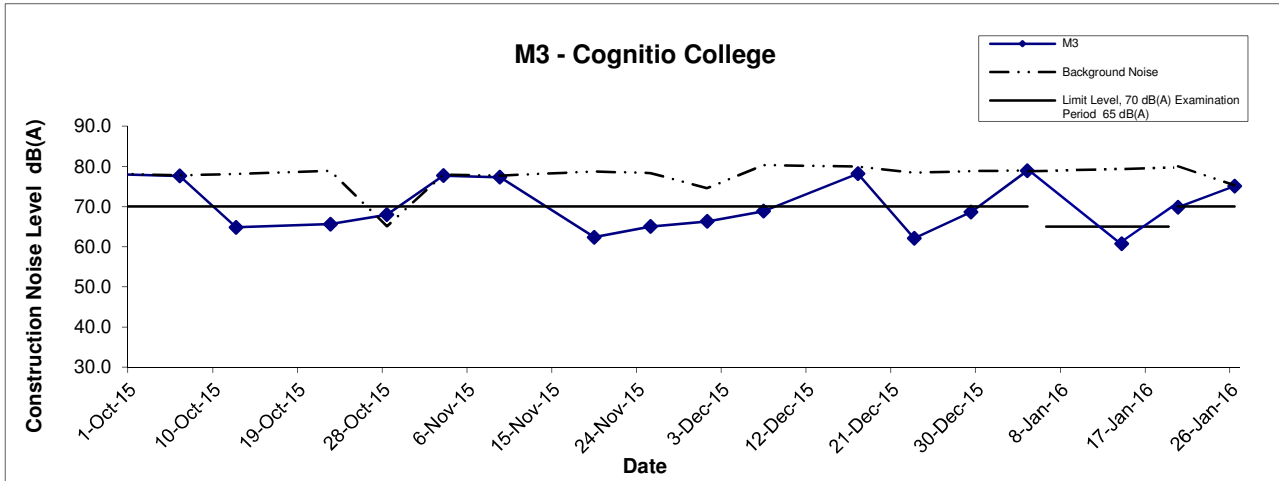
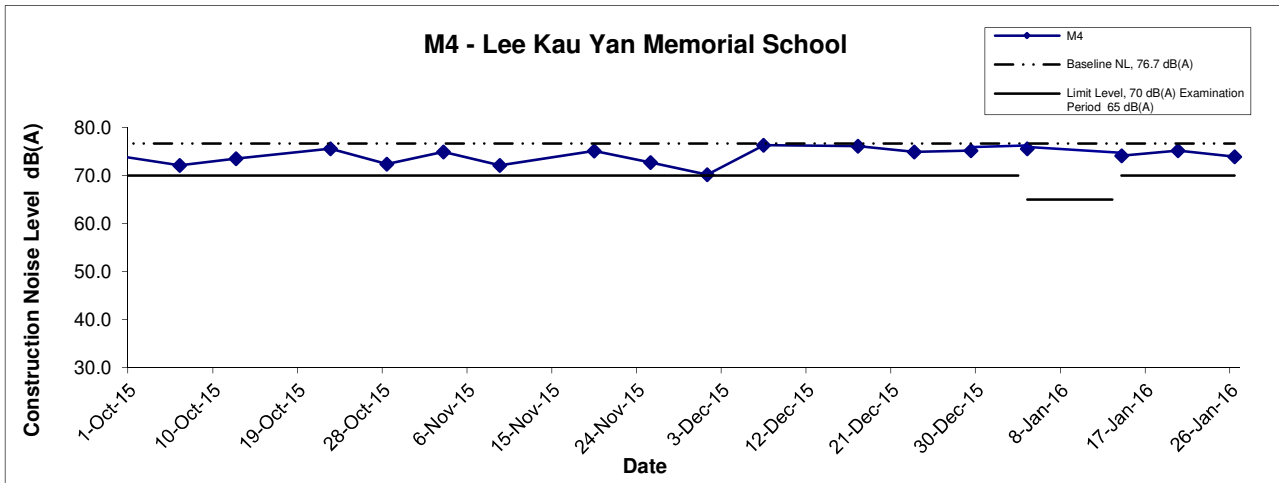
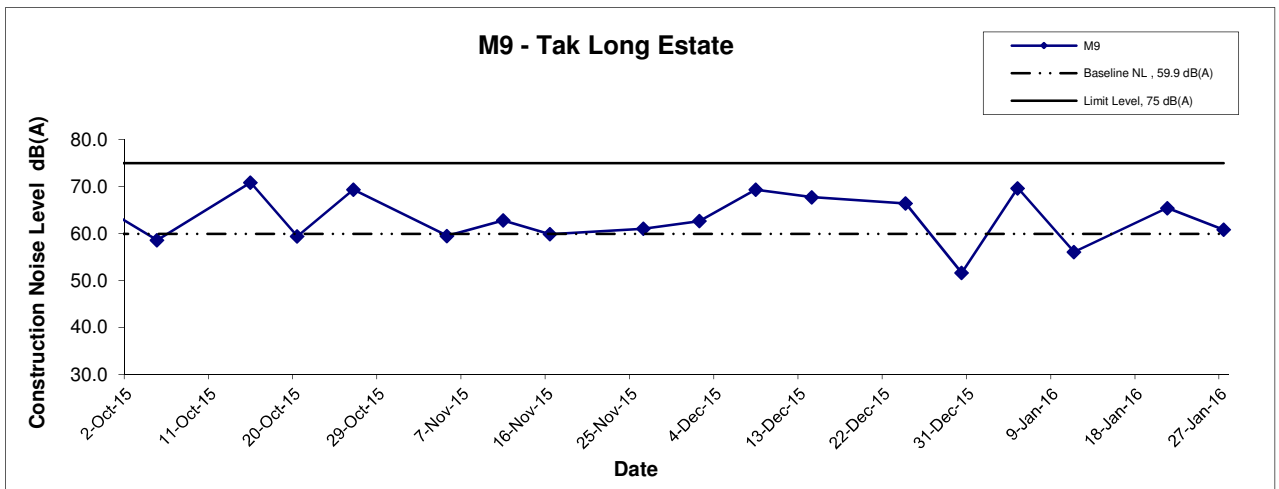
Title Contract No. KL/2012/02 Kai Tak Development - Stage 3A Infrastructure at Former North Apron Area  Graphical Presentation of Construction Noise Monitoring Results	Scale N.T.S	Project No. MA13043	CINOTECH
	Date Jan 16	Appendix G

## Noise Levels

Remarks: The construction noise levels in the Tables in Appendix G were adopted for plotting the graphs
