EP-337/2009 – New Distributor Roads Serving the Planned KTD

Contract No. KL/2012/02

Kai Tak Development –Stage 3A Infrastructure at Former
North Apron Area

Monthly EM&A Report

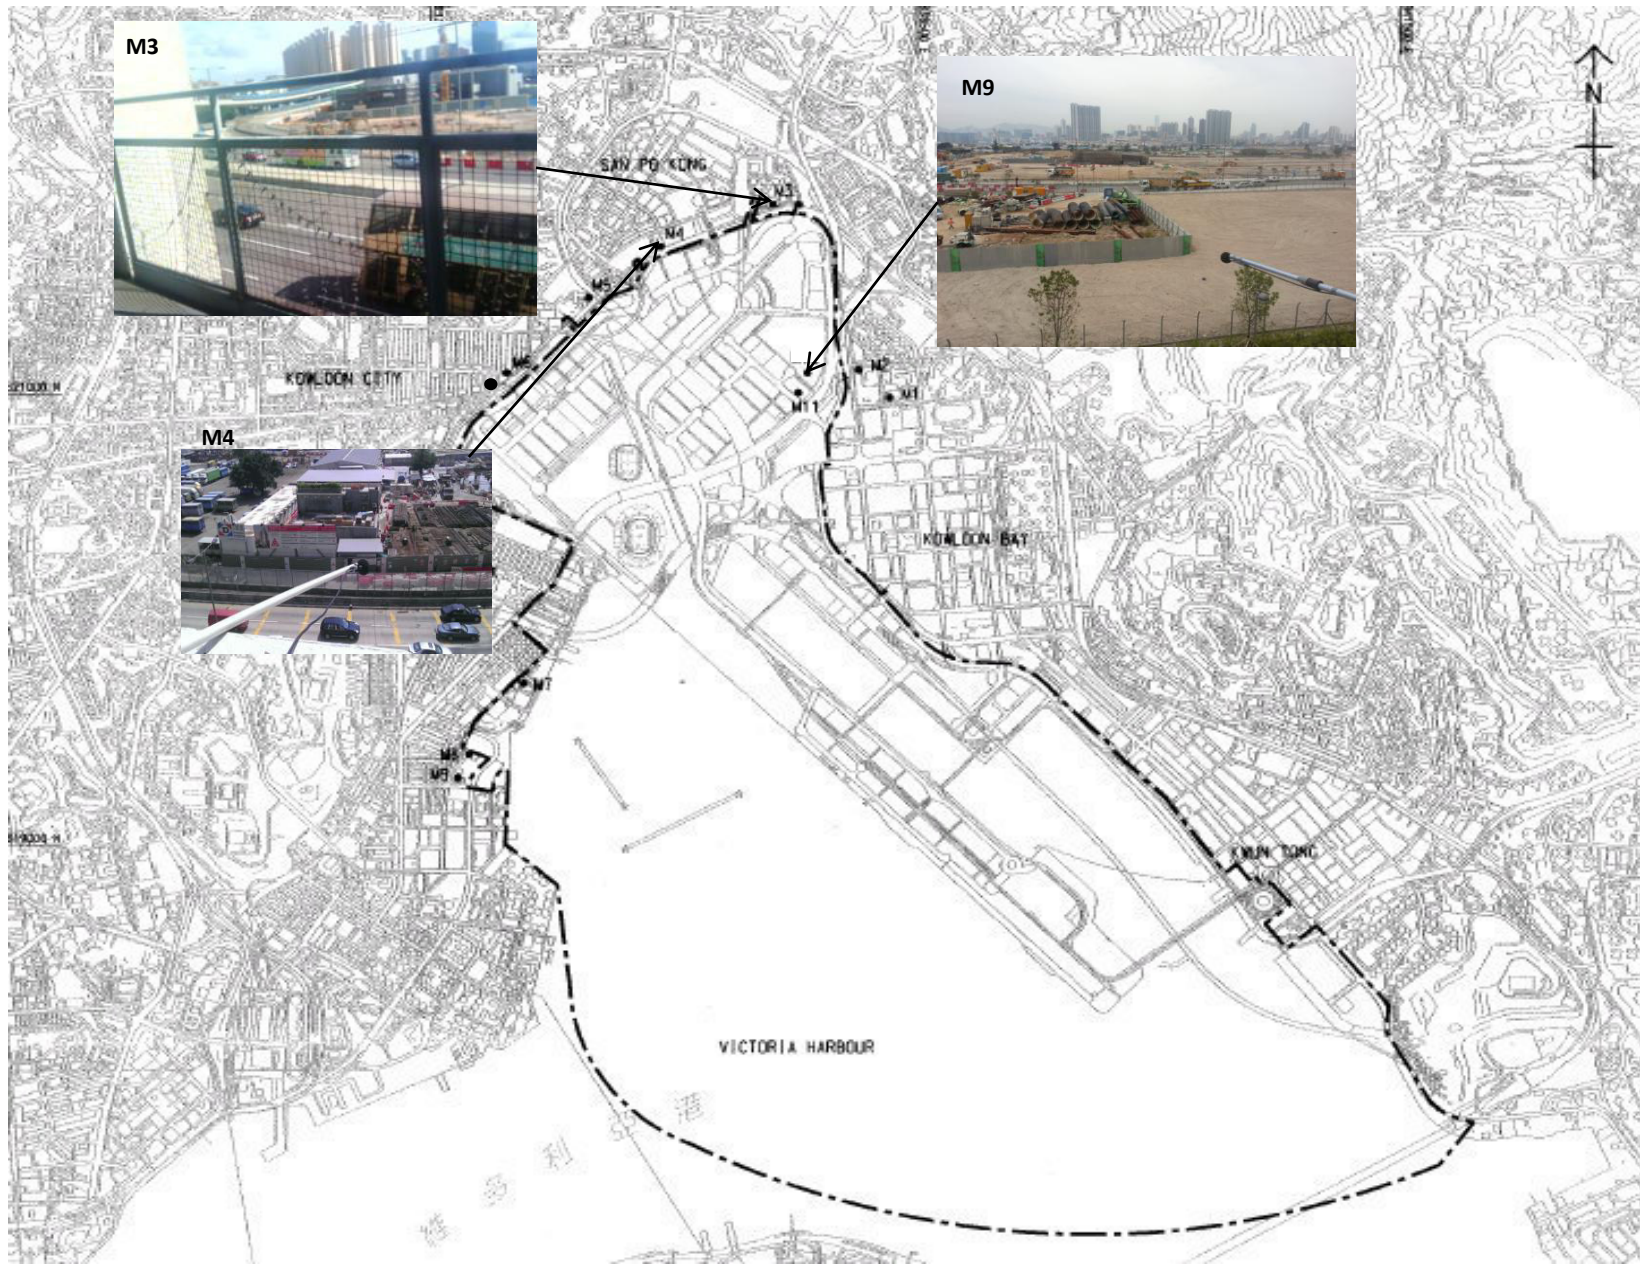
Date Apr-14	Figure 3

Title Contract No. KL/2012/02 Kai Tak Development –Stage 3A Infrastructure at Former North Apron Area Noise Monitoring Stations under Contract No.: KLN/2013/16	Scale N.T.S	Project No. MA13043

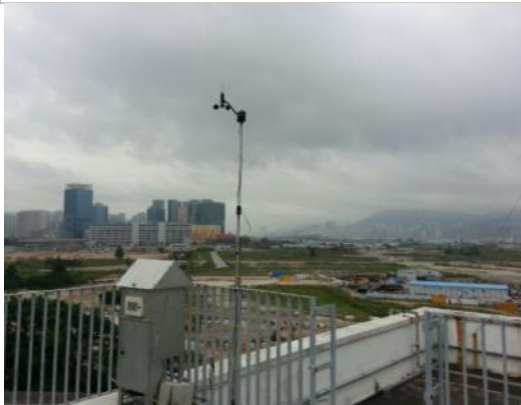
Anemometer Station from The Hong Kong Observatory

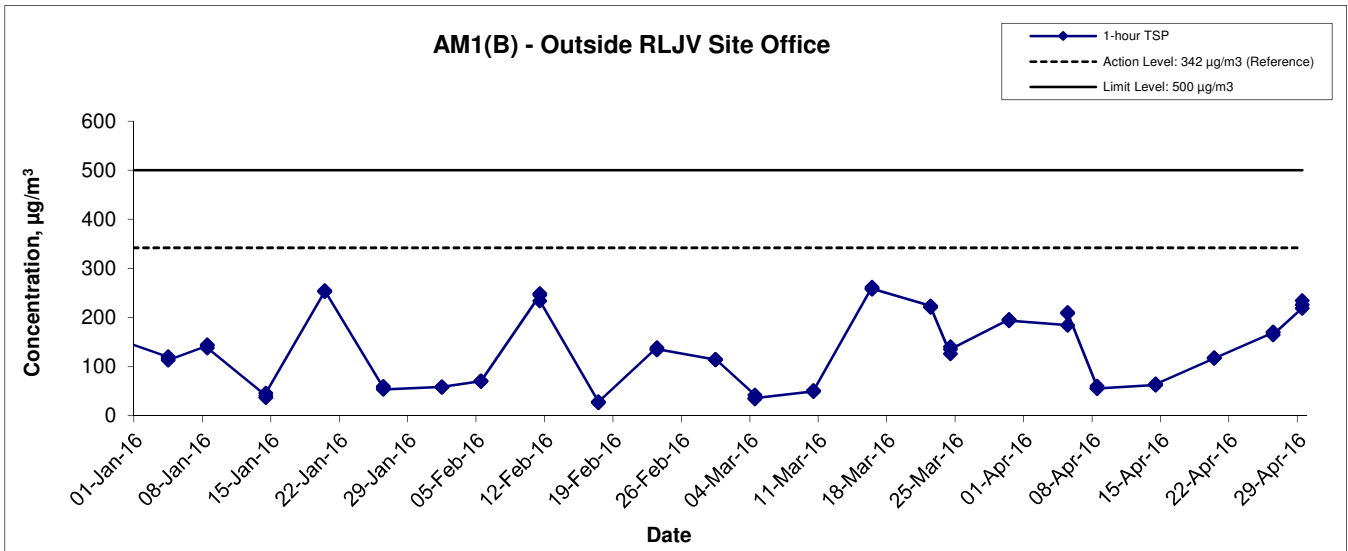
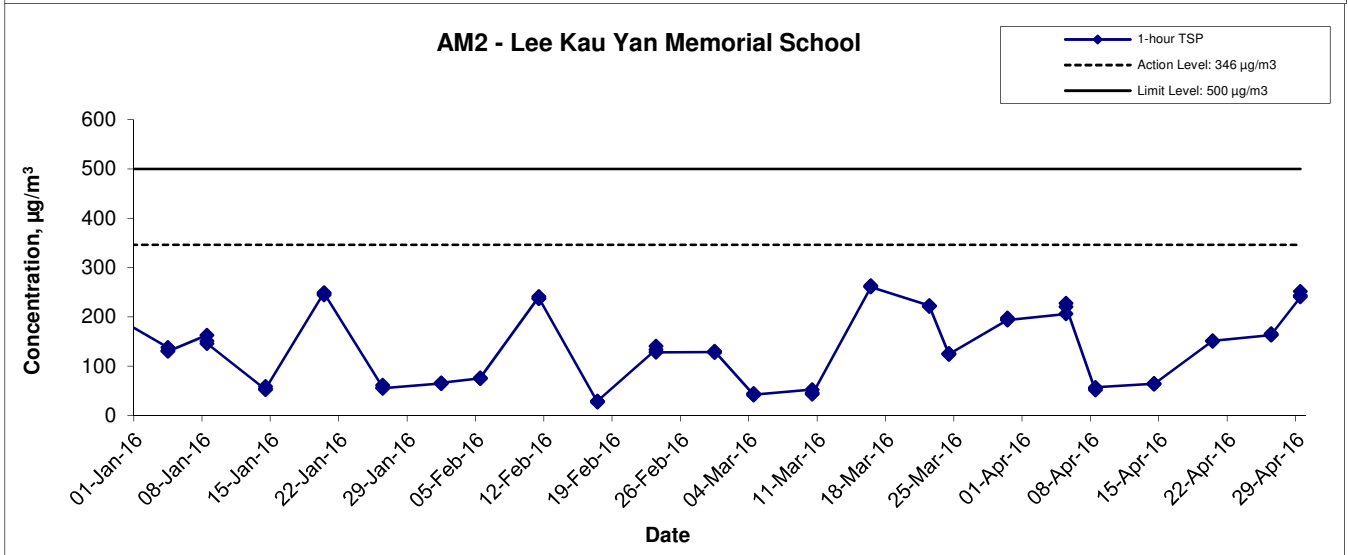
1-hr TSP Concentration Levels

Title Contract No. KL/2012/02 Kai Tak Development - Stage 3A Infrastructure at Former North Apron Area Graphical Presentation of 1-hour TSP Monitoring Results	Scale N.T.S	Project No. MA13043	
	Date Apr 16	Appendix E

- 2.17 All 1-hour TSP monitoring was conducted as scheduled in the reporting month. No Action/Limit Level exceedance was recorded.
- 2.18 All 24-hour TSP monitoring was conducted as scheduled in the reporting month. No Action/Limit Level exceedance was recorded.
- 2.19 The air temperature, precipitation and the relative humidity data was obtained from Hong Kong Observatory where the wind speed and wind direction were recorded by the installed Wind Anemometer set at rooftop (about 8/F) Lee Kau Yan Memorial School. The location is shown in **Figure 4**. This weather information for the reporting month is summarized in **Appendix C**.
- 2.20 The monitoring data and graphical presentations of 1-hour and 24-hour TSP monitoring results are shown in **Appendices E and F** respectively.

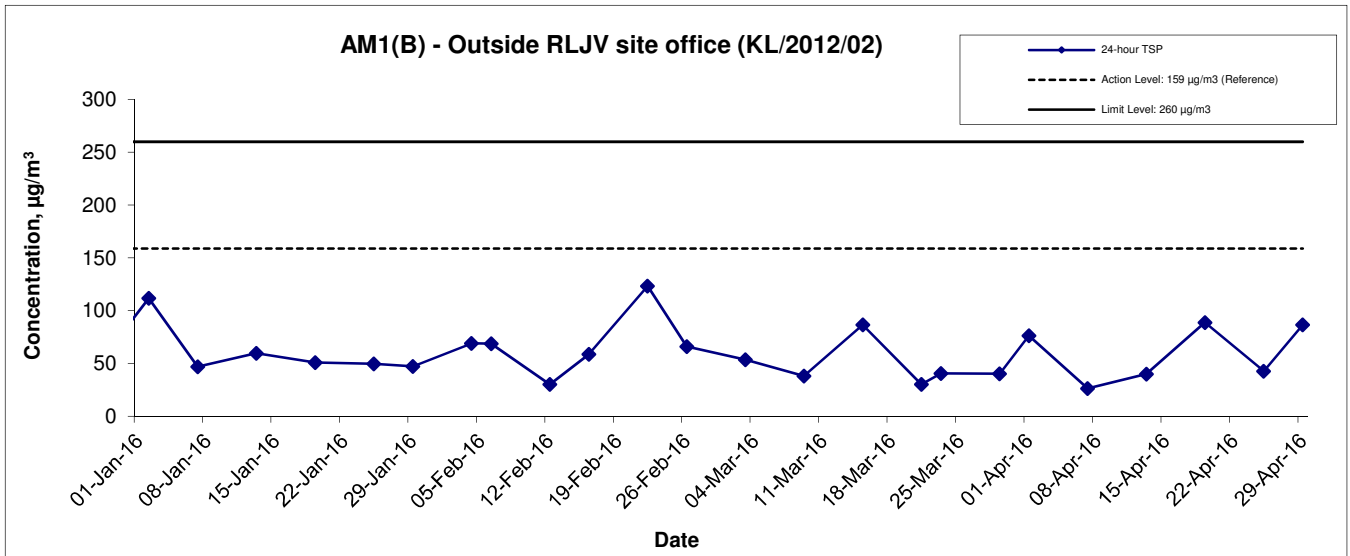
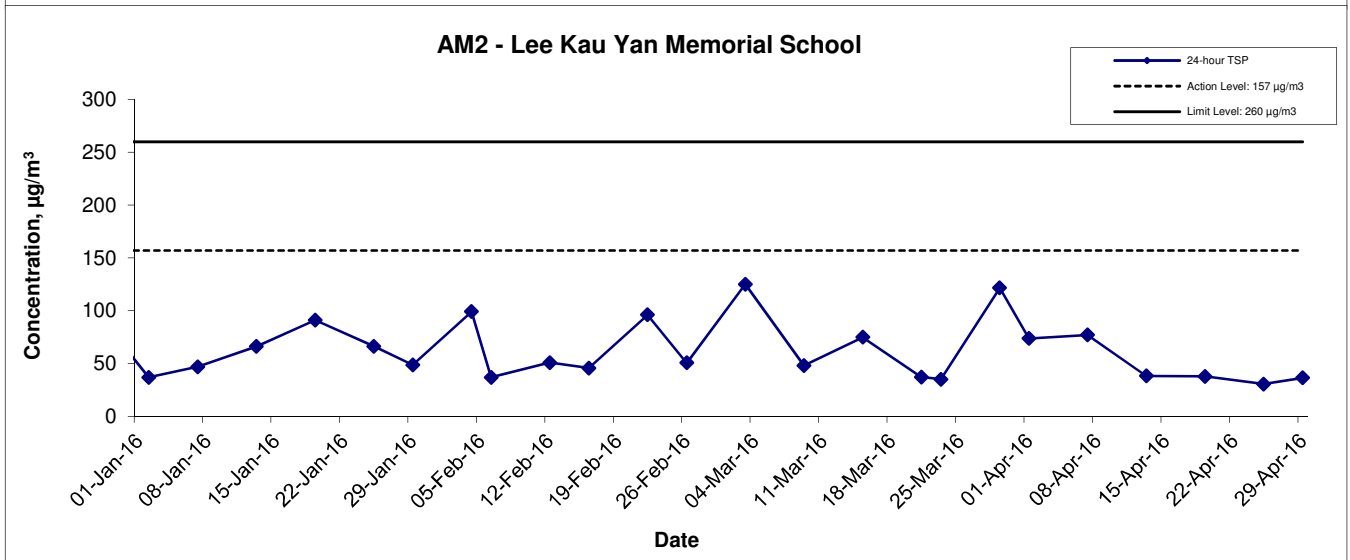
24-hr TSP Concentration Levels

Title Contract No. KL/2012/02 Kai Tak Development - Stage 3A Infrastructure at Former North Apron Area Graphical Presentation of 24-hour TSP Monitoring Results	Scale N.T.S	Project No. MA13043	CINOTECH
	Date Apr 16	Appendix F

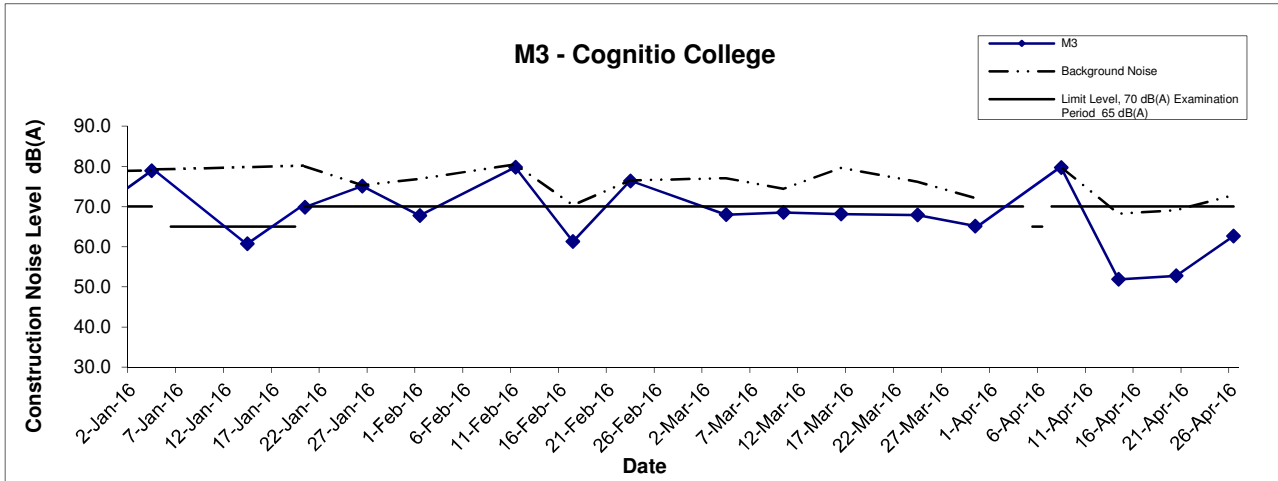
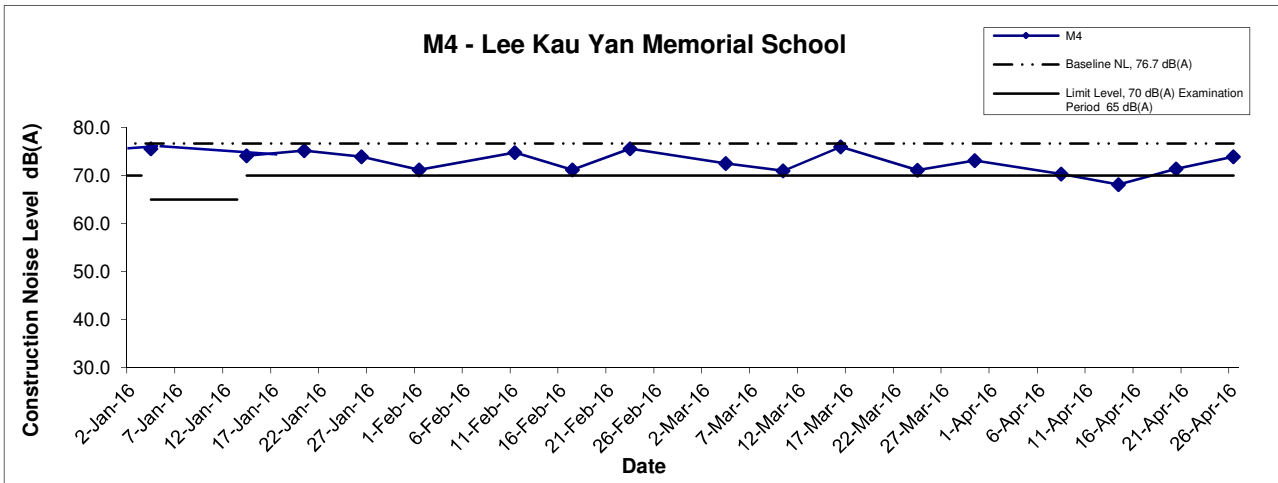
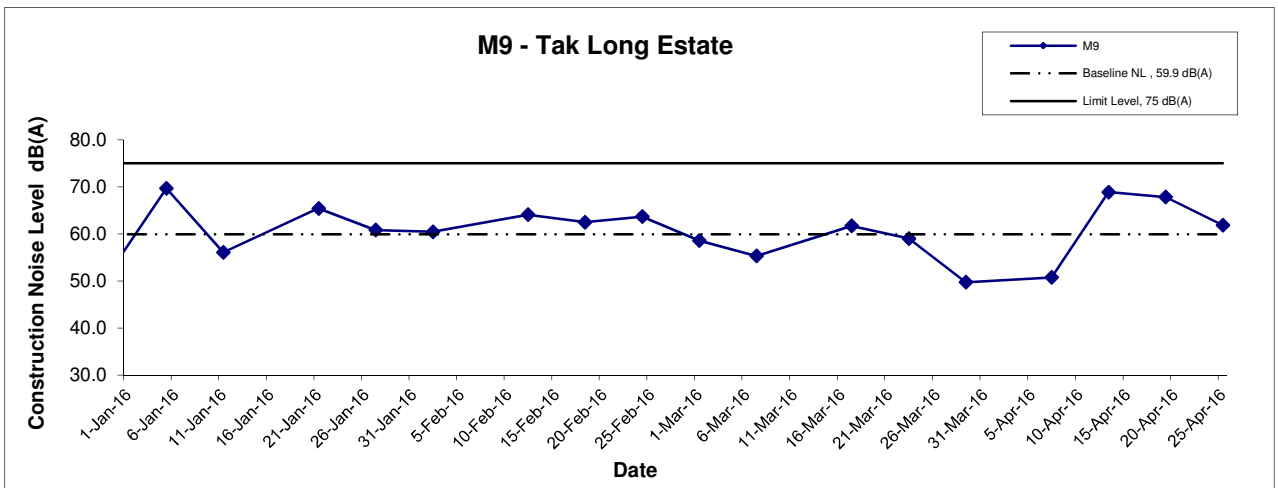
Remarks: The construction noise levels in the Tables in Appendix G were adopted for plotting the graphs

Title Contract No. KL/2012/02 Kai Tak Development - Stage 3A Infrastructure at Former North Apron Area Graphical Presentation of Construction Noise Monitoring Results	Scale N.T.S	Project No. MA13043	CINOTECH
	Date Apr 16	Appendix G
