EP-344/2009 – New Sewage Pumping Stations Serving KTD  
EP-337/2009 – New Distributor Roads Serving the Planned KTD

Contract No. KL/2012/03  
Kai Tak Development – Stage 4 Infrastructure at Former North  
Apron Area

Monthly EM&A Report

April 2016

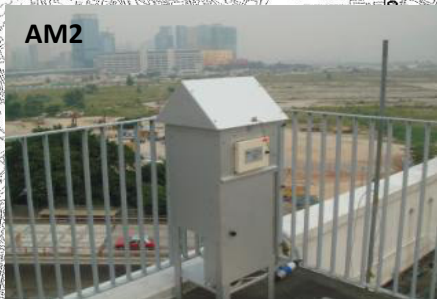
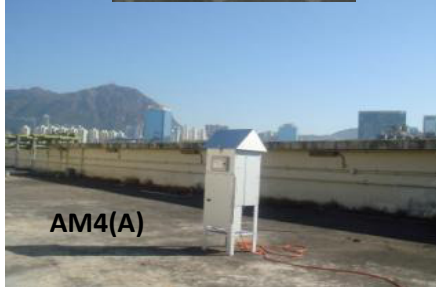
Scale	N.T.S	Project No.	MA13056
Date	Jan-14	Figure	2

Location		Northing	Easting
AM2	Lee Kau Yan Memorial School	821441.245	838153.917
AM3(A)	Holy Trinity Bradbury Centre	820769.390	837522.115
AM4(A)	EMSD Workshops	820147.495	838155.791
AM5(A)	Po Leung Kuk Ngan Po Ling College	819300.323	837659.613

Title Contract No. KL/2012/03  
 Kai Tak Development –Stage 4 Infrastructure at Former North Apron Area  
 Air Quality Monitoring Stations under this Project

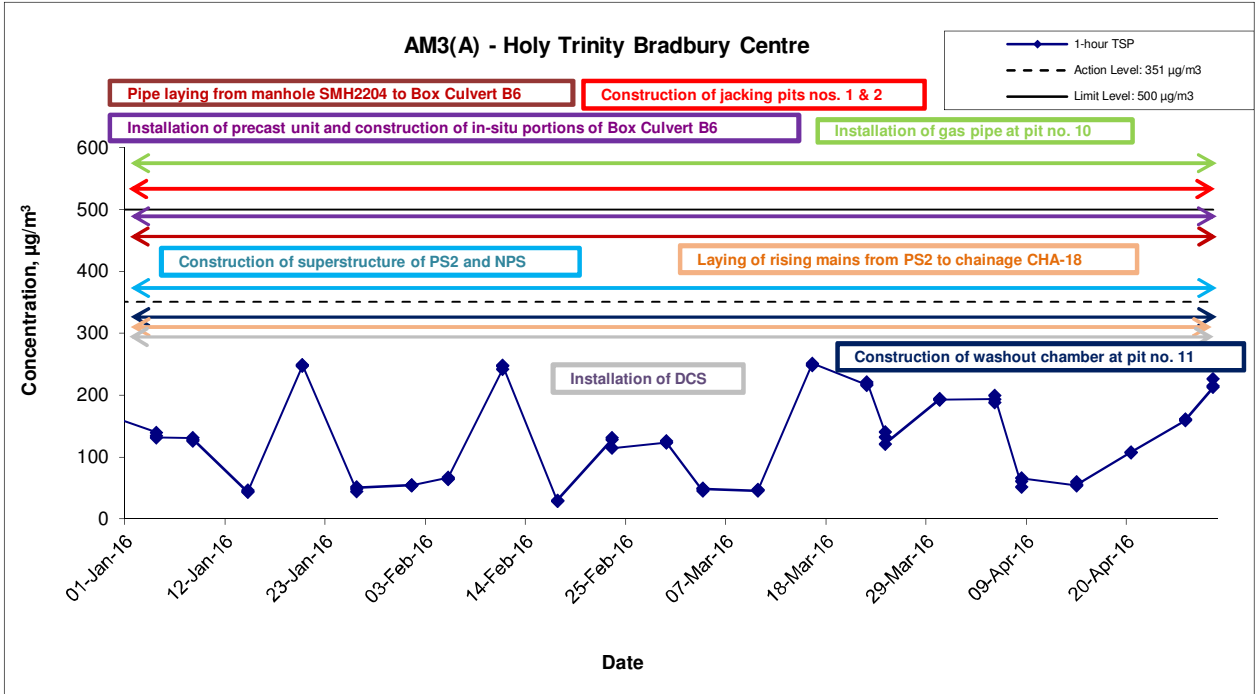
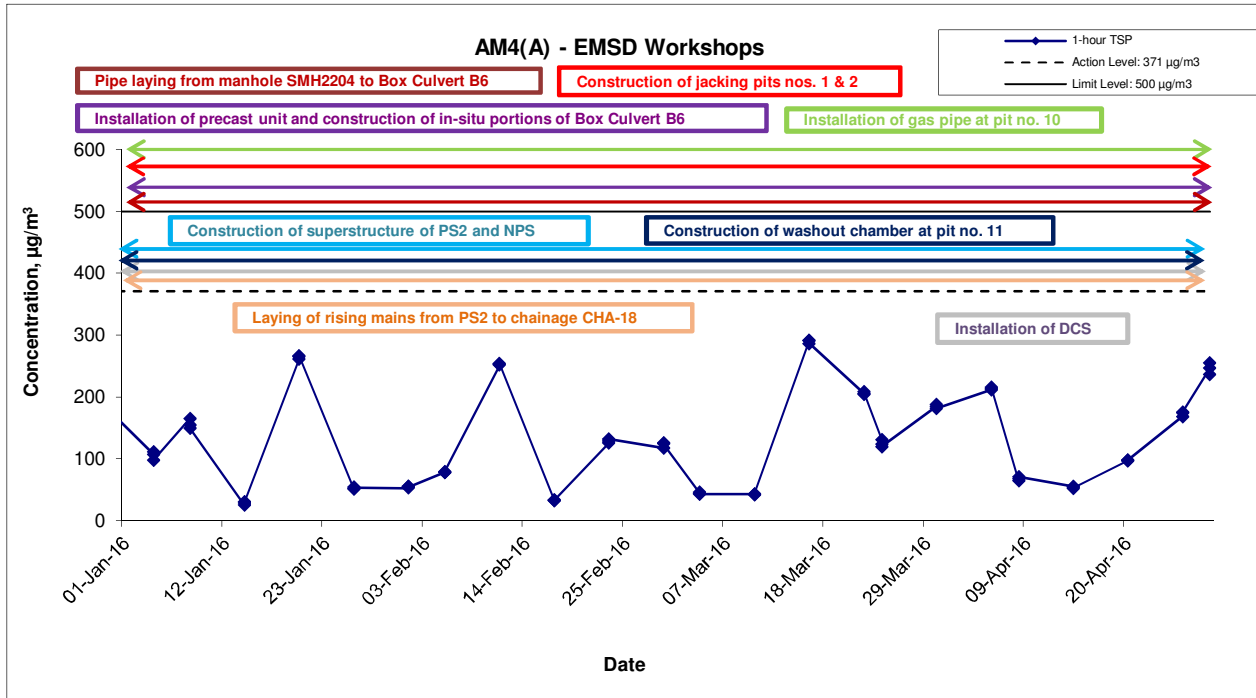
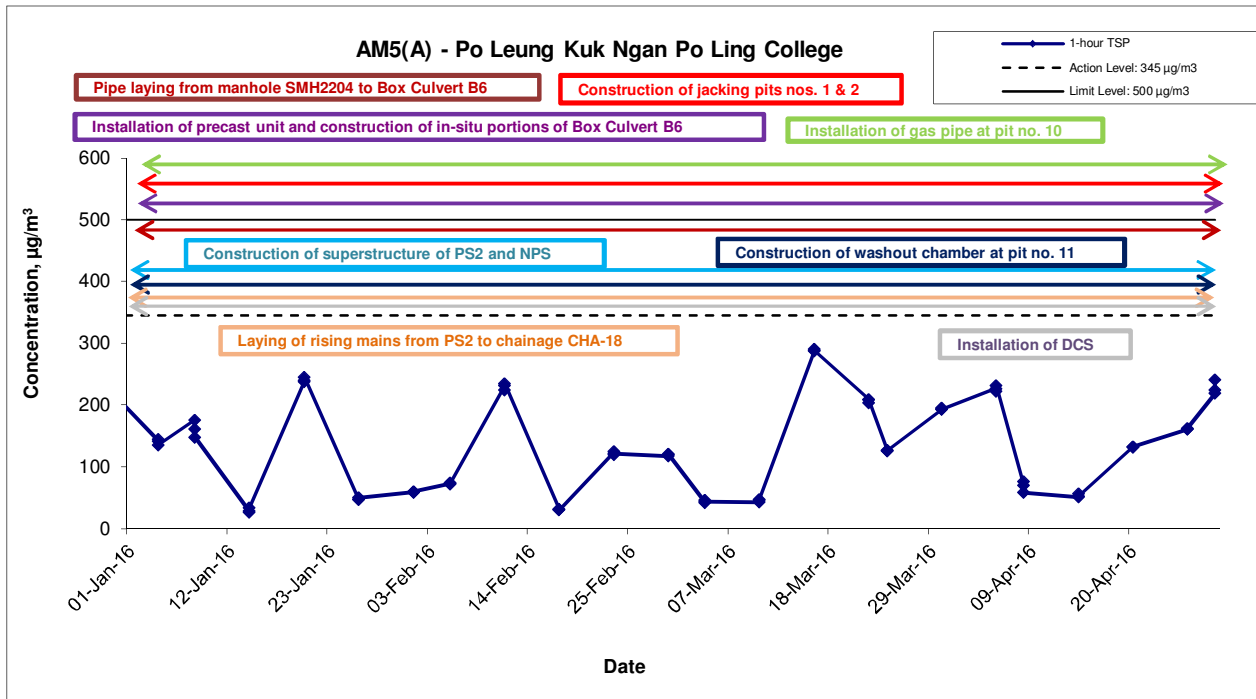
Title	Contract No. KL/2012/03	Scale	N.T.S	Project No.	MA13056	CINOTECH
	Kai Tak Development –Stage 4 Infrastructure at Former North Apron Area	Date	Apr 16	Appendix	E	
Graphical Presentation of 1-hour TSP Monitoring Results

### 1-hr TSP Concentration Levels

Title Contract No. KL/2012/03 Kai Tak Development –Stage 4 Infrastructure at Former North Apron Area Graphical Presentation of 1-hour TSP Monitoring Results	Scale N.T.S	Project No. MA13056	<b>CINOTECH</b>
	Date Apr 16	Appendix E

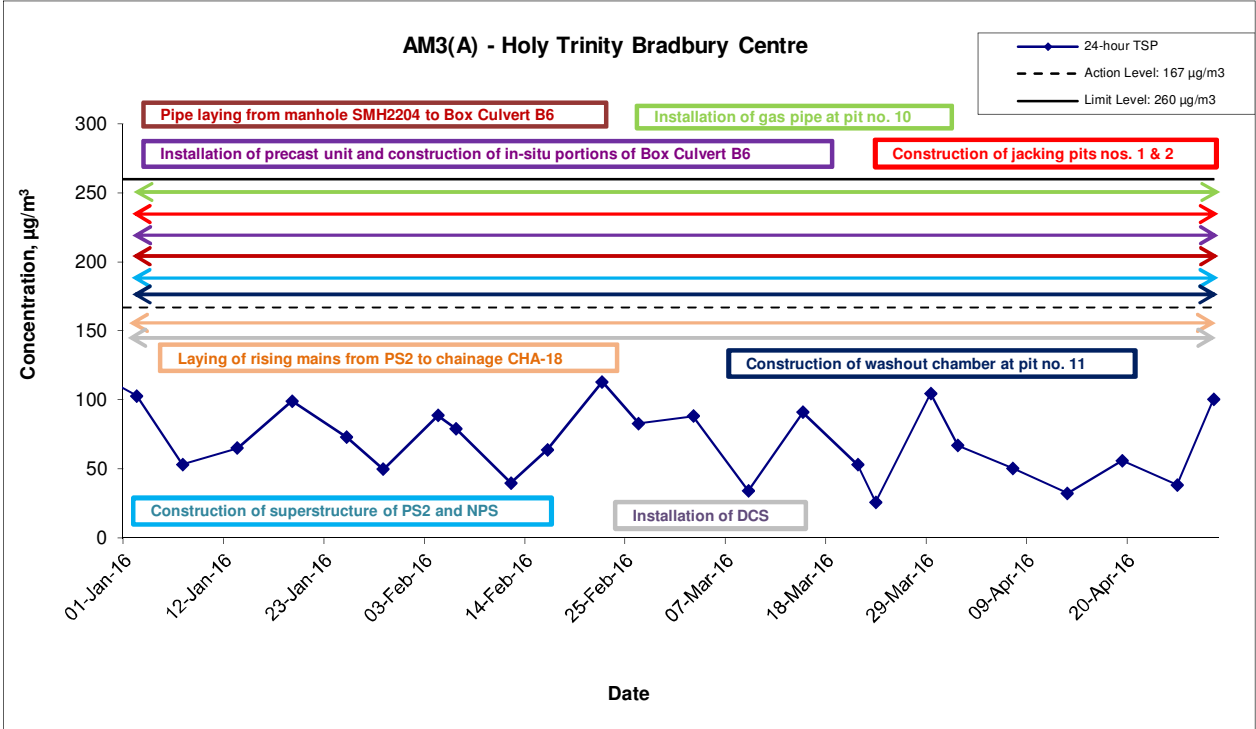
Scale N.T.S  
 Date Apr 16  
 Project No. MA13056  
 Appendix F

### 24-hr TSP Concentration Levels

Title Contract No. KL/2012/03  
 Kai Tak Development –Stage 4 Infrastructure at Former North Apron Area  
 Graphical Presentation of 24-hour TSP Monitoring Results

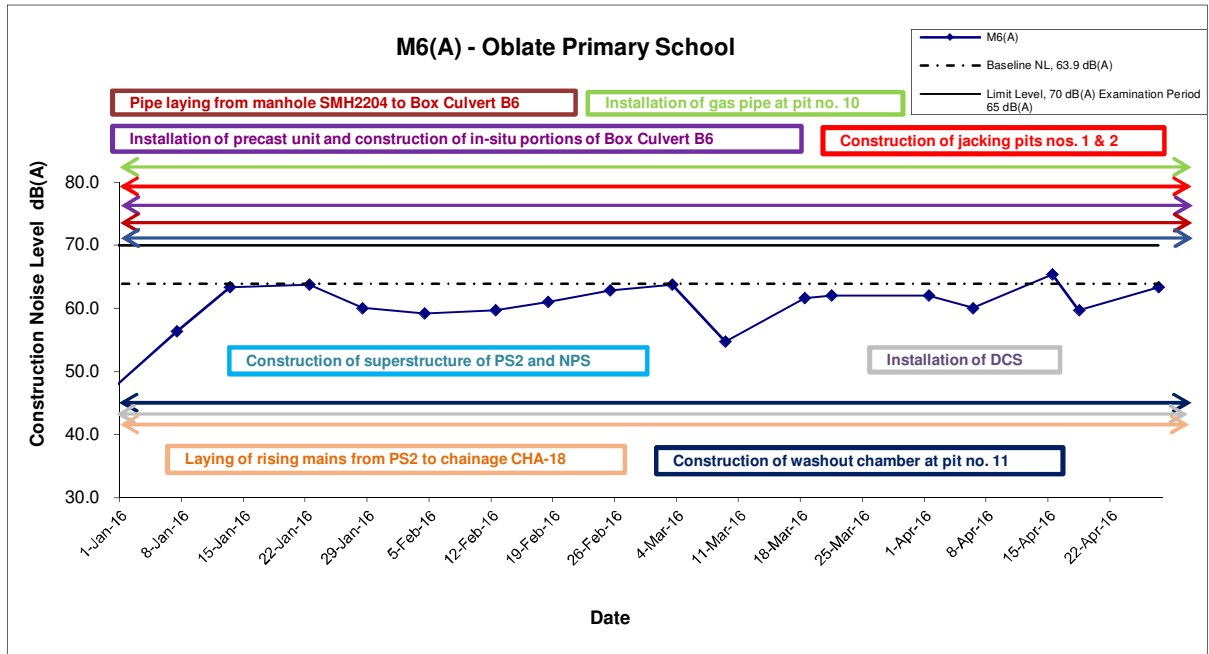
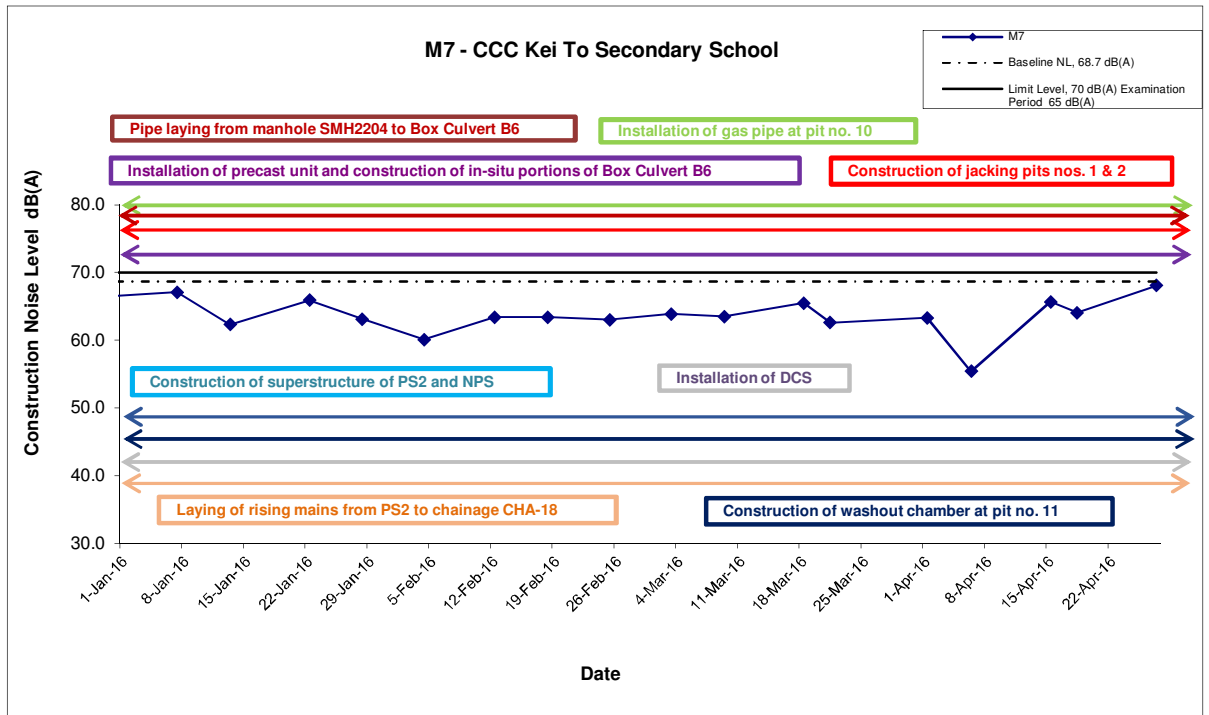
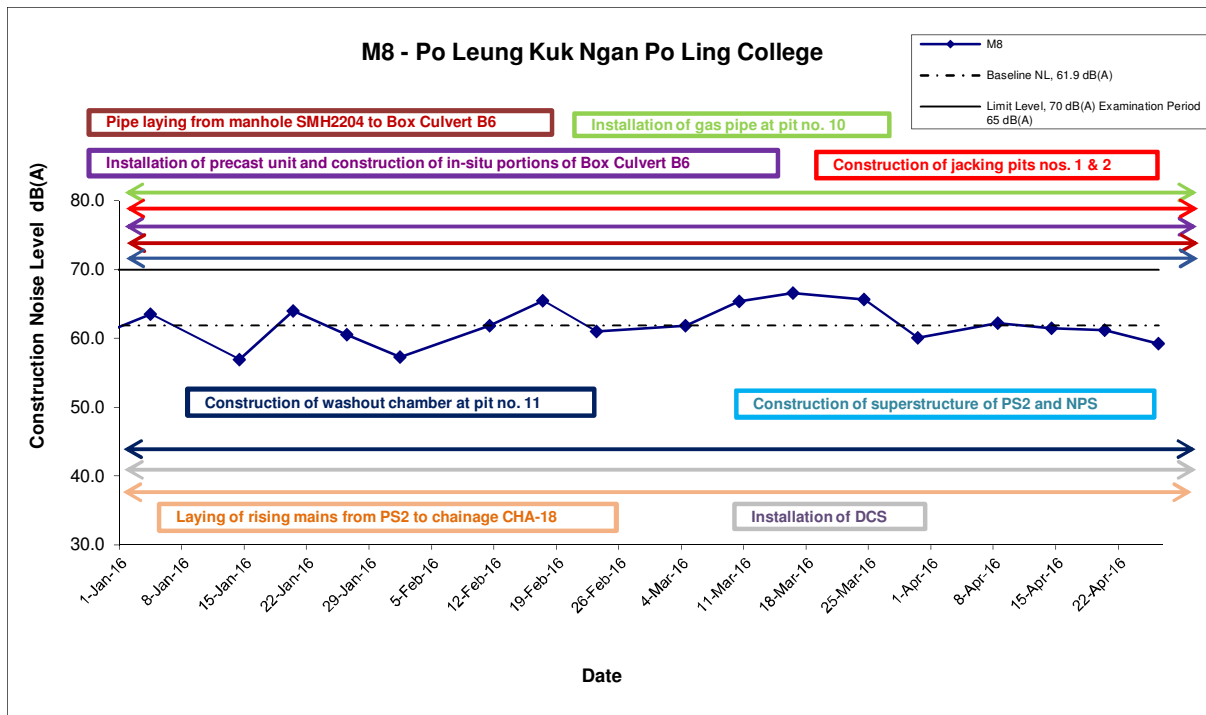
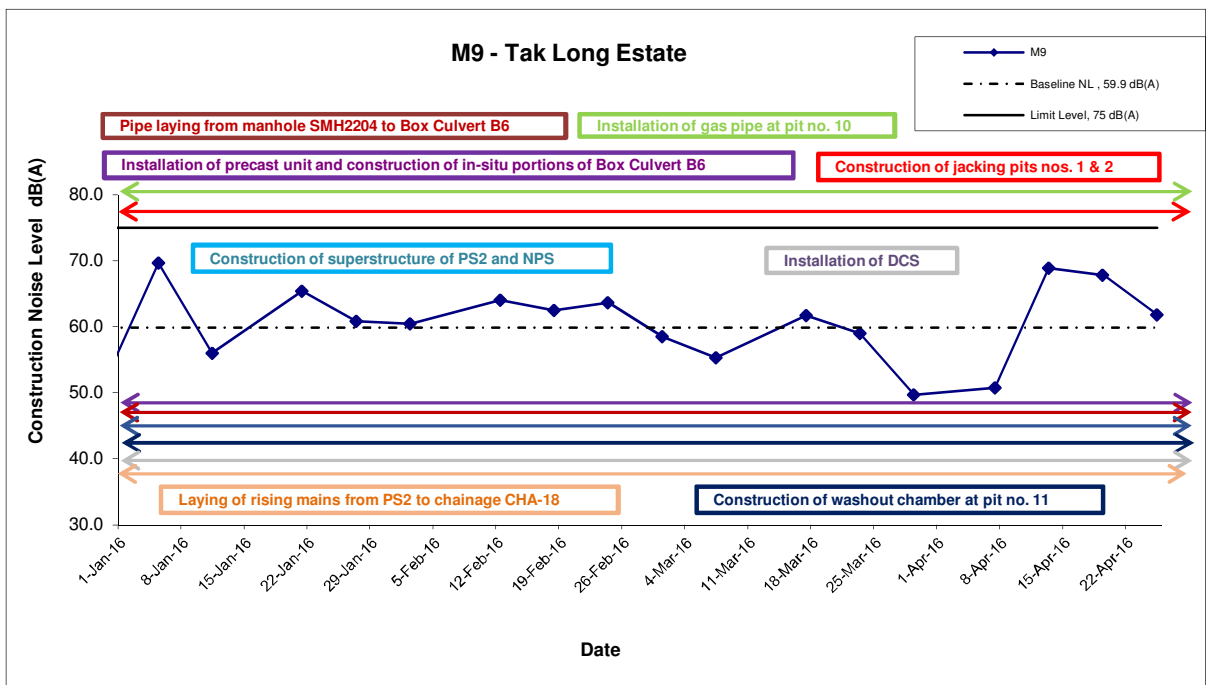
Remarks: The construction noise levels in the Tables in Appendix G were adopted for plotting the graphs

Title Contract No. KL/2012/03 Kai Tak Development –Stage 4 Infrastructure at Former North Apron Area Graphical Presentation of Construction Noise Monitoring Results	Scale N.T.S Date Apr 16	Project No. MA13056 Appendix G	
---	----------------------------------	---	--

Title Contract No. KL/2012/03 Kai Tak Development –Stage 4 Infrastructure at Former North Apron Area Graphical Presentation of Construction Noise Monitoring Results	Scale N.T.S	Project No. MA13056	
	Date Apr 16	Appendix G
