EP-344/2009 – New Sewage Pumping Stations Serving KTD  
EP-337/2009 – New Distributor Roads Serving the Planned KTD

Contract No. KL/2012/03  
Kai Tak Development –Stage 4 Infrastructure at Former North  
Apron Area

Monthly EM&A Report

May 2016

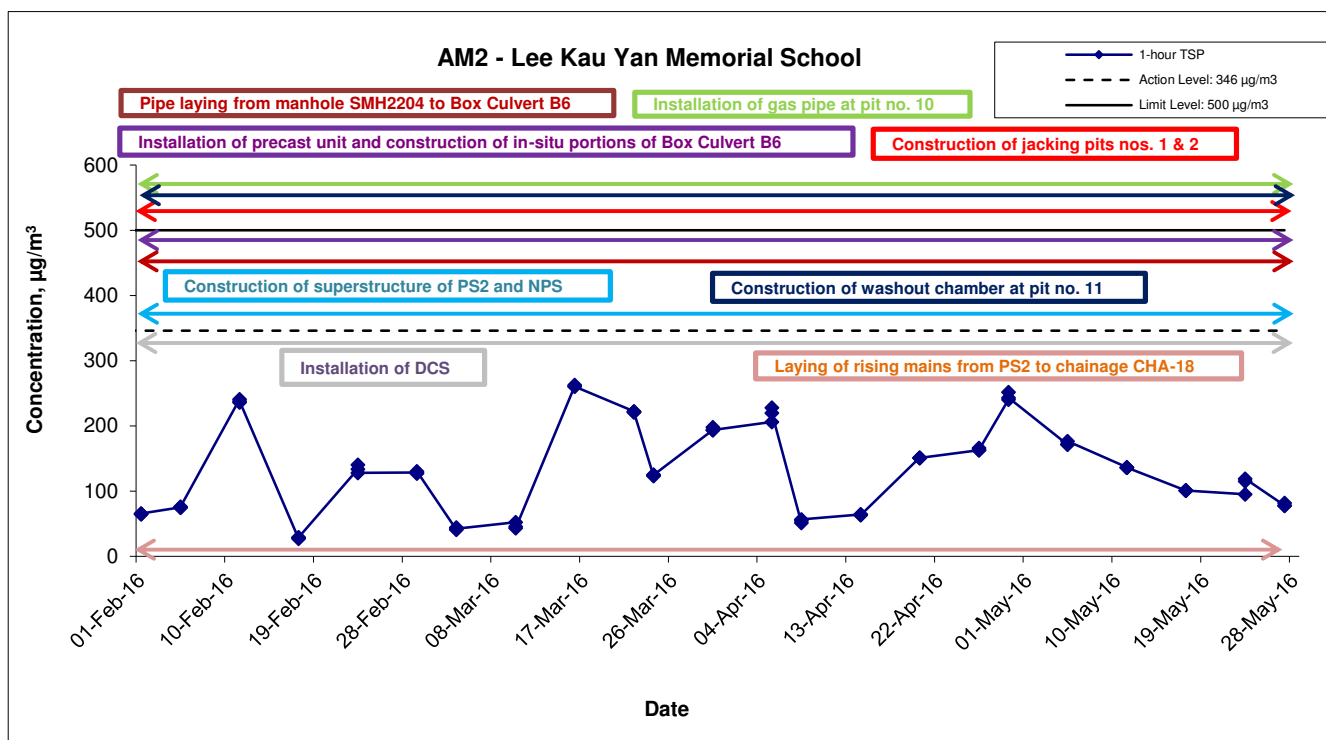
<b>Title</b> Contract No. KL/2012/03 Kai Tak Development –Stage 4 Infrastructure at Former North Apron Area  Graphical Presentation of 1-hour TSP Monitoring Results	<b>Scale</b> N.T.S	<b>Project No.</b> MA13056	<b>CINOTECH</b>
	<b>Date</b> May 16	<b>Appendix</b> E

<b>Title</b> Contract No. KL/2012/03 Kai Tak Development –Stage 4 Infrastructure at Former North Apron Area  Graphical Presentation of 1-hour TSP Monitoring Results	<b>Scale</b> N.T.S	<b>Project No.</b> MA13056

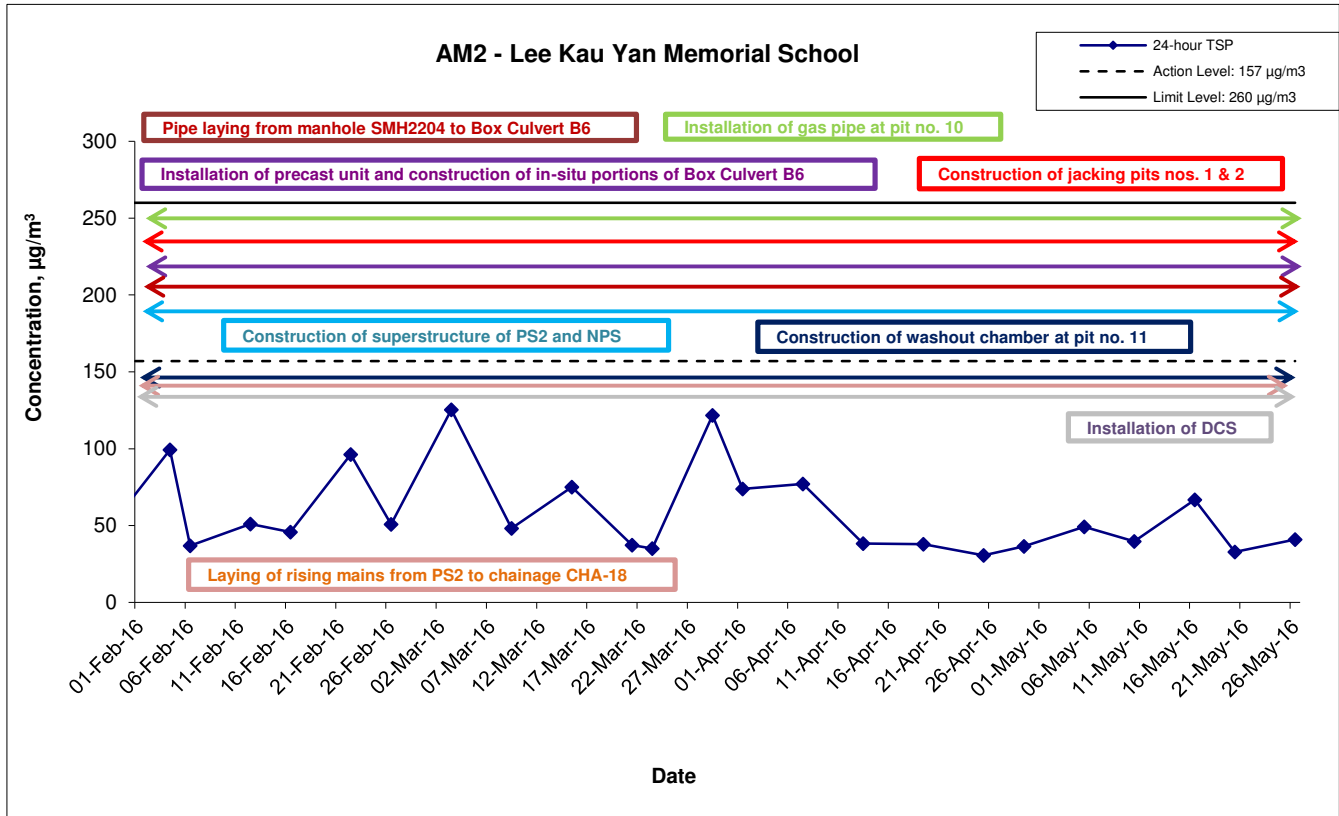
<b>Title</b> Contract No. KL/2012/03 Kai Tak Development –Stage 4 Infrastructure at Former North Apron Area  Graphical Presentation of 24-hour TSP Monitoring Results	<b>Scale</b> N.T.S	<b>Project No.</b> MA13056	
	<b>Date</b> May 16	<b>Appendix</b> F

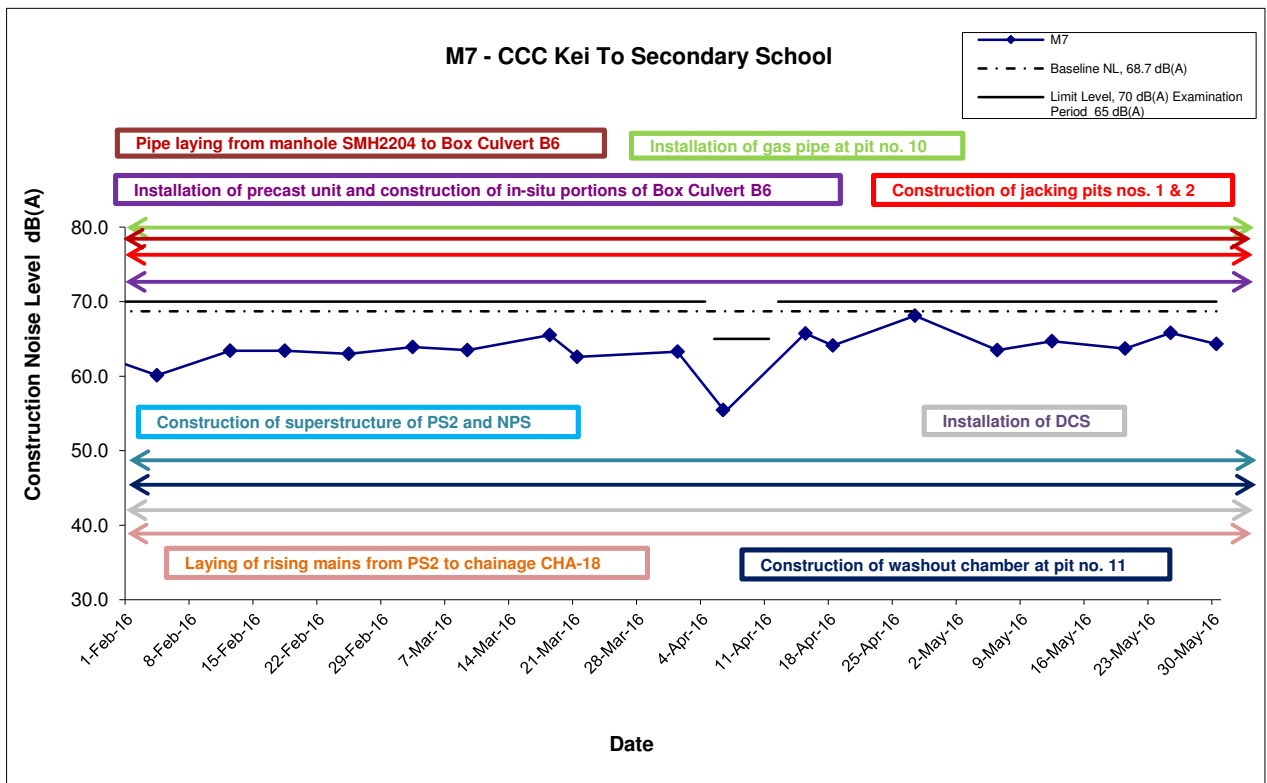
Remarks: The construction noise levels in the Tables in Appendix G were adopted for plotting the graphs

<b>Title</b> Contract No. KL/2012/03 Kai Tak Development –Stage 4 Infrastructure at Former North Apron Area  Graphical Presentation of Construction Noise Monitoring Results	<b>Scale</b> N.T.S	<b>Project No.</b> MA13056	
	<b>Date</b> May 16	<b>Appendix</b> G

<b>Title</b> Contract No. KL/2012/03 Kai Tak Development –Stage 4 Infrastructure at Former North Apron Area Graphical Presentation of Construction Noise Monitoring Results	<b>Scale</b> N.T.S	<b>Project No.</b> MA13056	
	<b>Date</b> May 16	<b>Appendix</b> G
