EP-337/2009 – New Distributor Roads Serving the Planned KTD

Contract No. KL/2012/02
Kai Tak Development – Stage 3A Infrastructure at Former
North Apron Area

Monthly EM&A Report

June 2016

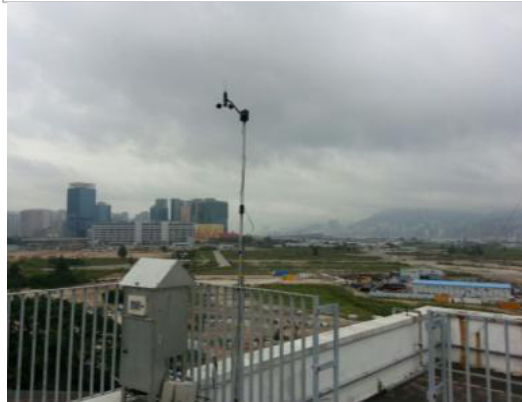
Anemometer Station from The Hong Kong Observatory

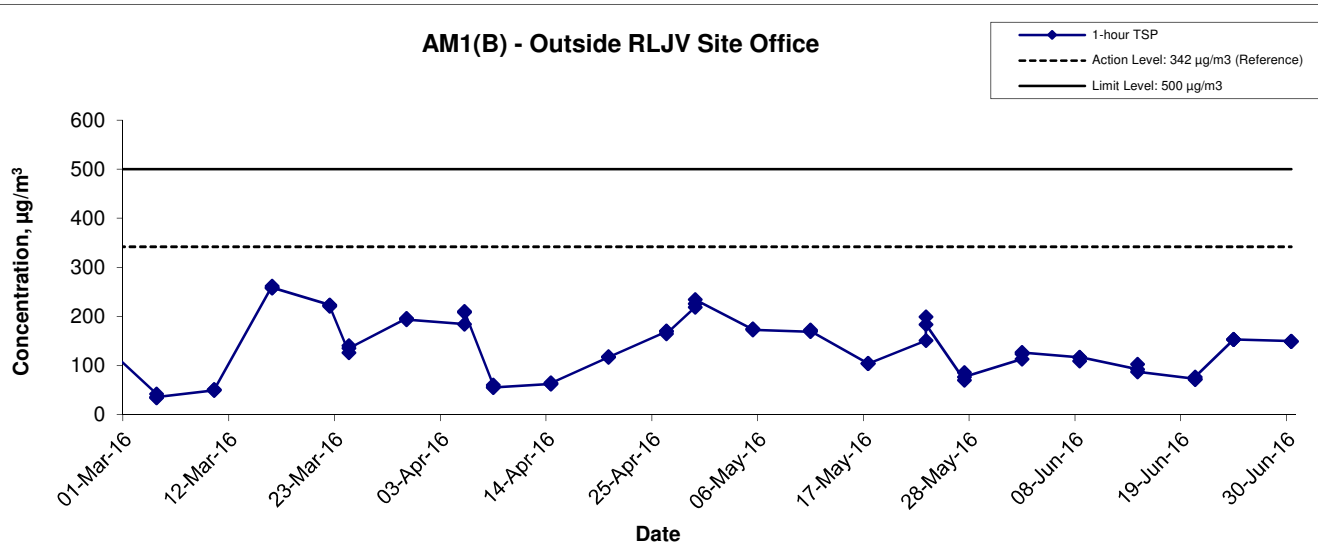
AM1(B) - Outside RLJV Site Office

Title Contract No. KL/2012/02
 Kai Tak Development - Stage 3A Infrastructure at Former North Apron Area
 Graphical Presentation of 1-hour TSP Monitoring Results

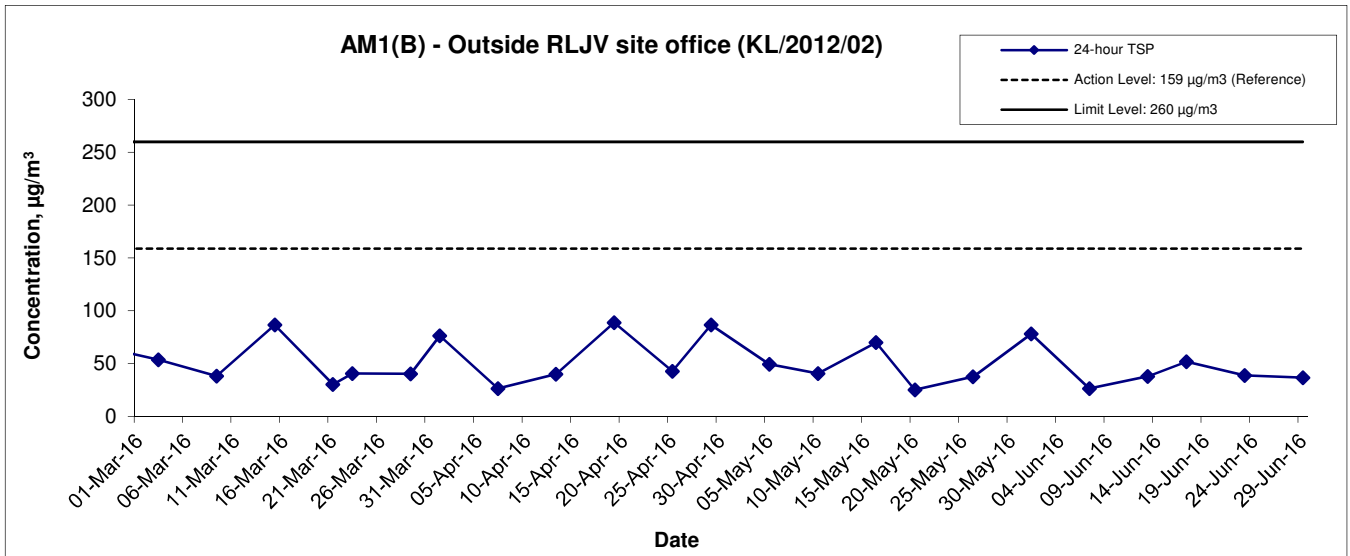
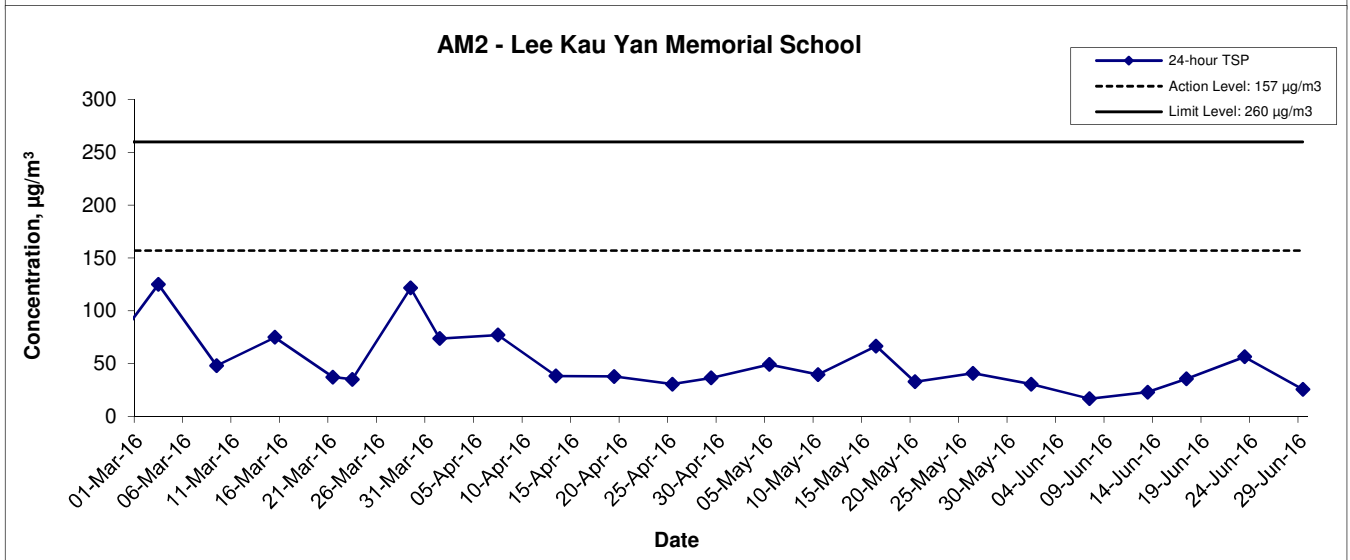
24-hr TSP Concentration Levels

Title Contract No. KL/2012/02 Kai Tak Development - Stage 3A Infrastructure at Former North Apron Area Graphical Presentation of 24-hour TSP Monitoring Results	Scale	Project No.	CINOTECH
	Date	Appendix	
	N.T.S	MA13043	
	Jun 16	F

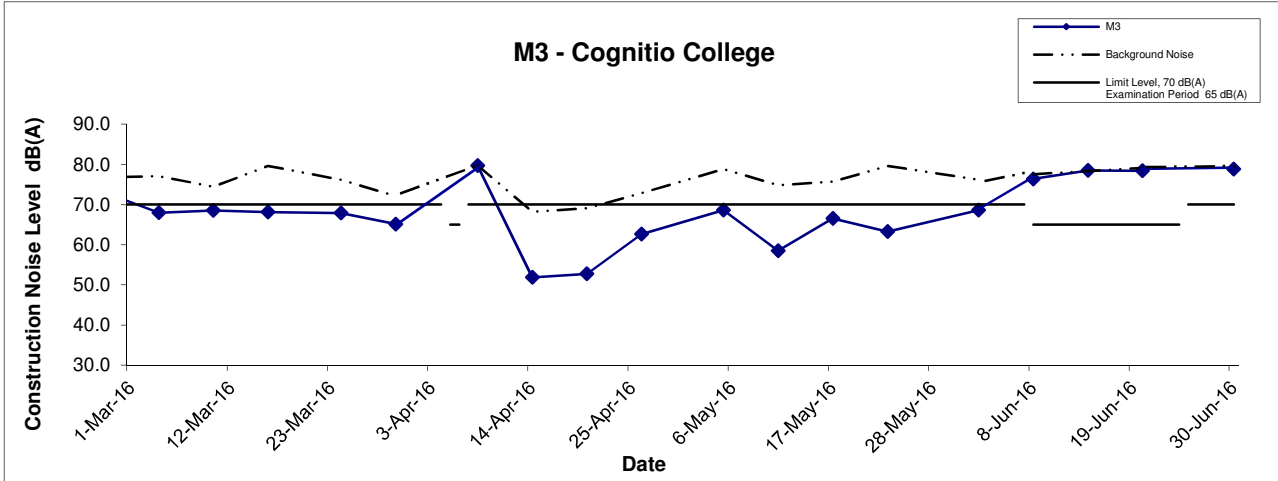
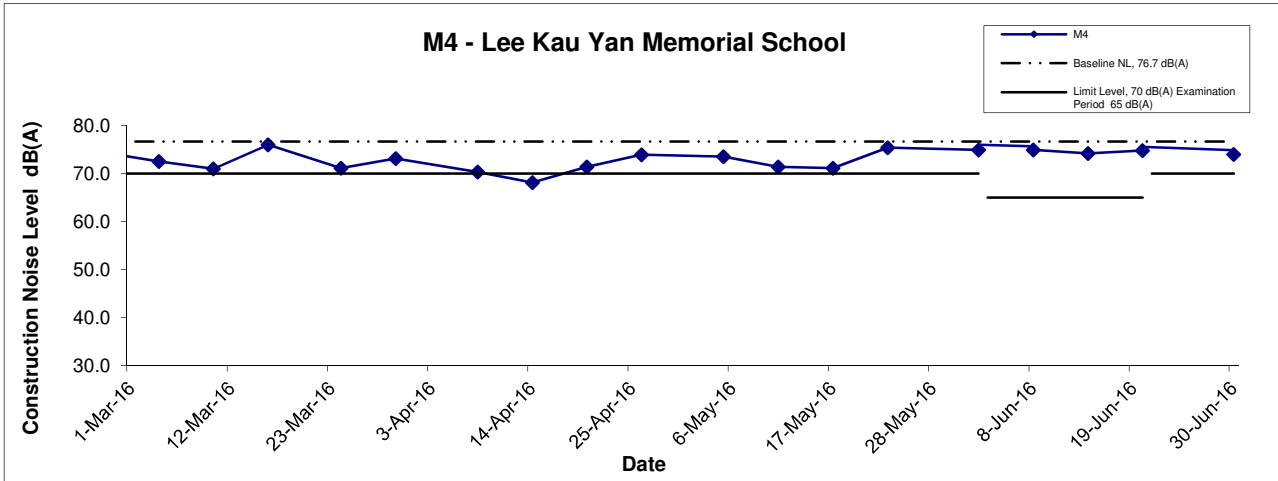
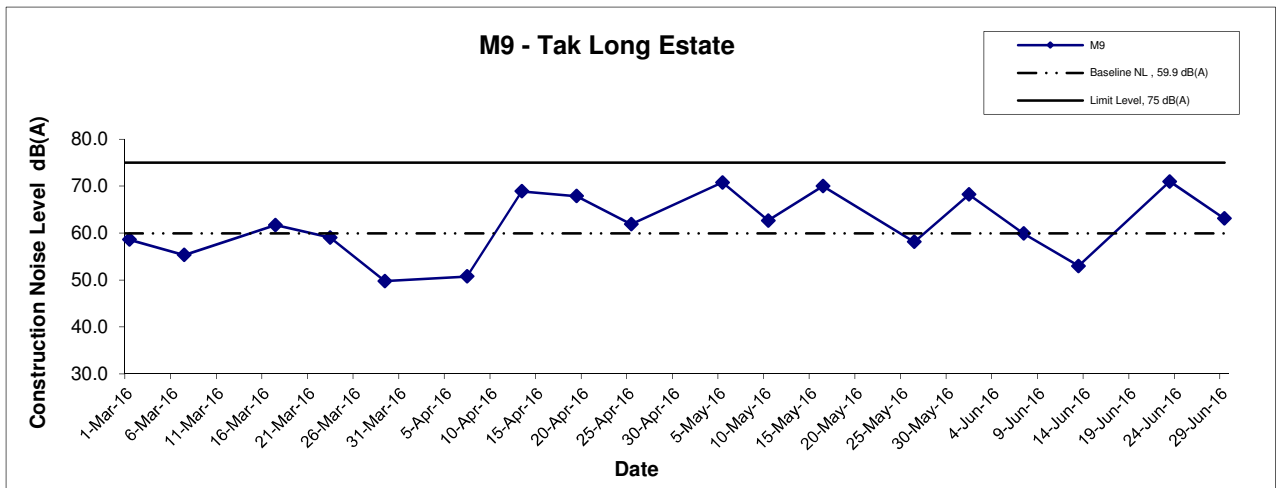
Noise Levels

Remarks: The construction noise levels in the Tables in Appendix G were adopted for plotting the graphs

Title Contract No. KL/2012/02 Kai Tak Development - Stage 3A Infrastructure at Former North Apron Area Graphical Presentation of Construction Noise Monitoring Results	Scale N.T.S	Project No. MA13043	
	Date Jun 16	Appendix G
