EP-344/2009 – New Sewage Pumping Stations Serving KTD  
EP-337/2009 – New Distributor Roads Serving the Planned KTD

Contract No. KL/2012/03  
Kai Tak Development – Stage 4 Infrastructure at Former North  
Apron Area

Monthly EM&A Report

June 2016

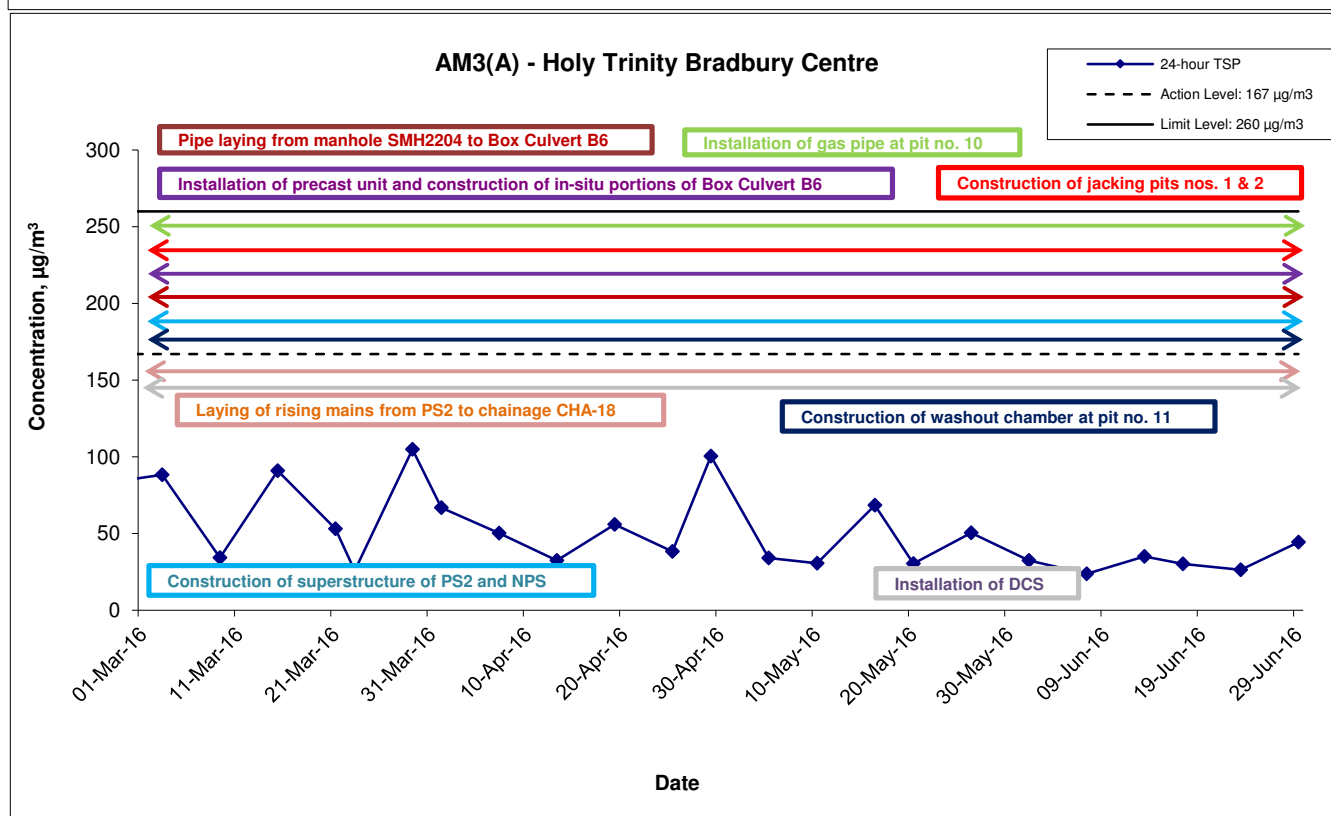
## 24-hr TSP Concentration Levels

<b>Title</b> Contract No. KL/2012/03 Kai Tak Development –Stage 4 Infrastructure at Former North Apron Area  Graphical Presentation of 24-hour TSP Monitoring Results	<b>Scale</b>	<b>Project</b>	
	N.T.S	No. MA13056	
	<b>Date</b> Jun 16	<b>Appendix</b> F
