EP-337/2009 – New Distributor Roads Serving the Planned KTD

Contract No. KL/2012/02

Kai Tak Development –Stage 3A Infrastructure at Former
North Apron Area

Monthly EM&A Report

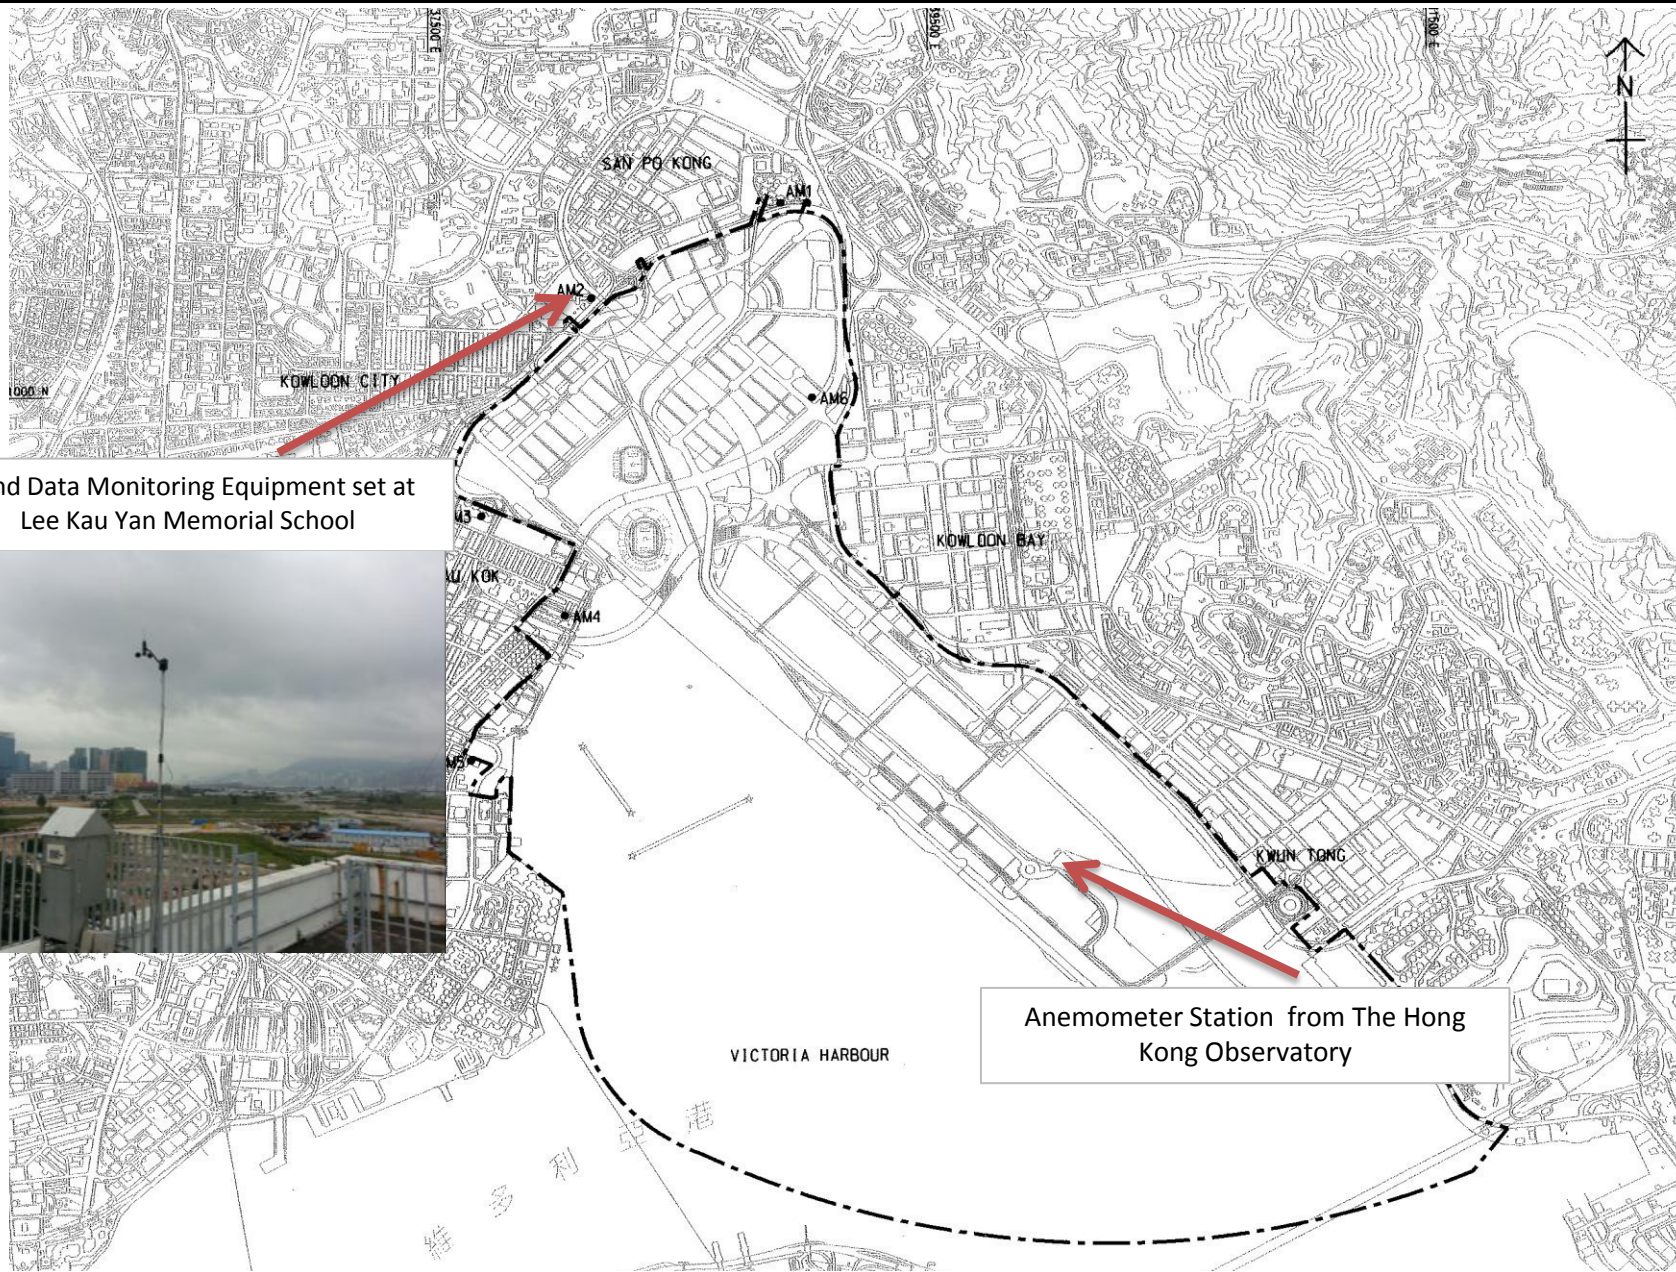
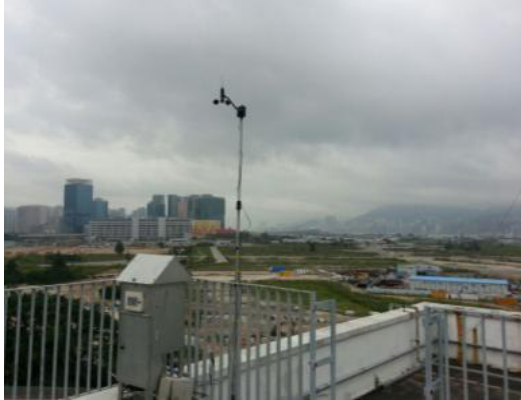
Title Contract No. KL/2012/02
 Kai Tak Development –Stage 3A Infrastructure at Former North Apron Area
 Location of Wind Data Monitoring Equipment

- 2.21 The air temperature, precipitation and the relative humidity data was obtained from Hong Kong Observatory where the wind speed and wind direction were recorded by the installed Wind Anemometer set at rooftop (about 8/F) Lee Kau Yan Memorial School. The location is shown in **Figure 4**. This weather information for the reporting month is summarized in **Appendix C**.

Wind Data Monitoring Equipment set at Lee Kau Yan Memorial School

Anemometer Station from The Hong Kong Observatory

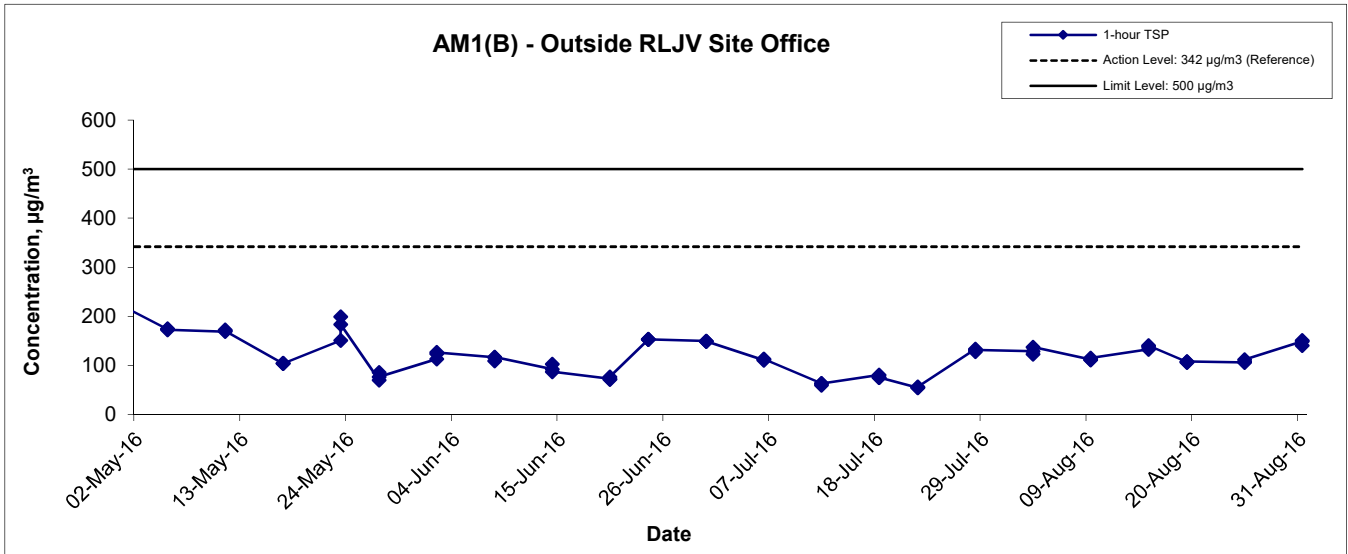
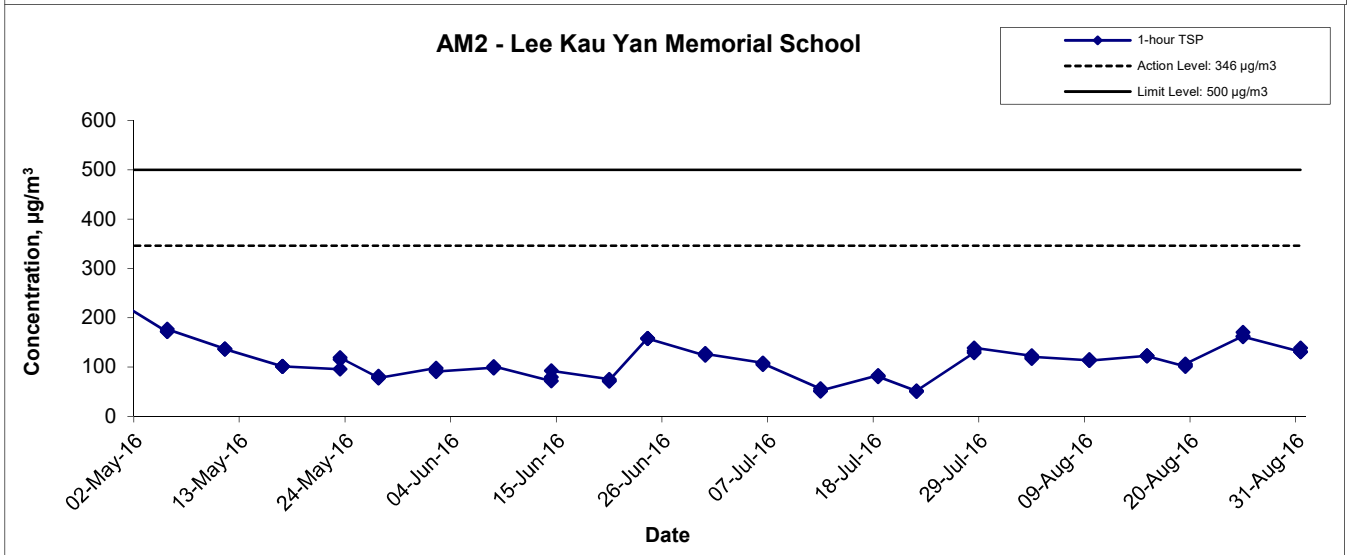
Title Contract No. KL/2012/02 Kai Tak Development - Stage 3A Infrastructure at Former North Apron Area Graphical Presentation of 1-hour TSP Monitoring Results	Scale N.T.S	Project No. MA13043	
	Date Aug 16	Appendix E

Location AM2 - Lee Kau Yan Memorial School			
Date	Time	Weather	Particulate Concentration ($\mu\text{g}/\text{m}^3$)
3-Aug-16	13:00	Cloudy	122.8
3-Aug-16	14:00	Cloudy	117.2
3-Aug-16	15:00	Cloudy	120.5
9-Aug-16	13:00	Cloudy	113.4
9-Aug-16	14:00	Cloudy	115.2
9-Aug-16	15:00	Cloudy	113.0
15-Aug-16	9:00	Cloudy	122.7
15-Aug-16	10:00	Cloudy	122.5
15-Aug-16	11:00	Cloudy	122.0
19-Aug-16	9:00	Cloudy	101.1
19-Aug-16	10:00	Cloudy	103.4
19-Aug-16	11:00	Cloudy	106.1
25-Aug-16	9:00	Sunny	162.6
25-Aug-16	10:00	Sunny	170.5
25-Aug-16	11:00	Sunny	161.5
31-Aug-16	13:00	Cloudy	130.7
31-Aug-16	14:00	Cloudy	130.9
31-Aug-16	15:00	Cloudy	138.7
		Average	126.4
		Maximum	170.5
		Minimum	101.1

1-hr TSP Concentration Levels

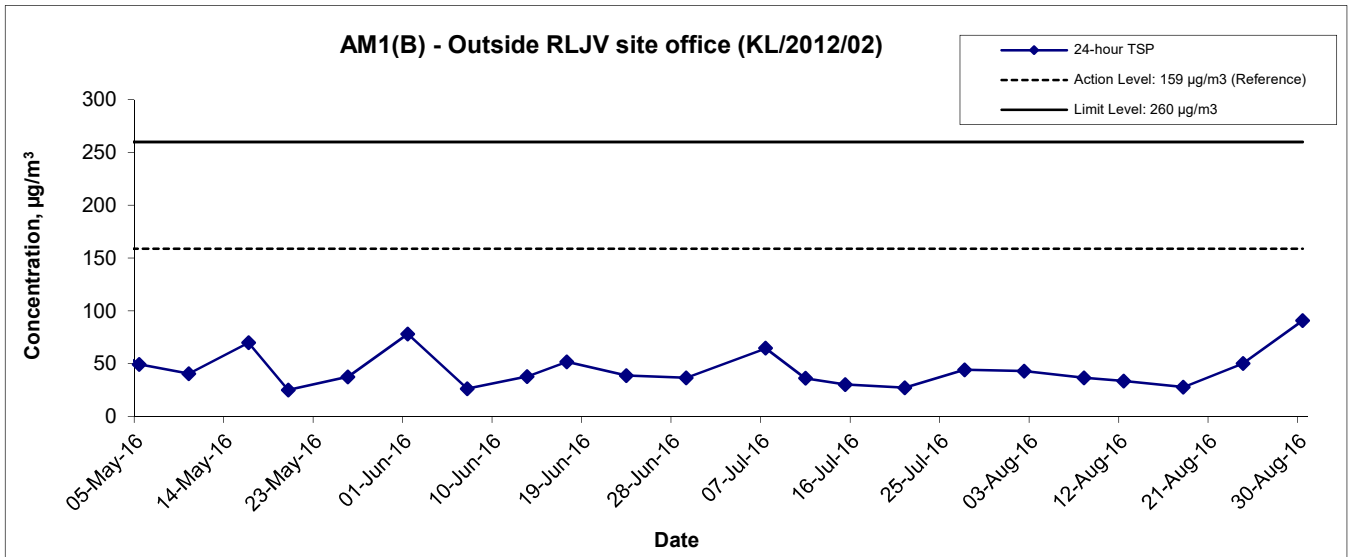
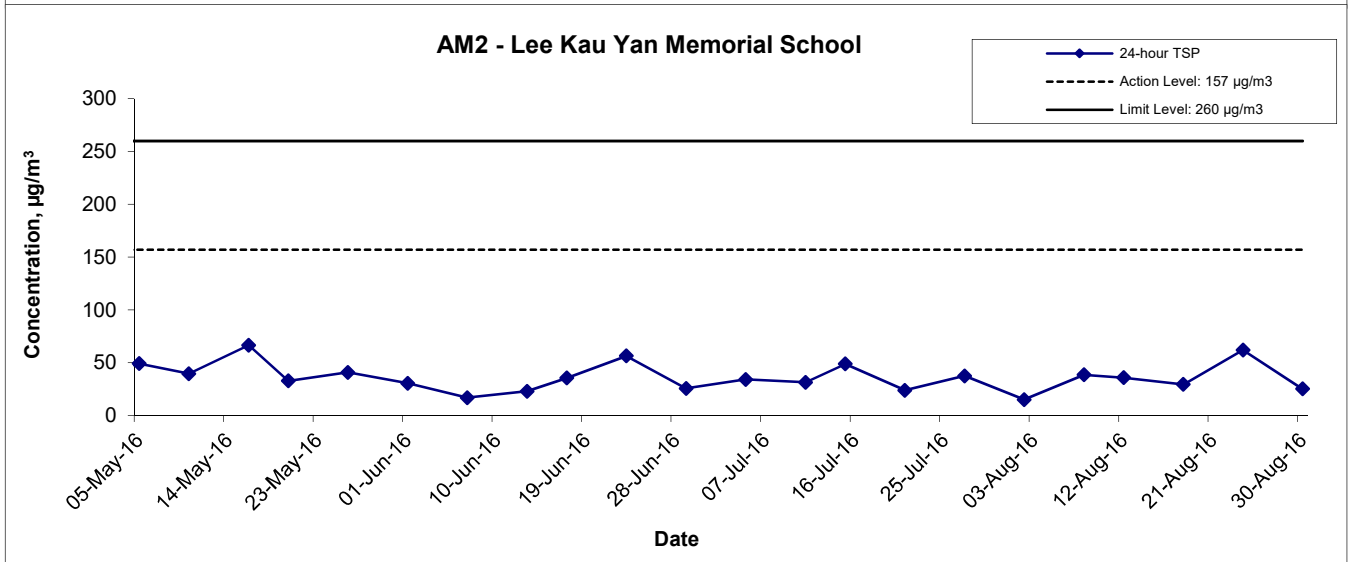
Title Contract No. KL/2012/02 Kai Tak Development - Stage 3A Infrastructure at Former North Apron Area Graphical Presentation of 24-hour TSP Monitoring Results	Scale	Project		CINOTECH
	N.T.S	No.	MA13043	
Date	Aug 16	Appendix	F

24-hr TSP Concentration Levels

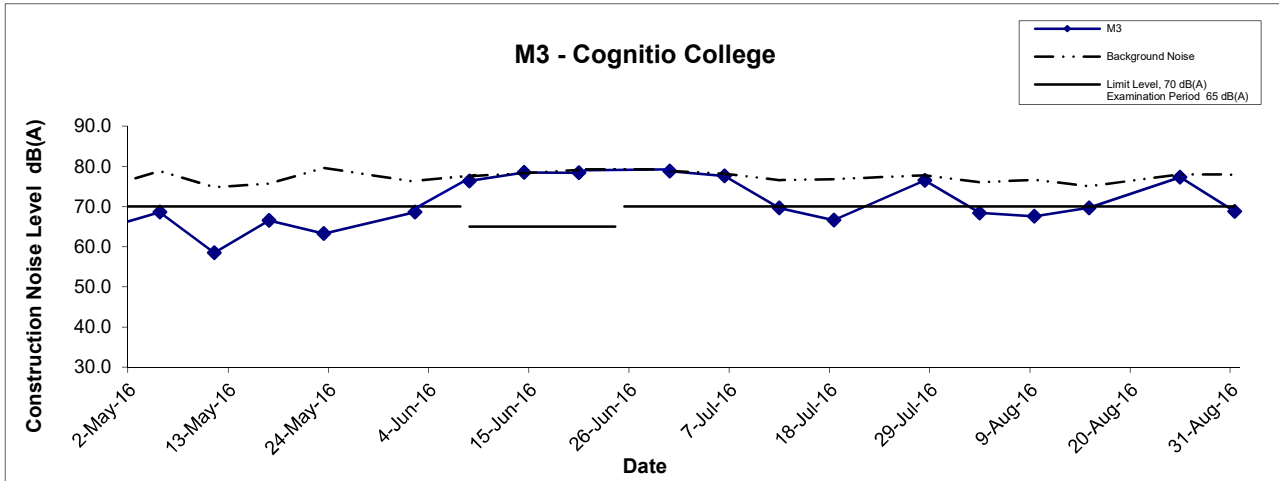
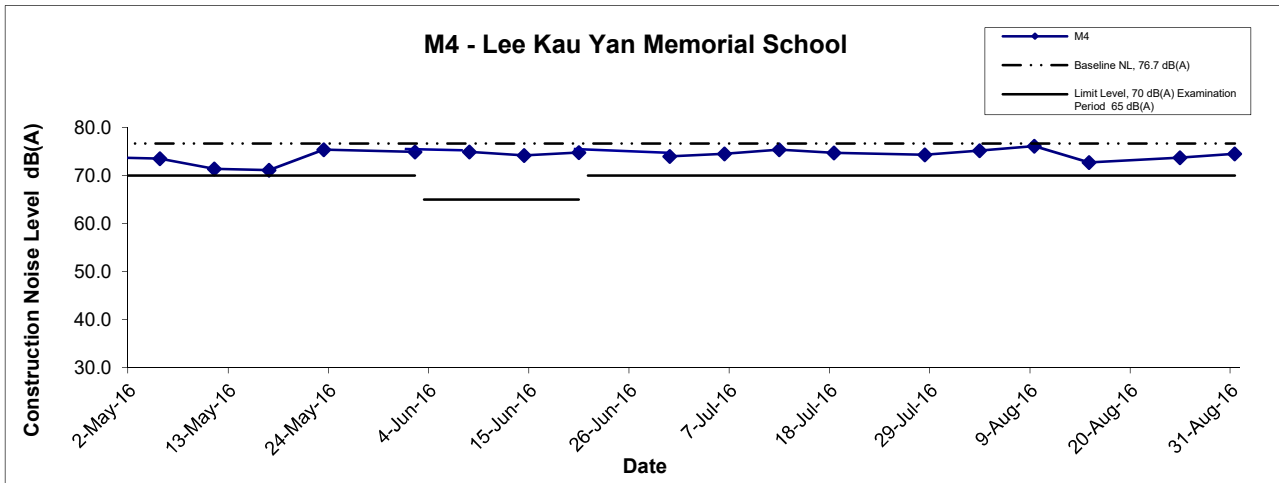
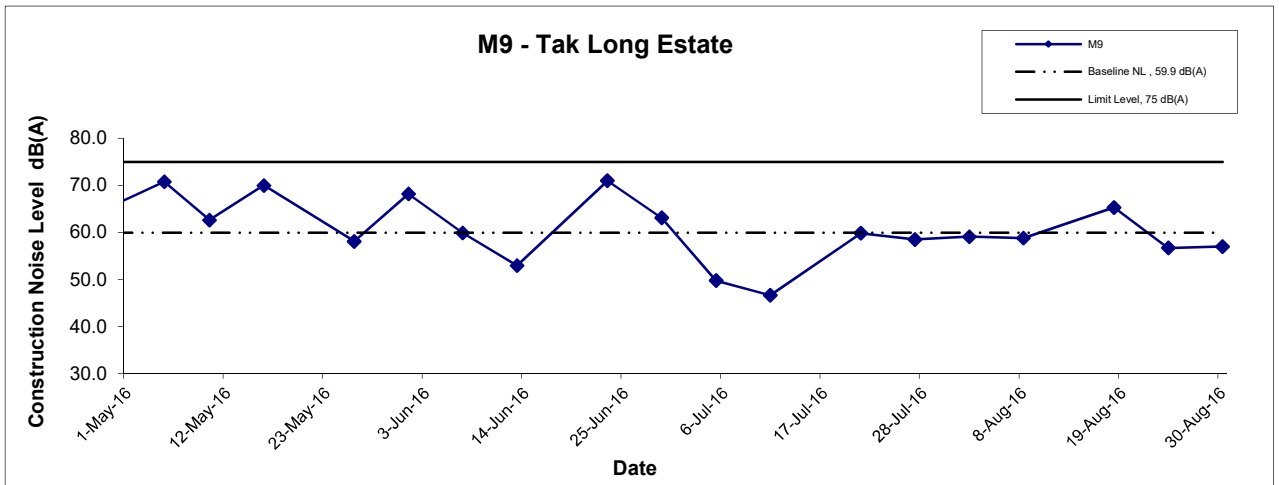
Title Contract No. KL/2012/02 Kai Tak Development - Stage 3A Infrastructure at Former North Apron Area Graphical Presentation of Construction Noise Monitoring Results	Scale N.T.S	Project No. MA13043	CINOTECH
	Date Aug 16	Appendix G

Location M9 - Tak Long Estate							
Date	Time	Weather	Unit: dB (A) (30-min)				
			Measured Noise Level			Baseline Level	Construction Noise Level
			L _{eq}	L ₁₀	L ₉₀	L _{eq}	L _{eq}
2-Aug-16	15:30	Cloudy	59.1	60.6	56.8	59.9	59.1 Measured ≤ Baseline
8-Aug-16	13:00	Sunny	58.8	60.3	56.7		58.8 Measured ≤ Baseline
18-Aug-16	14:10	Cloudy	66.4	70.1	62.2		65.3
24-Aug-16	13:25	Sunny	61.6	63.6	59.1		56.7
30-Aug-16	13:00	Sunny	61.7	63.0	58.6		57.0

Noise Levels

Remarks: The construction noise levels in the Tables in Appendix G were adopted for plotting the graphs
