EP-344/2009 – New Sewage Pumping Stations Serving KTD
EP-337/2009 – New Distributor Roads Serving the Planned KTD

Contract No. KL/2012/03
Kai Tak Development – Stage 4 Infrastructure at Former North
Apron Area

Monthly EM&A Report

August 2016

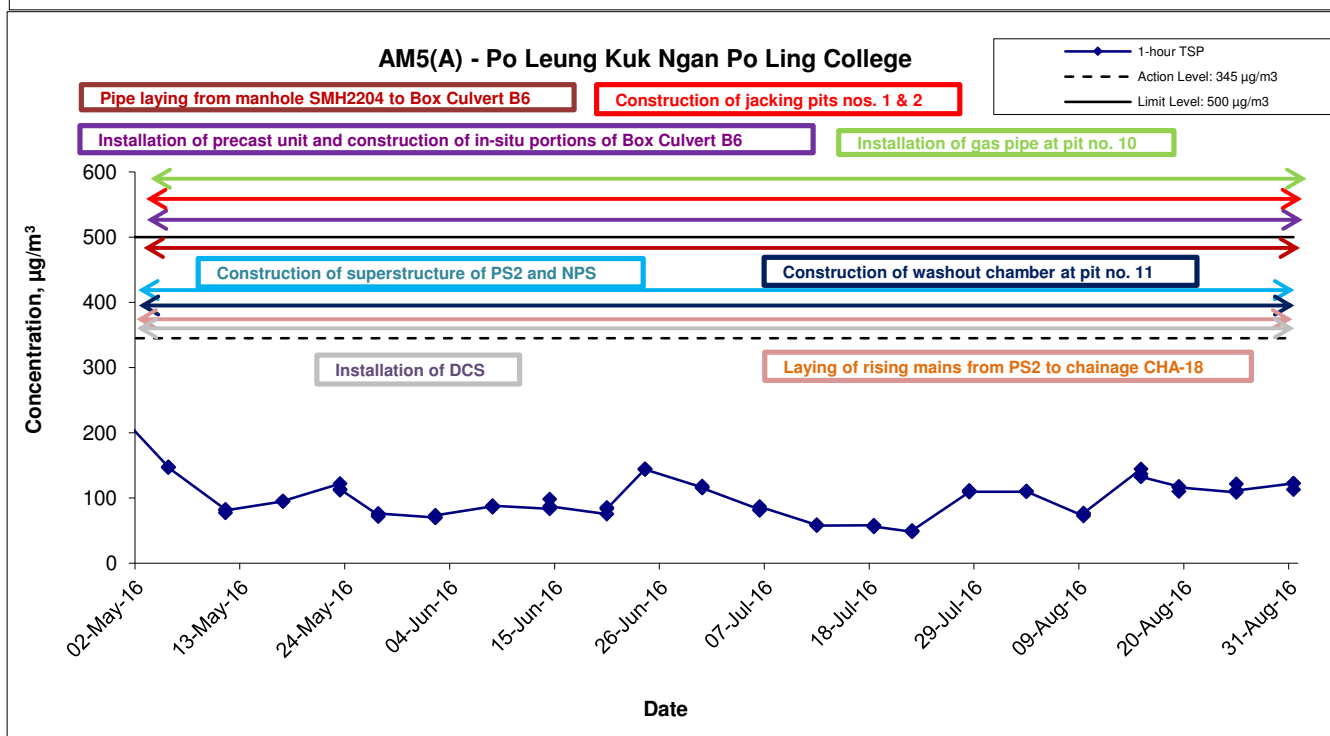
1-hr TSP Concentration Levels

Title Contract No. KL/2012/03 Kai Tak Development –Stage 4 Infrastructure at Former North Apron Area Graphical Presentation of 1-hour TSP Monitoring Results	Scale N.T.S	Project No. MA13056	CINOTECH
	Date Aug 16	Appendix E

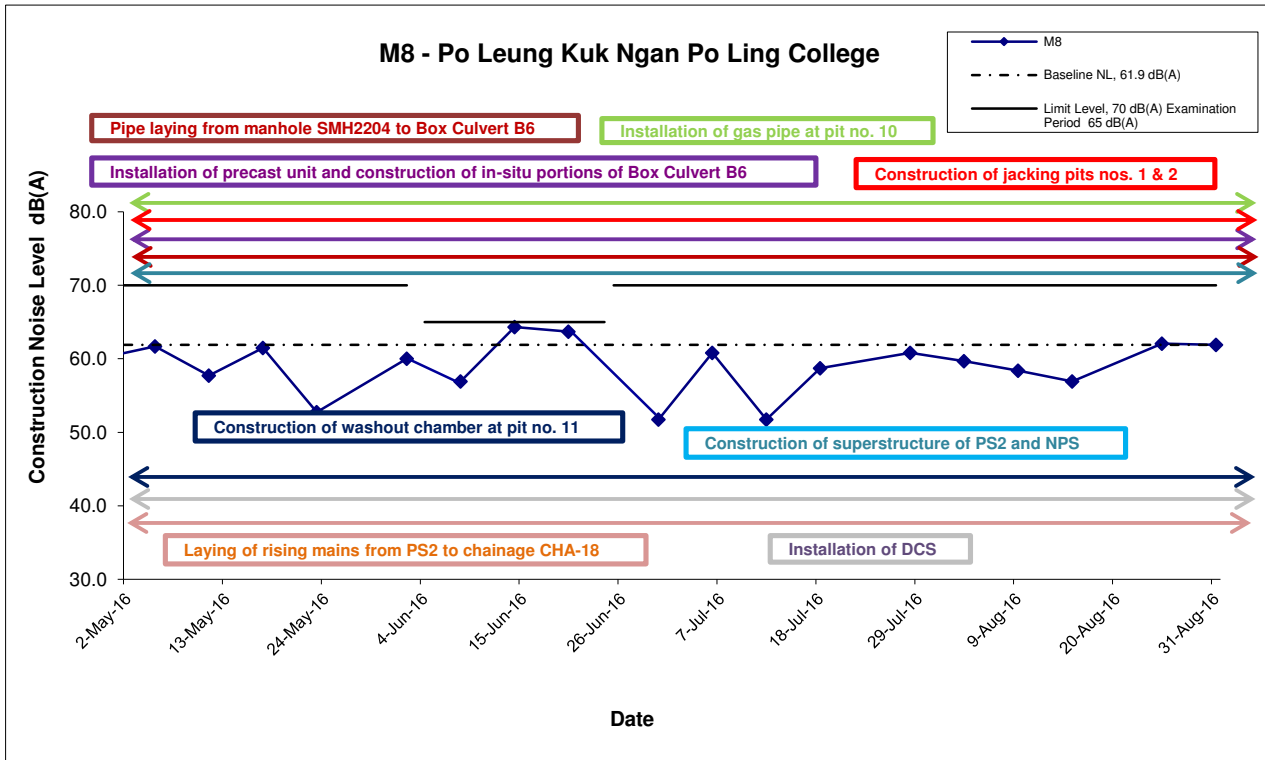
Noise Levels

Remarks: The construction noise levels in the Tables in Appendix G were adopted for plotting the graphs

Title Contract No. KL/2012/03 Kai Tak Development –Stage 4 Infrastructure at Former North Apron Area Graphical Presentation of Construction Noise Monitoring Results	Scale N.T.S	Project No. MA13056	CINOTECH
	Date Aug 16	Appendix G
