**EP-337/2009 – New Distributor Roads Serving the  
Planned KTD**

**Contract No. KL/2012/02  
Kai Tak Development –Stage 3A Infrastructure at  
Former North Apron Area**

Monthly EM&A Report

October 2016

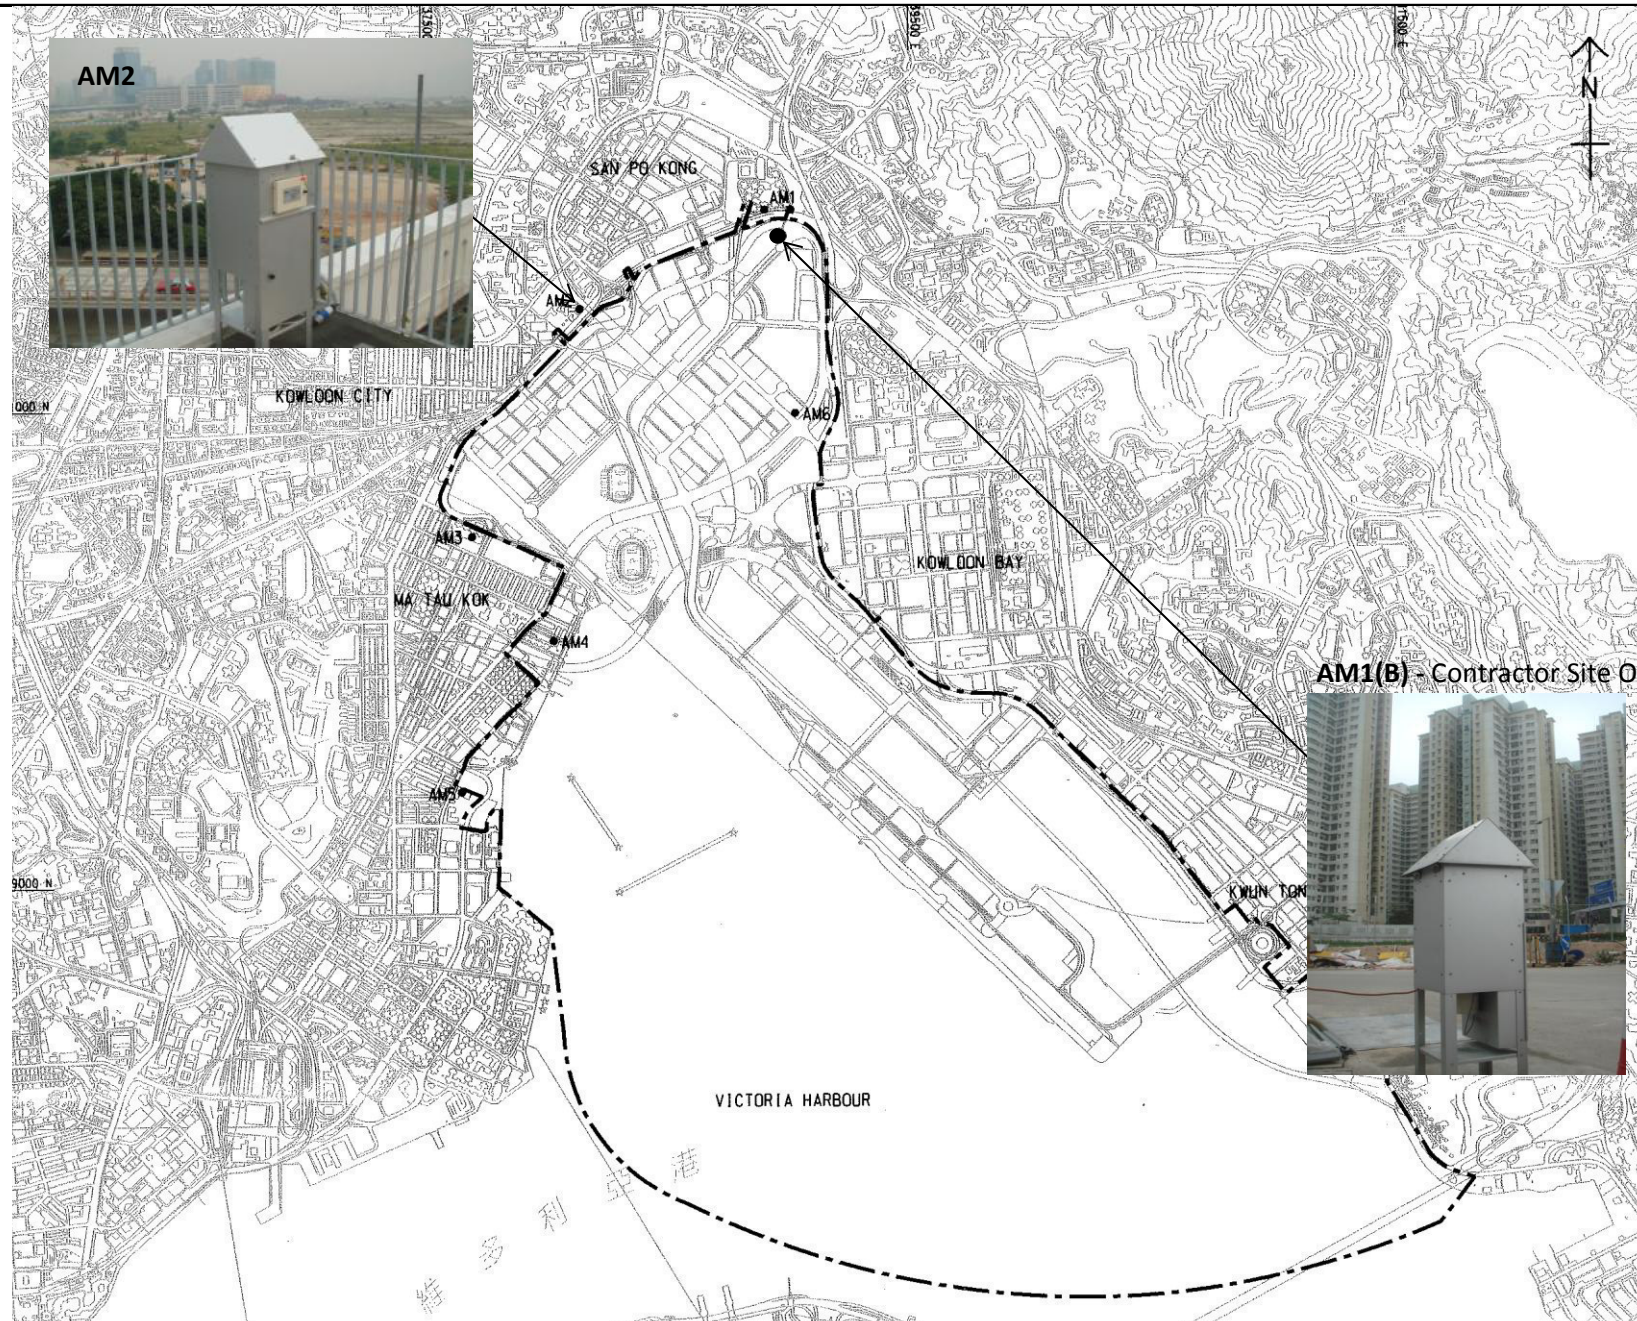
Title	Contract No. KL/2012/02		Scale	Project
	Kai Tak Development –Stage 3A Infrastructure at Former North Apron Area		N.T.S	No. MA13043
Date			Figure	
Air Quality Monitoring Stations under Contract No.: KLN/2013/16		Apr-14	2	CINOTECH

AM1(B) - Contractor Site Office (KL/2012/02)

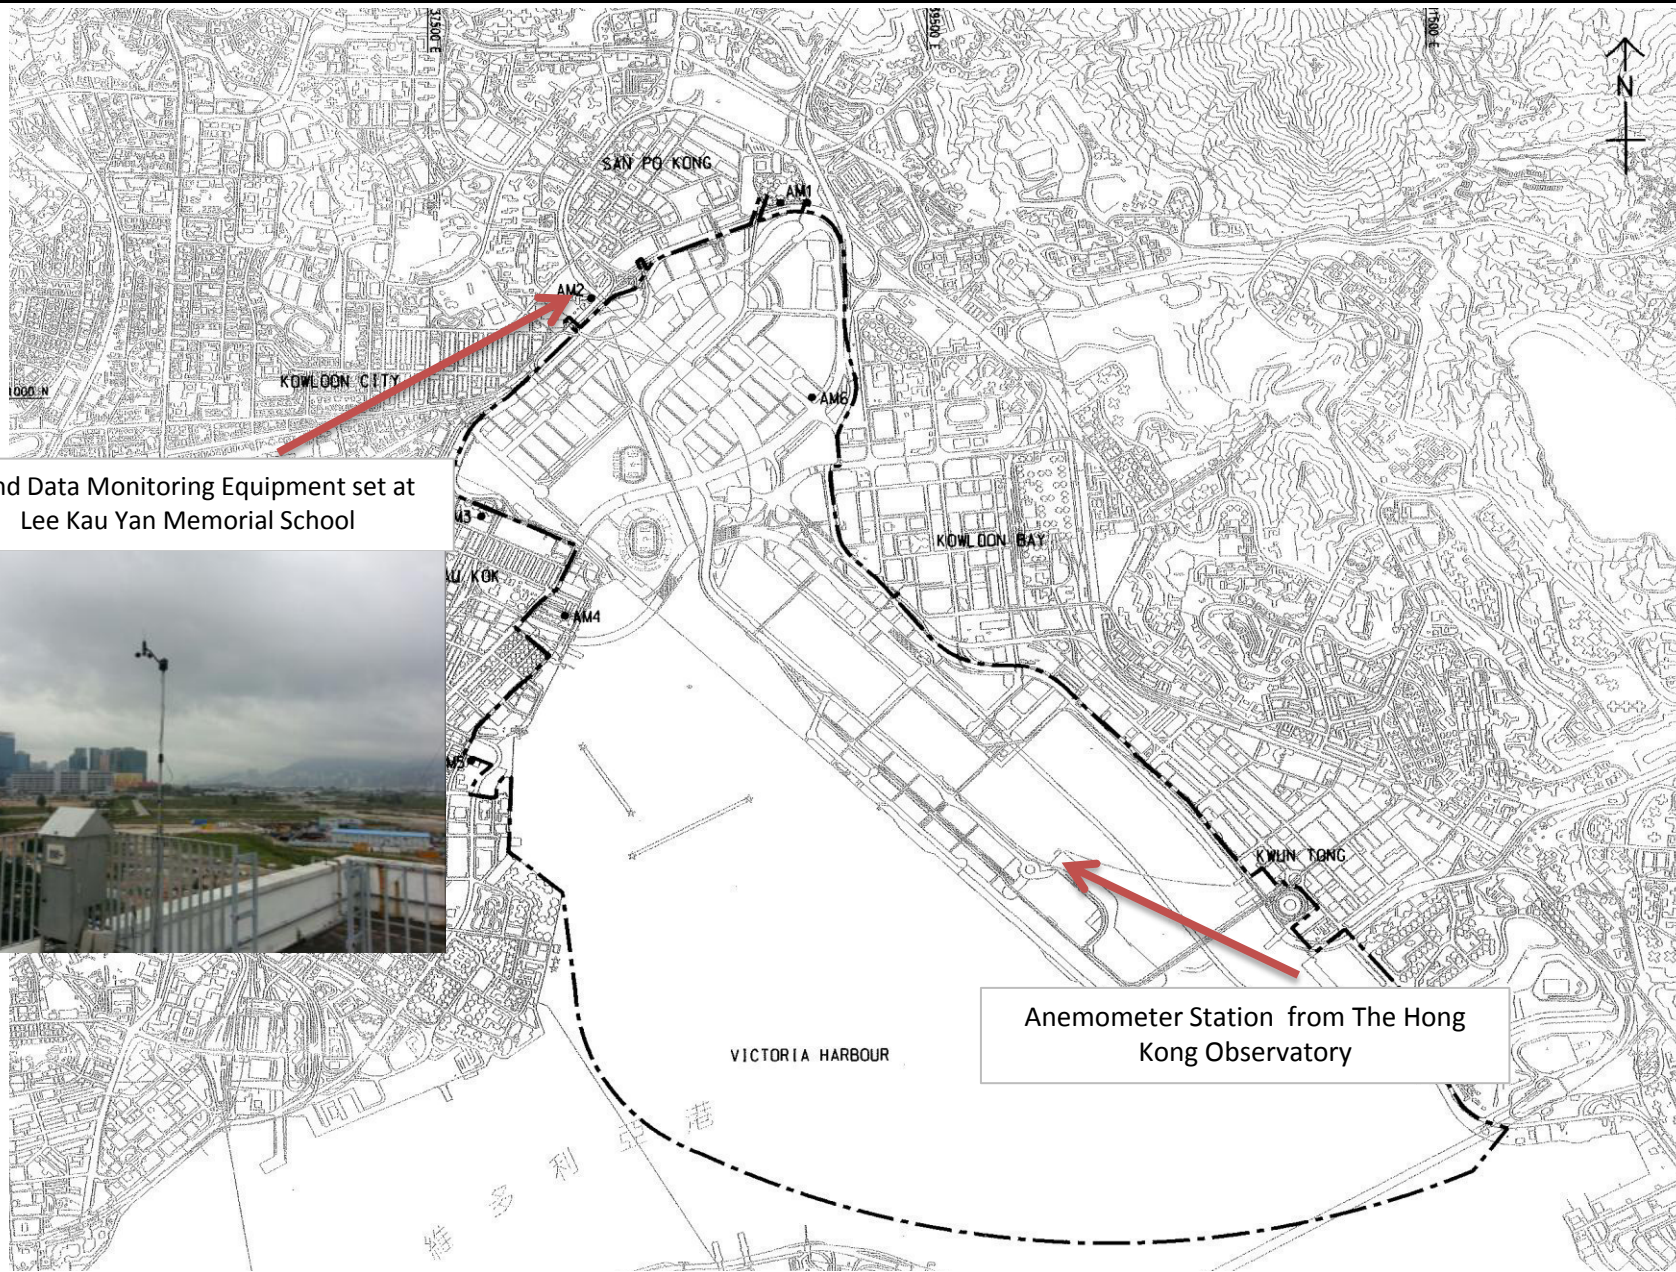
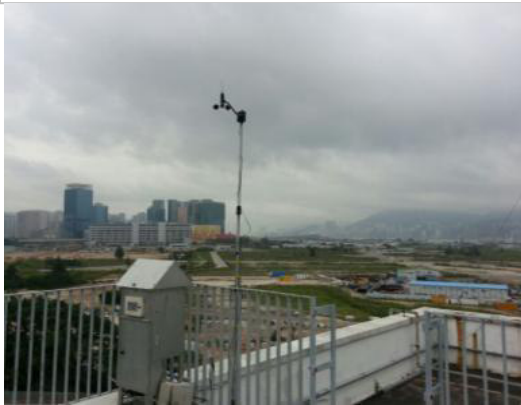
Title Contract No. KL/2012/02  
 Kai Tak Development –Stage 3A Infrastructure at Former North Apron Area  
 Location of Wind Data Monitoring Equipment

2.21 The air temperature, precipitation and the relative humidity data was obtained from Hong Kong Observatory where the wind speed and wind direction were recorded by the installed Wind Anemometer set at rooftop (about 8/F) Lee Kau Yan Memorial School. The location is shown in **Figure 4**. This weather information for the reporting month is summarized in **Appendix C**.

Wind Data Monitoring Equipment set at Lee Kau Yan Memorial School

Anemometer Station from The Hong Kong Observatory

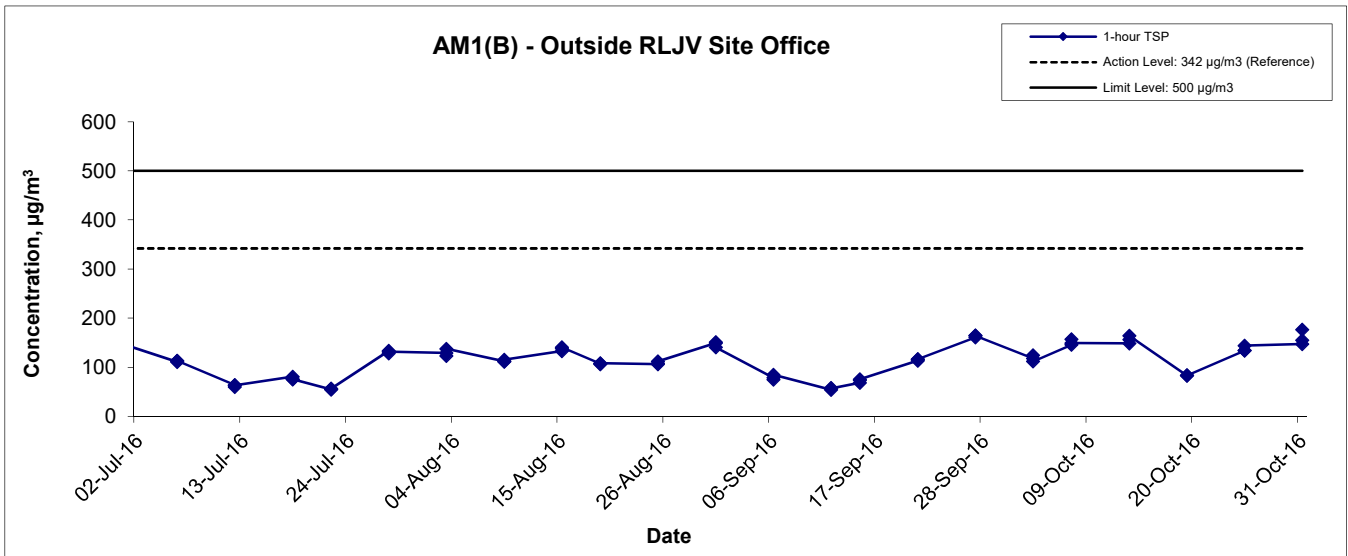
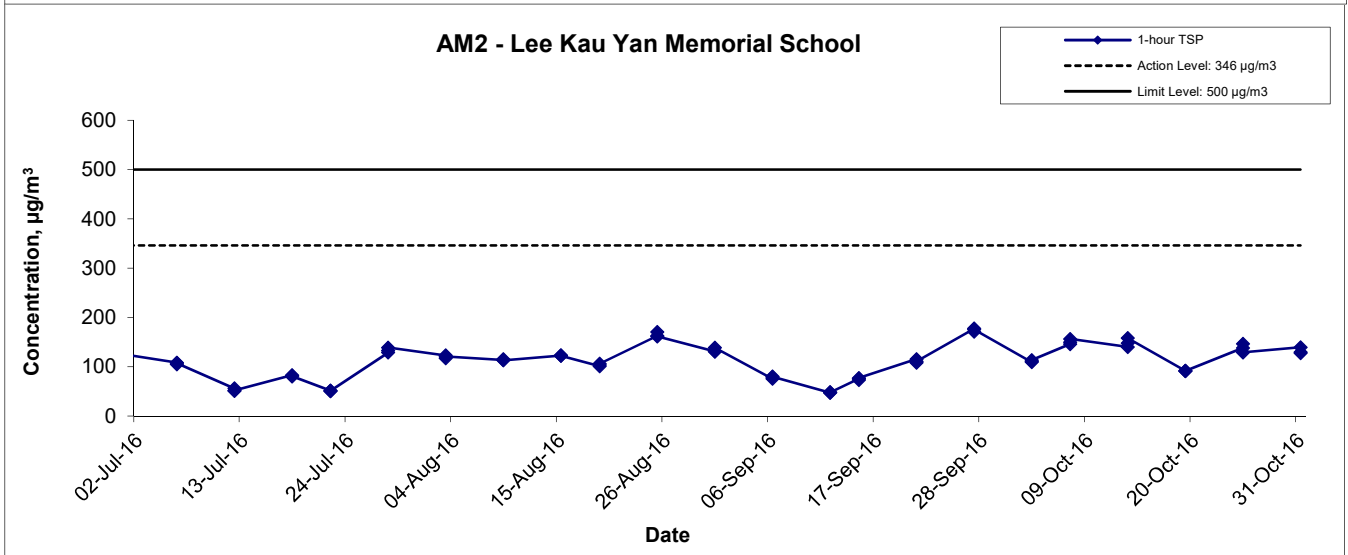
Title Contract No. KL/2012/02 Kai Tak Development - Stage 3A Infrastructure at Former North Apron Area Graphical Presentation of 1-hour TSP Monitoring Results	Scale N.T.S	Project No. MA13043	
	Date Oct 16	Appendix E

### 1-hr TSP Concentration Levels

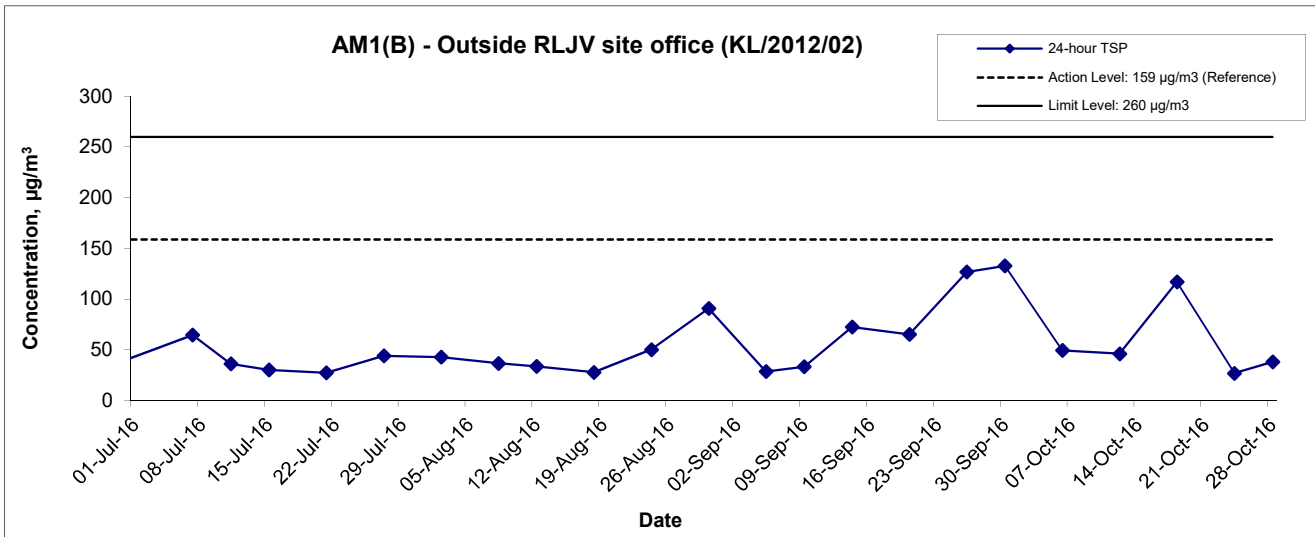
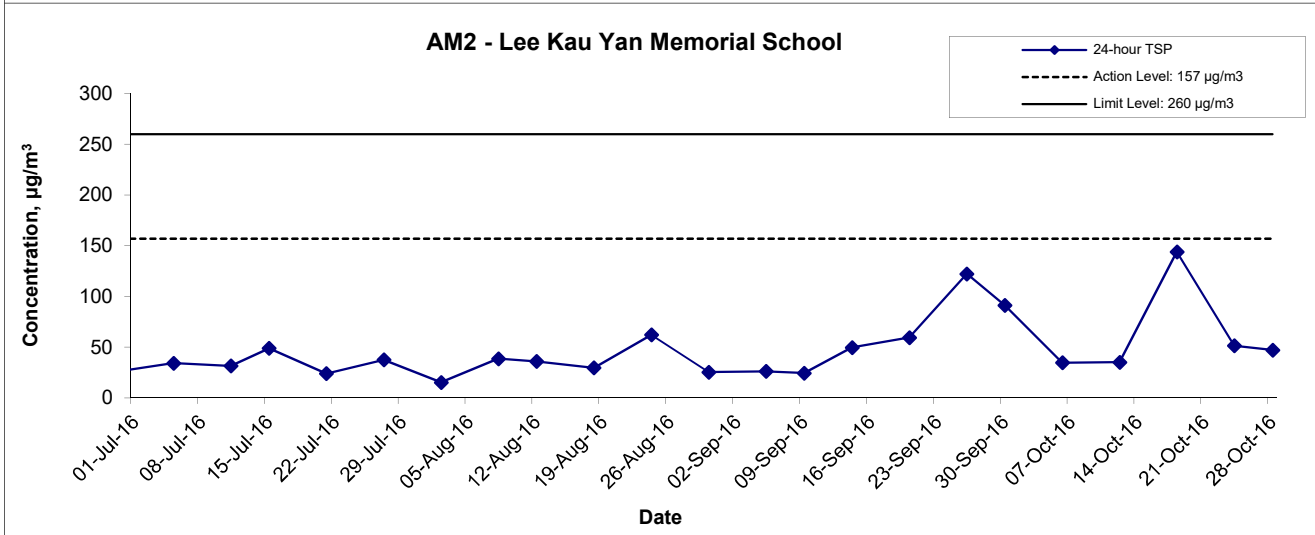
Title Kai Tak Development - Stage 3A Infrastructure at Former North Apron Area  Graphical Presentation of 24-hour TSP Monitoring Results	Contract No. KL/2012/02	Scale N.T.S	Project No. MA13043	
	Date Oct 16	Appendix F

### 24-hr TSP Concentration Levels

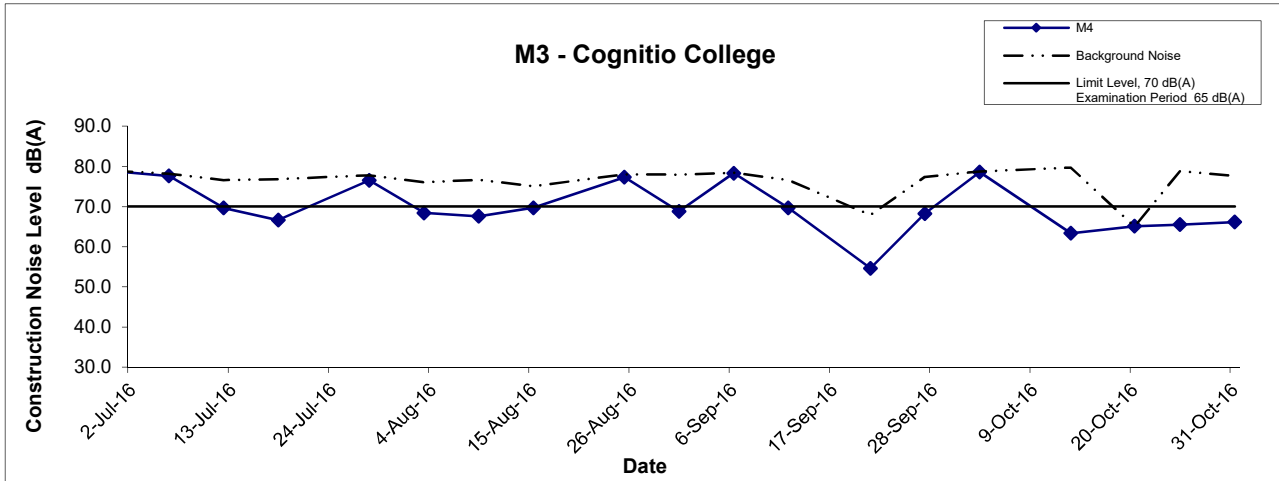
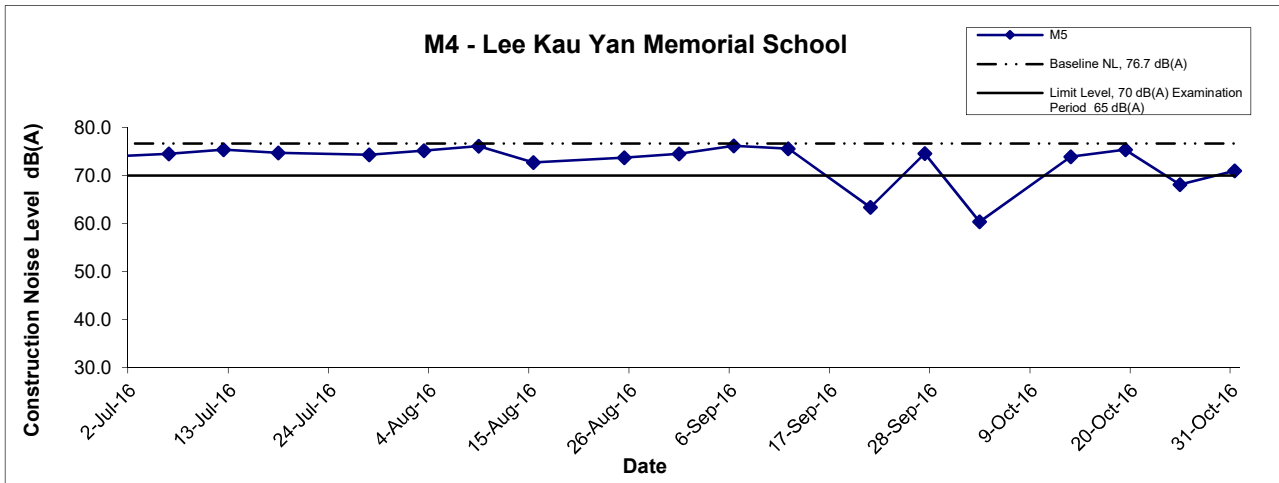
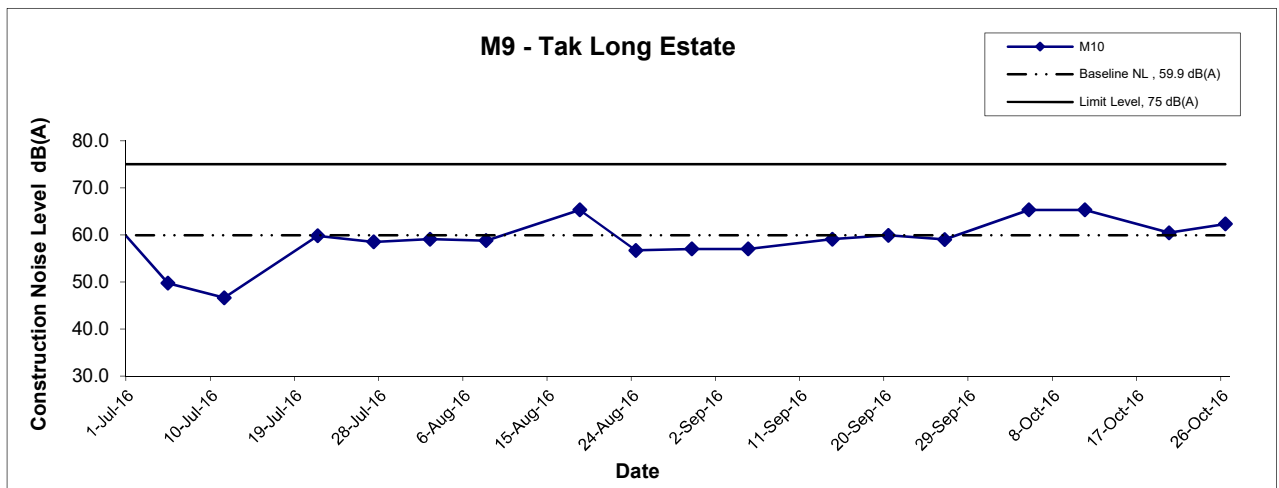
Title Kai Tak Development - Stage 3A Infrastructure at Former North Apron Area Graphical Presentation of Construction Noise Monitoring Results	Contract No. KL/2012/02	Scale N.T.S	Project No. MA13043	CINOTECH
	Date Oct 16	Appendix G

## Noise Levels

Remarks: The construction noise levels in the Tables in Appendix G were adopted for plotting the graphs
