**MaterialLab****MONTHLY EM&A REPORT****May 2017**

**Contract No.** : KLN/2015/07

**Contract Name** : Environmental Monitoring Works for  
Contract KL/2014/03 – Kai Tak Development  
– Stage 3 Infrastructure Works for Developments  
at the Southern Part of the Former Runway

**Report No.** : 0405/15/ED/0802A

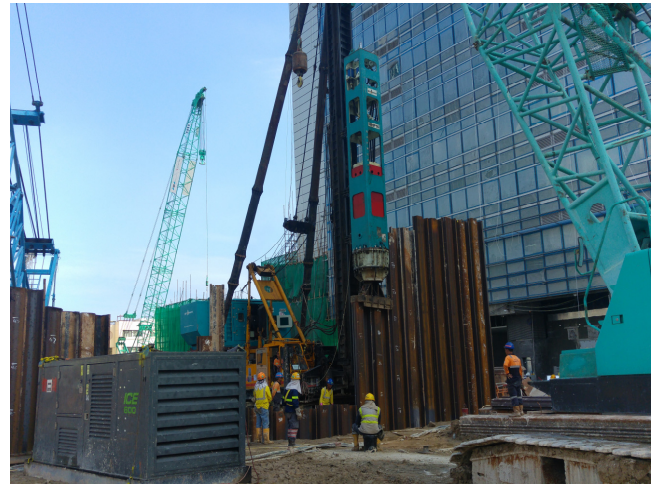
Site inspection photo of 11<sup>th</sup> May 2017

Parameters	Date	Observations and Recommendations	Follow-up
General Condition	11 May 2017	Stagnant water shall be removed. (Portion I and Zone1)	The item was rectified by the Contractor and inspected on 17 May 2017.
	25 May 2017	Stagnant water shall be removed. (Portion I and Zone1)	The item was rectified by the Contractor and inspected on 1 June 2017.
