## 8<sup>th</sup> CONSOLIDATED MONTHLY EM&A REPORT

June 2017

**EP No.** : EP-337/2009 –  
New Distributor Roads Serving the Planned Kai Tak  
Development Area

**Contract No.** : KLN/2016/05 –  
Independent Environmental Checker for  
Contract No. KL/2015/02 Kai Tak Development –  
Stage 5A Infrastructure at Former North Apron Area

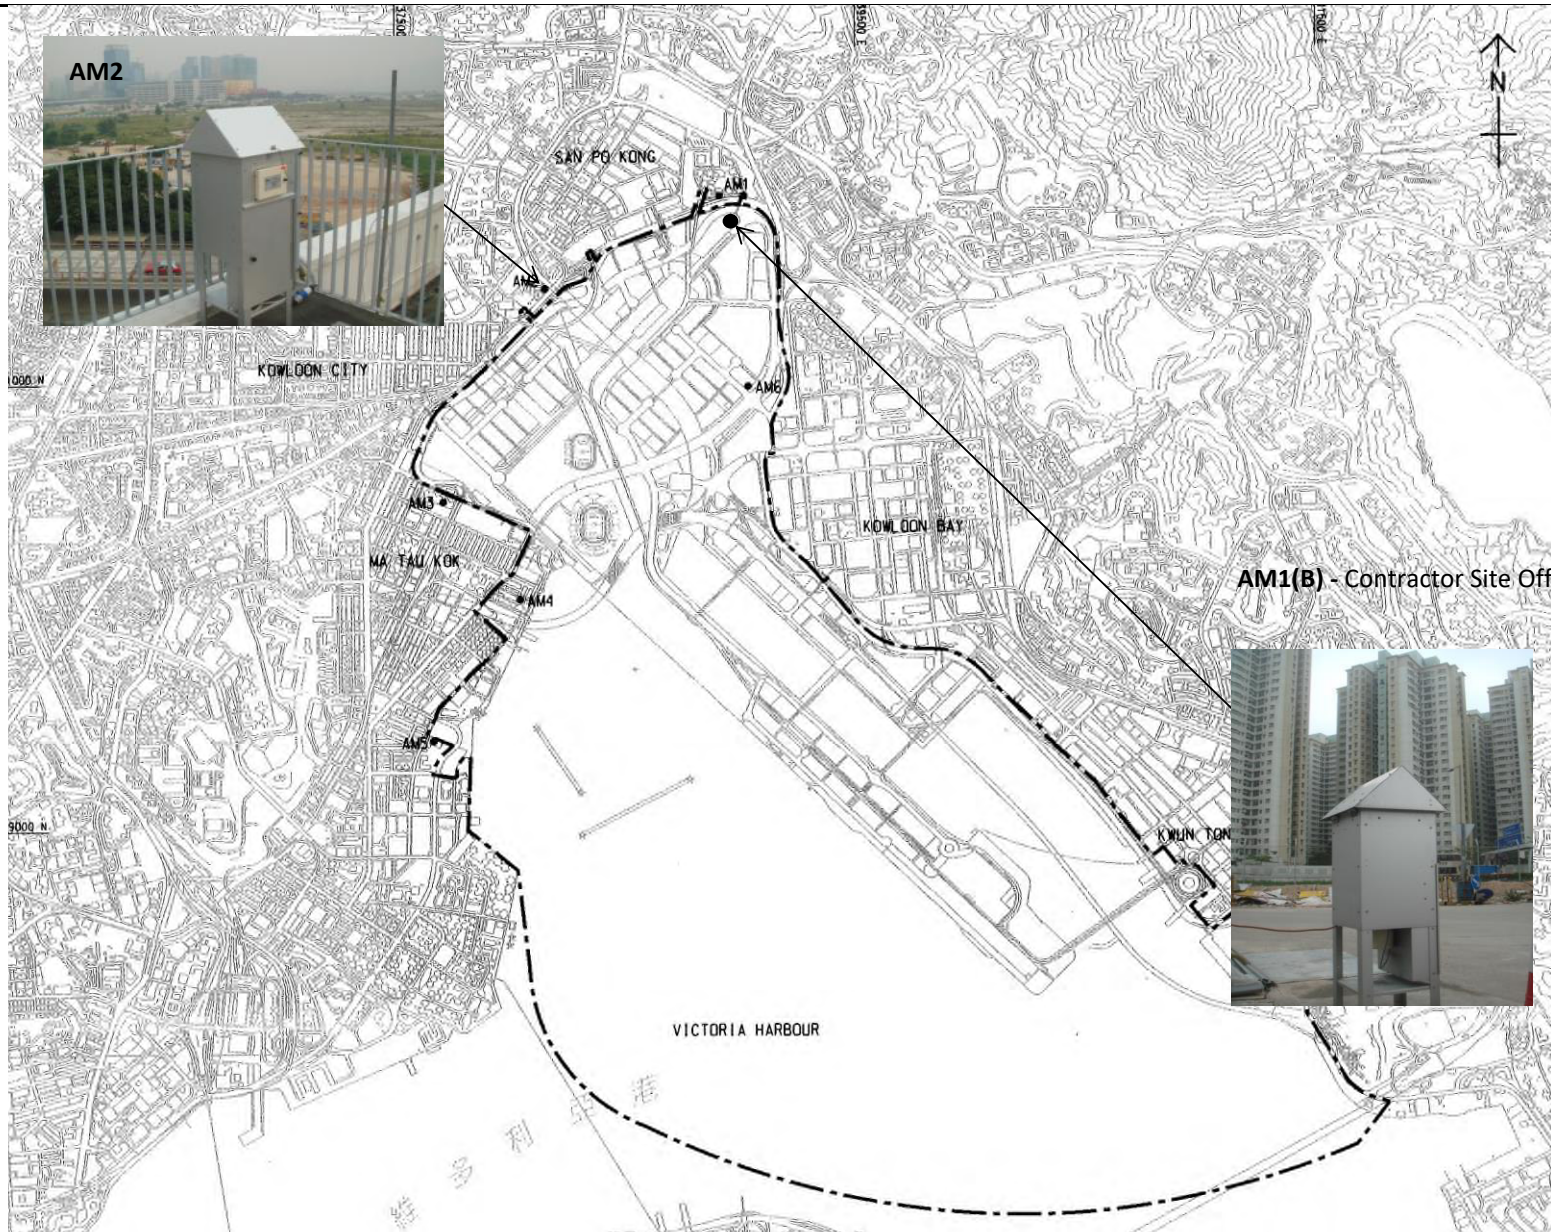
Title Contract No. KL/2012/02  Kai Tak Development –Stage 3A Infrastructure at Former North Apron Area  Location of Air Quality Monitoring Stations under this Project	Scale N.T.S	Project No. MA13043	
	Date Apr-17	Figure 2

AM1(B) - Contractor Site Office (KL/2012/02)

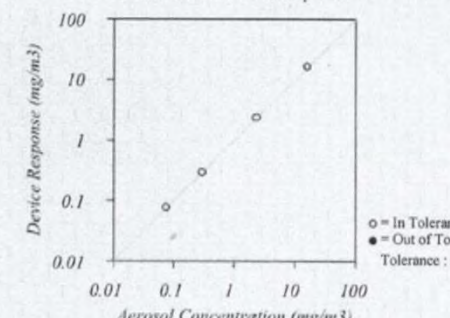
### Concentration Linearity Plot

Environment Conditions		<b>Model</b>	<b>AM510</b>
Temperature	75.16 (24.0) °F (°C)	<b>Serial Number</b>	<b>11208032</b>
Relative Humidity	23.8 %RH		
Barometric Pressure	29.36 (994.2) inHg (hPa)

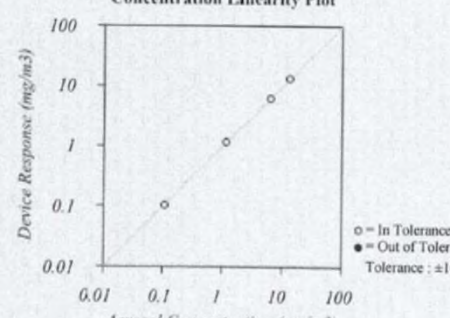
### Concentration Linearity Plot

Environment Conditions		<b>Model</b>	<b>AM510</b>
Temperature	75.7 (24.3) °F (°C)	<b>Serial Number</b>	<b>11108001</b>
Relative Humidity	26 %RH		
Barometric Pressure	28.93 (979.7) inHg (hPa)

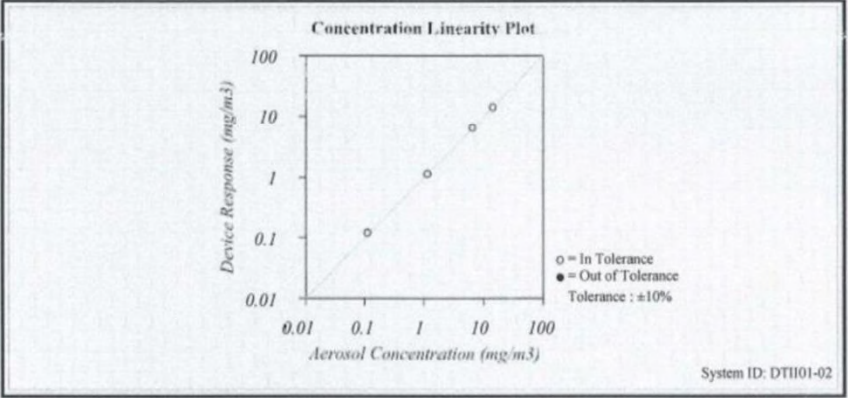
### Concentration Linearity Plot

Environment Conditions			Model	AM510
Temperature	74.7 (23.7)	°F (°C)	Serial Number	11404005
Relative Humidity	33	%RH		
Barometric Pressure	28.55 (966.8)	inHg (hPa)

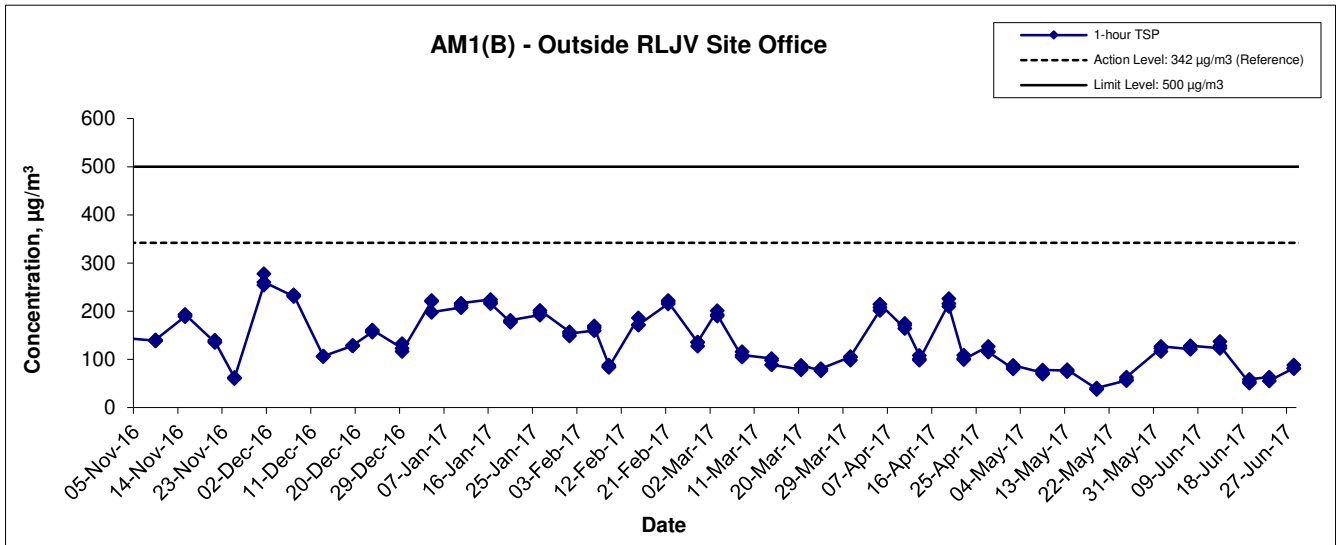
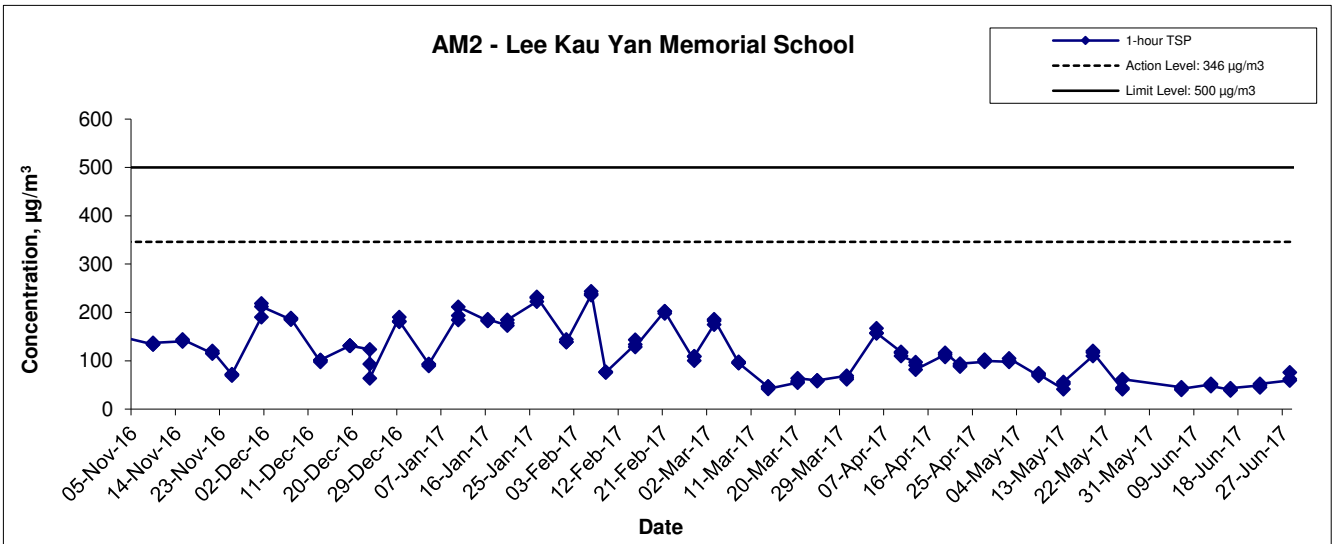
Title Kai Tak Development - Stage 3A Infrastructure at Former North Apron Area  Graphical Presentation of 1-hour TSP Monitoring Results	Contract No. KL/2012/02	Scale N.T.S	Project No. MA13043	
	Date Jun 17	Appendix E

### 1-hr TSP Concentration Levels

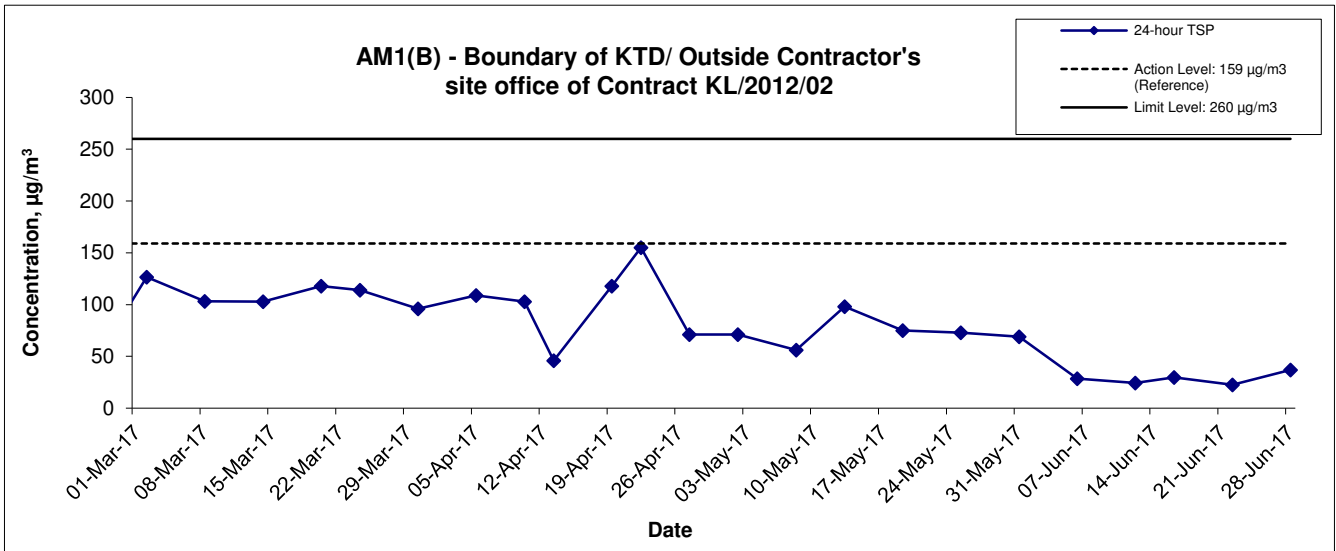
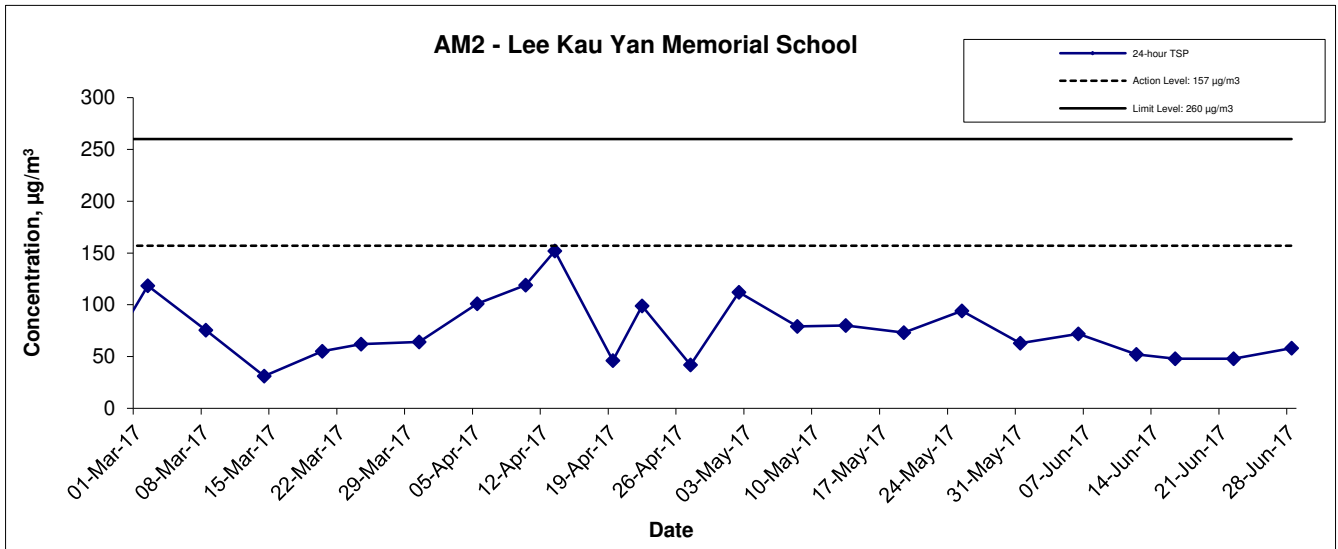
Title	Contract No. KL/2012/02		Scale	Project	
	Kai Tak Development - Stage 3A Infrastructure at Former North Apron Area			No. MA13043	
Graphical Presentation of 24-hour TSP Monitoring Results		Date	Appendix	F

### 24-hr TSP Concentration Levels

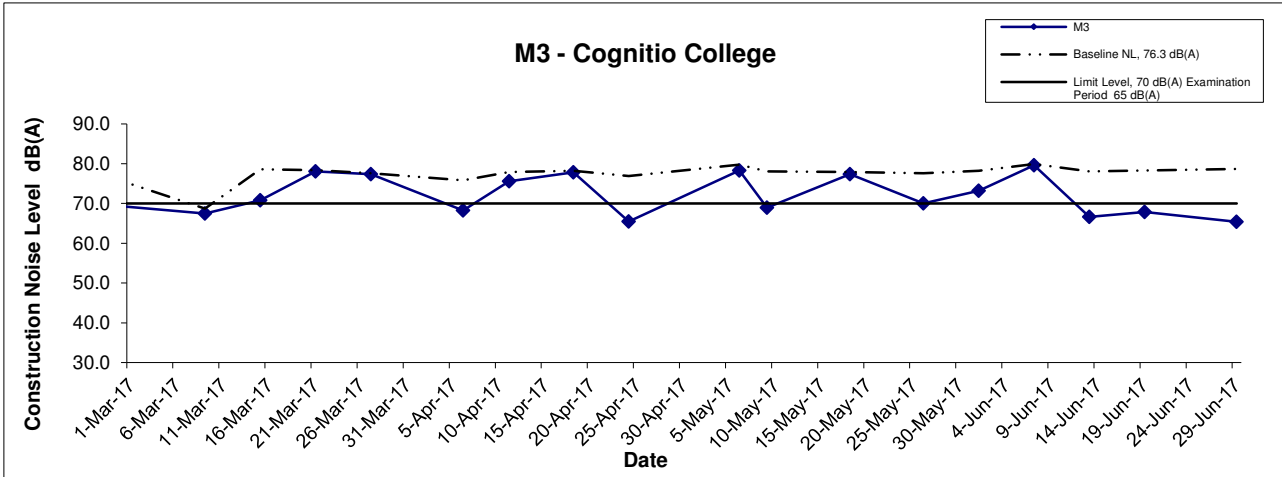
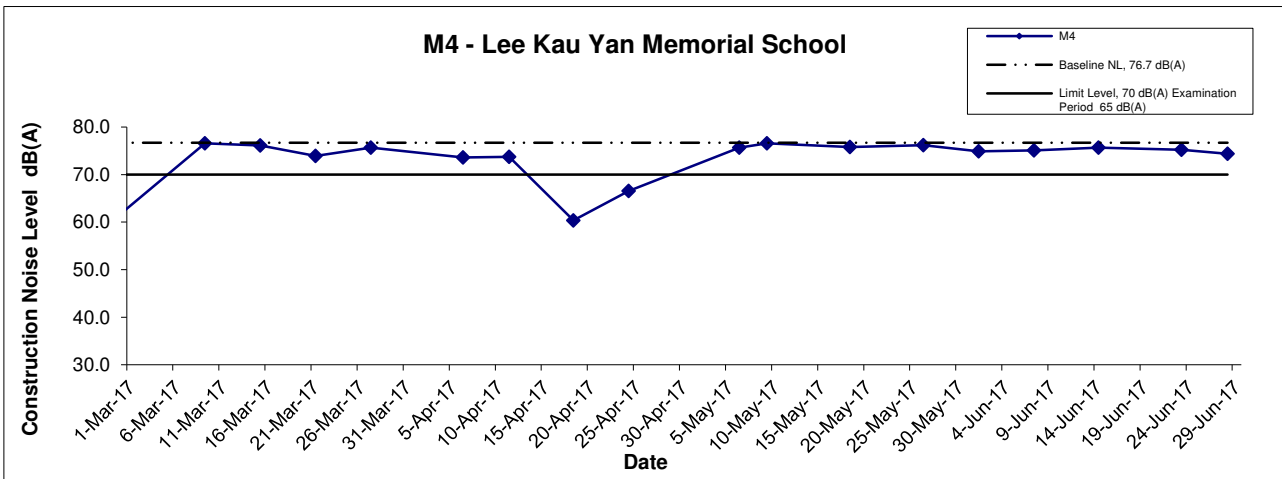
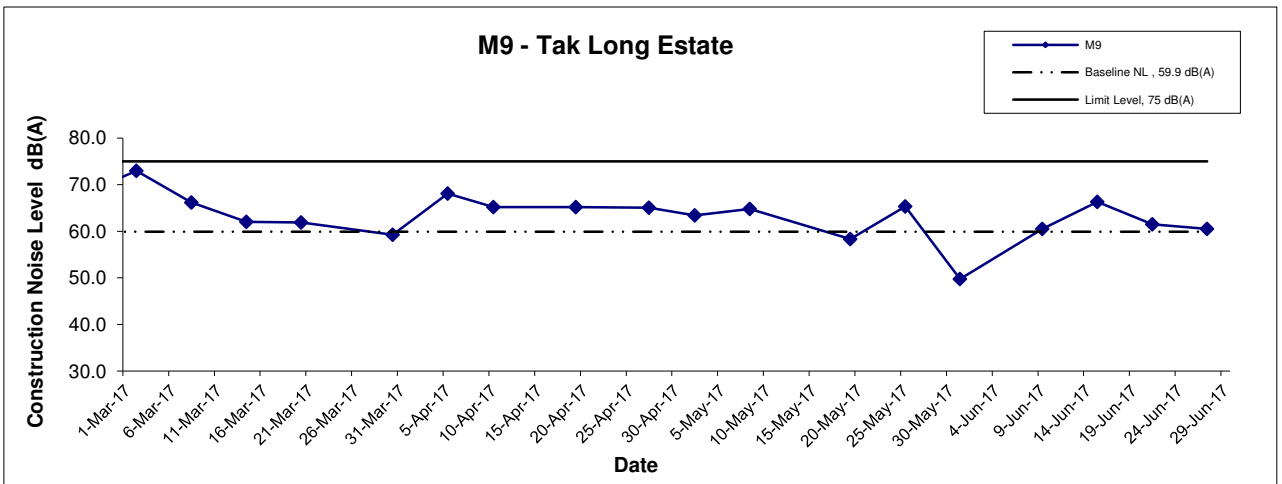
Title Contract No. KL/2012/02 Kai Tak Development - Stage 3A Infrastructure at Former North Apron Area Graphical Presentation of Construction Noise Monitoring Results	Scale N.T.S	Project No. MA13043	CINOTECH
	Date Jun 17	Appendix G

Remarks: The construction noise levels in the Tables in Appendix G were adopted for plotting the graphs

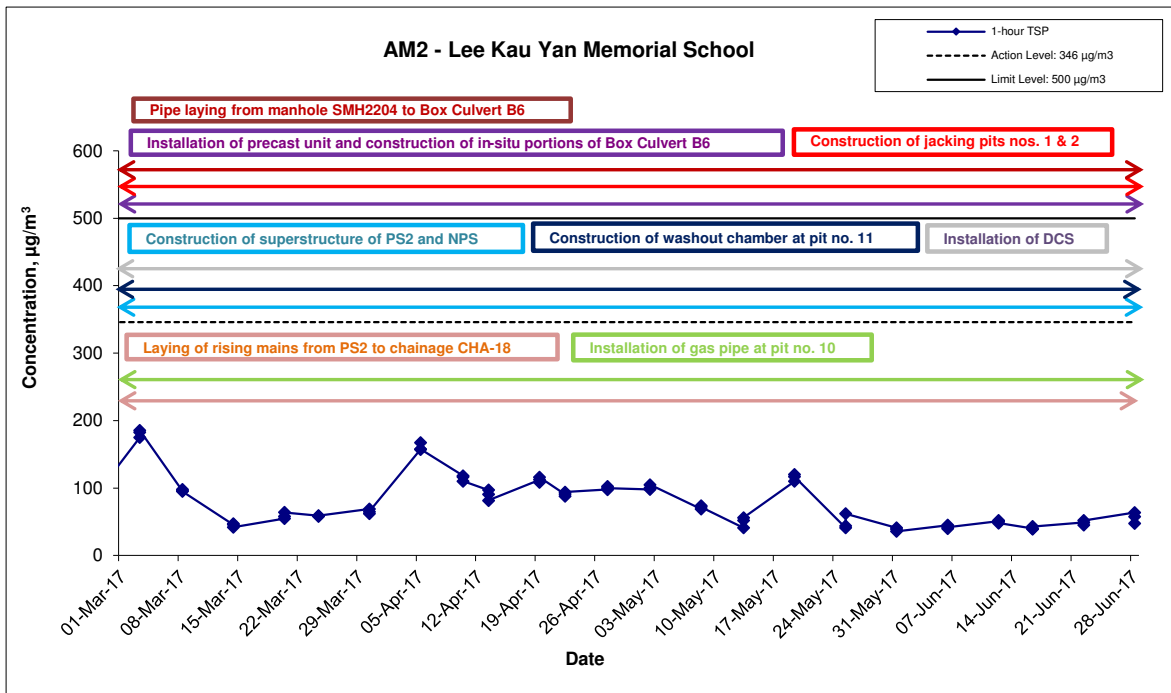
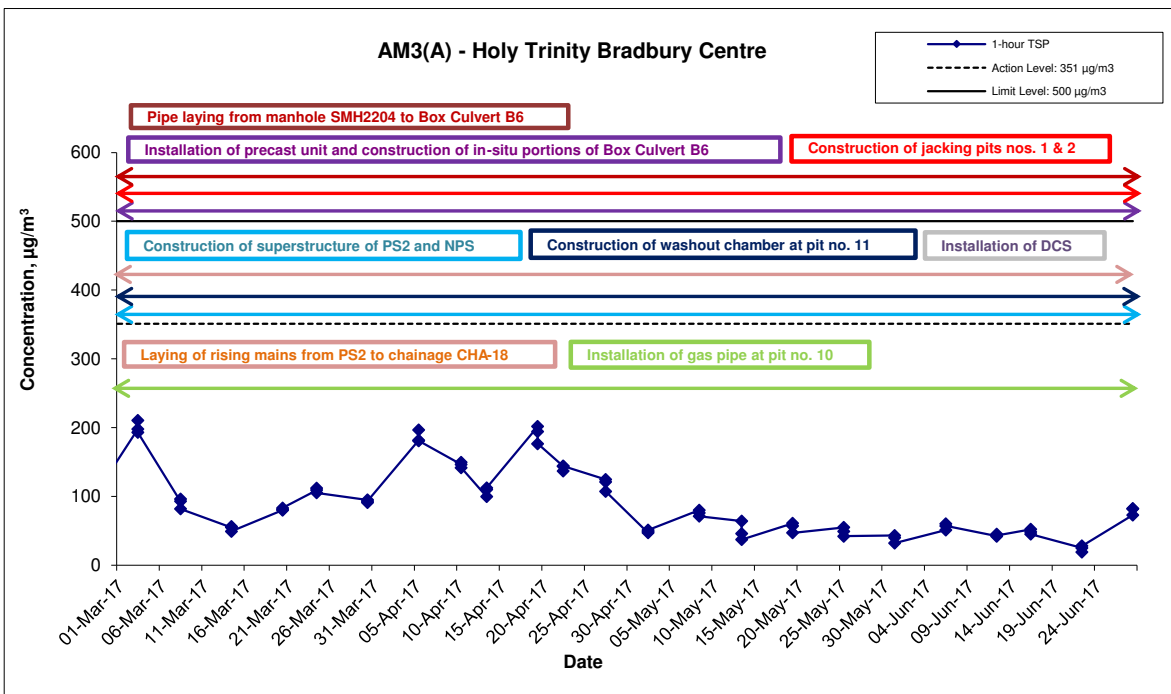
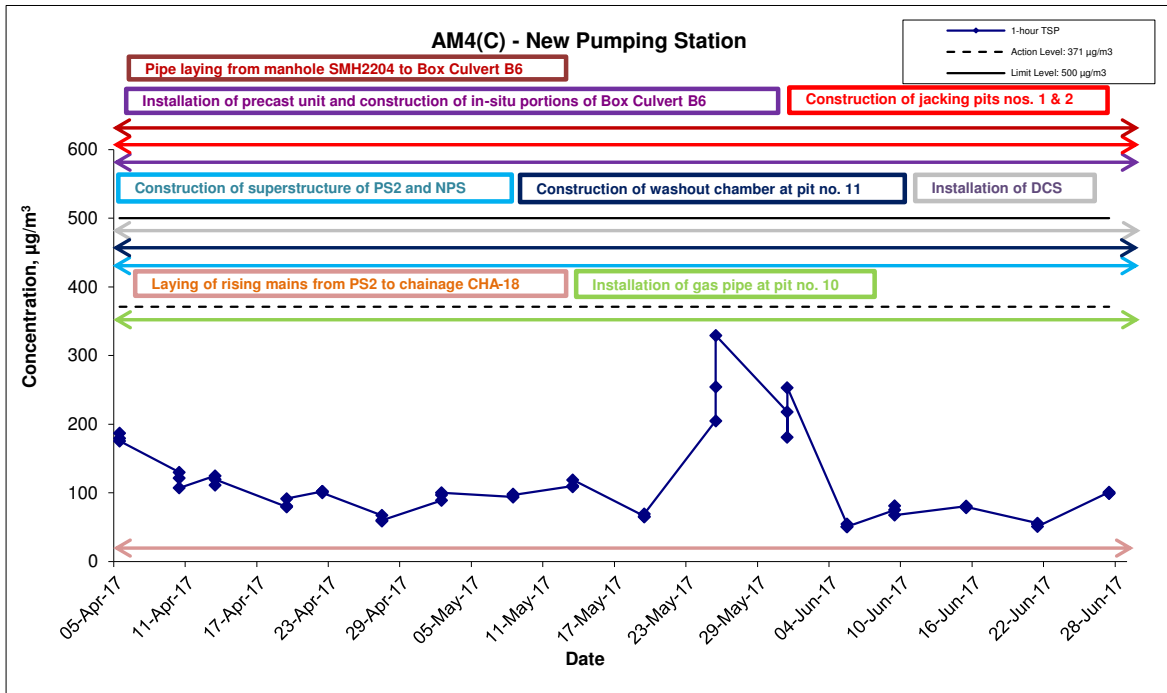
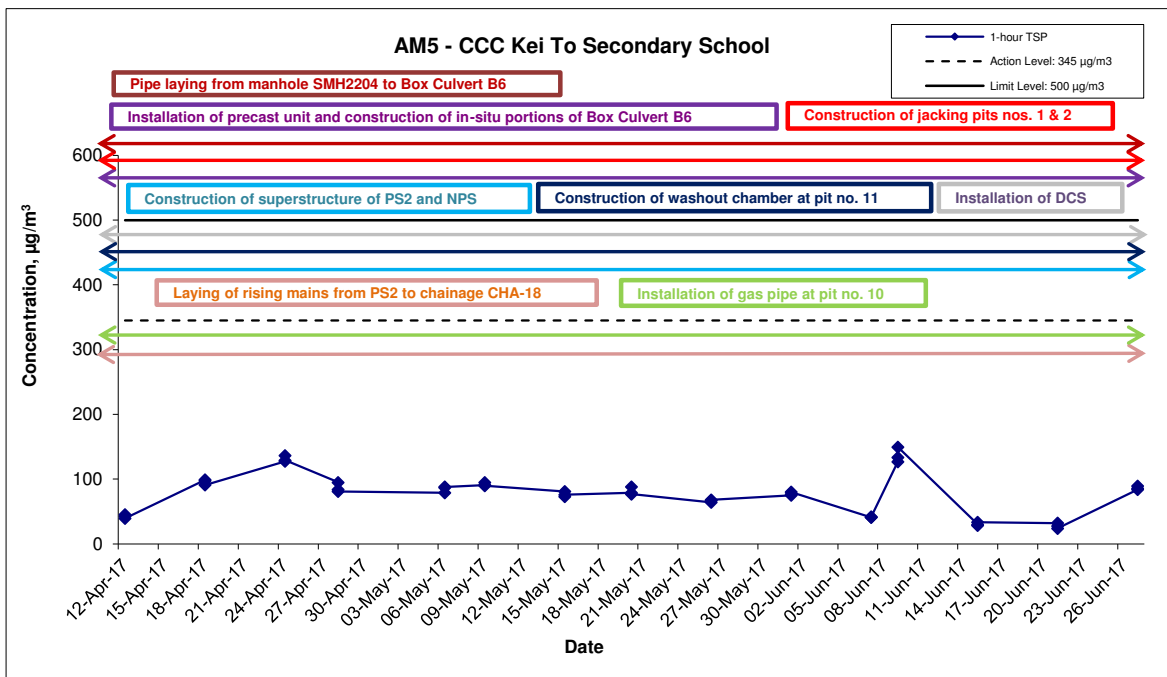
Title Contract No. KL/2012/03 Kai Tak Development –Stage 4 Infrastructure at Former North Apron Area  Graphical Presentation of 1-hour TSP Monitoring Results	Scale N.T.S	Project No. MA13056	<b>CINOTECH</b>
	Date Jun 17	Appendix E

### 1-hr TSP Concentration Levels

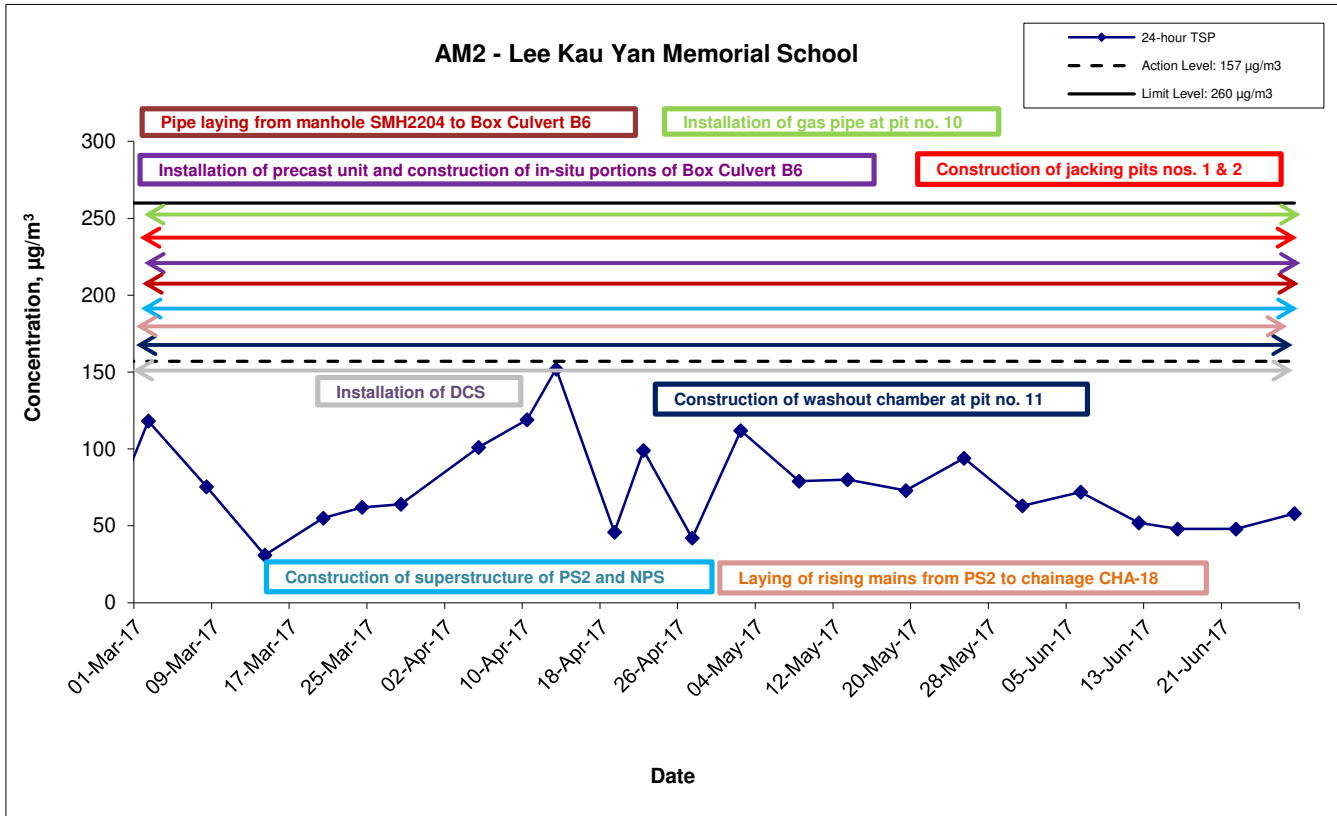
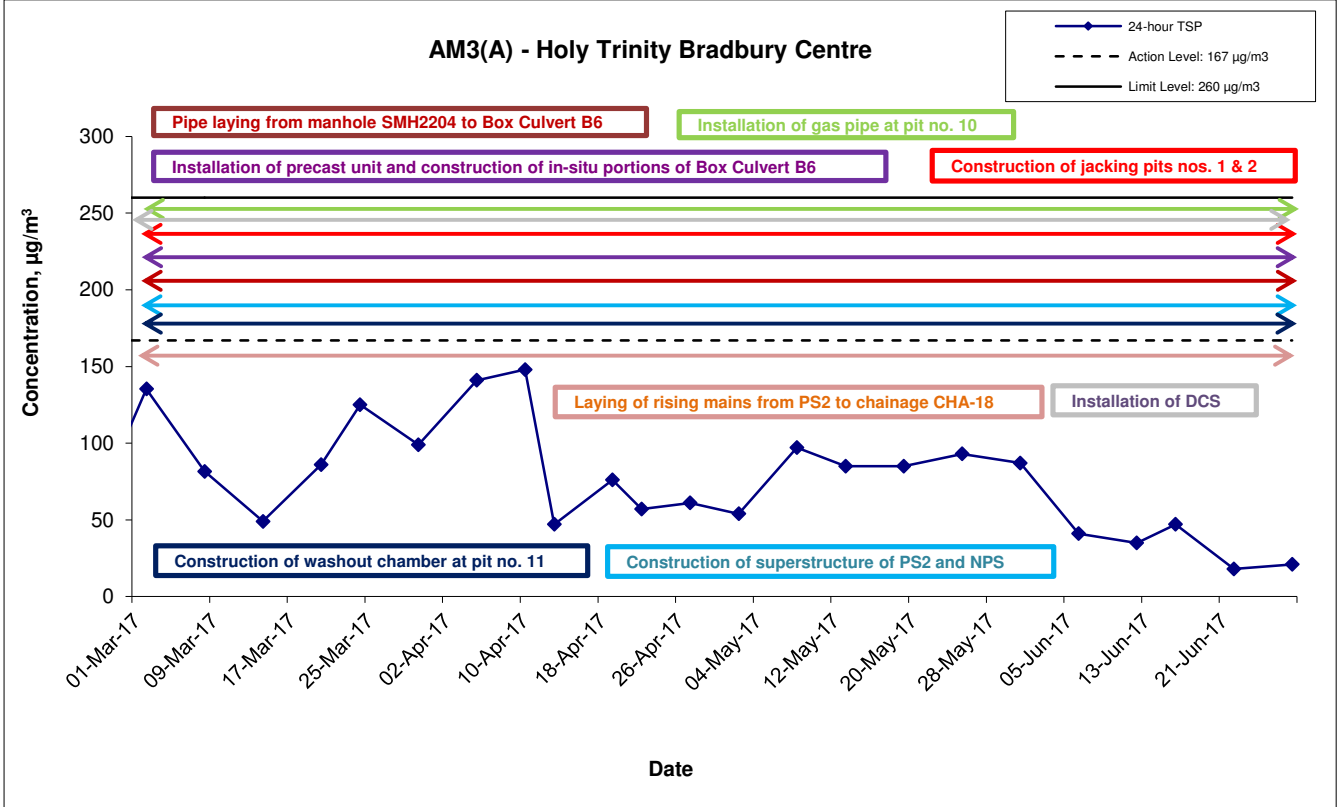
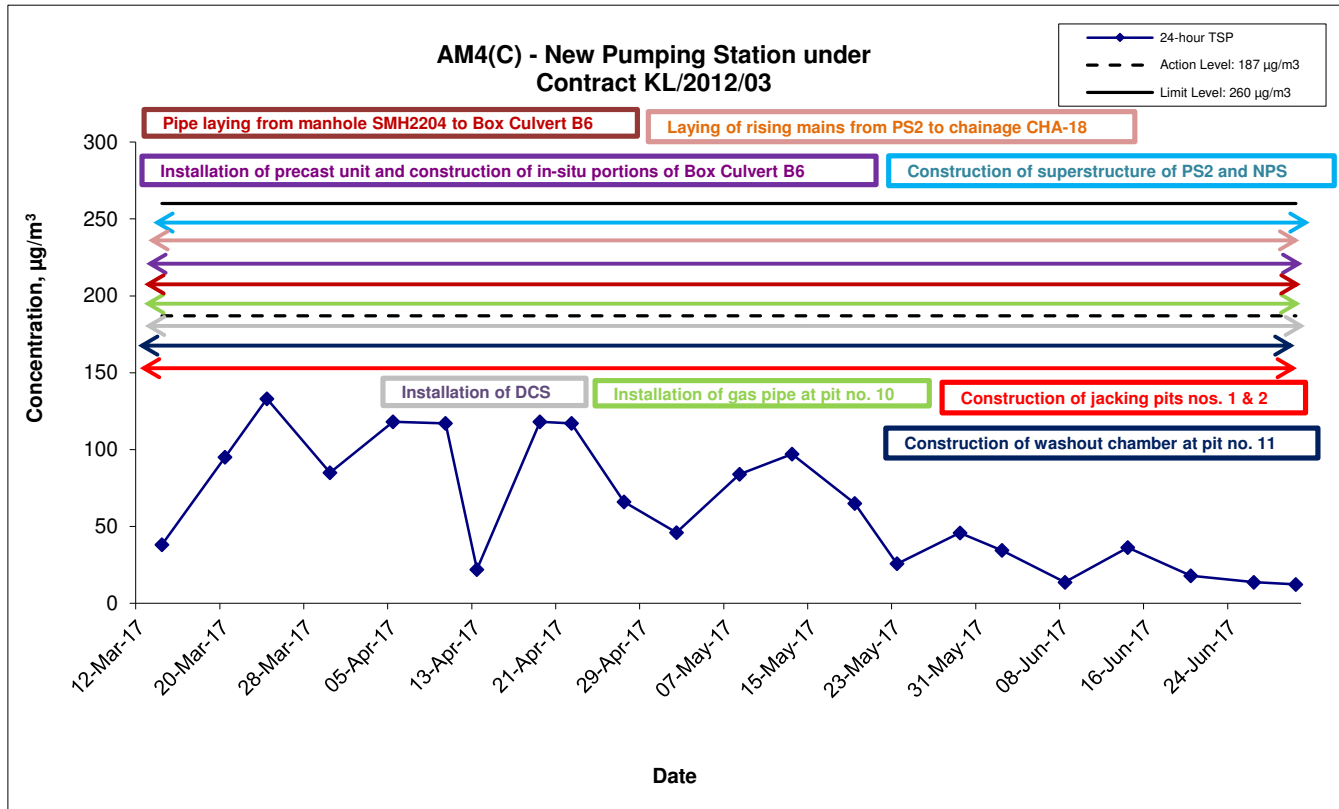
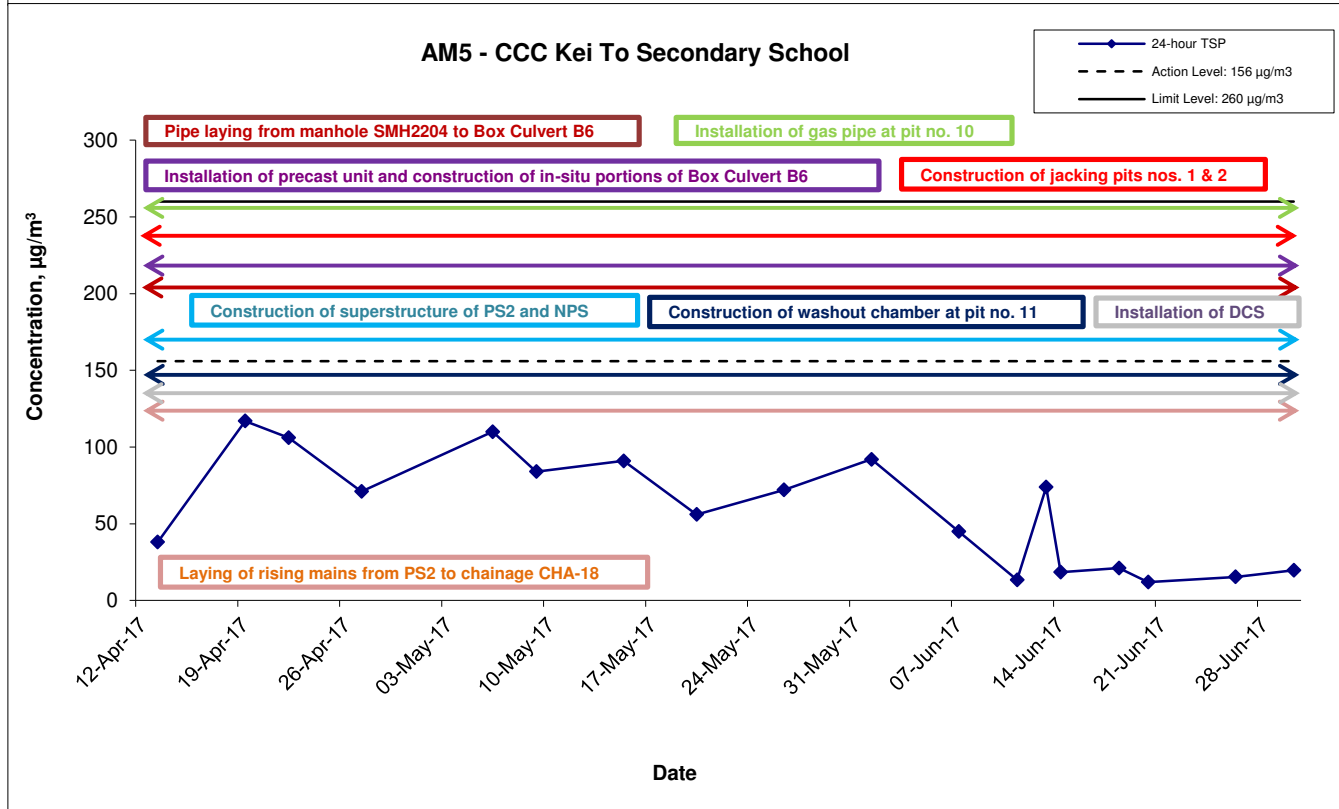
Title Contract No. KL/2012/03 Kai Tak Development –Stage 4 Infrastructure at Former North Apron Area Graphical Presentation of 24-hour TSP Monitoring Results	Scale N.T.S	Project No. MA13056	CINOTECH
	Date Jun 17	Appendix F

### 24-hr TSP Concentration Levels

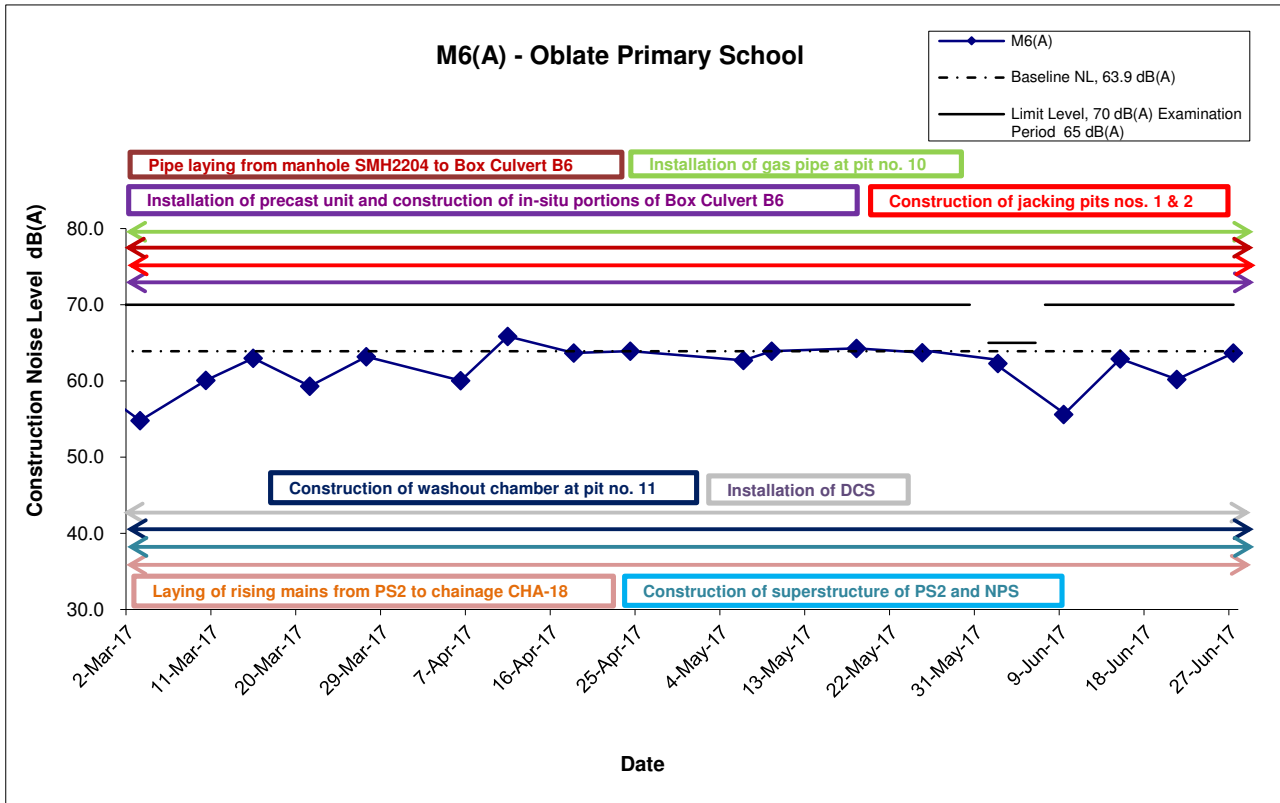
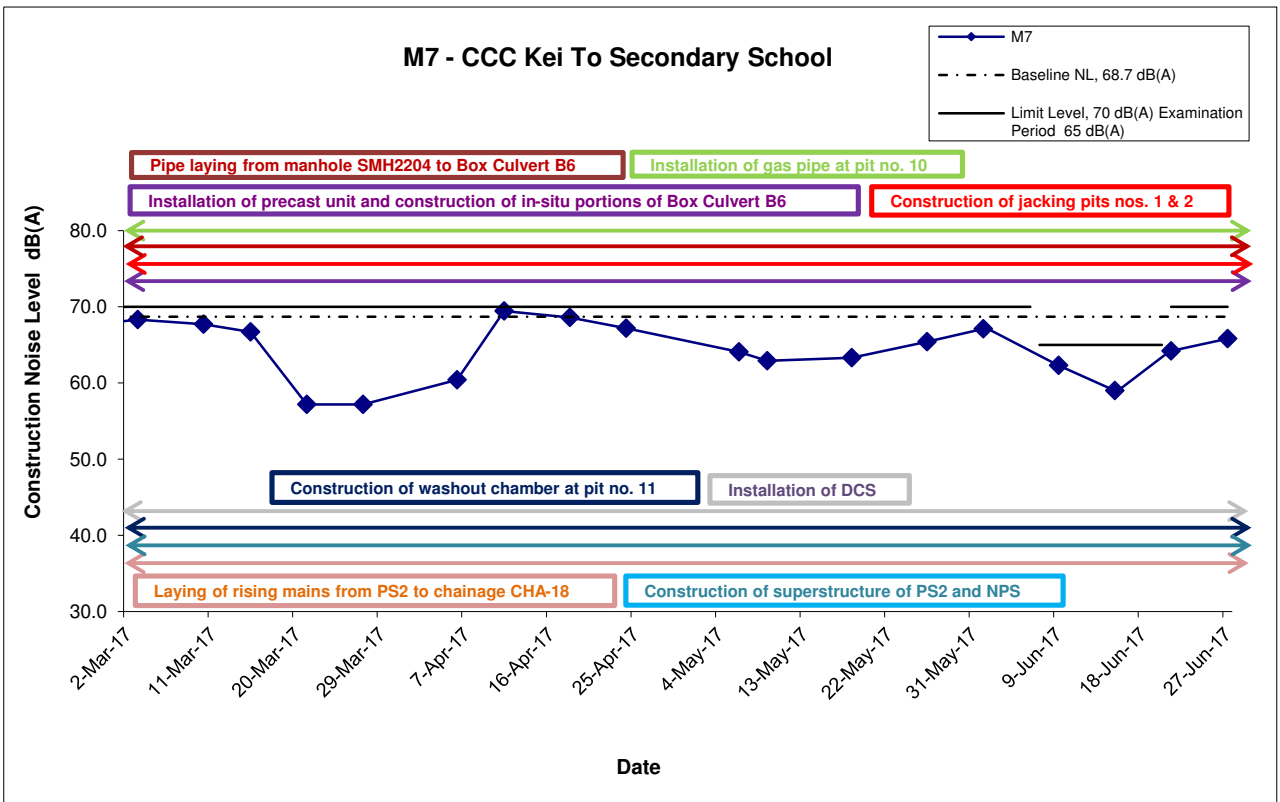
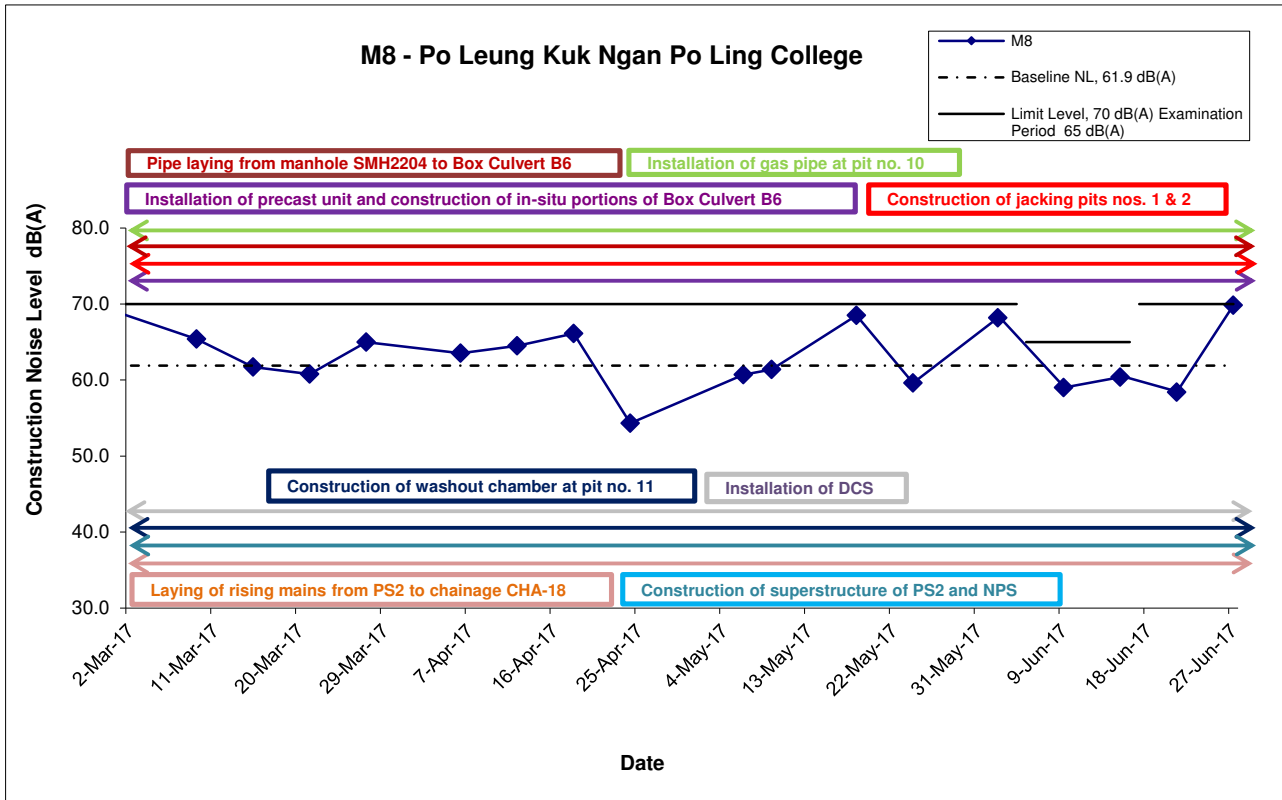
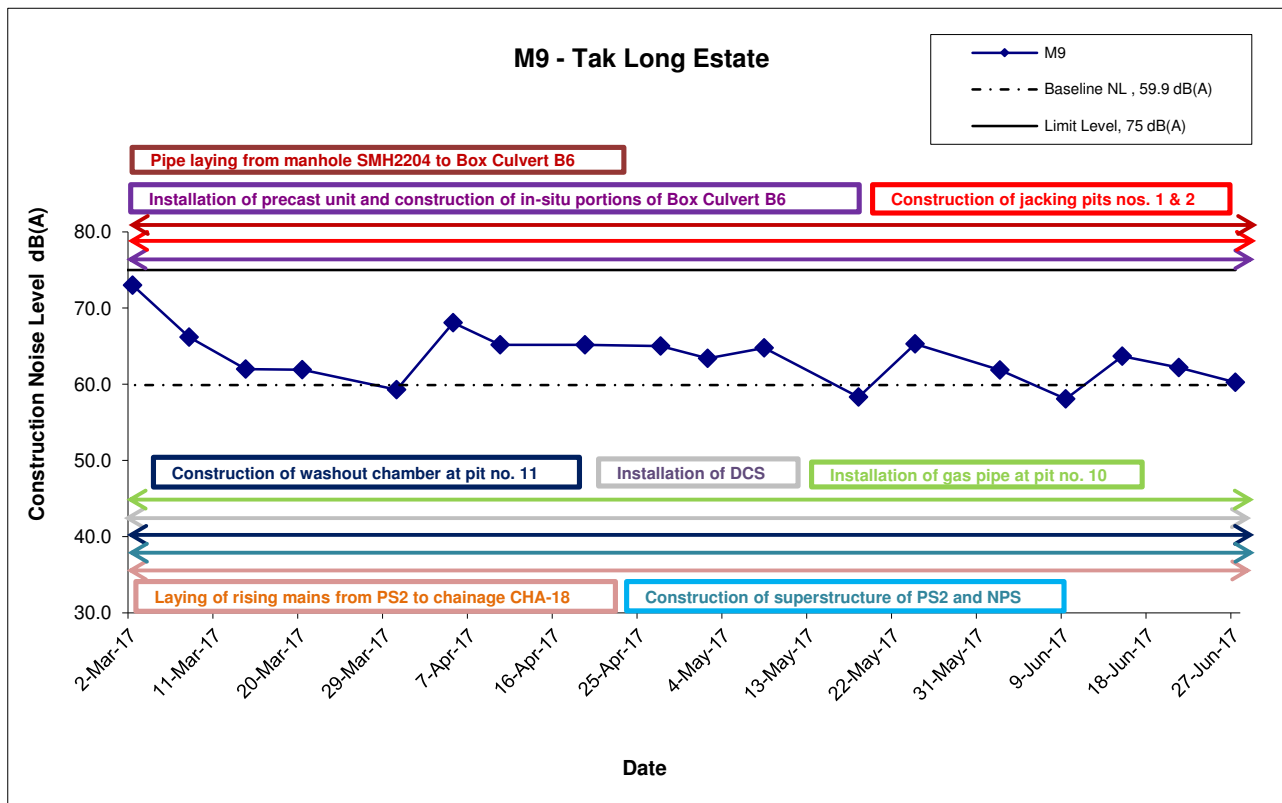
Title Contract No. KL/2012/03 Kai Tak Development –Stage 4 Infrastructure at Former North Apron Area Graphical Presentation of Construction Noise Monitoring Results	Scale N.T.S Date Jun 17	Project No. MA13056 Appendix G	
---	----------------------------------	---	--

Remarks: The construction noise levels in the Tables in Appendix G were adopted for plotting the graphs

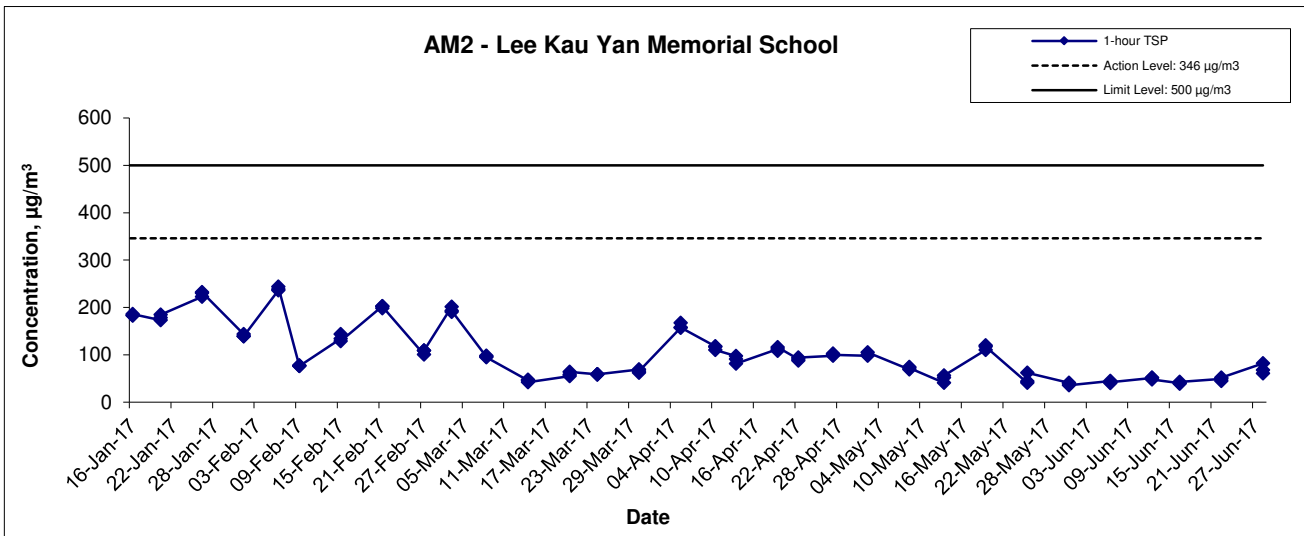
Contract No. KLN/2016/04  
 Environmental Monitoring Works for Contract No. KL/2015/02  
 Kai Tak Development –Stage 5A Infrastructure at Former North Apron  
 Graphical Presentation of 1-hour TSP Monitoring Results

### 1-hr TSP Concentration Levels

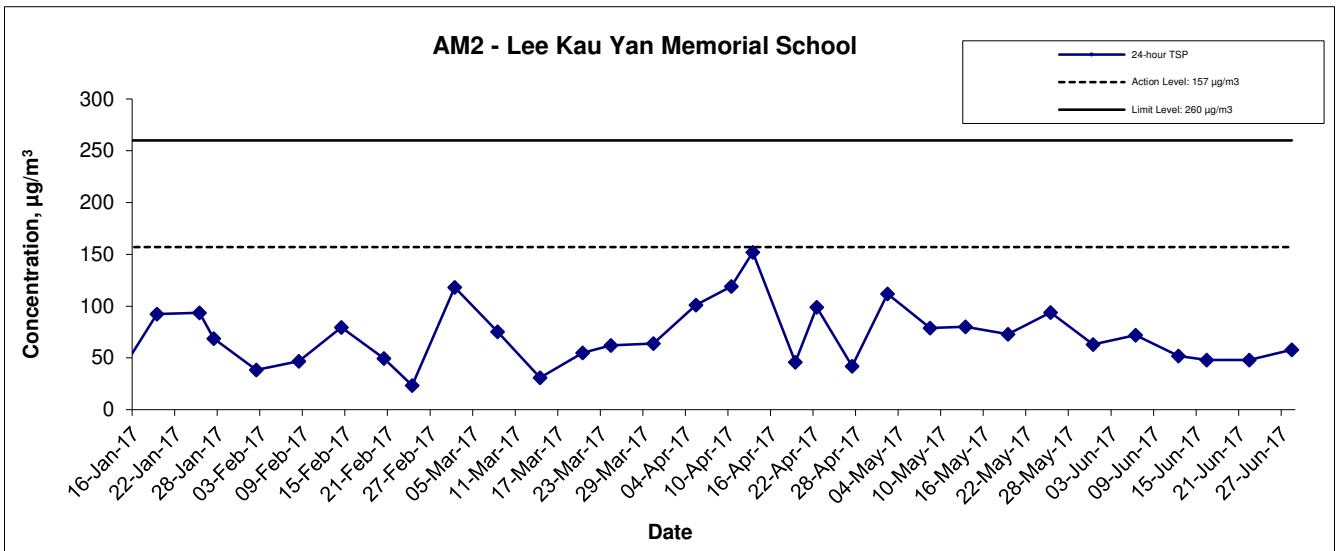
Title Contract No. KLN/2016/04 Environmental Monitoring Works for Contract No. KL/2015/02 Kai Tak Development –Stage 5A Infrastructure at Former North Apron Graphical Presentation of 24-hour TSP Monitoring Results	Scale	Project		
		N.T.S		No. MA16043
	Date	Jun 17		Appendix F

### 24-hr TSP Concentration Levels

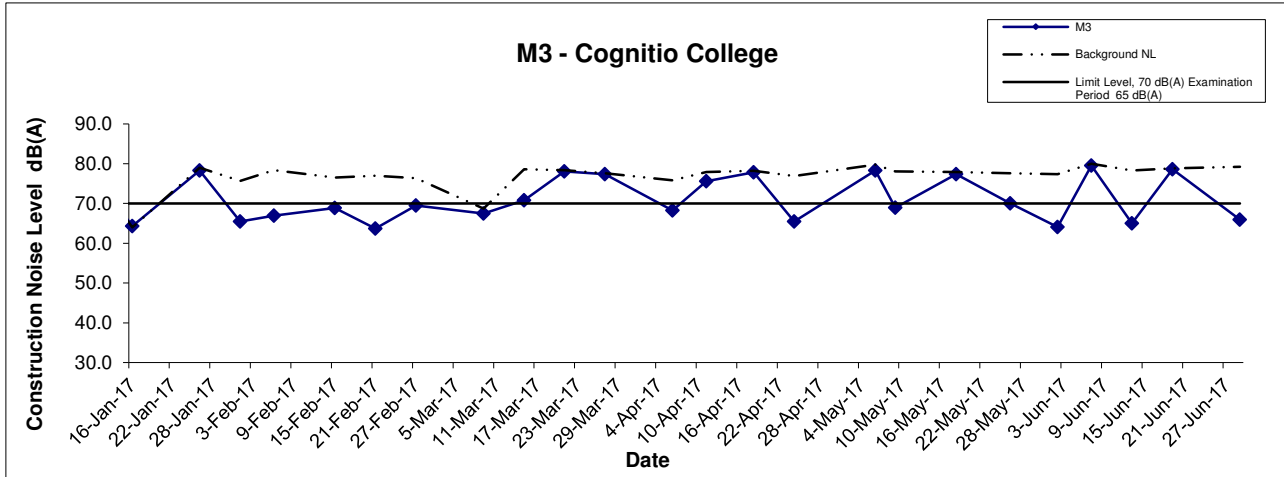
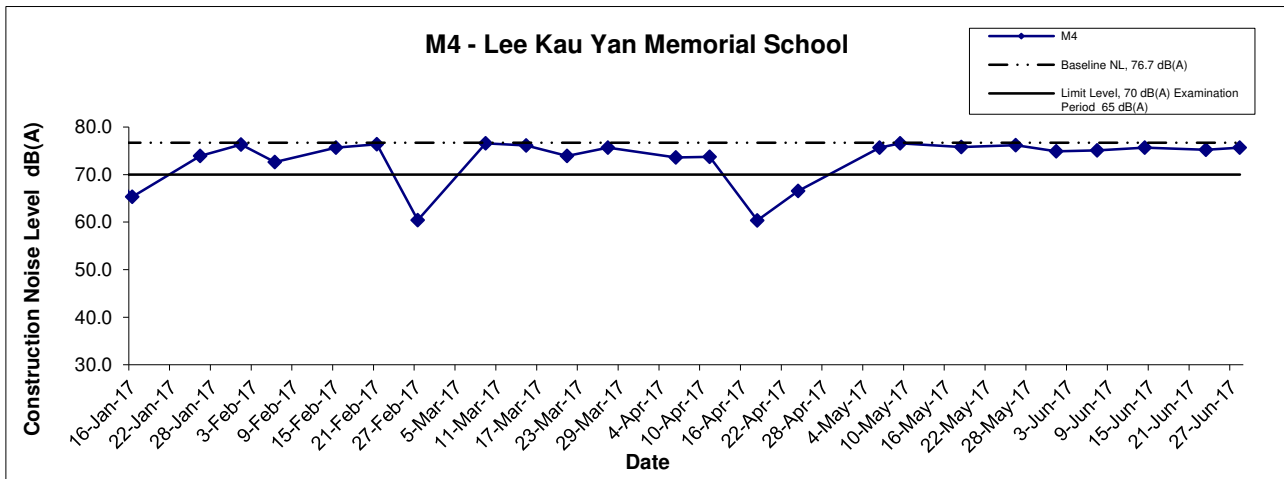
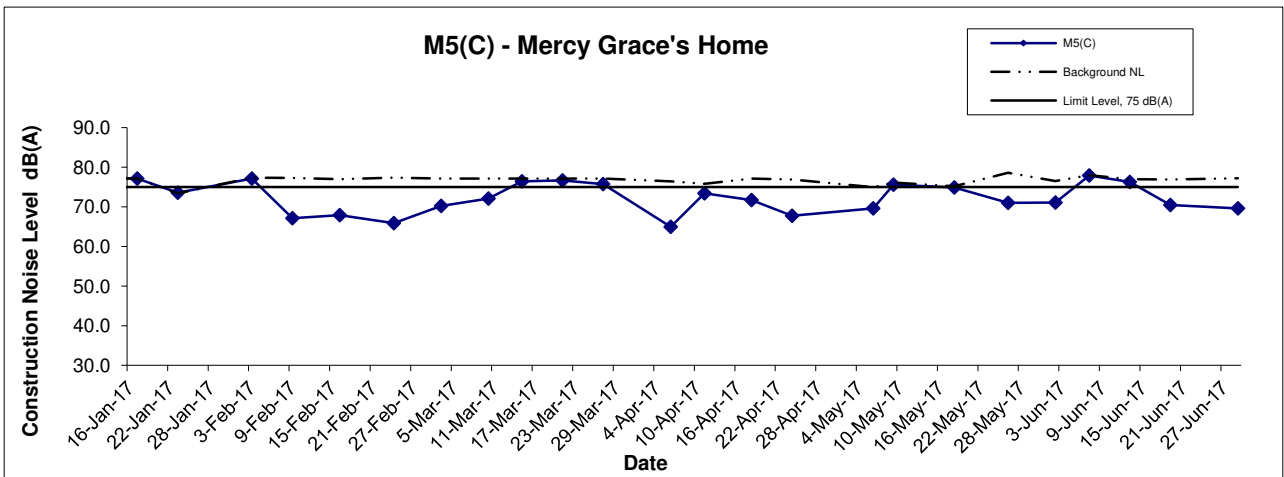
## Noise Levels

Remarks: The construction noise levels in the Tables in Appendix G were adopted for plotting the graphs
