11th CONSOLIDATED MONTHLY EM&A REPORT

September 2017

EP No. : EP-337/2009 –
New Distributor Roads Serving the Planned Kai Tak
Development Area

Contract No. : KLN/2016/05 –
Independent Environmental Checker for
Contract No. KL/2015/02 Kai Tak Development –
Stage 5A Infrastructure at Former North Apron Area

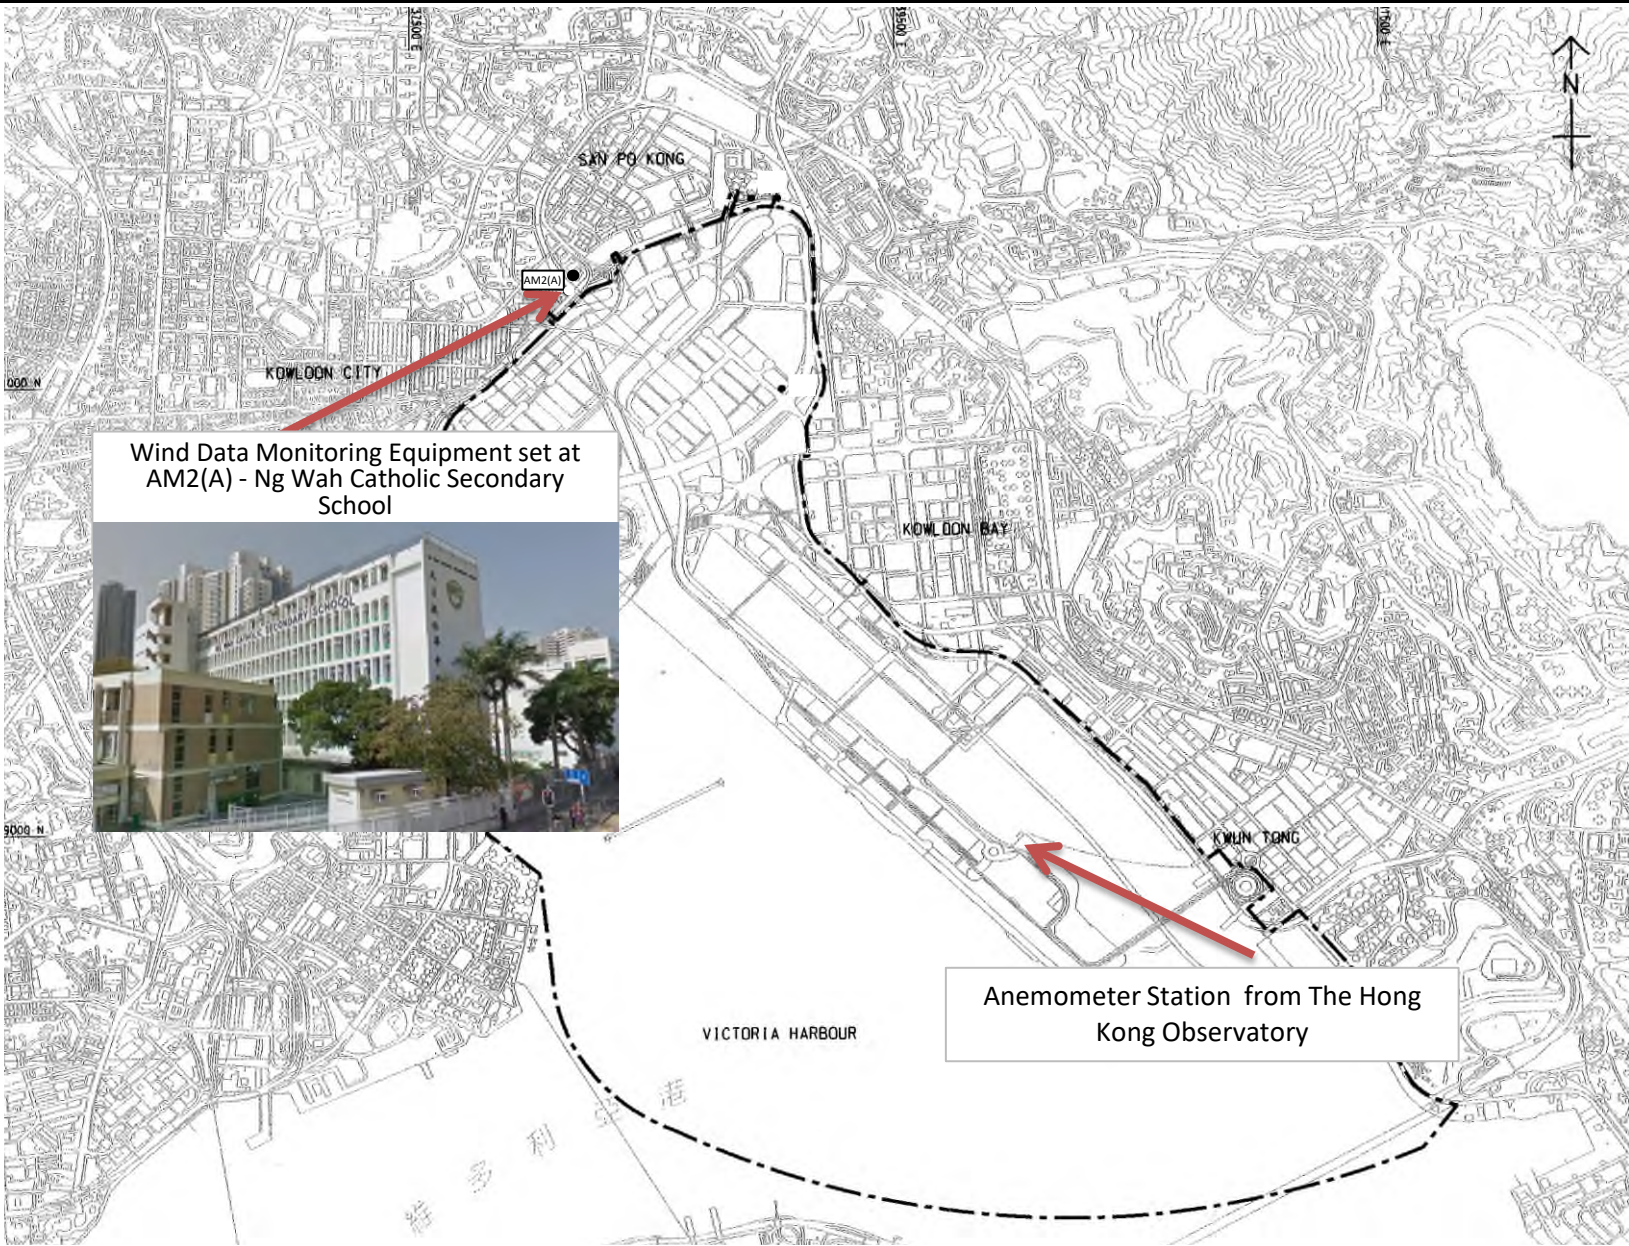
Wind Data Monitoring Equipment set at AM2(A) - Ng Wah Catholic Secondary School

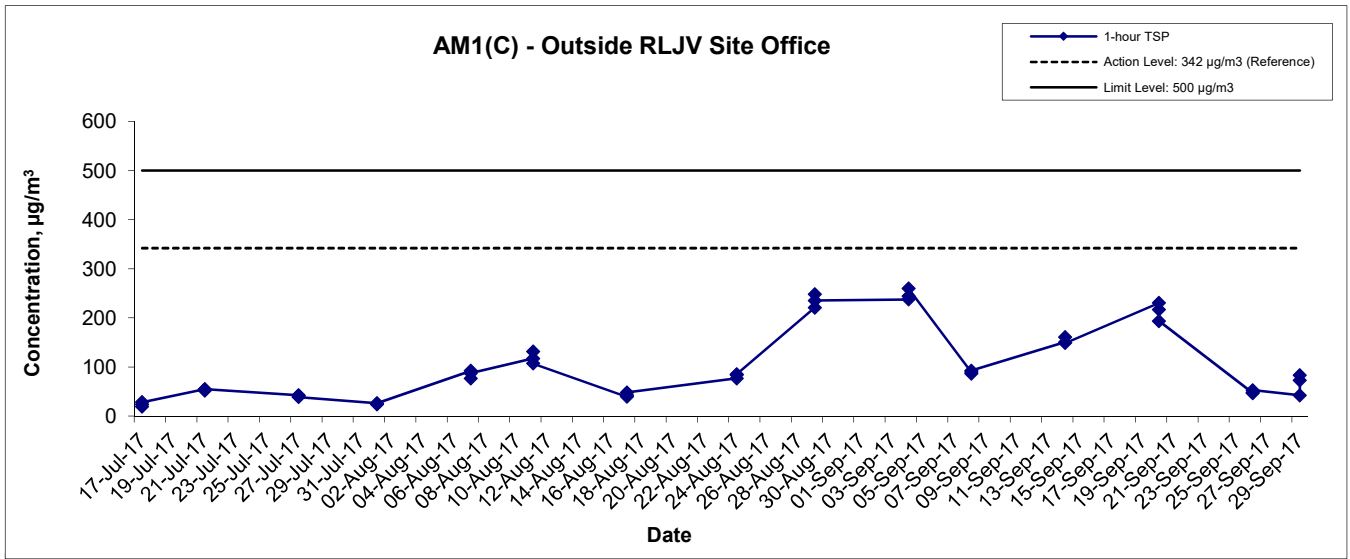
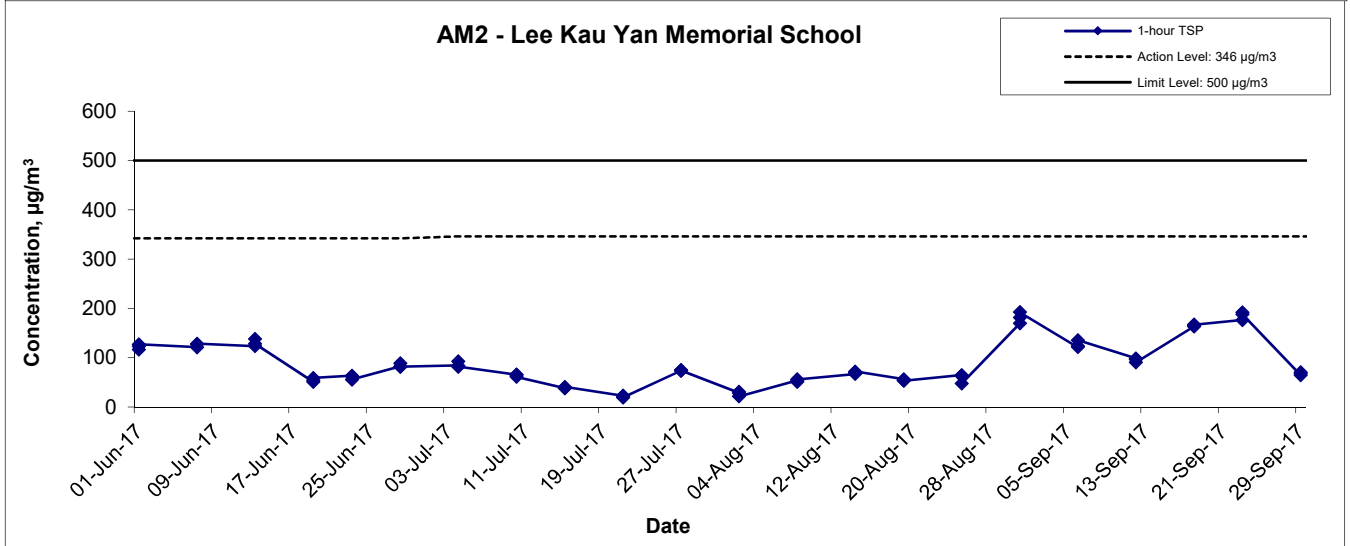
Title Contract No. KL/2012/02 Kai Tak Development - Stage 3A Infrastructure at Former North Apron Area Graphical Presentation of 1-hour TSP Monitoring Results	Scale N.T.S	Project No. MA13043	
	Date Sep 17	Appendix E

1-hr TSP Concentration Levels

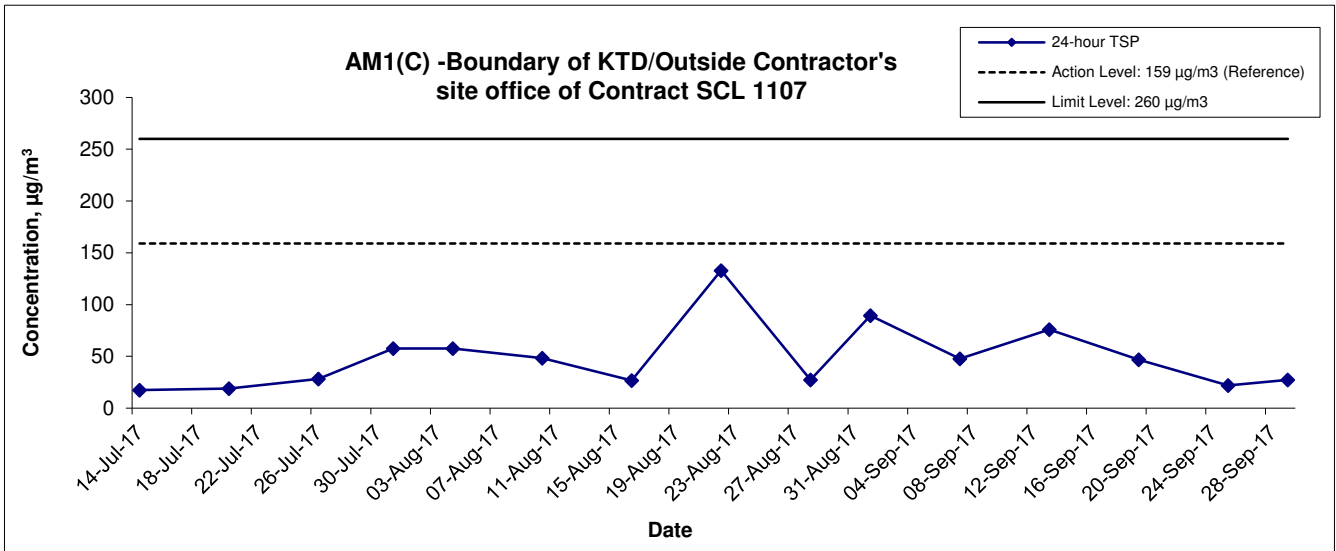
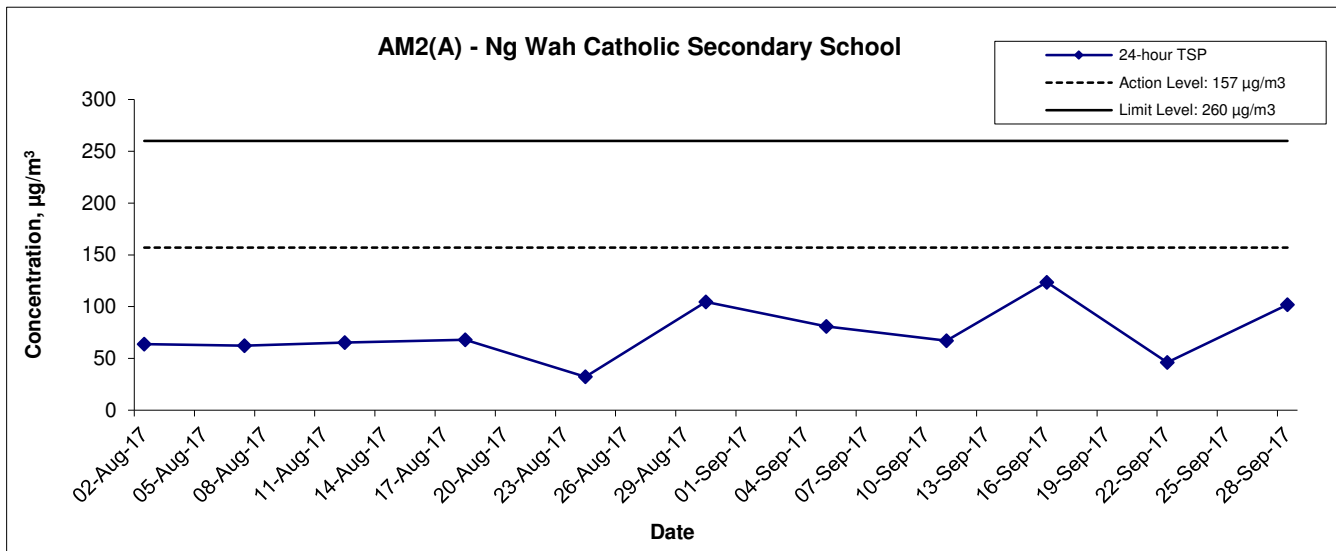
Title Contract No. KL/2012/02 Kai Tak Development - Stage 3A Infrastructure at Former North Apron Area Graphical Presentation of 24-hour TSP Monitoring Results	Scale N.T.S	Project No. MA13043	
	Date Sep 17	Appendix F

24-hr TSP Concentration Levels

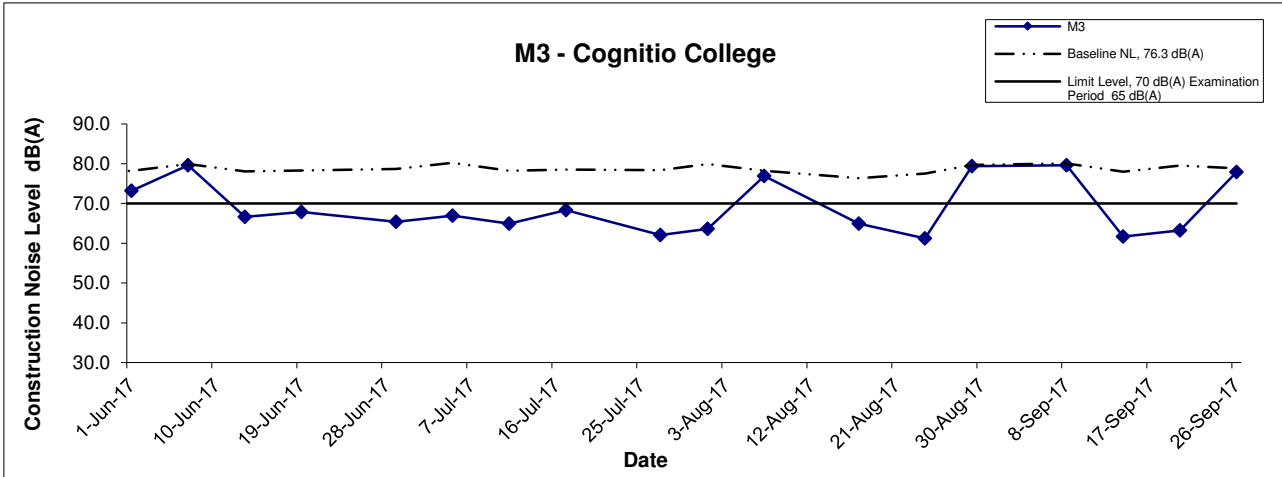
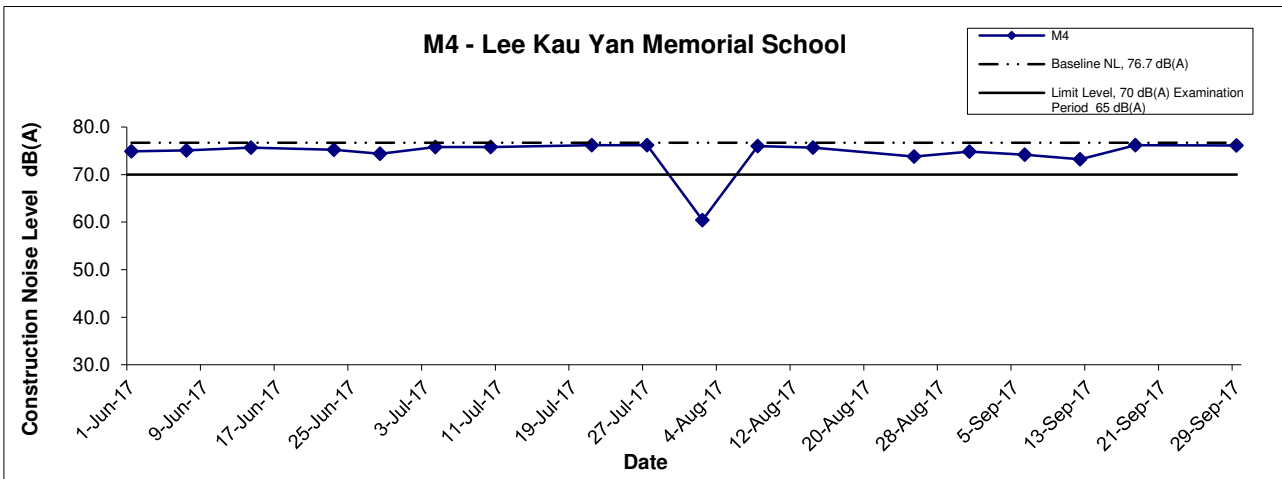
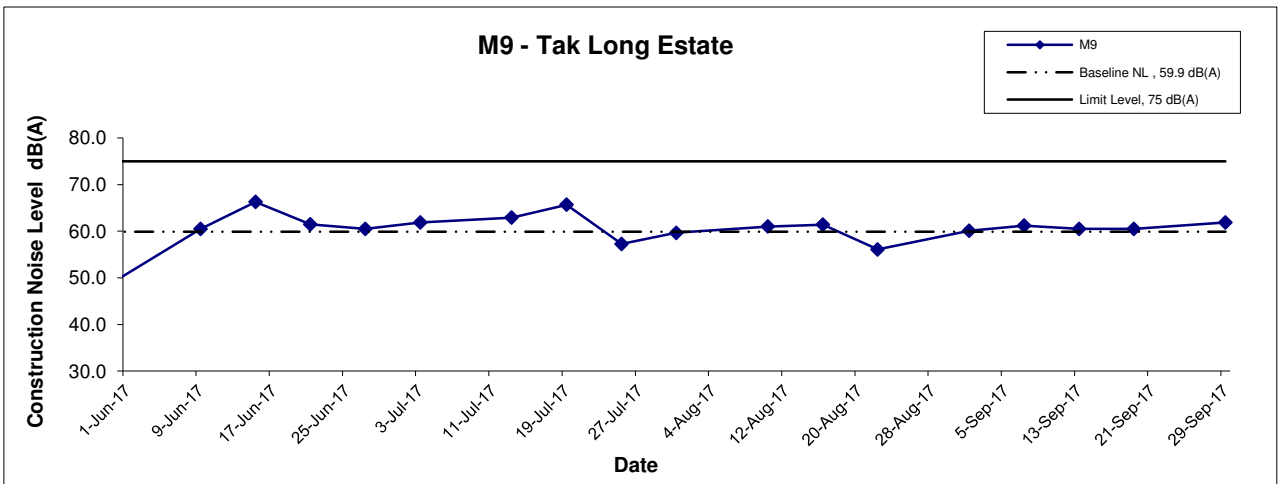
Title Contract No. KL/2012/02 Kai Tak Development - Stage 3A Infrastructure at Former North Apron Area Graphical Presentation of Construction Noise Monitoring Results	Scale N.T.S	Project No. MA13043	CINOTECH
	Date Sep 17	Appendix G

Noise Levels

Remarks: The construction noise levels in the Tables in Appendix G were adopted for plotting the graphs

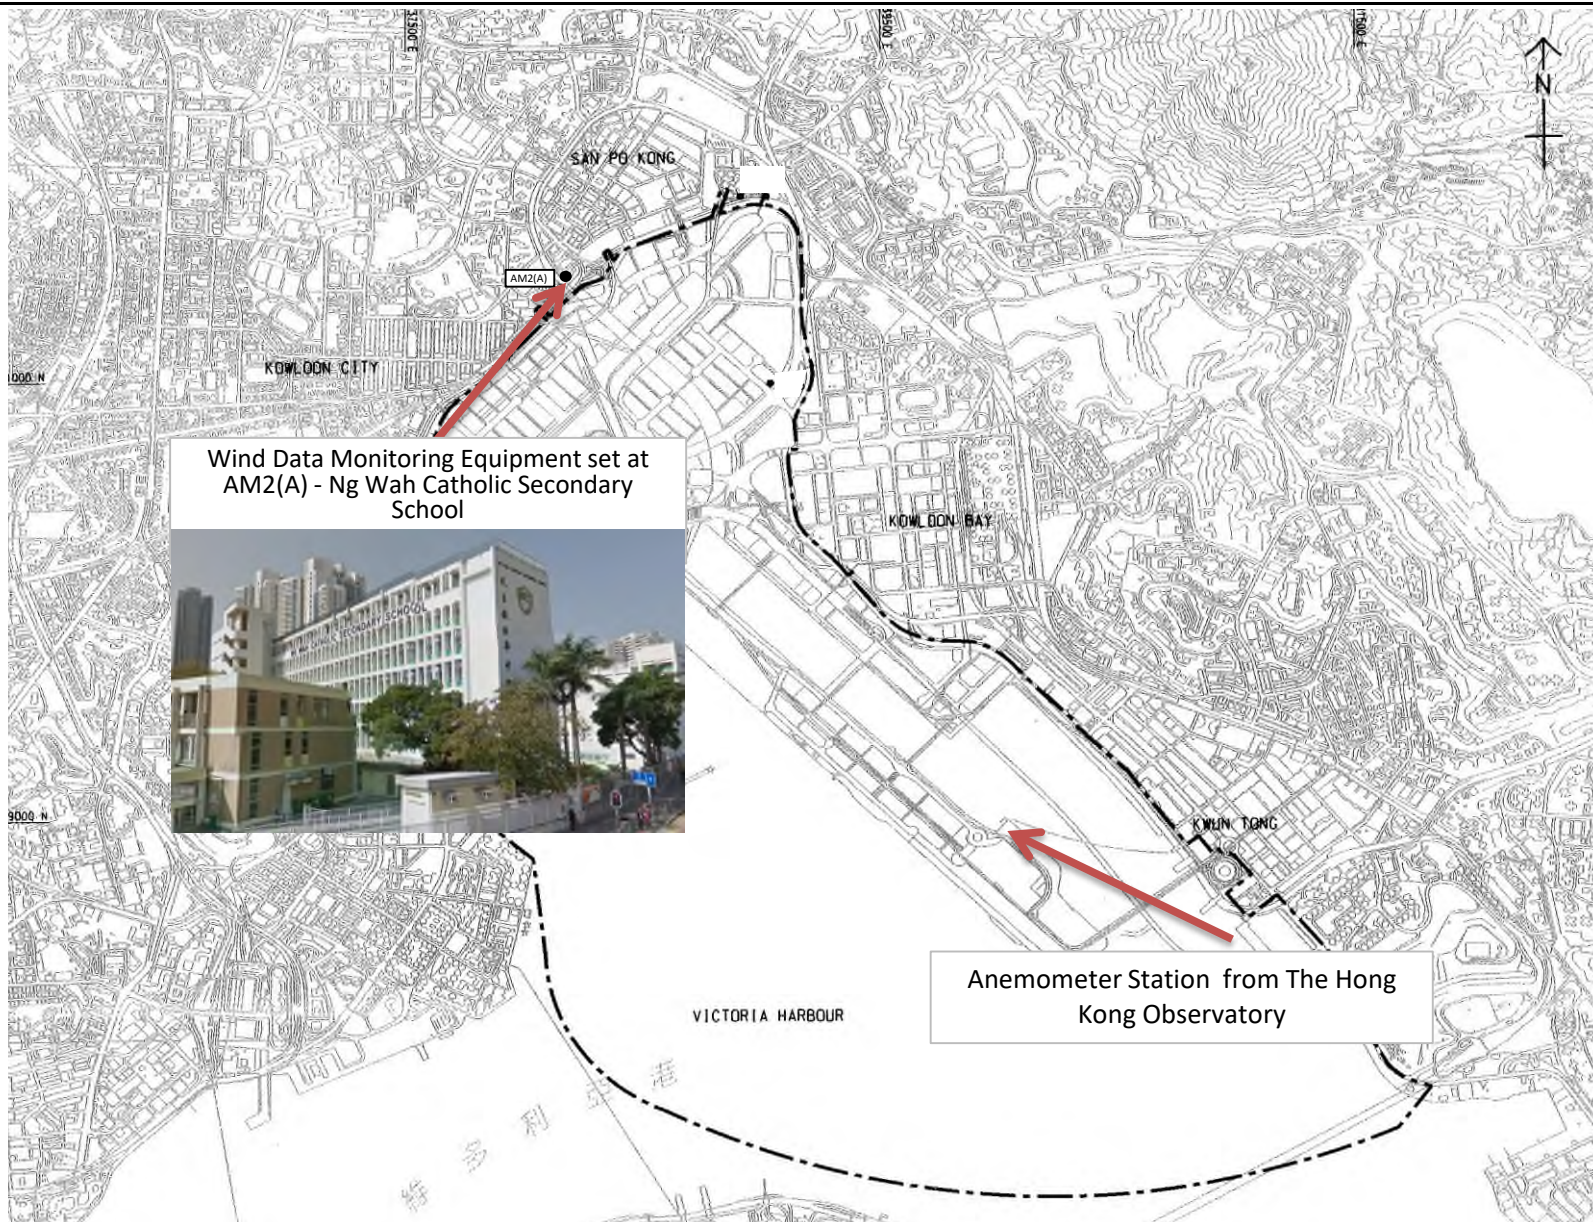
Wind Data Monitoring Equipment set at
AM2(A) - Ng Wah Catholic Secondary
School

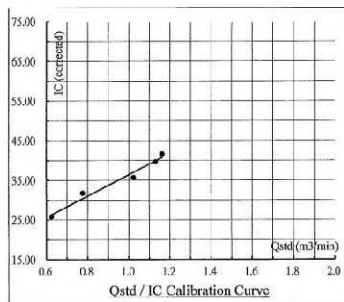
Method	Calibration equation	Slope, m	Intercept, b	Corr. coeff., r
Dickson recorder	$Q_{std} = 1/m [I (1 + \sqrt{ ((Pa / 760) (298 / Ta)) }) - b]$	26.799	9.6023	0.9854

Calibration curve requirements: (A). $r > 0.990$; (B). At least 5 Qstd numbers are in the TSP range (1.1 - 1.7 m³/min).

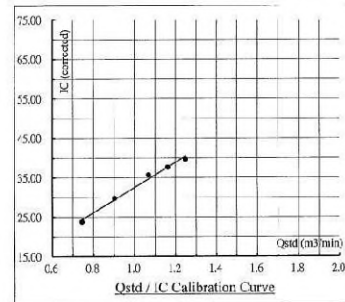
Method	Calibration equation	Slope, m	Intercept, b	Corr. coeff., r
Dickson recorder	$Q_{std} = 1/m [I (1 + \sqrt{ ((Pa / 760) (298 / Ta)) }) - b]$	31.825	0.6791	0.9958

Calibration curve requirements: (A). $r > 0.990$; (B). At least 3 Qstd numbers are in the TSP range (1.1 - 1.7 m³/min).

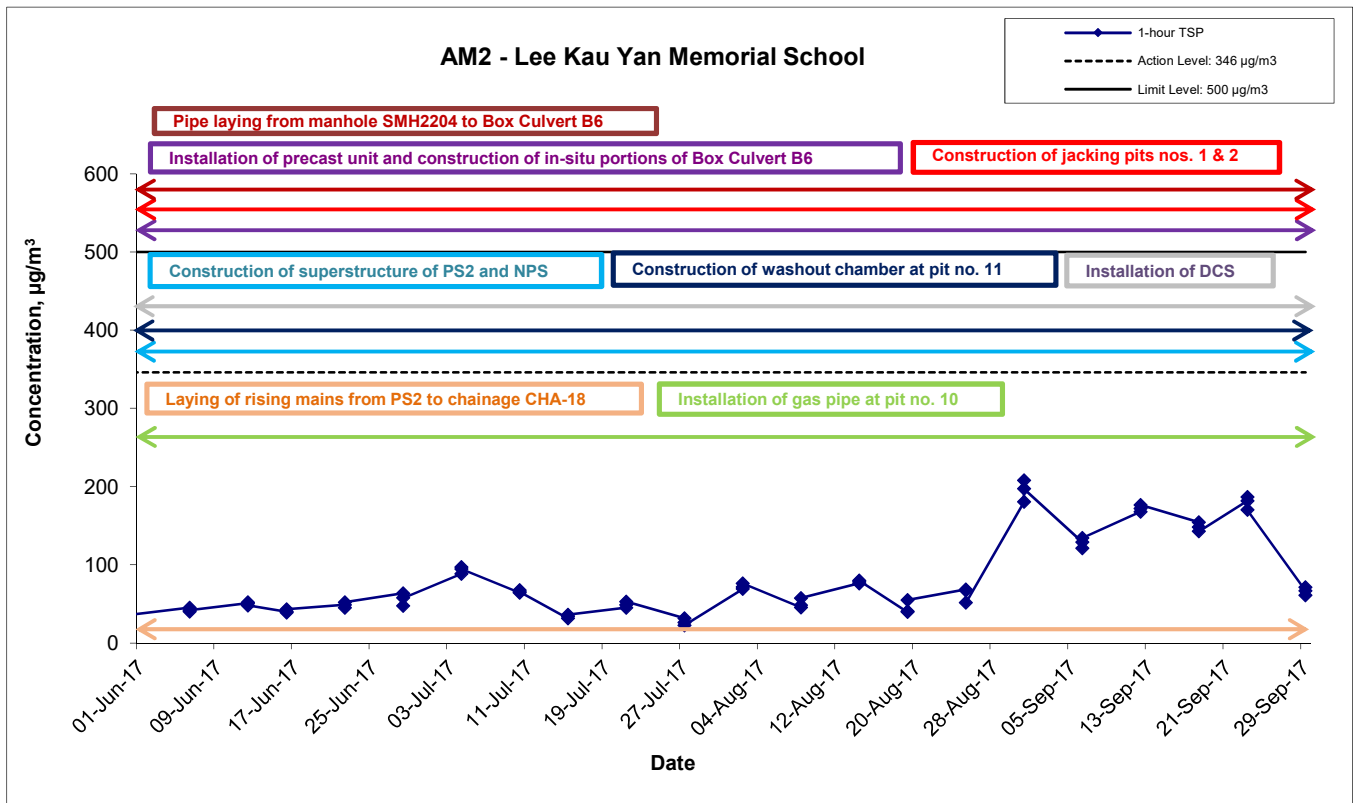
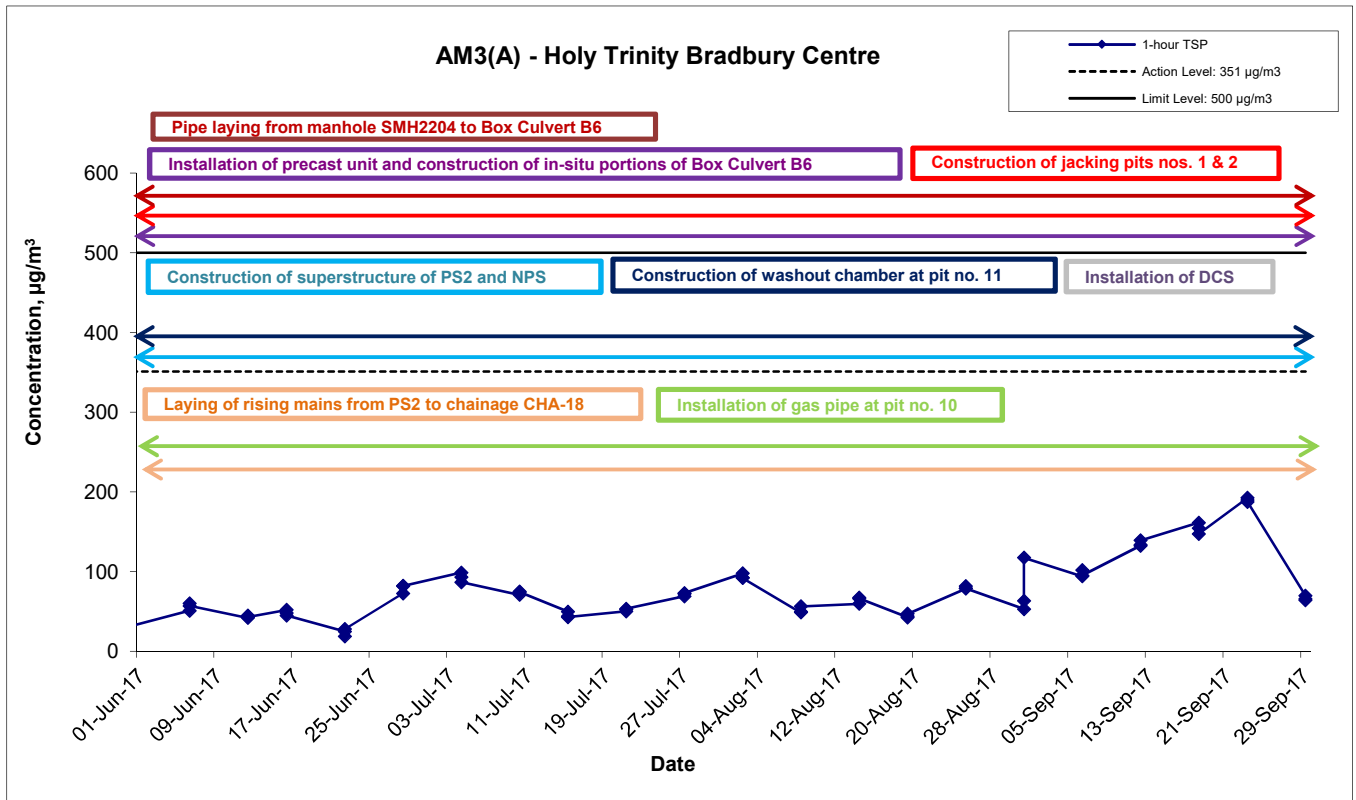
Title Kai Tak Development –Stage 4 Infrastructure at Former North Apron Area Graphical Presentation of 1-hour TSP Monitoring Results	Contract No. KL/2012/03	Scale N.T.S	Project No. MA13056	CINOTECH
		Date Sep 17	Appendix E

1-hr TSP Concentration Levels

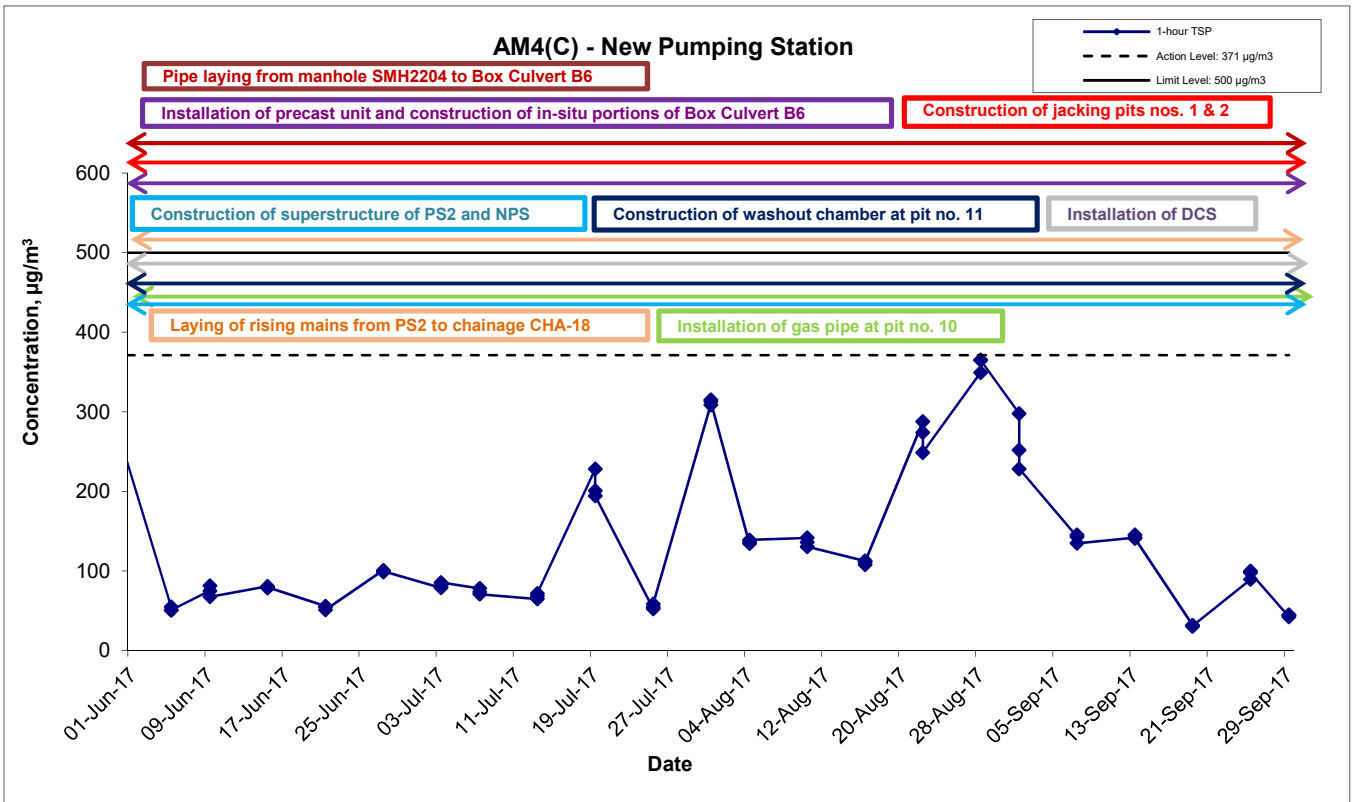
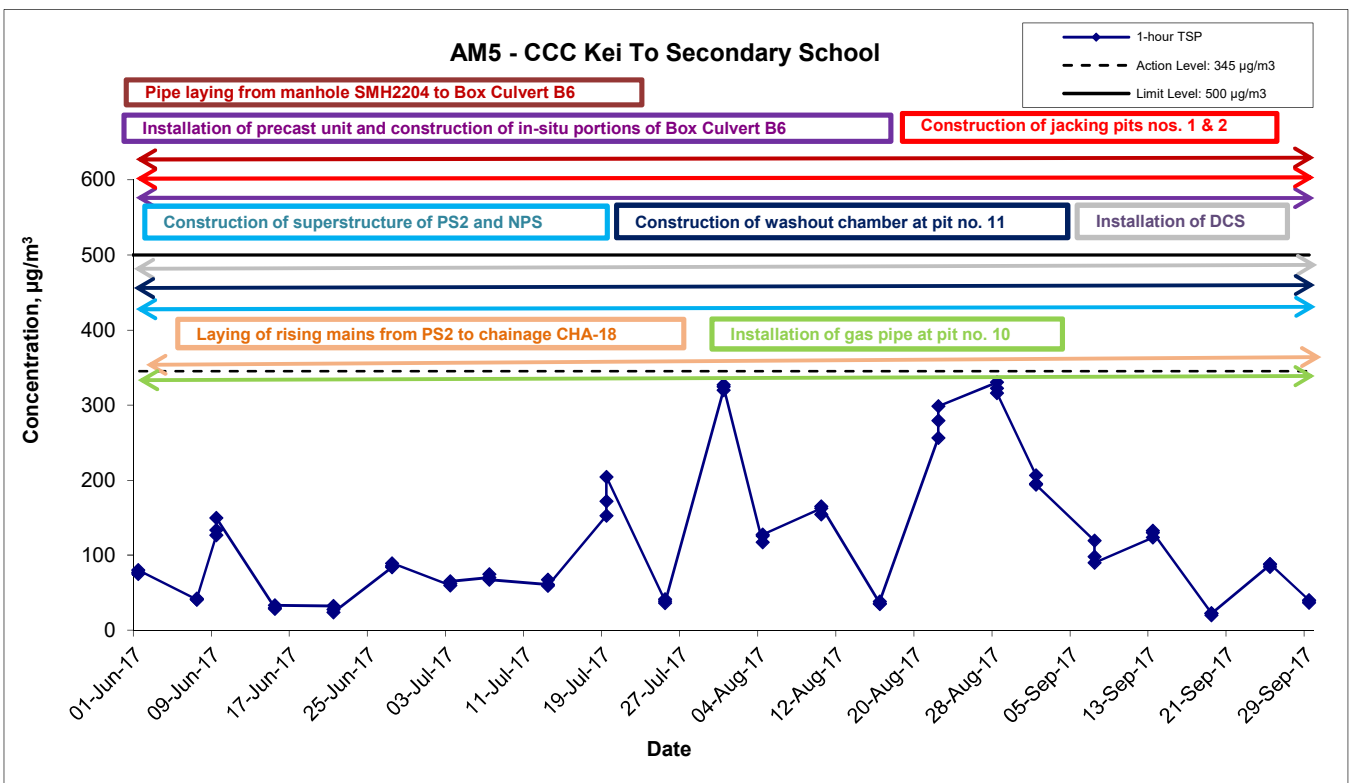
Title Kai Tak Development –Stage 4 Infrastructure at Former North Apron Area Graphical Presentation of 1-hour TSP Monitoring Results	Contract No. KL/2012/03	Scale N.T.S	Project No. MA13056	CINOTECH
		Date Sep 17	Appendix E

1-hr TSP Concentration Levels

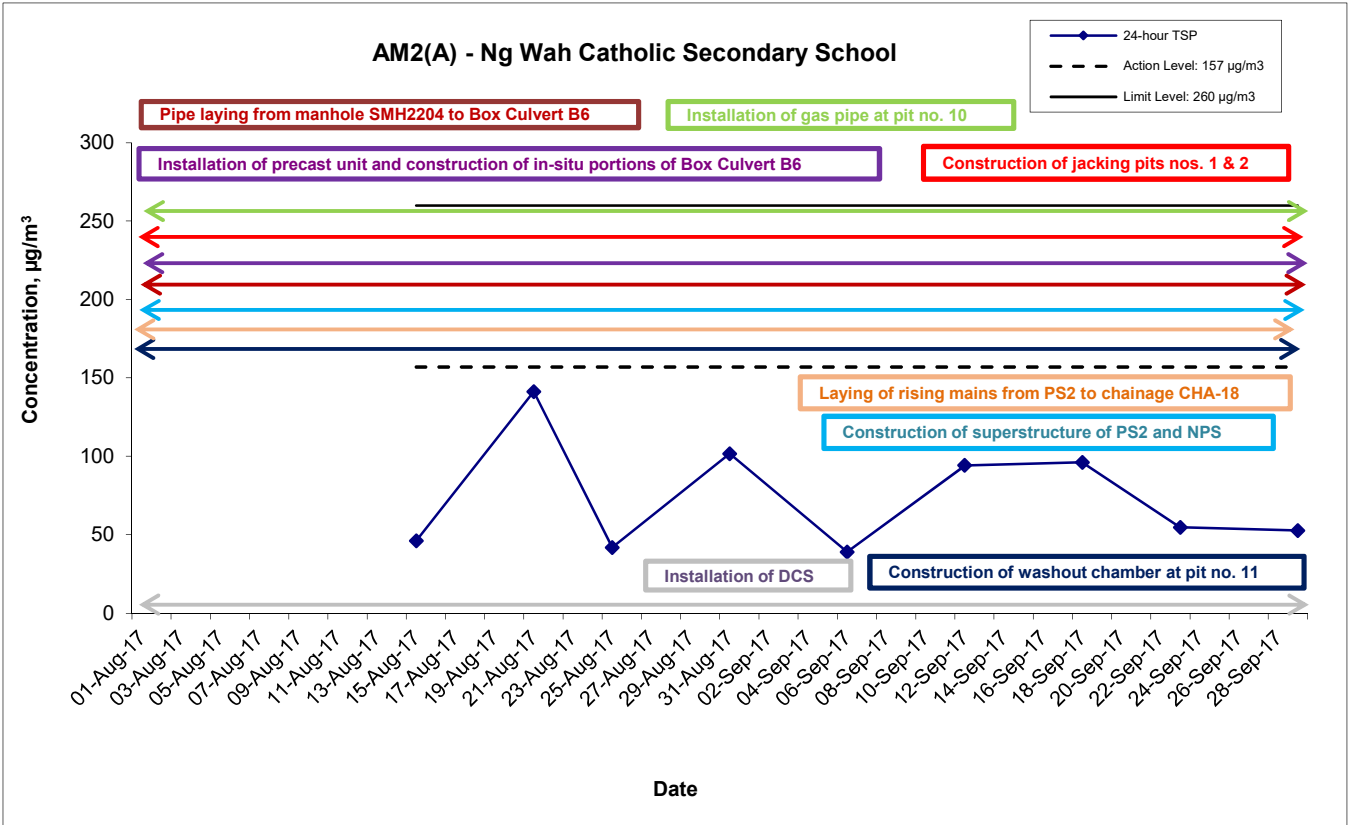
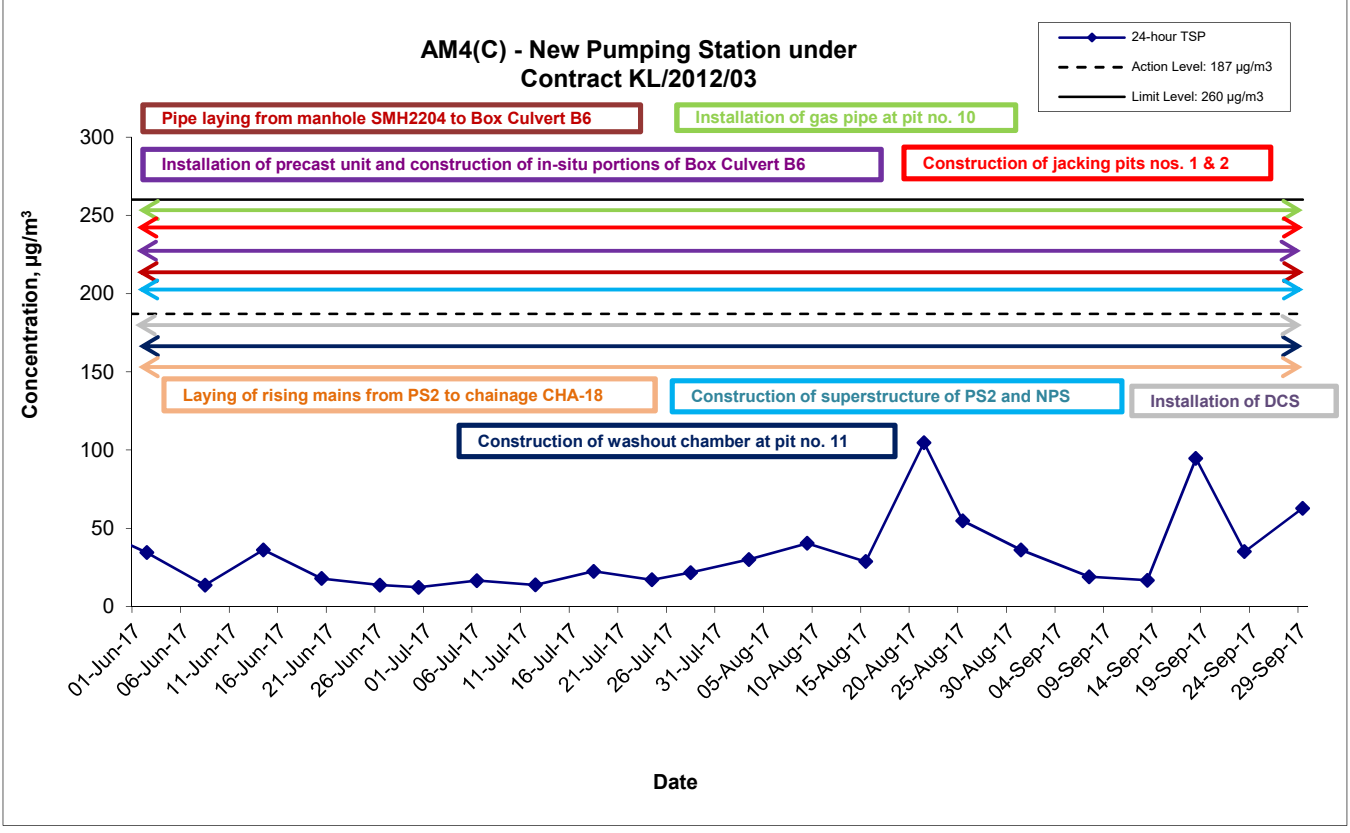
Title Contract No. KL/2012/03 Kai Tak Development –Stage 4 Infrastructure at Former North Apron Area Graphical Presentation of 24-hour TSP Monitoring Results	Scale	Project		
		N.T.S		No. MA13056
	Date	Sep 17		Appendix F

24-hr TSP Concentration Levels

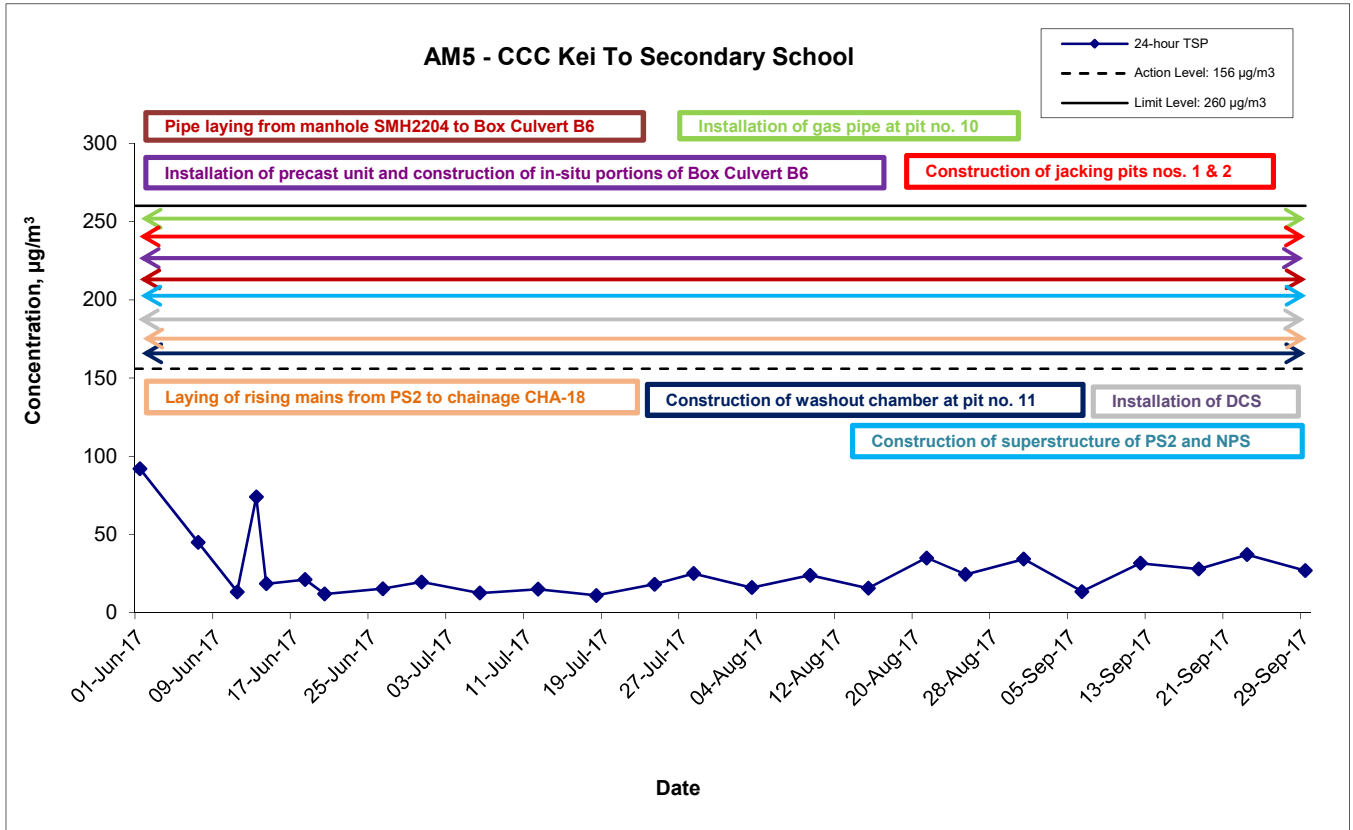
Title Contract No. KL/2012/03 Kai Tak Development –Stage 4 Infrastructure at Former North Apron Area Graphical Presentation of 24-hour TSP Monitoring Results	Scale N.T.S	Project No. MA13056	CINOTECH
	Date Sep 17	Appendix F

24-hr TSP Concentration Levels

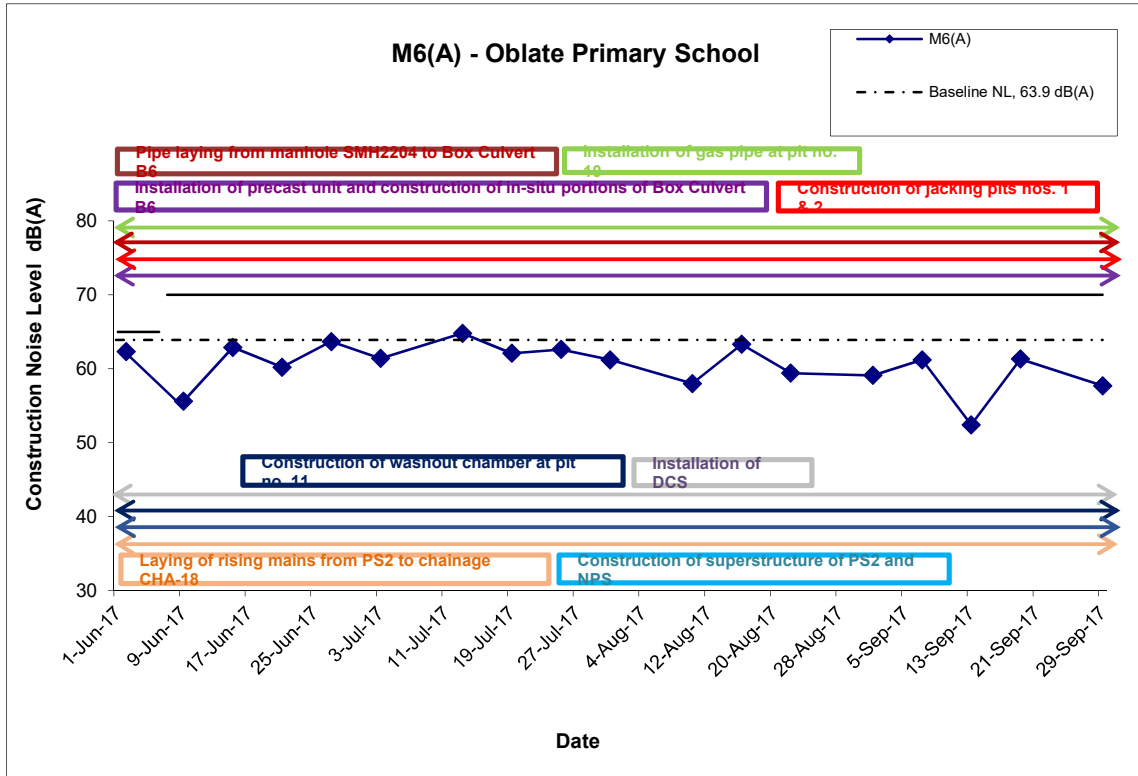
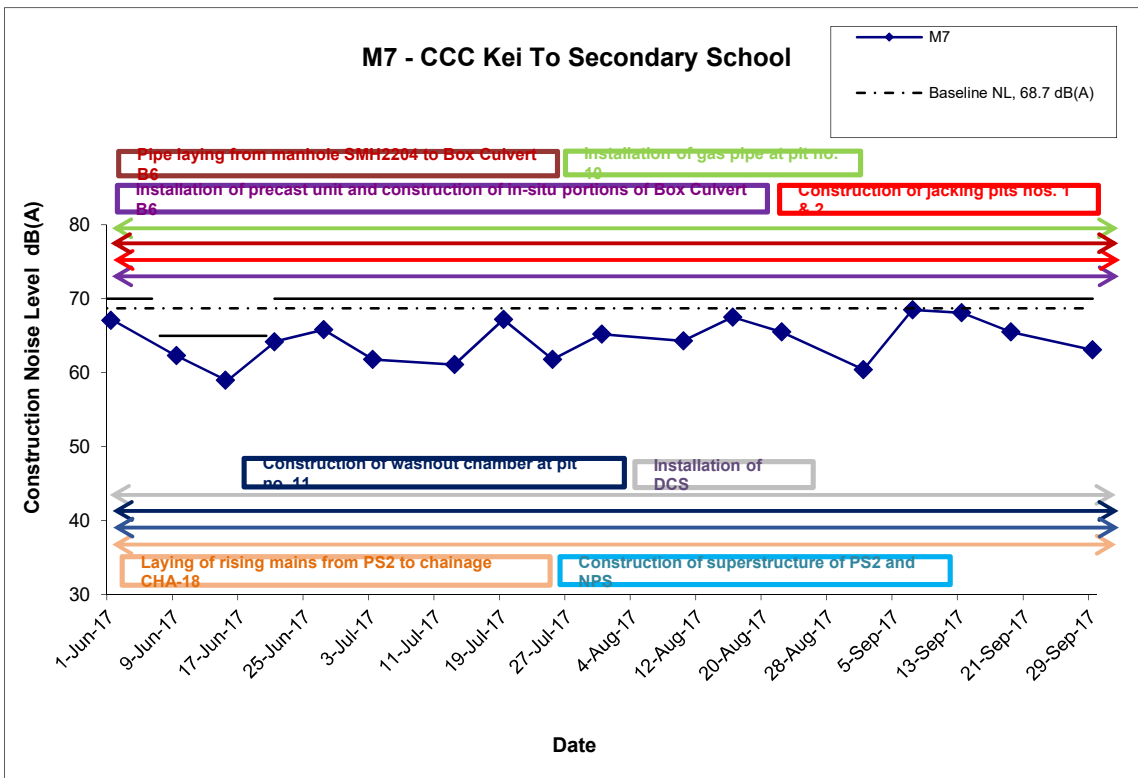
Title Contract No. KL/2012/03 Kai Tak Development –Stage 4 Infrastructure at Former North Apron Area Graphical Presentation of Construction Noise Monitoring Results	Scale	Project No.	CINOTECH
	Date	Appendix	
	N.T.S	VA13056	
	Sep 17	G

Noise Levels

Remarks: The construction noise levels in the Tables in Appendix G were adopted for plotting the graphs

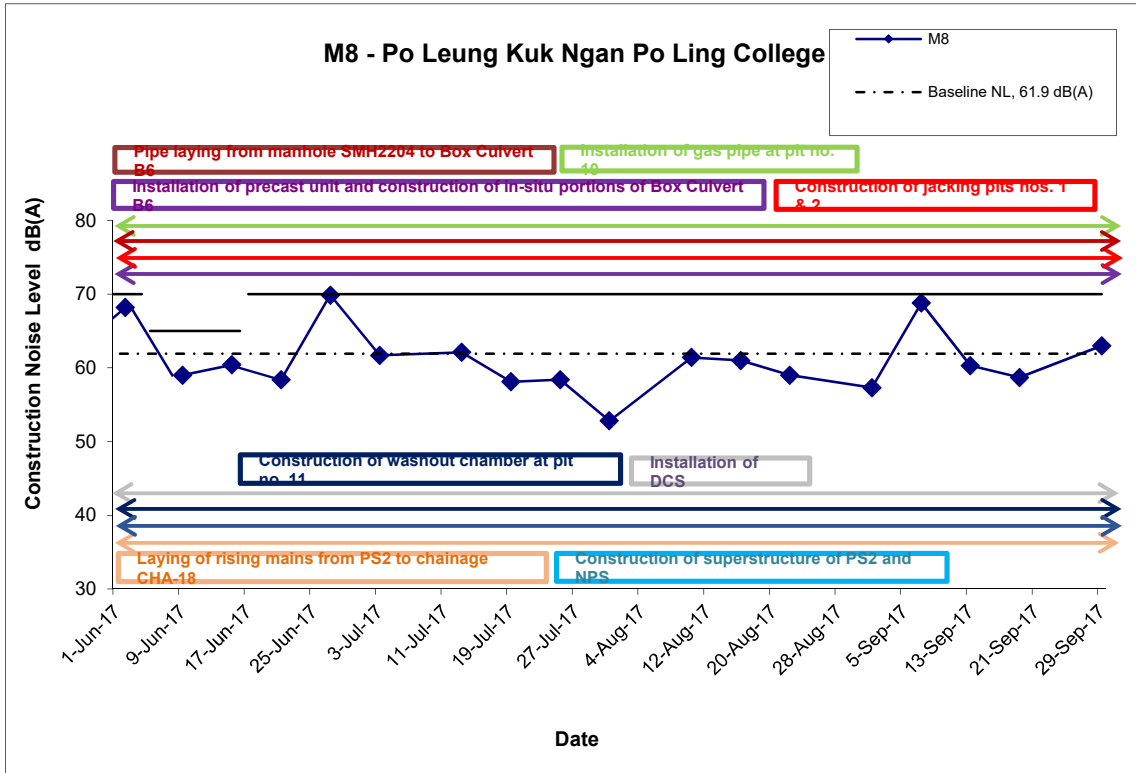
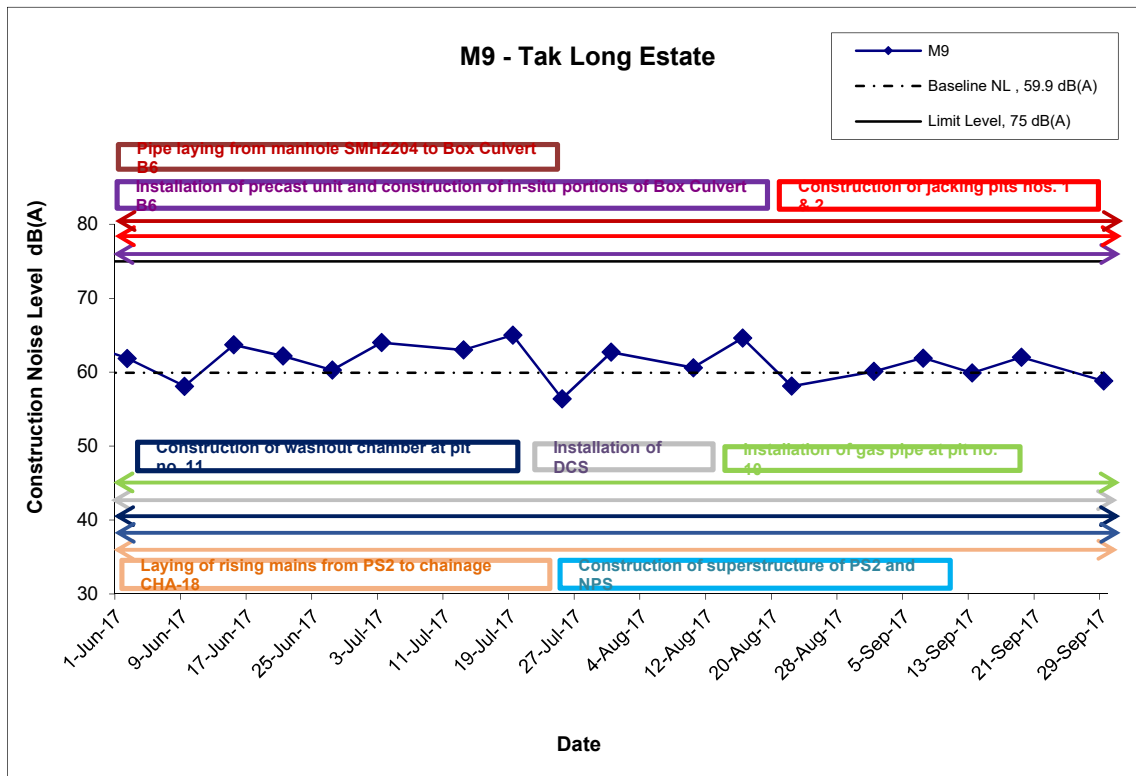
Title Contract No. KL/2012/03 Kai Tak Development –Stage 4 Infrastructure at Former North Apron Area Graphical Presentation of Construction Noise Monitoring Results	Scale N.T.S Date Sep 17	Project No. VA13056 Appendix G	
---	--------------------------------------	---	--

Noise Levels

Remarks: The construction noise levels in the Tables in Appendix G were adopted for plotting the graphs

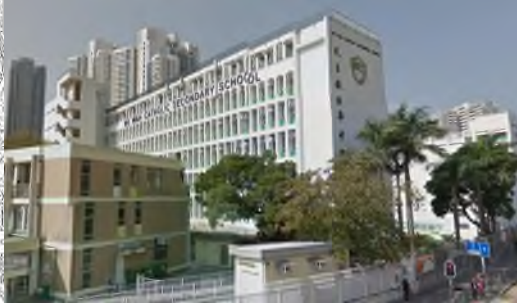
Anemometer Station from The Hong Kong Observatory

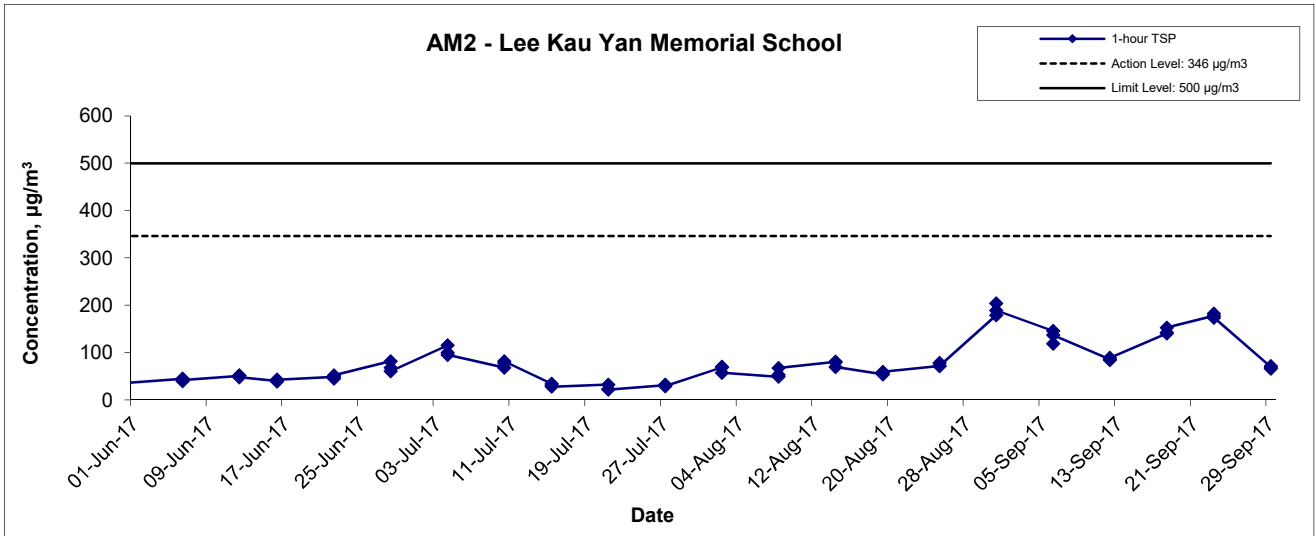
Title Contract No. KLN/2016/04 Environmental Monitoring Works for Contract No. KL/2015/02 Kai Tak Development –Stage 5A Infrastructure at Former North Apron Graphical Presentation of 1-hour TSP Monitoring Results	Scale N.T.S	Project No. MA16043	CINOTECH
	Date Sep 17	Appendix E

1-hr TSP Concentration Levels
