11th CONSOLIDATED MONTHLY EM&A REPORT

September 2017

EP No. : EP-337/2009 –
New Distributor Roads Serving the Planned Kai Tak
Development Area

Contract No. : KLN/2016/05 –
Independent Environmental Checker for
Contract No. KL/2015/02 Kai Tak Development –
Stage 5A Infrastructure at Former North Apron Area

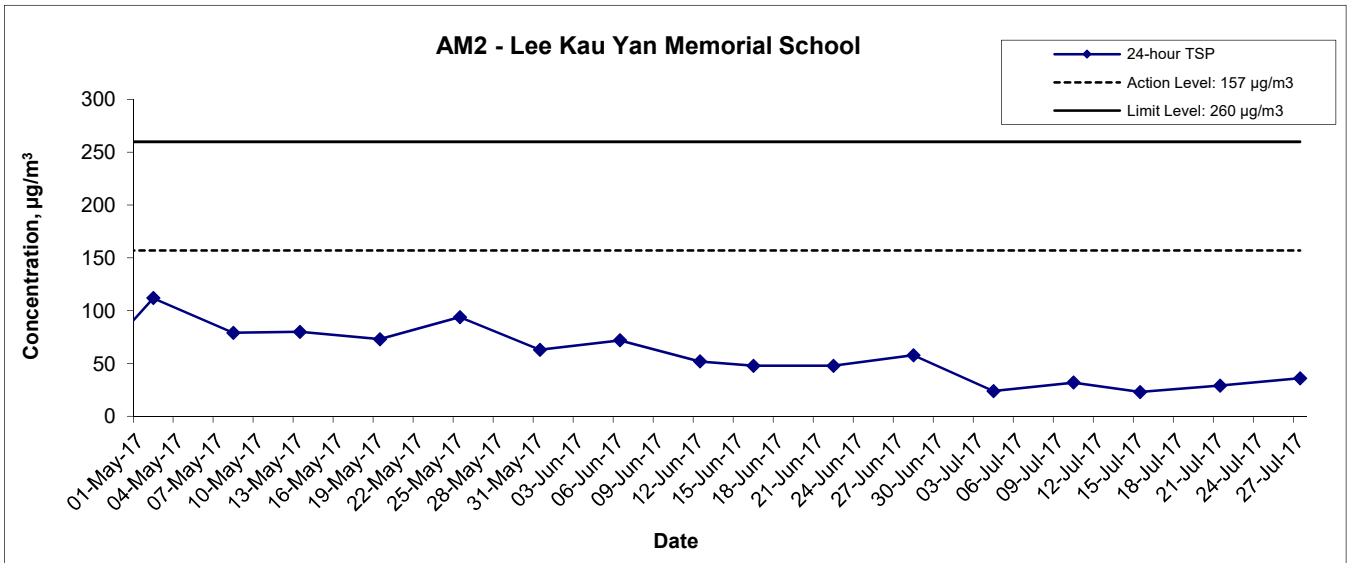
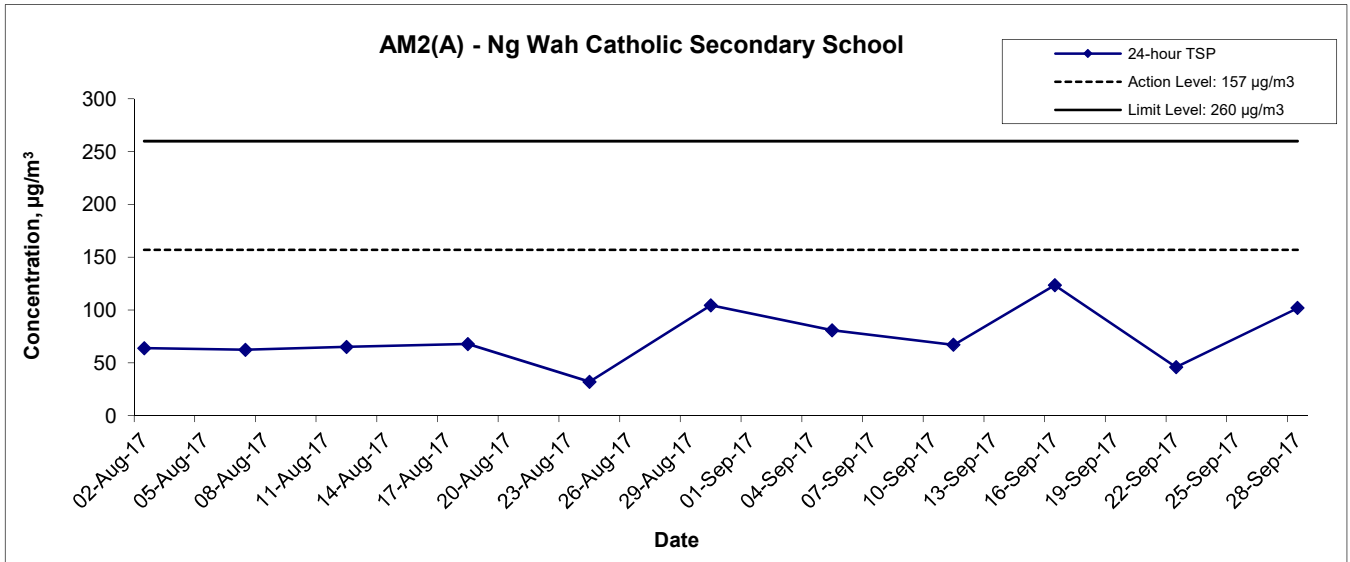
Title Contract No. KLN/2016/04 Environmental Monitoring Works for Contract No. KL/2015/02 Kai Tak Development –Stage 5A Infrastructure at Former North Apron Graphical Presentation of 24-hour TSP Monitoring Results	Scale N.T.S	Project No. MA16043	CINOTECH
	Date Sep 17	Appendix F

24-hr TSP Concentration Levels

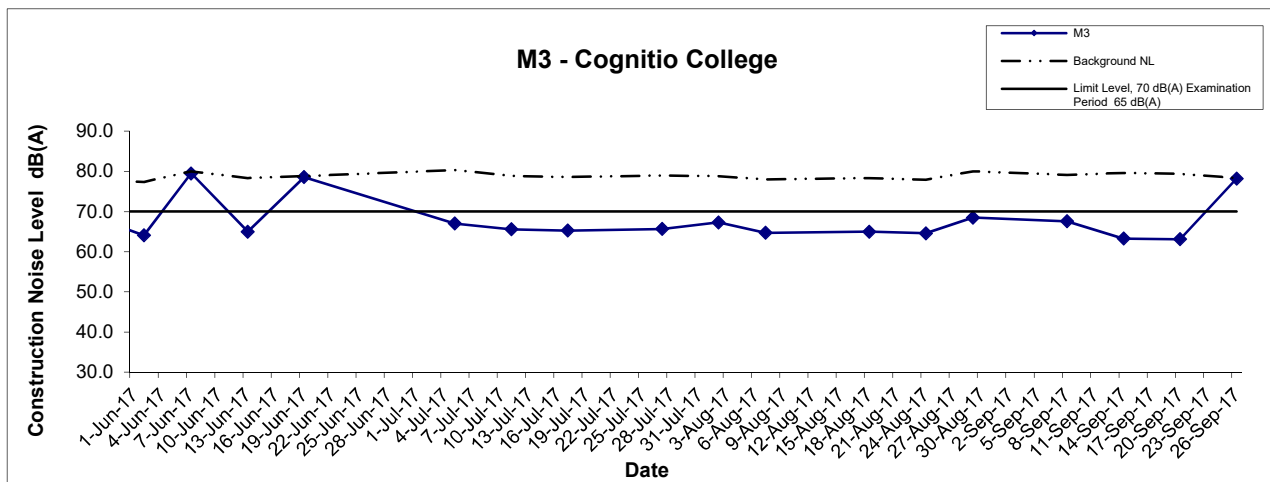
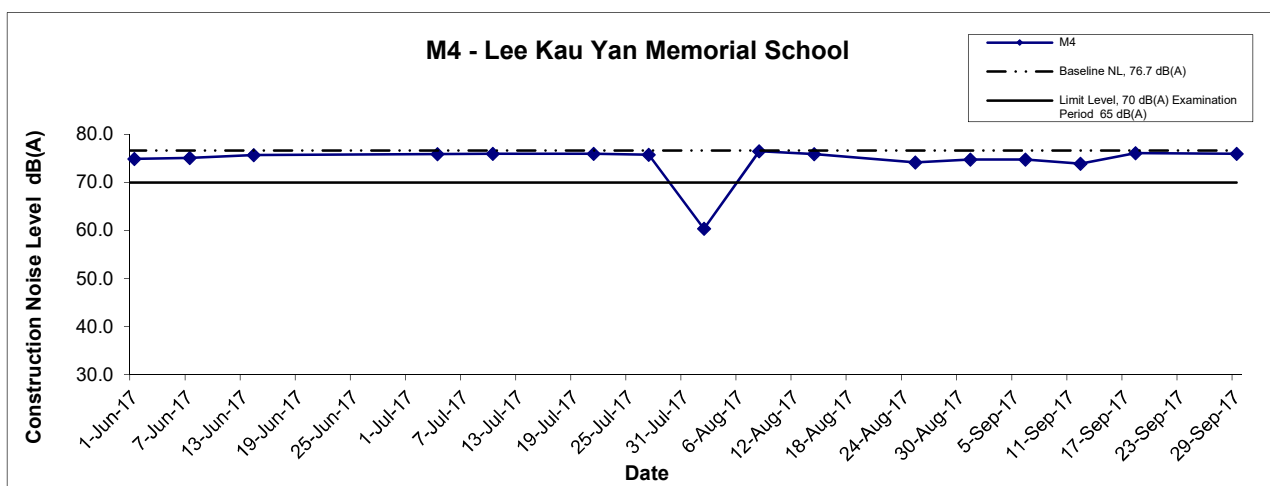
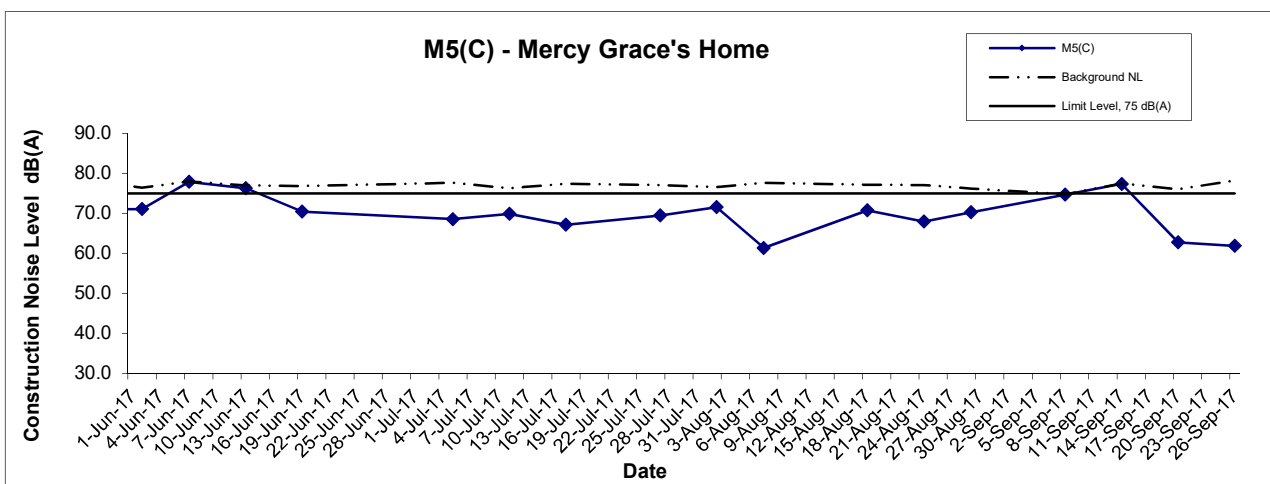
Noise Levels

Remarks: The construction noise levels in the Tables in Appendix G were adopted for plotting the graphs
