14th CONSOLIDATED MONTHLY EM&A REPORT

December 2017

EP No. : EP-337/2009 –
New Distributor Roads Serving the Planned Kai Tak
Development Area

Contract No. : KLN/2016/05 –
Independent Environmental Checker for
Contract No. KL/2015/02 Kai Tak Development –
Stage 5A Infrastructure at Former North Apron Area

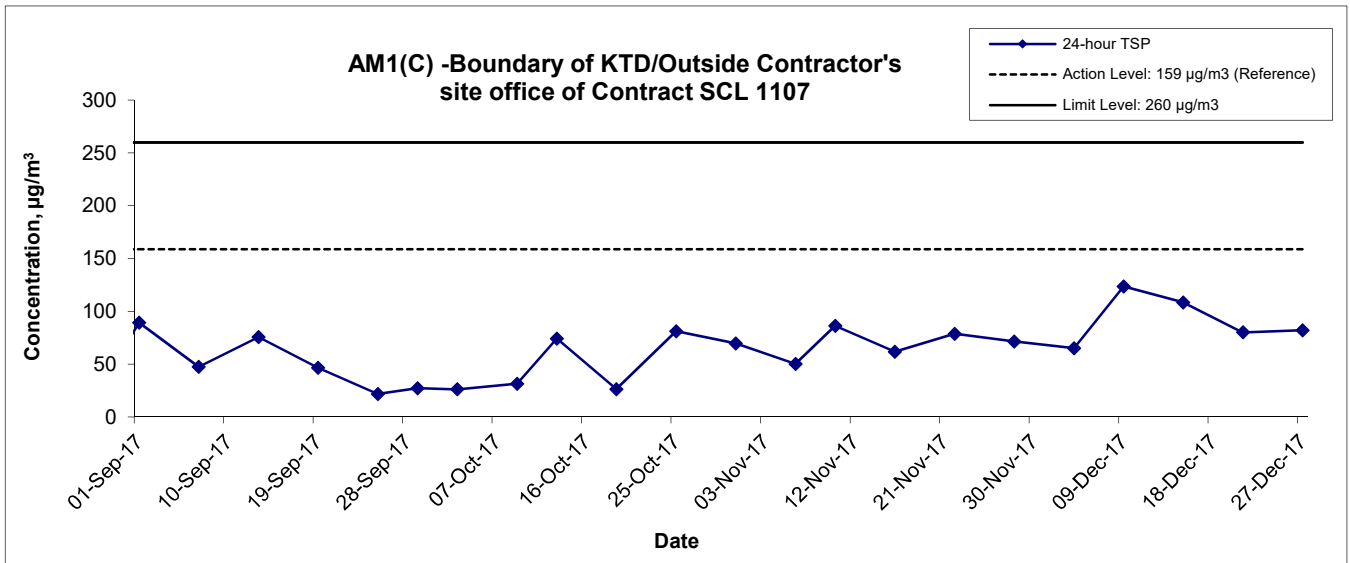
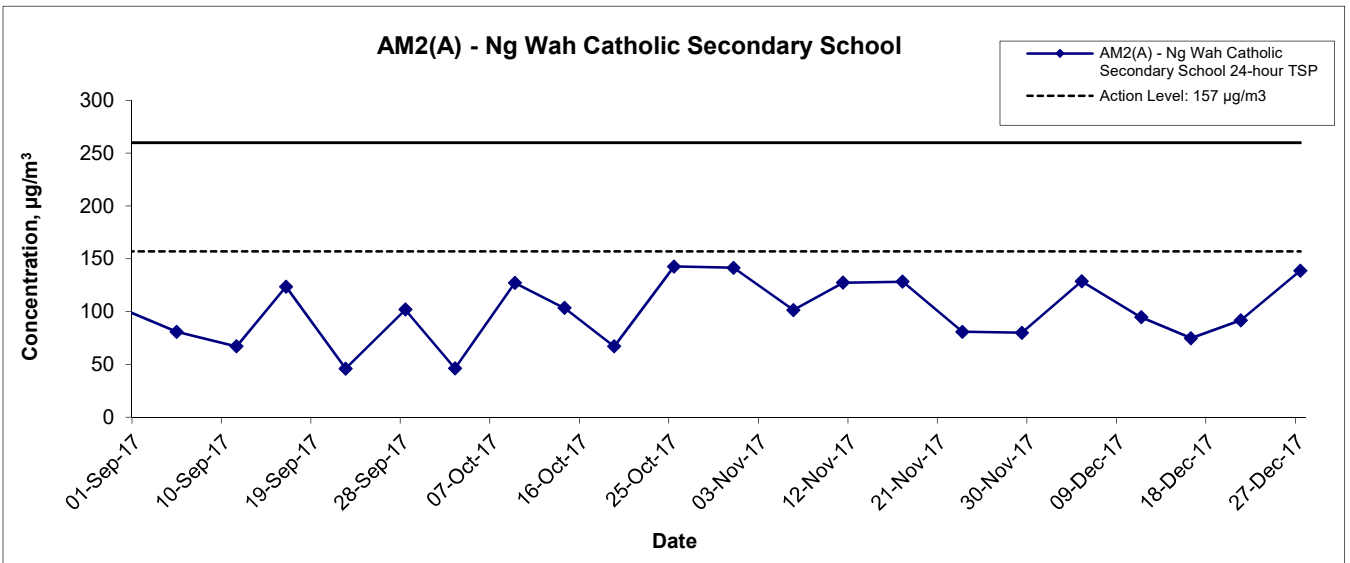
Title Contract No. KL/2012/02 Kai Tak Development - Stage 3A Infrastructure at Former North Apron Area Graphical Presentation of 24-hour TSP Monitoring Results	Scale N.T.S	Project No. MA13043	
	Date Dec 17	Appendix F

24-hr TSP Concentration Levels

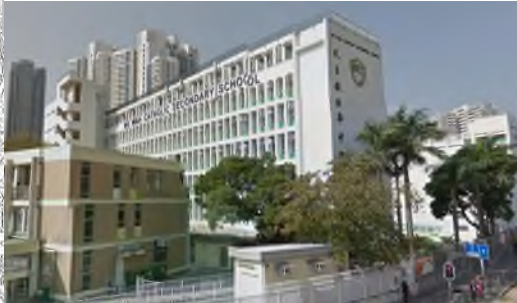
Anemometer Station from The Hong Kong Observatory

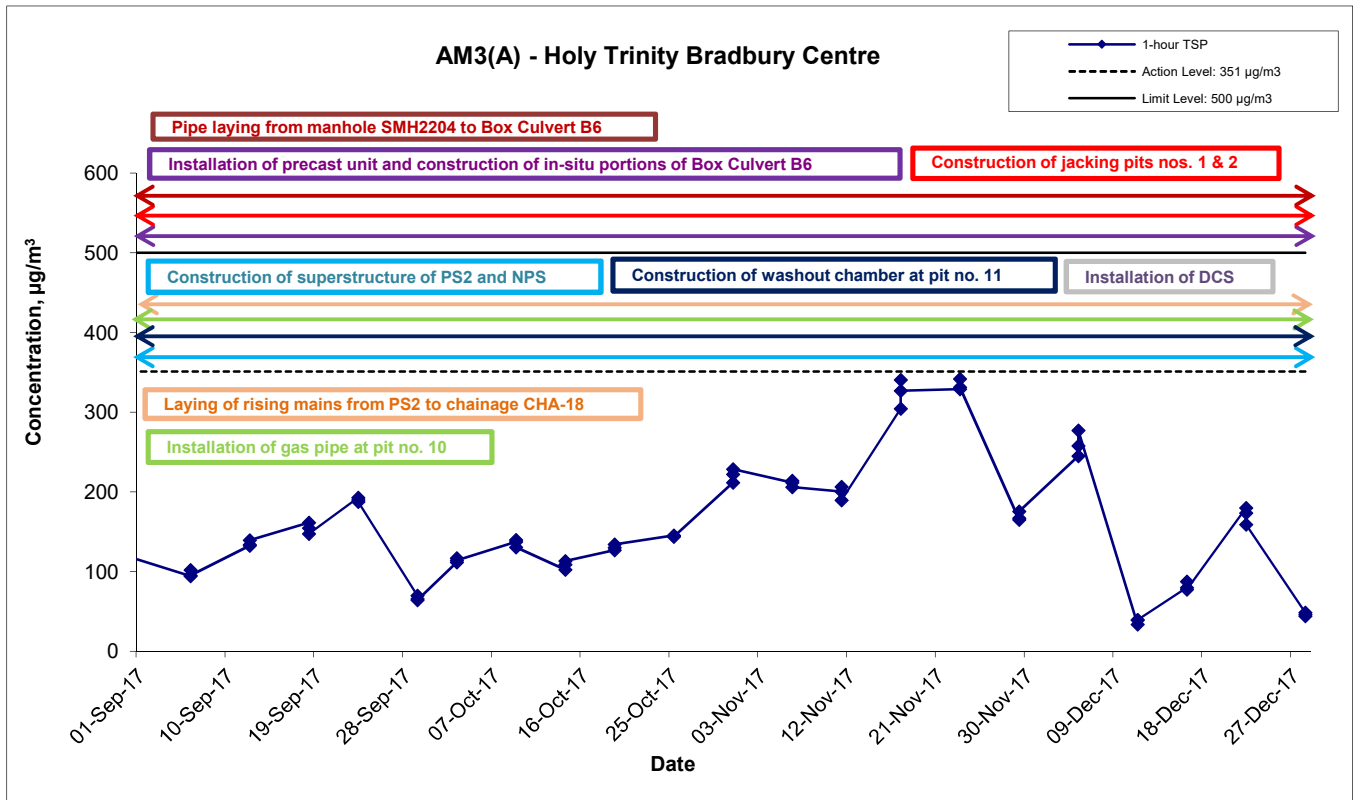
Title Contract No. KL/2012/03 Kai Tak Development –Stage 4 Infrastructure at Former North Apron Area Graphical Presentation of 1-hour TSP Monitoring Results	Scale N.T.S	Project No. MA13056	CINOTECH
	Date Dec 17	Appendix E

1-hr TSP Concentration Levels

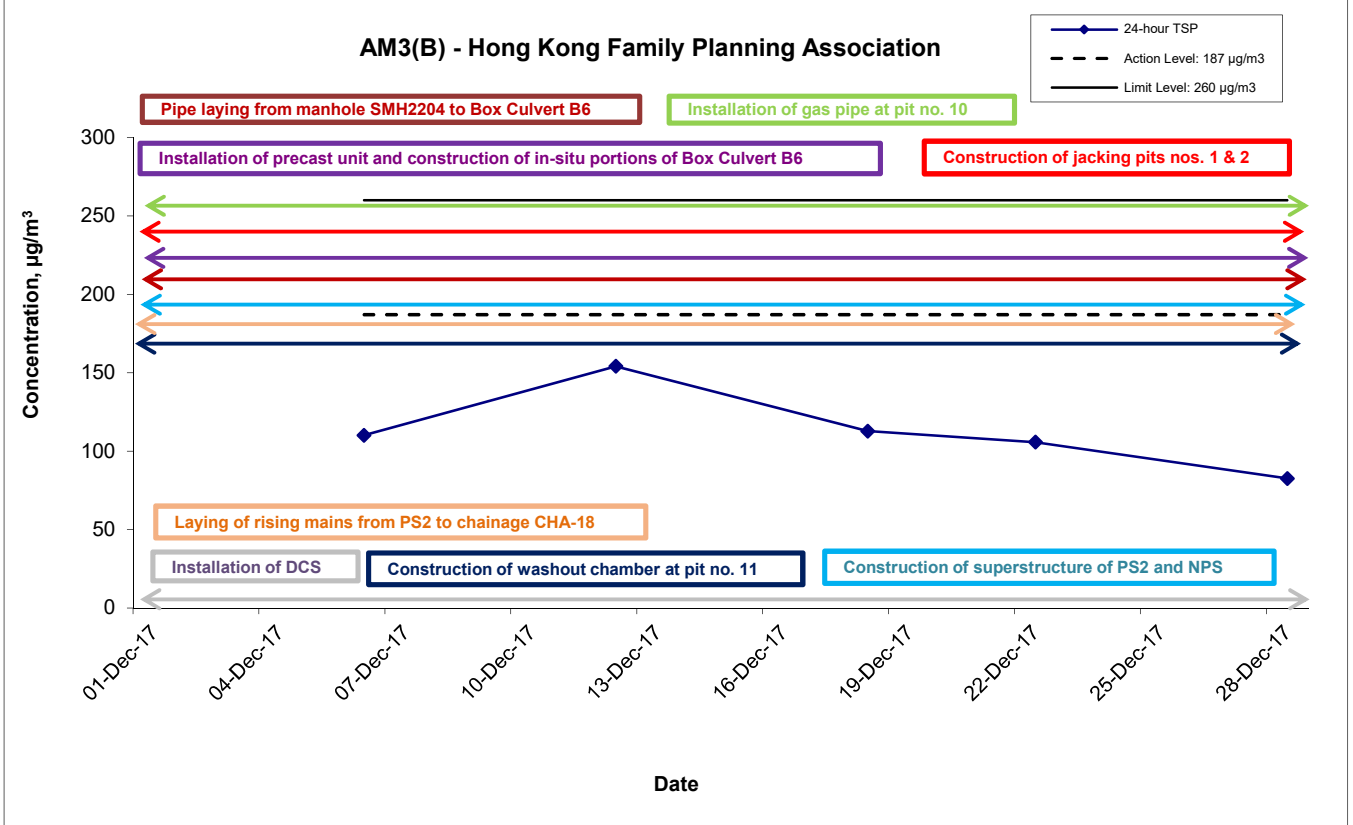
Title Kai Tak Development –Stage 4 Infrastructure at Former North Apron Area Graphical Presentation of 24-hour TSP Monitoring Results	Contract No. KL/2012/03	Scale N.T.S	Project No. MA13056	CINOTECH
		Date Dec 17	Appendix F

24-hr TSP Concentration Levels

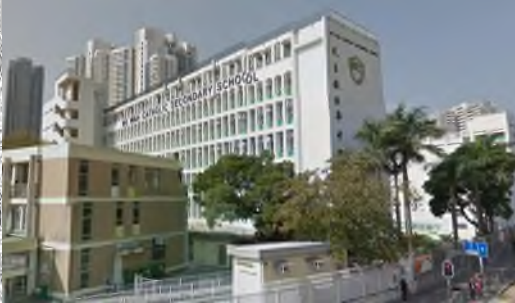
Anemometer Station from The Hong Kong Observatory

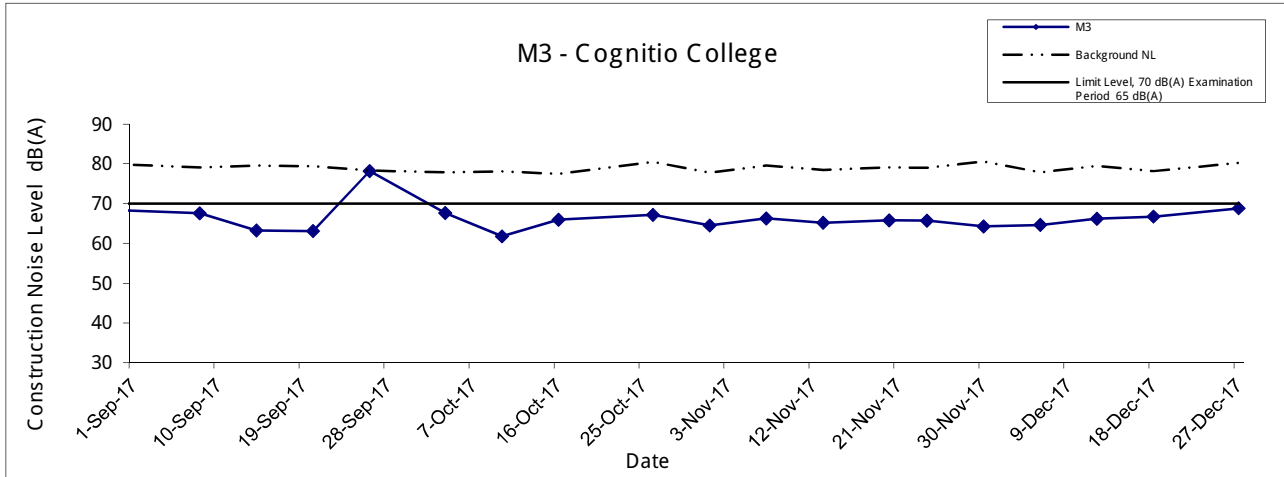
Noise Levels

Remarks: The construction noise levels in the Tables in Appendix G were adopted for plotting the graphs
