18th CONSOLIDATED MONTHLY EM&A REPORT

April 2018

EP No. : EP-337/2009 –
New Distributor Roads Serving the Planned Kai Tak
Development Area

Contract No. : KLN/2016/05 –
Independent Environmental Checker for
Contract No. KL/2015/02 Kai Tak Development –
Stage 5A Infrastructure at Former North Apron Area

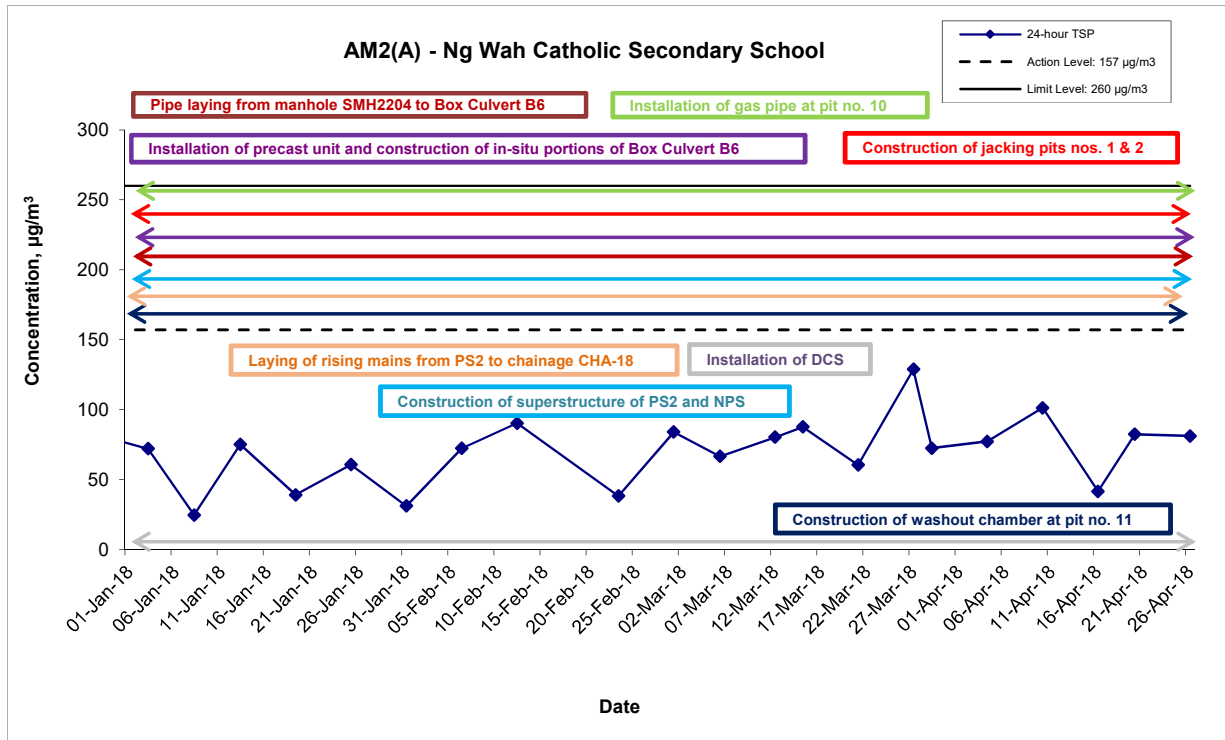
Title Contract No. KL/2012/03 Kai Tak Development –Stage 4 Infrastructure at Former North Apron Area Graphical Presentation of 24-hour TSP Monitoring Results	Scale N.T.S	Project No. MA13056	CINOTECH
	Date Apr 18	Appendix F

24-hr TSP Concentration Levels
