MONTHLY EM&A REPORT

May 2018

Contract No. : KLN/2015/07

Contract Name : Environmental Monitoring Works for
Contract KL/2014/03 – Kai Tak Development
– Stage 3 Infrastructure Works for Developments
at the Southern Part of the Former Runway

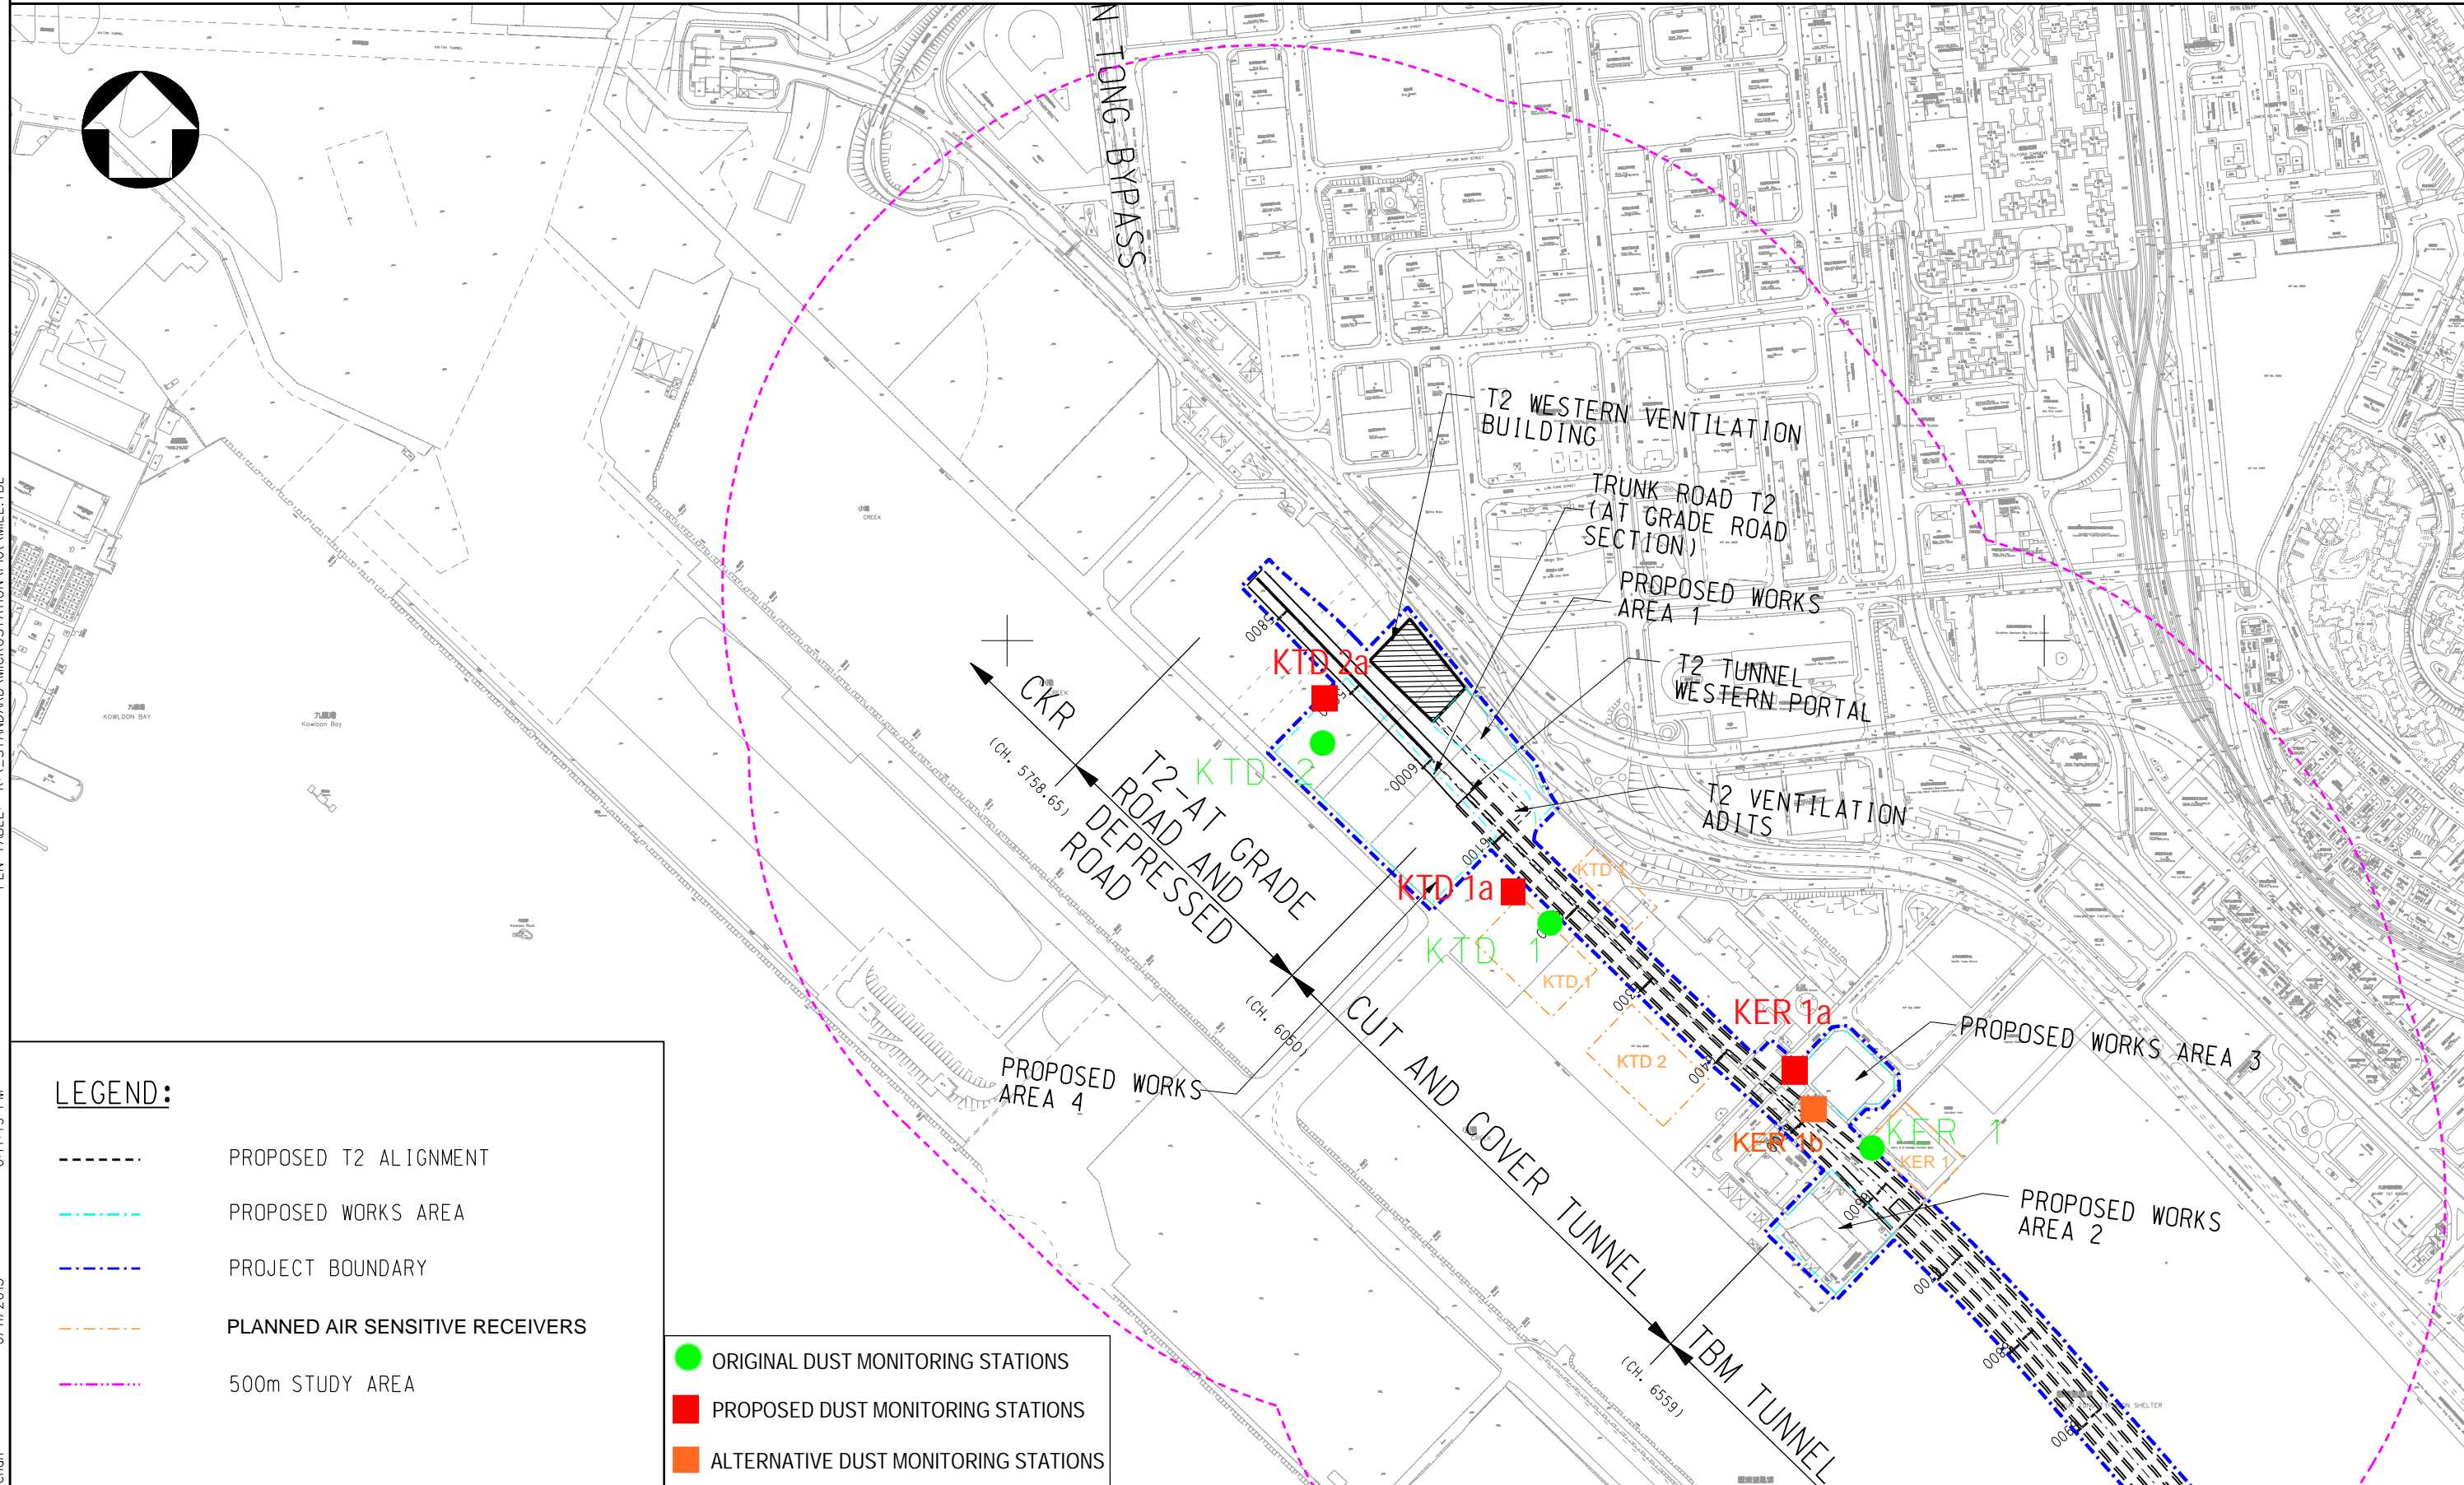
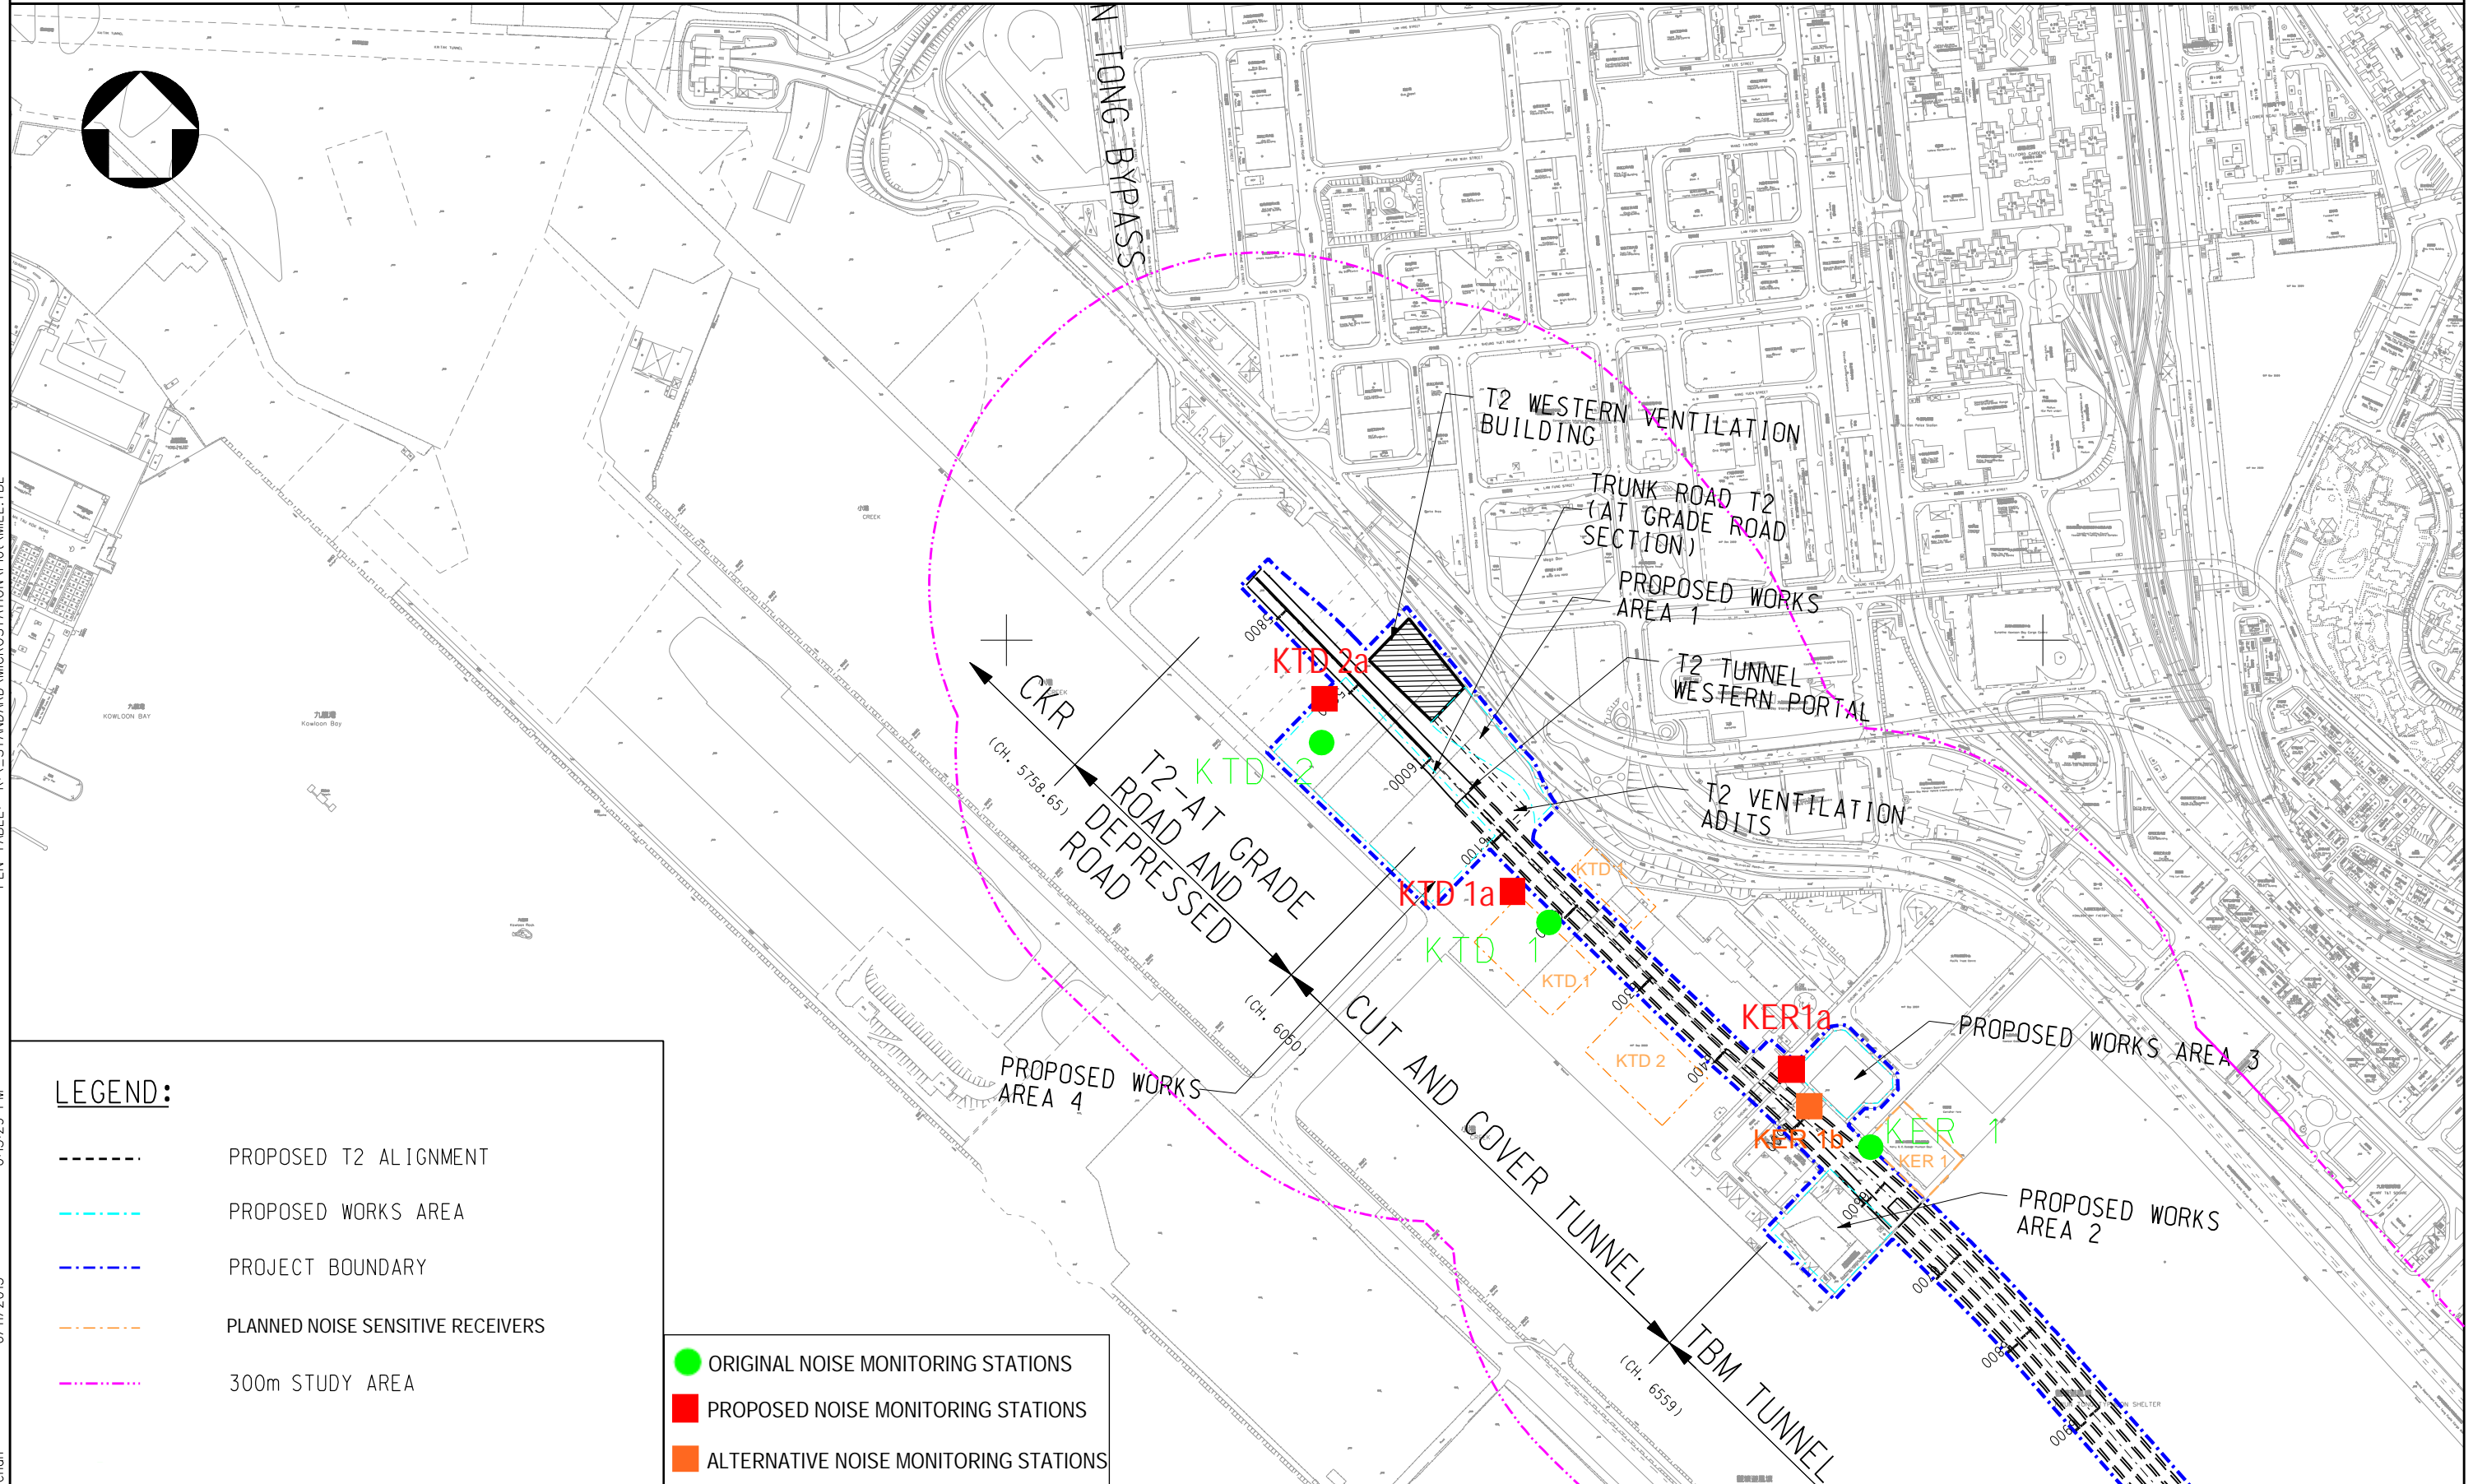
Figure 2

Air and Noise Monitoring Locations

Drawing title IDENTIFIED DUST MONITORING STATIONS AT SOUTH APRON OF FORMER KAI TAK AIRPORT	Original Size A3	Scale 1 : 6000	Date 30/01/2012
Rev. Description Date		© Copyright reserved		Drawing No. FIGURE 2.1a(revised) Rev. --

2.5.2 According to the approved alternative baseline air quality and noise monitoring locations (EPD reference: EP2/K19/A/21 Pt.5), the original monitoring locations (KTD1, KTD2 and KER1) are proposed to be replaced by alternative monitoring locations (KTD1a, KTD2a and KER1b) for air quality monitoring, they are summarized in **Table 2.2** and shown in **Figure 2**.
