19th CONSOLIDATED MONTHLY EM&A REPORT

May 2018

EP No. : EP-337/2009 –
New Distributor Roads Serving the Planned Kai Tak
Development Area

Contract No. : KLN/2016/05 –
Independent Environmental Checker for
Contract No. KL/2015/02 Kai Tak Development –
Stage 5A Infrastructure at Former North Apron Area

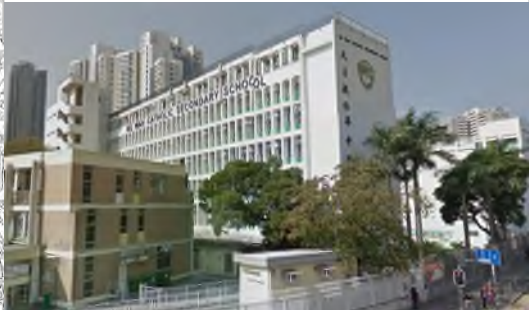
Anemometer Station from The Hong Kong Observatory

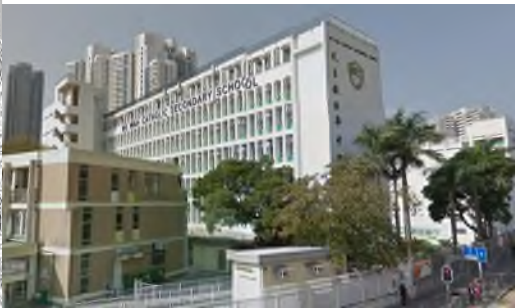
Anemometer Station from The Hong
Kong Observatory

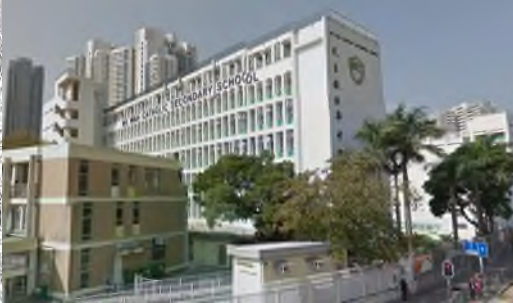
Anemometer Station from The Hong Kong Observatory
