## 20<sup>th</sup> CONSOLIDATED MONTHLY EM&A REPORT

June 2018

**EP No.** : EP-337/2009 –  
New Distributor Roads Serving the Planned Kai Tak  
Development Area

**Contract No.** : KLN/2016/05 –  
Independent Environmental Checker for  
Contract No. KL/2015/02 Kai Tak Development –  
Stage 5A Infrastructure at Former North Apron Area

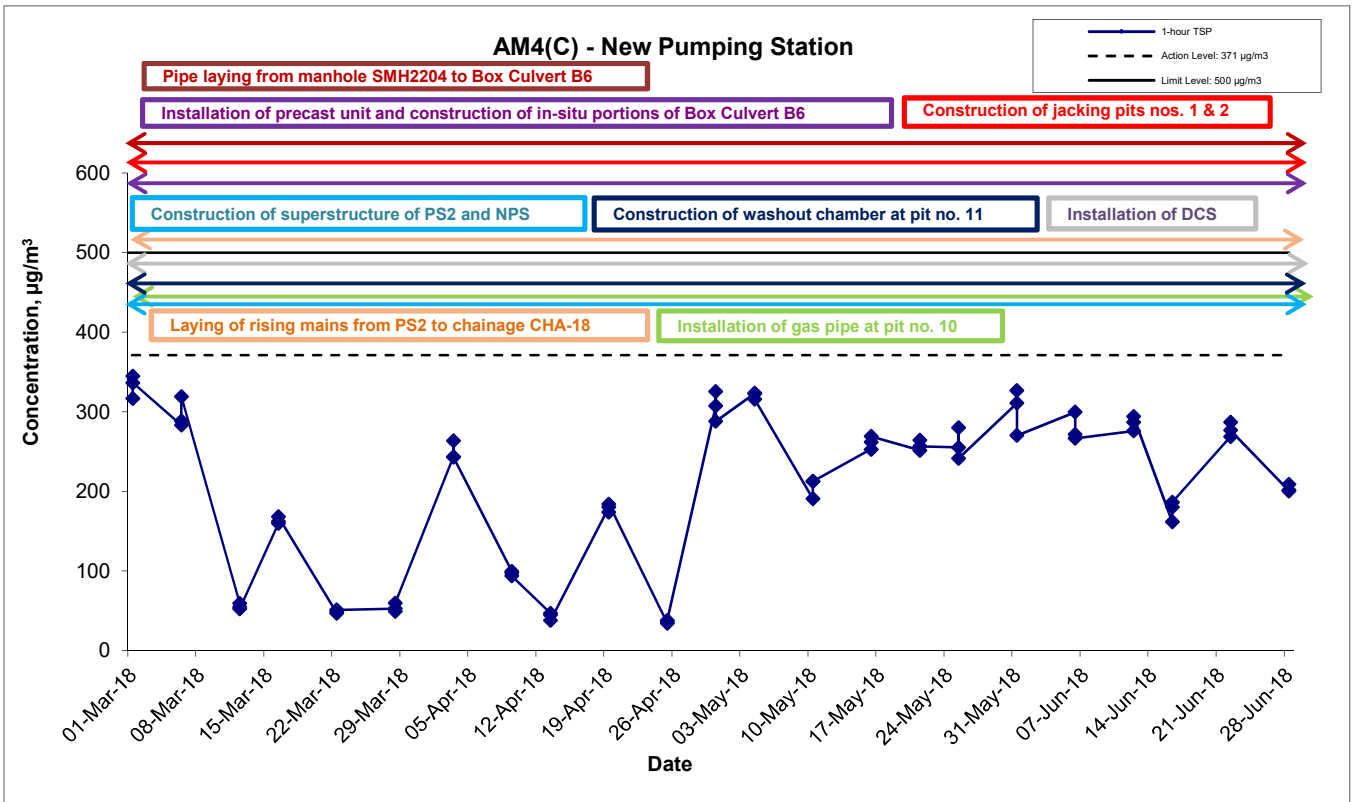
Title	Contract No. KL/2012/03	Scale	Project No.	CINOTECH
	Kai Tak Development –Stage 4 Infrastructure at Former North Apron Area	N.T.S	MA13056	
	Graphical Presentation of 1-hour TSP Monitoring Results	Date	Appendix	
		Jun 18	E
