## 7<sup>th</sup> CONSOLIDATED QUARTERLY EM&A REPORT

July 2018 – September 2018

**EP No.** : EP-337/2009 –  
New Distributor Roads Serving the Planned Kai Tak  
Development Area

**Contract No.** : KLN/2016/05 –  
Independent Environmental Checker for  
Contract No. KL/2015/02 Kai Tak Development –  
Stage 5A Infrastructure at Former North Apron Area

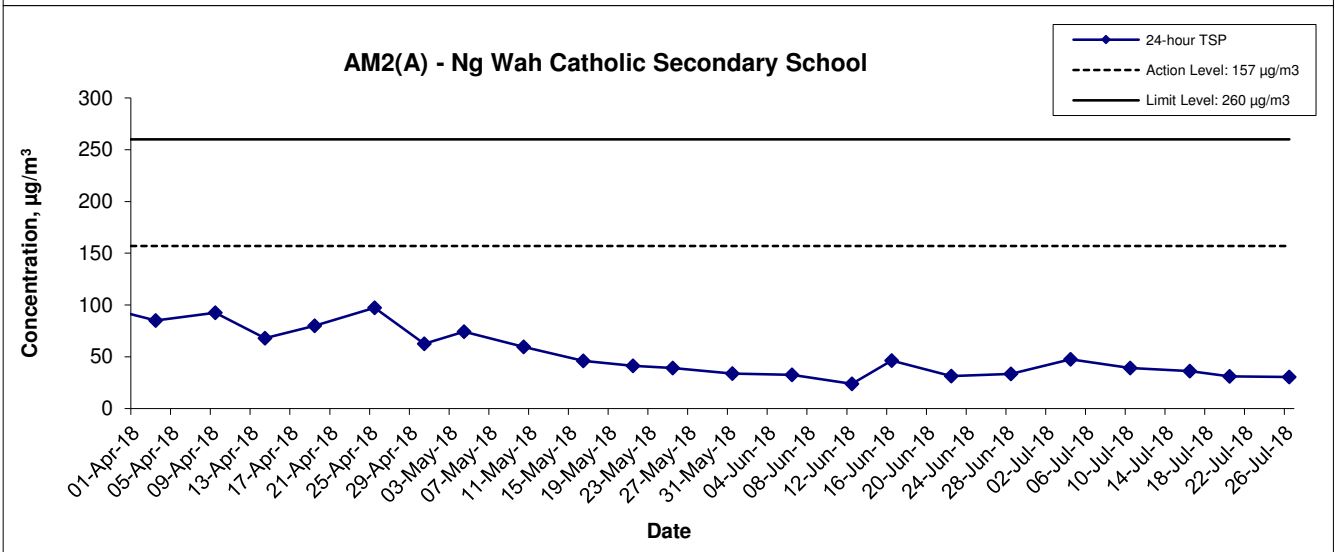
## 24-hr TSP Concentration Levels

Title Contract No. KL/2012/02 Kai Tak Development - Stage 3A Infrastructure at Former North Apron Area  Graphical Presentation of 24-hour TSP Monitoring Results	Scale	N.T.S	Project No.	MA13043	CINOTECH
	Date	Jul 18	Appendix	C

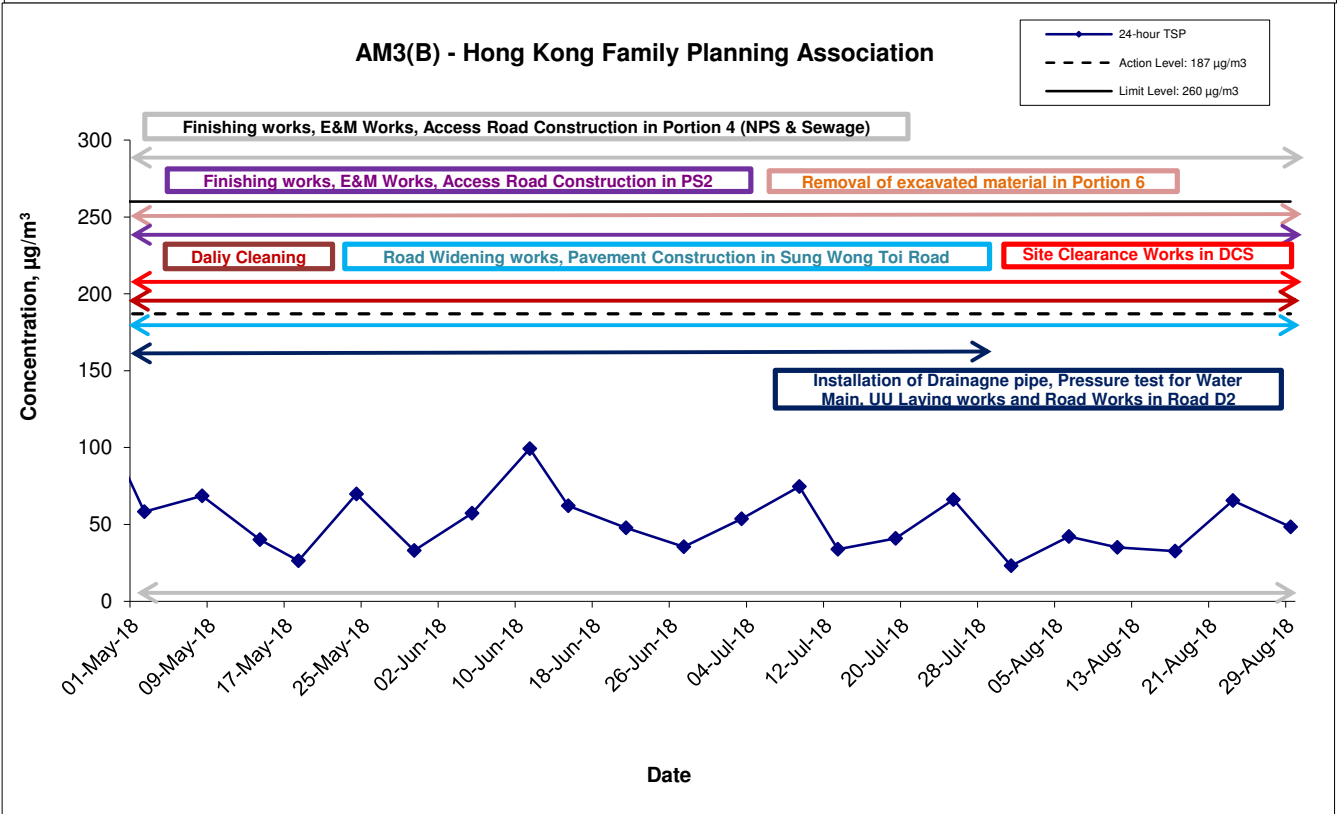
### 24-hr TSP Concentration Levels

Title Contract No. KL/2012/03 Kai Tak Development –Stage 4 Infrastructure at Former North Apron Area  Graphical Presentation of 24-hour TSP Monitoring Results	Scale N.T.S	Project No. MA13056	CINOTECH
	Date Aug 18	Appendix C

Title Contract No. KL/2012/03 Kai Tak Development –Stage 4 Infrastructure at Former North Apron Area Graphical Presentation of 24-hour TSP Monitoring Results	Scale N.T.S	Project No. MA13056	CINOTECH
	Date Aug 18	Appendix C

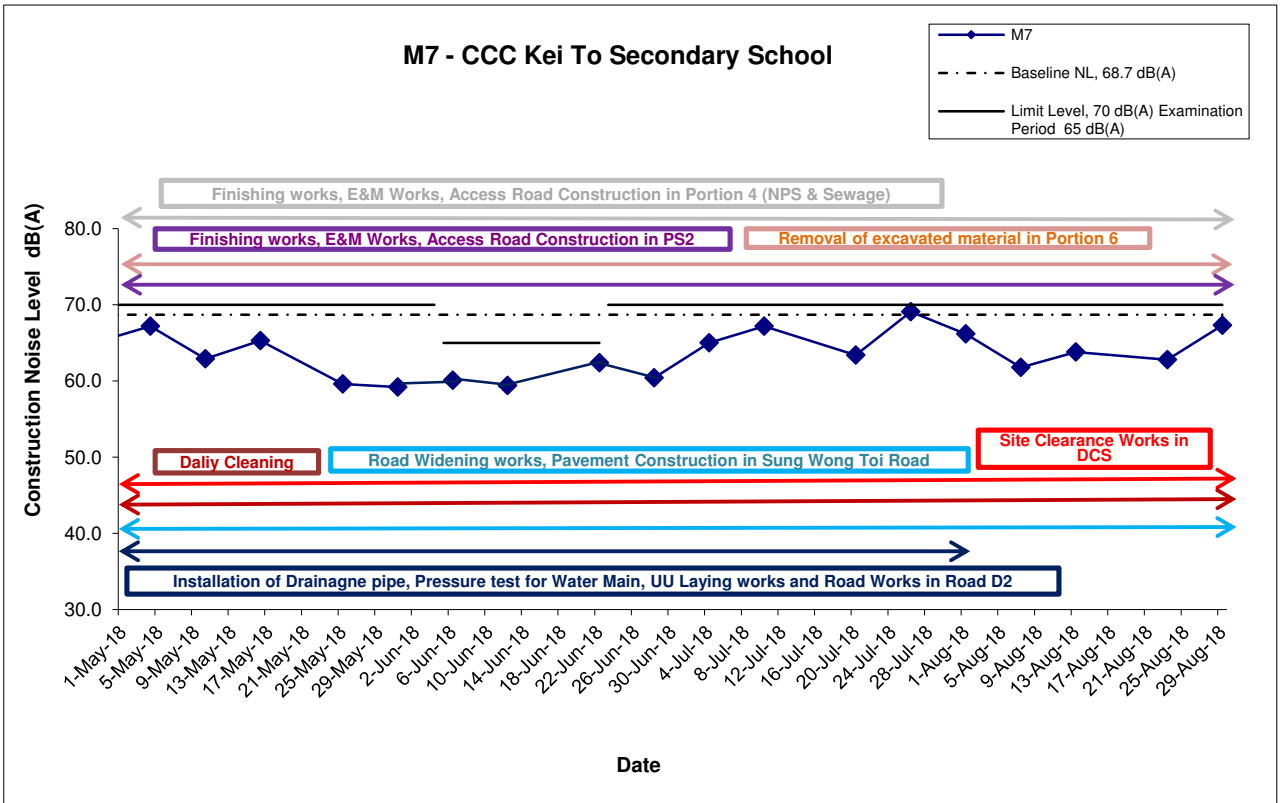
## Noise Levels

Remarks: The construction noise levels in the Tables in Appendix G were adopted for plotting the graphs

<p>Title</p> <p style="text-align: center;">Contract No. KL/2012/03 Kai Tak Development –Stage 4 Infrastructure at Former North Apron Area</p> <p style="text-align: center;">Graphical Presentation of Construction Noise Monitoring Results</p>	<p>Scale</p> <p style="text-align: center;">N.T.S</p> <p>Date</p> <p style="text-align: center;">Aug 18</p>	<p>Project No.</p> <p style="text-align: center;">MA13056</p> <p>Appendix</p> <p style="text-align: center;">D</p>	
---	---	--	--

Title Contract No. KL/2012/03 Kai Tak Development –Stage 4 Infrastructure at Former North Apron Area Graphical Presentation of Construction Noise Monitoring Results	Scale N.T.S Date Aug 18	Project No. MA13056 Appendix D	
---	----------------------------------	---	--
