## 8<sup>th</sup> CONSOLIDATED QUARTERLY EM&A REPORT

October 2018 – December 2018

**EP No.** : EP-337/2009 –  
New Distributor Roads Serving the Planned Kai Tak  
Development Area

**Contract No.** : KLN/2016/05 –  
Independent Environmental Checker for  
Contract No. KL/2015/02 Kai Tak Development –  
Stage 5A Infrastructure at Former North Apron Area

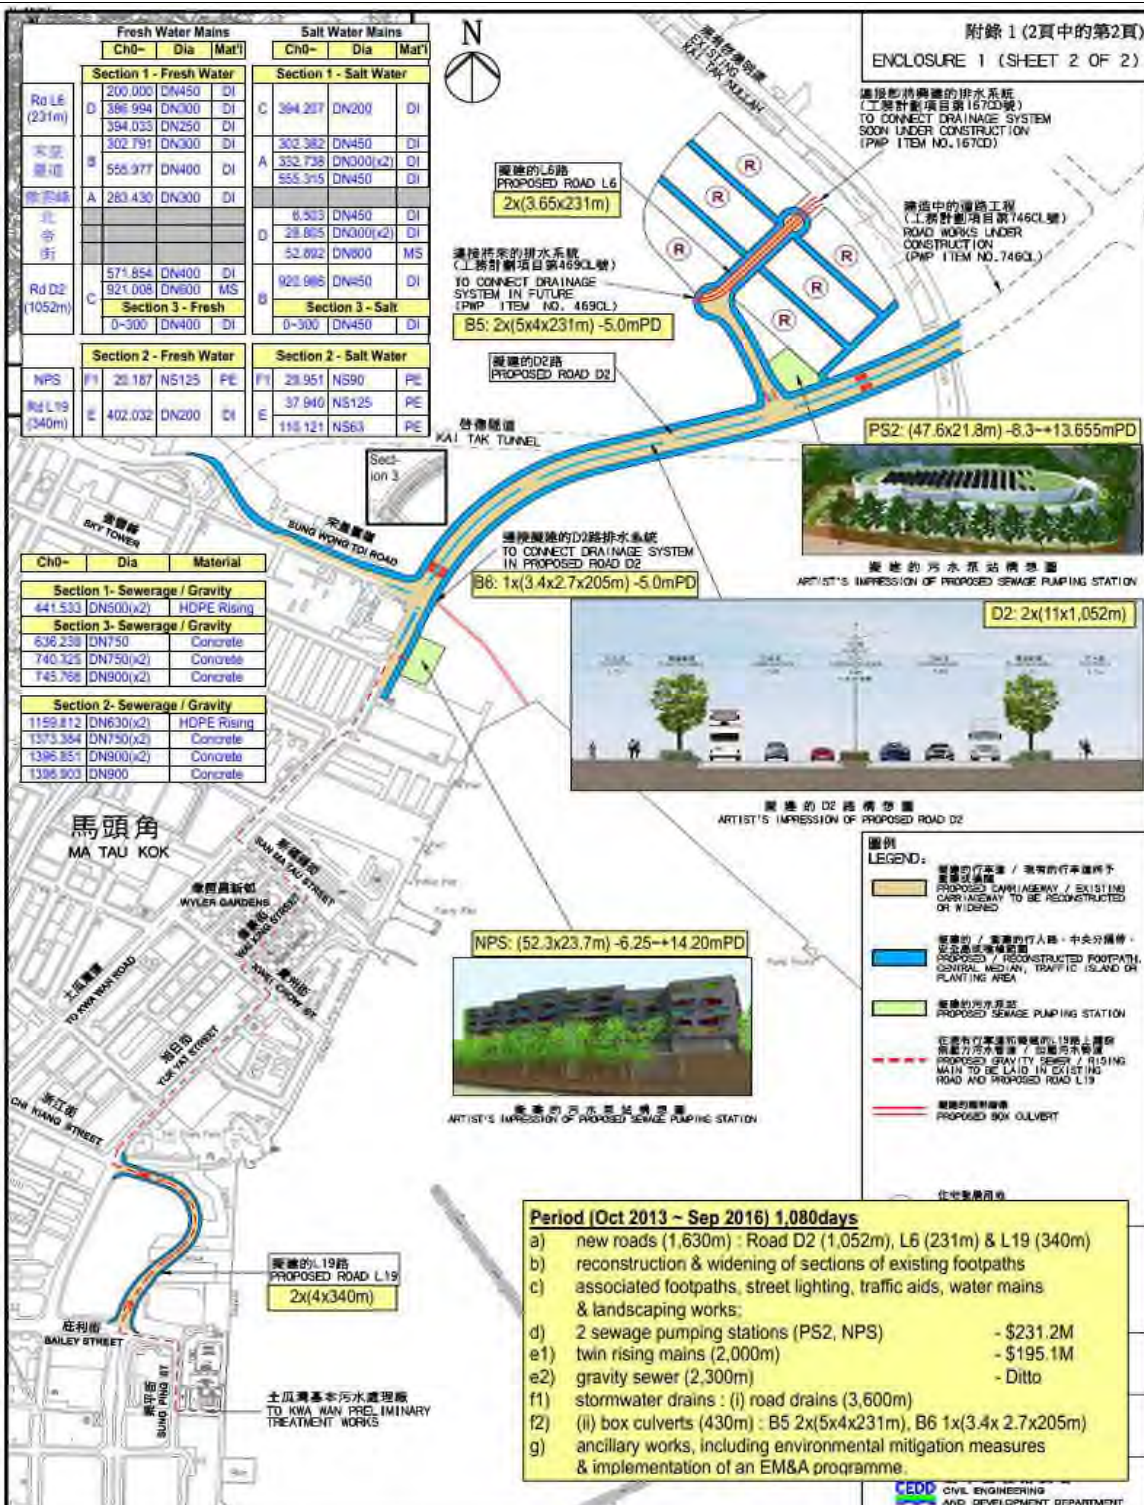
Title	KL/2012/03 - Kai Tak Development - Stage 4 Infrastructure at Former North Apron Area	Scale	N.T.S	Project No.	MA13056
	Site Layout Plan	Date	Sep-13	Figure	1

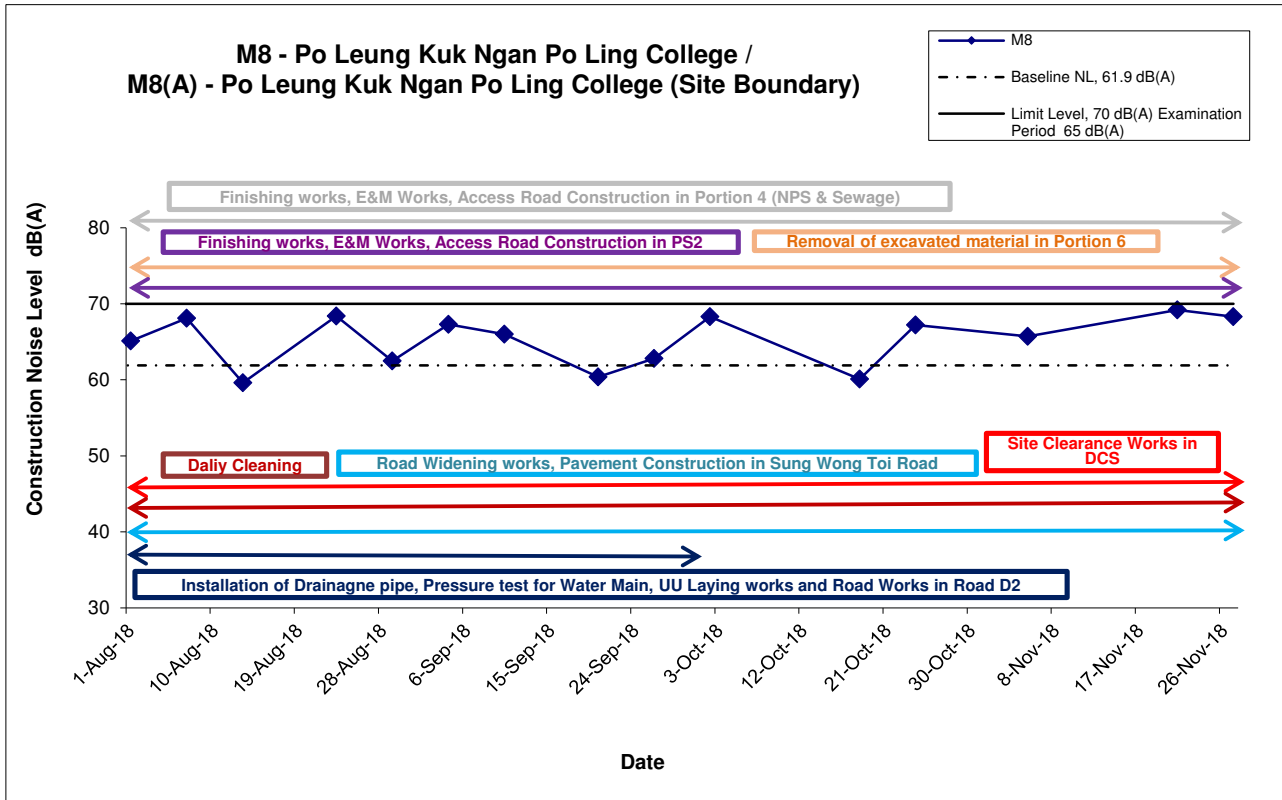
Remarks: The construction noise levels in the Tables in Appendix G were adopted for plotting the graphs

Title Contract No. KL/2012/03 Kai Tak Development –Stage 4 Infrastructure at Former North Apron Area Graphical Presentation of Construction Noise Monitoring Results	Scale N.T.S Date Nov 18	Project No. MA13056 Appendix D	
---	----------------------------------	---	--
