**EP-344/2009 – New Sewage Pumping Stations  
Serving KTD**  
**EP-337/2009 – New Distributor Roads Serving the  
Planned KTD**

**Contract No. KL/2012/03  
Kai Tak Development –Stage 4 Infrastructure at  
Former North Apron Area**

Monthly EM&A Report

March 2019

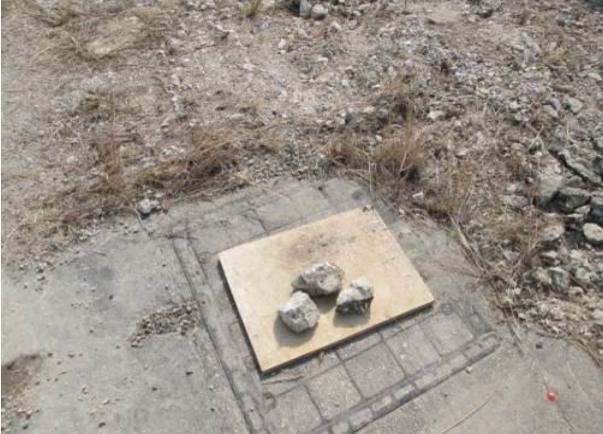
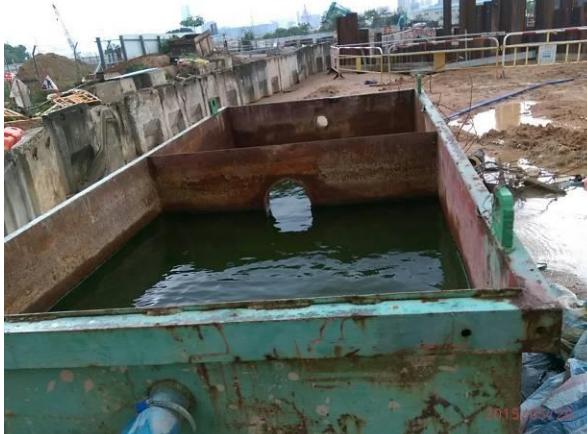
To prevent any surface runoff discharge into any stream course.	Follow-up measure(s) after identification of wastewater discharges from site.

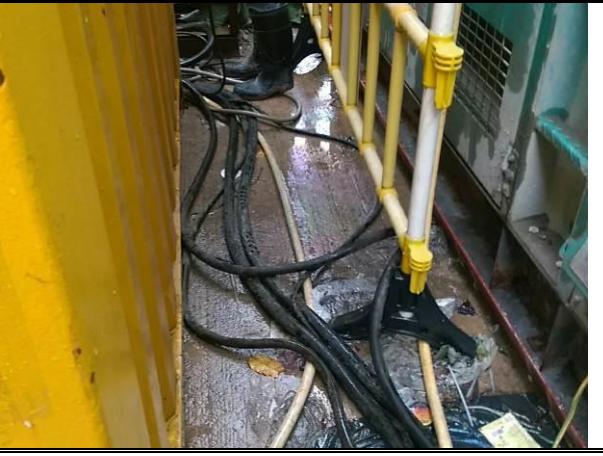
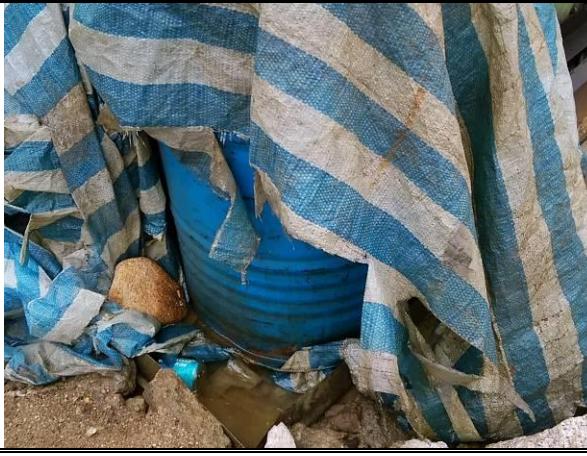
To avoid any discharge or accidental spillage of chemical waste or oil directly from the site	To avoid improper handling or storage of oil drum on site

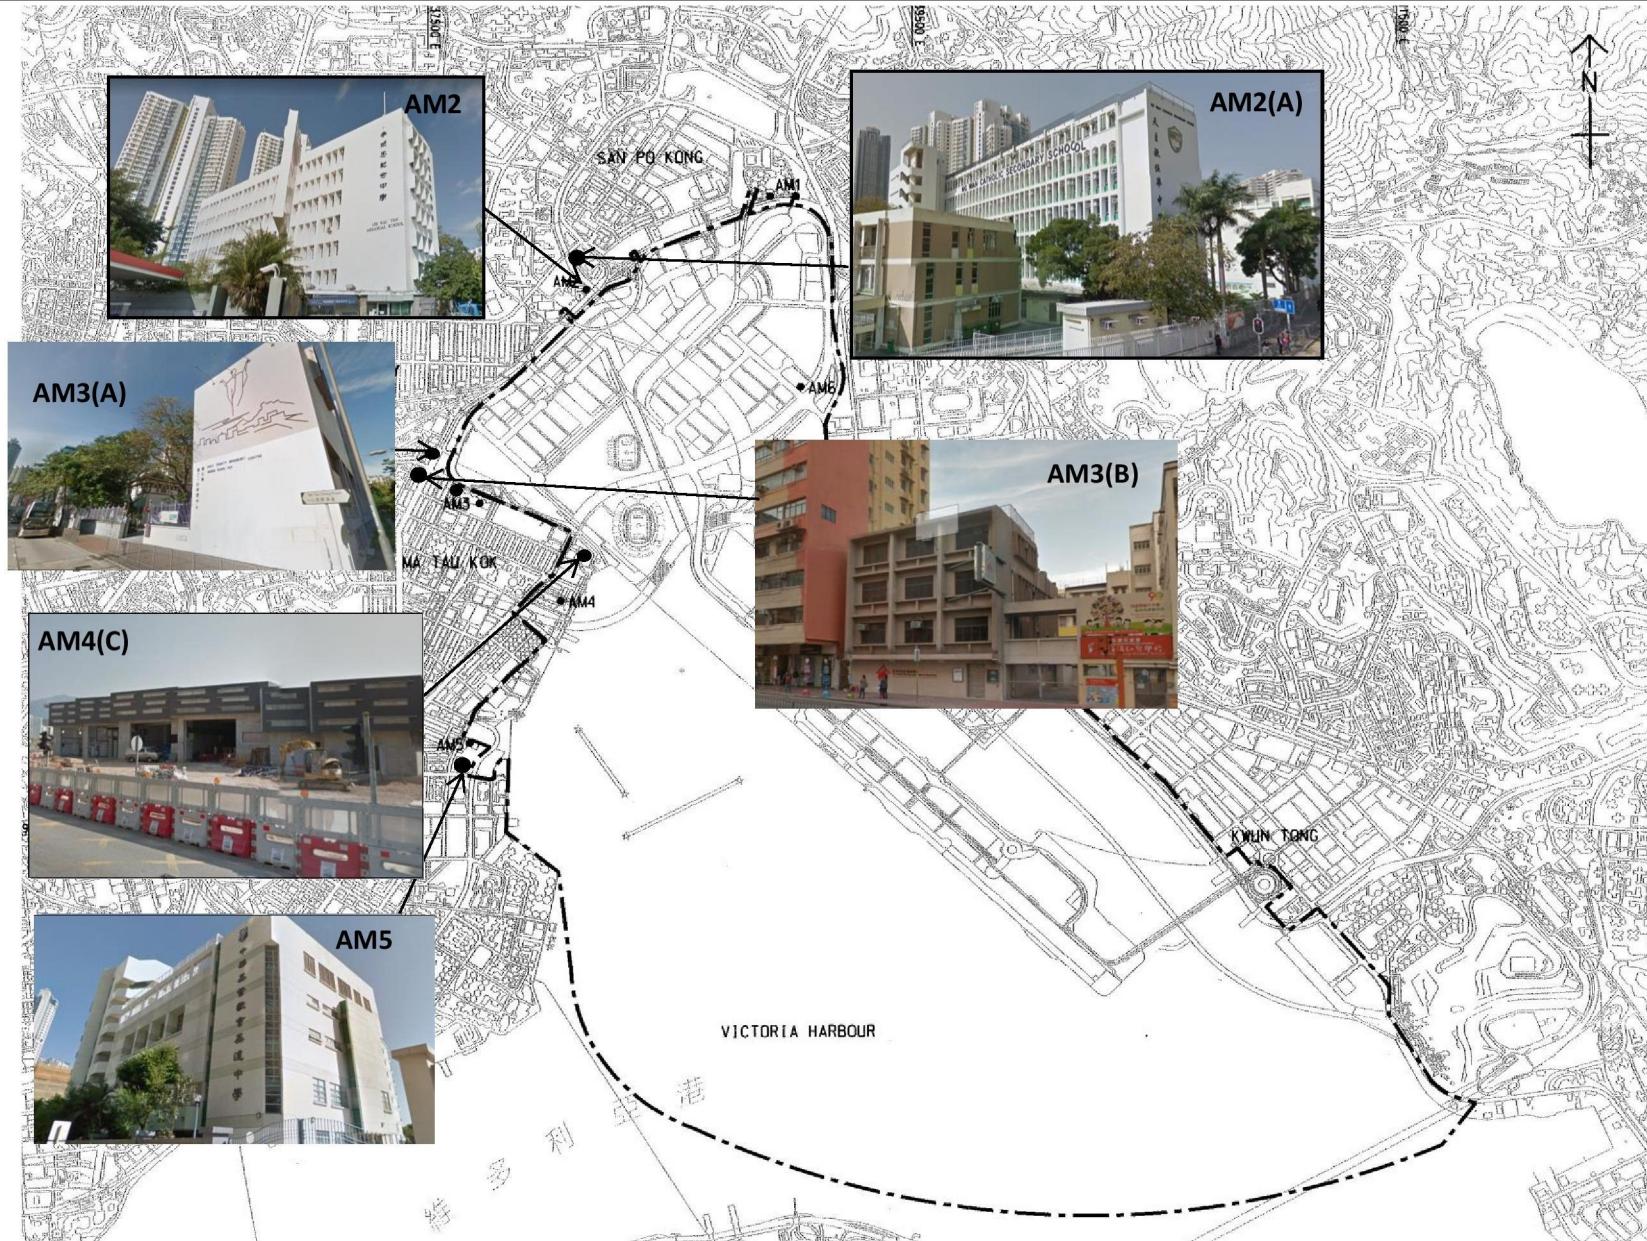
MA13056  
 Figure  
 2

- 2.2 Seven designated monitoring stations were selected for air quality monitoring programme. Impact dust monitoring was conducted at six of the air quality monitoring stations (AM2, AM2(A), AM3(A), AM3(B), AM4(C) and AM5). **Table 2.1** describes the air quality monitoring locations, which are also depicted in **Figure 2**.

Contract No. KL/2012/03  
 Kai Tak Development –Stage 4 Infrastructure at Former North Apron Area  
 Air Quality Monitoring Stations under this Project

- 1.13 Air quality monitoring stations within 500m and noise monitoring stations within 300m from the boundary of this Project are considered as relevant monitoring locations. In such regard, the relevant air quality and noise monitoring locations are tabulated in **Table 1.3** (see **Figure 2 and 3** for their locations).

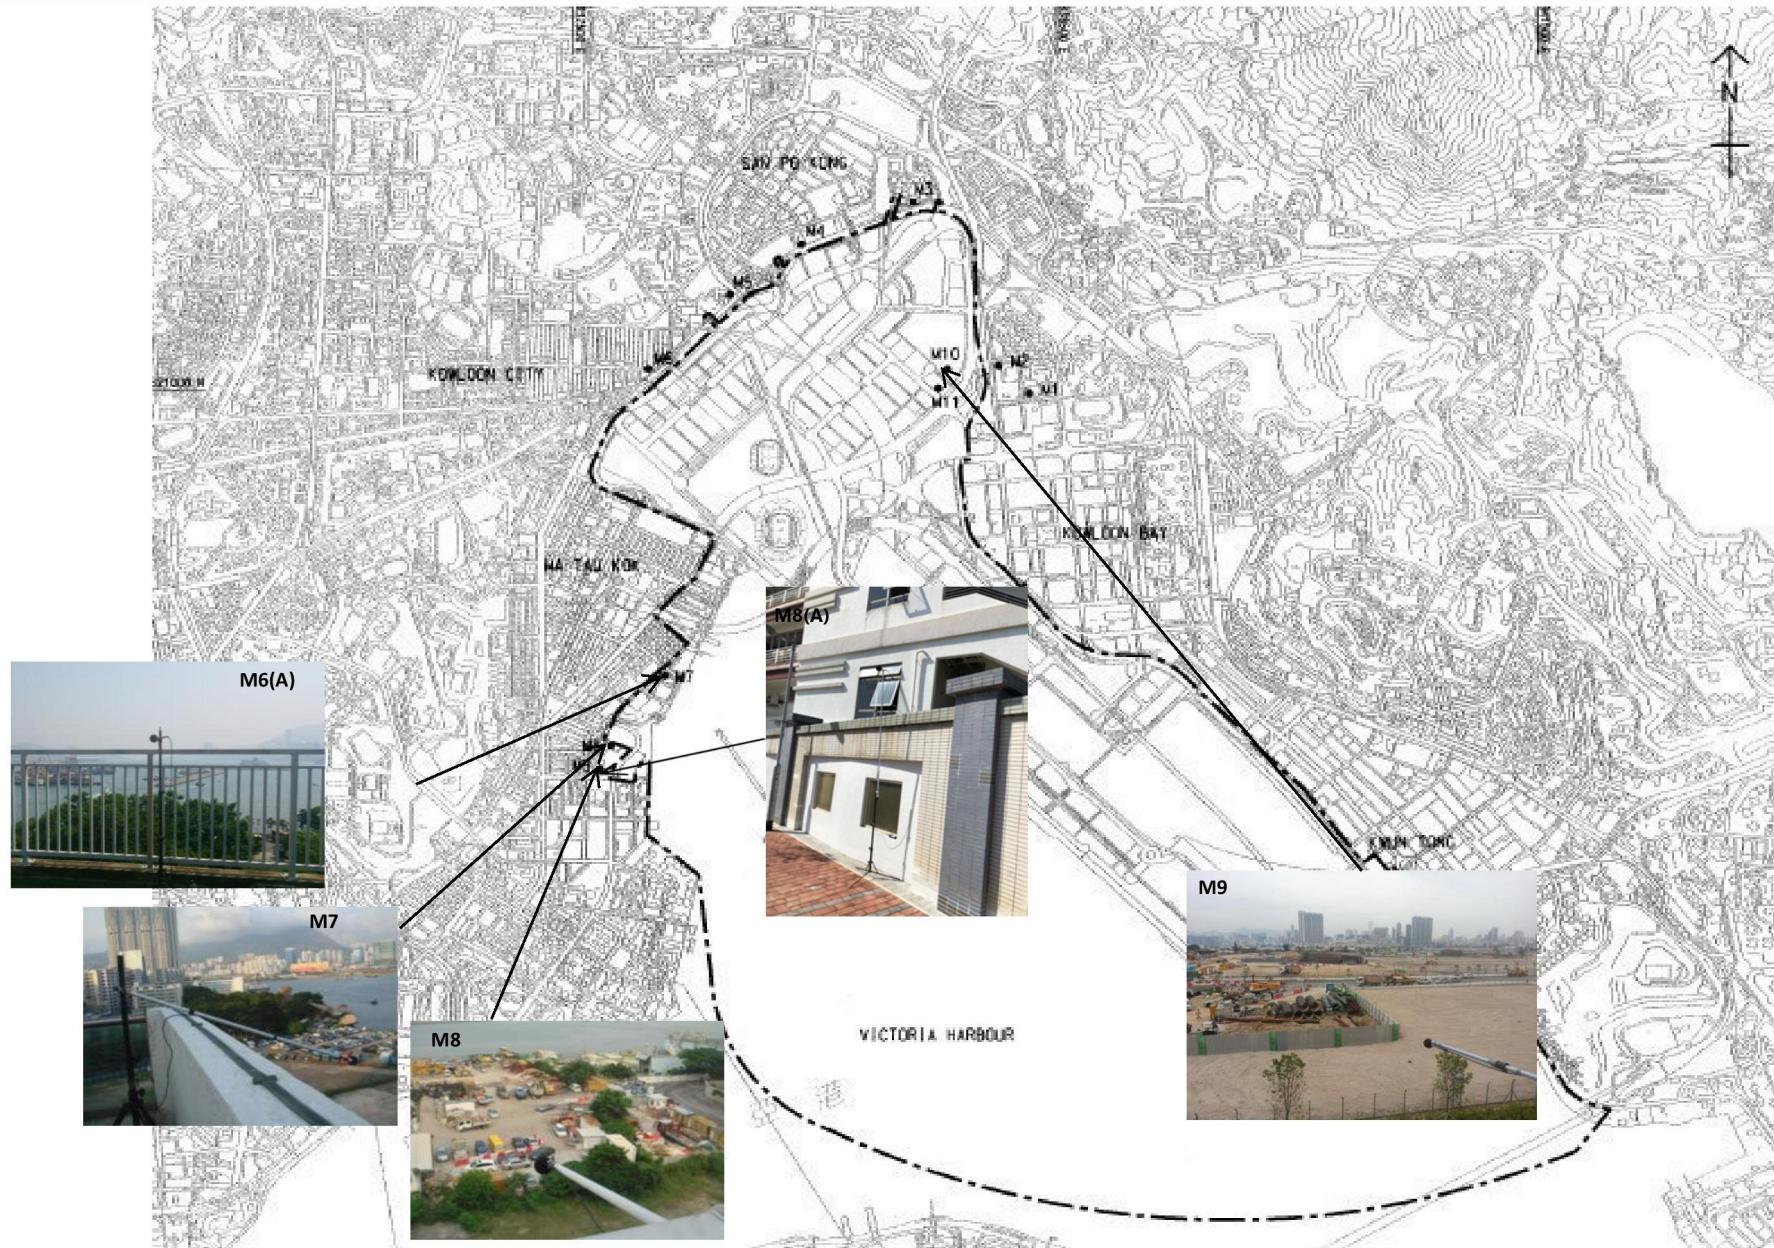
Scale N.T.S	Project No. MA13056	<b>WELLAB 決力</b> consulting . testing . research
Date Dec-16	Figure 3

- 3.2 Five designated monitoring stations were selected for noise monitoring programme. Noise monitoring was conducted at four designated monitoring stations (M6, M7, M8 and M9). **Figure 3** shows the locations of these stations.
- 3.3 Construction noise monitoring at Station M6 – Holy Carpenter Primary School was rejected by the premise owner on 6<sup>th</sup> October 2014. The monitoring station has been relocated at a proposed alternative noise monitoring station M6(A) – Oblate Primary School since 10<sup>th</sup> October 2014 to carry out the monitoring works.
- 3.4 The proposal for alternative position of M8 (remark as M8(A)) was agreed by IEC on 20<sup>th</sup> March 2019 in accordance with the Section 2.3.9 of EM&A Manual of the Project and the Environmental Protection Department (EPD) has no major objection on the proposal. No Action/Limit Level exceedance was recorded.

Title  
 Contract No. KL/2012/03  
 Kai Tak Development –Stage 4 Infrastructure at Former North Apron Area  
 Noise Monitoring Stations under this Project

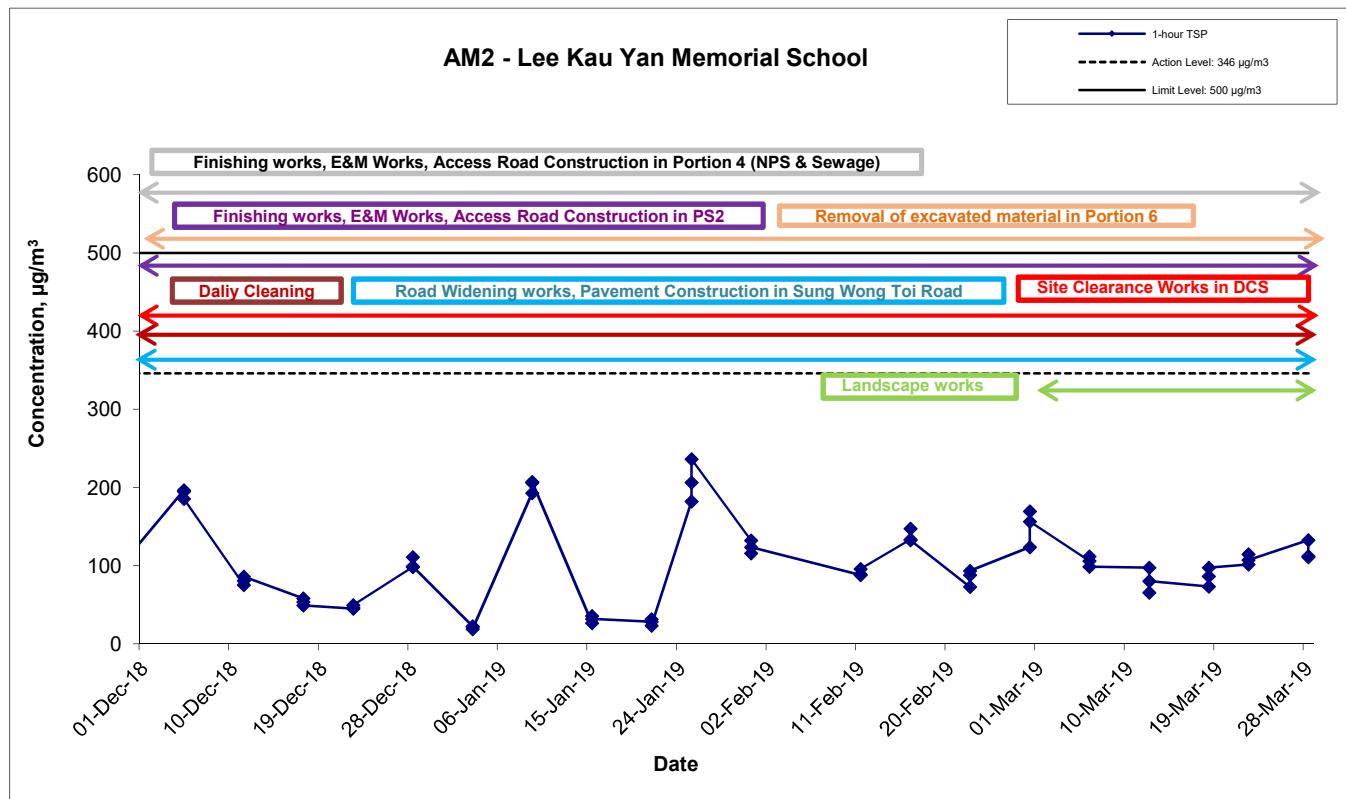
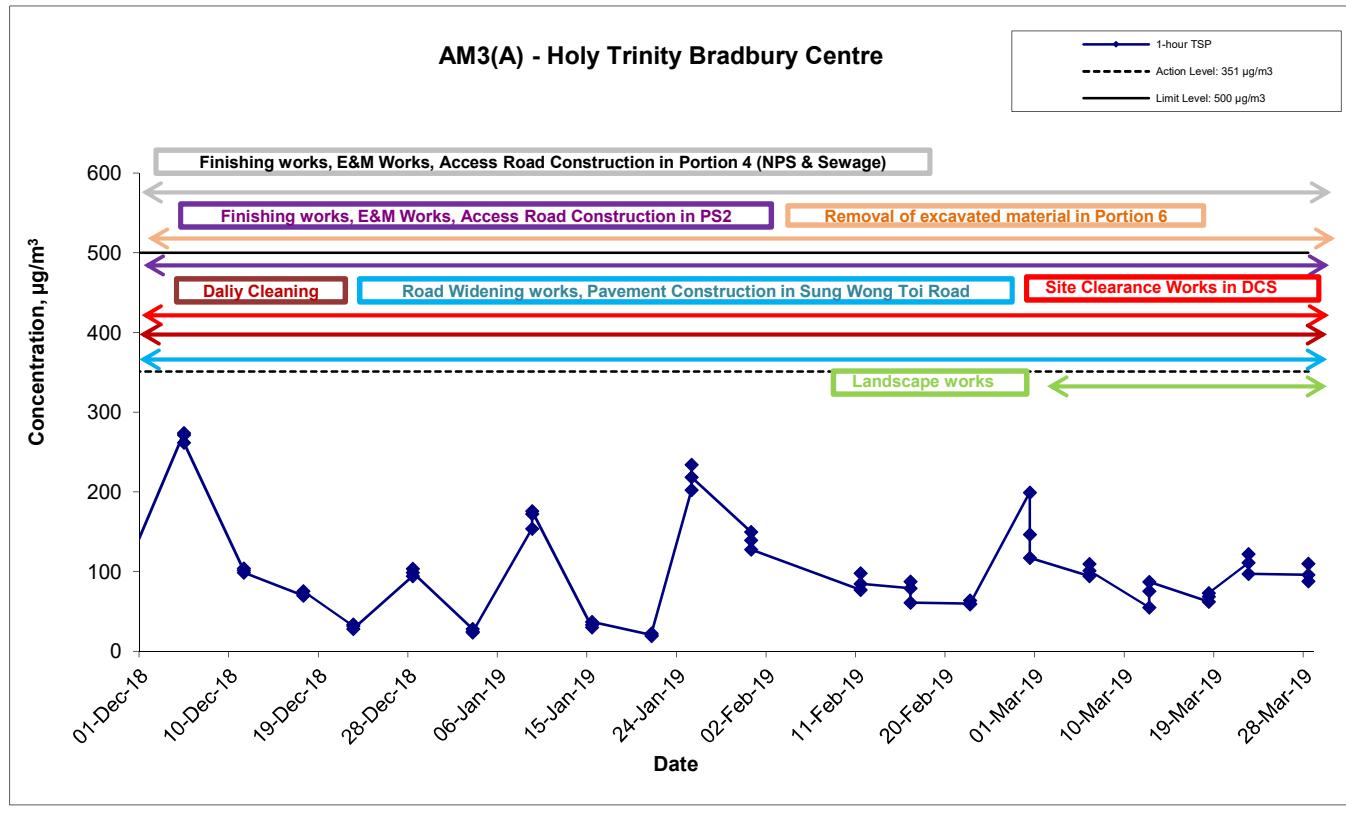
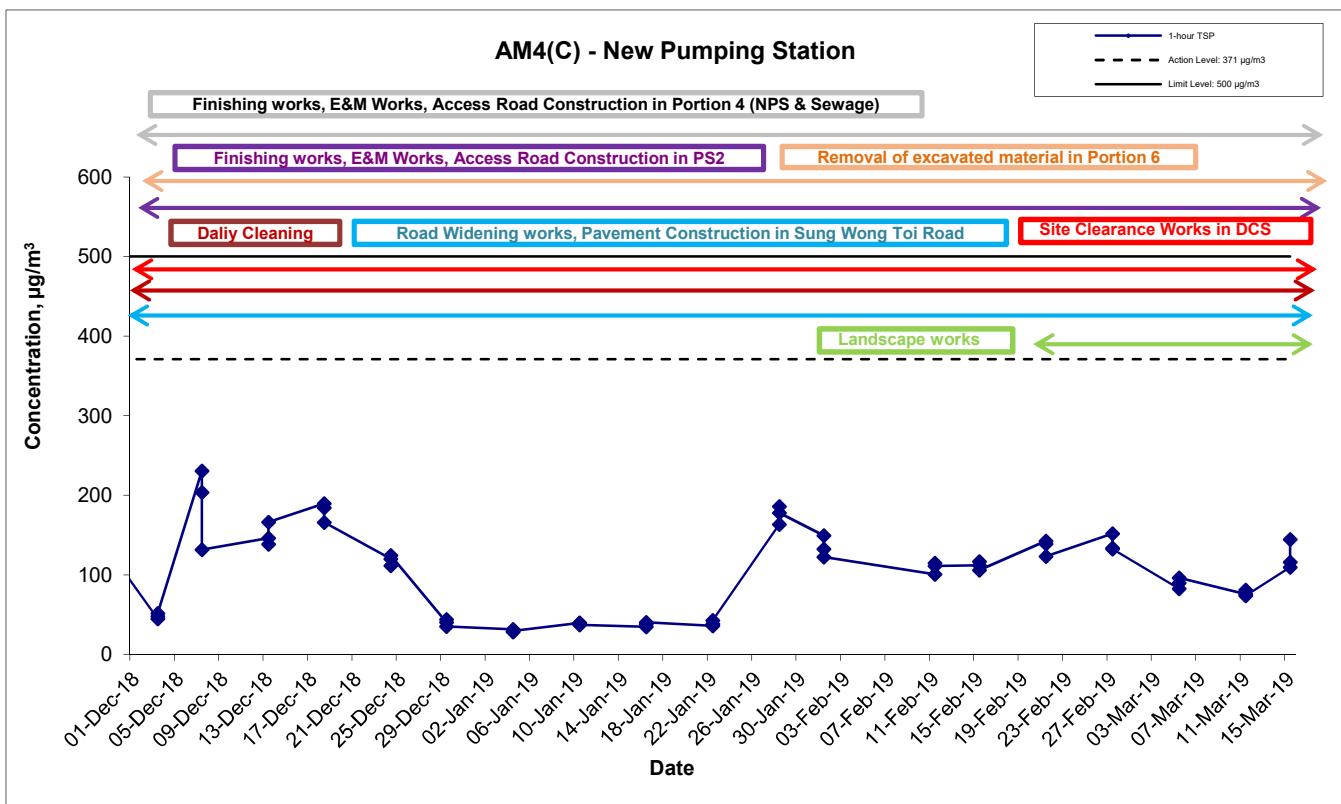
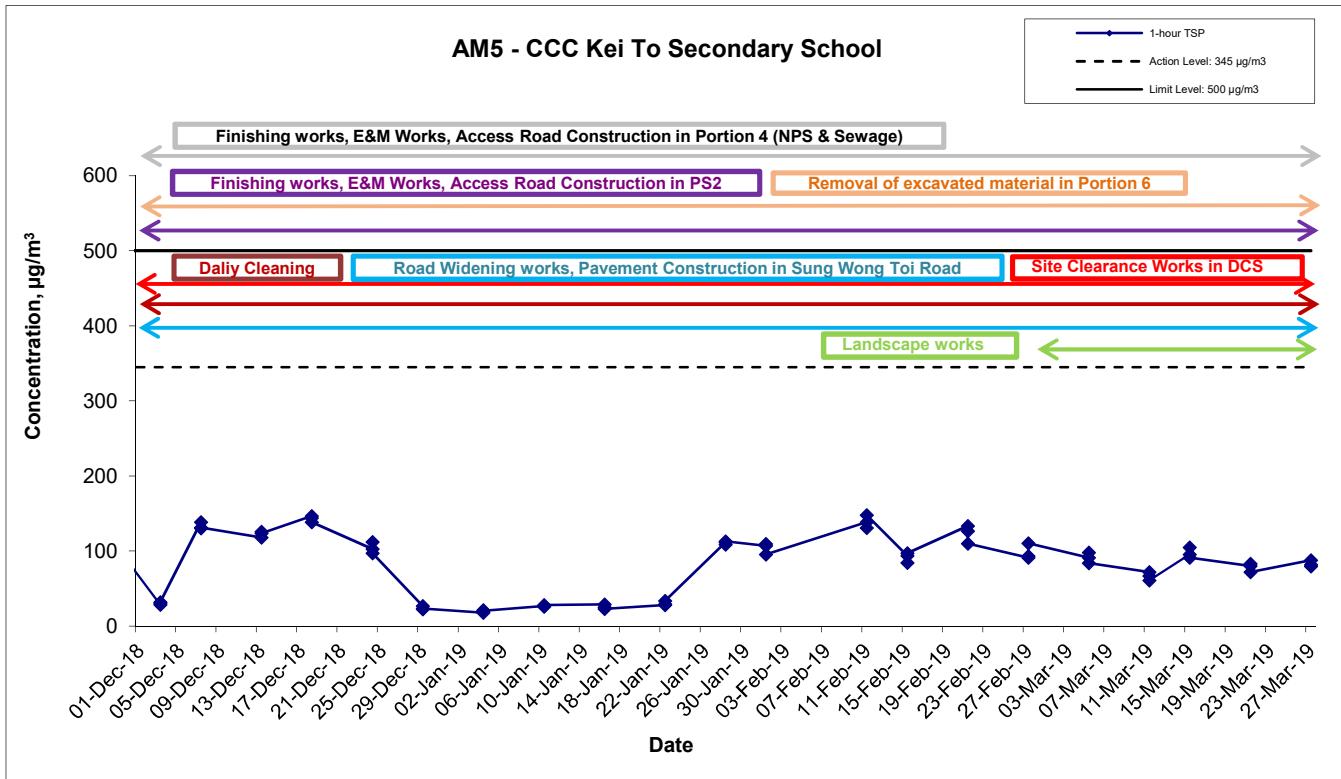
Title	Contract No. KL/2012/03 Kai Tak Development –Stage 4 Infrastructure at Former North Apron Area	Scale	Project No. MA13056	<b>WELLAB 雄力</b> consulting . testing . research
		N.T.S		
	Graphical Presentation of 1-hour TSP Monitoring Results	Date	Appendix	E
		Mar 19

### 1-hr TSP Concentration Levels

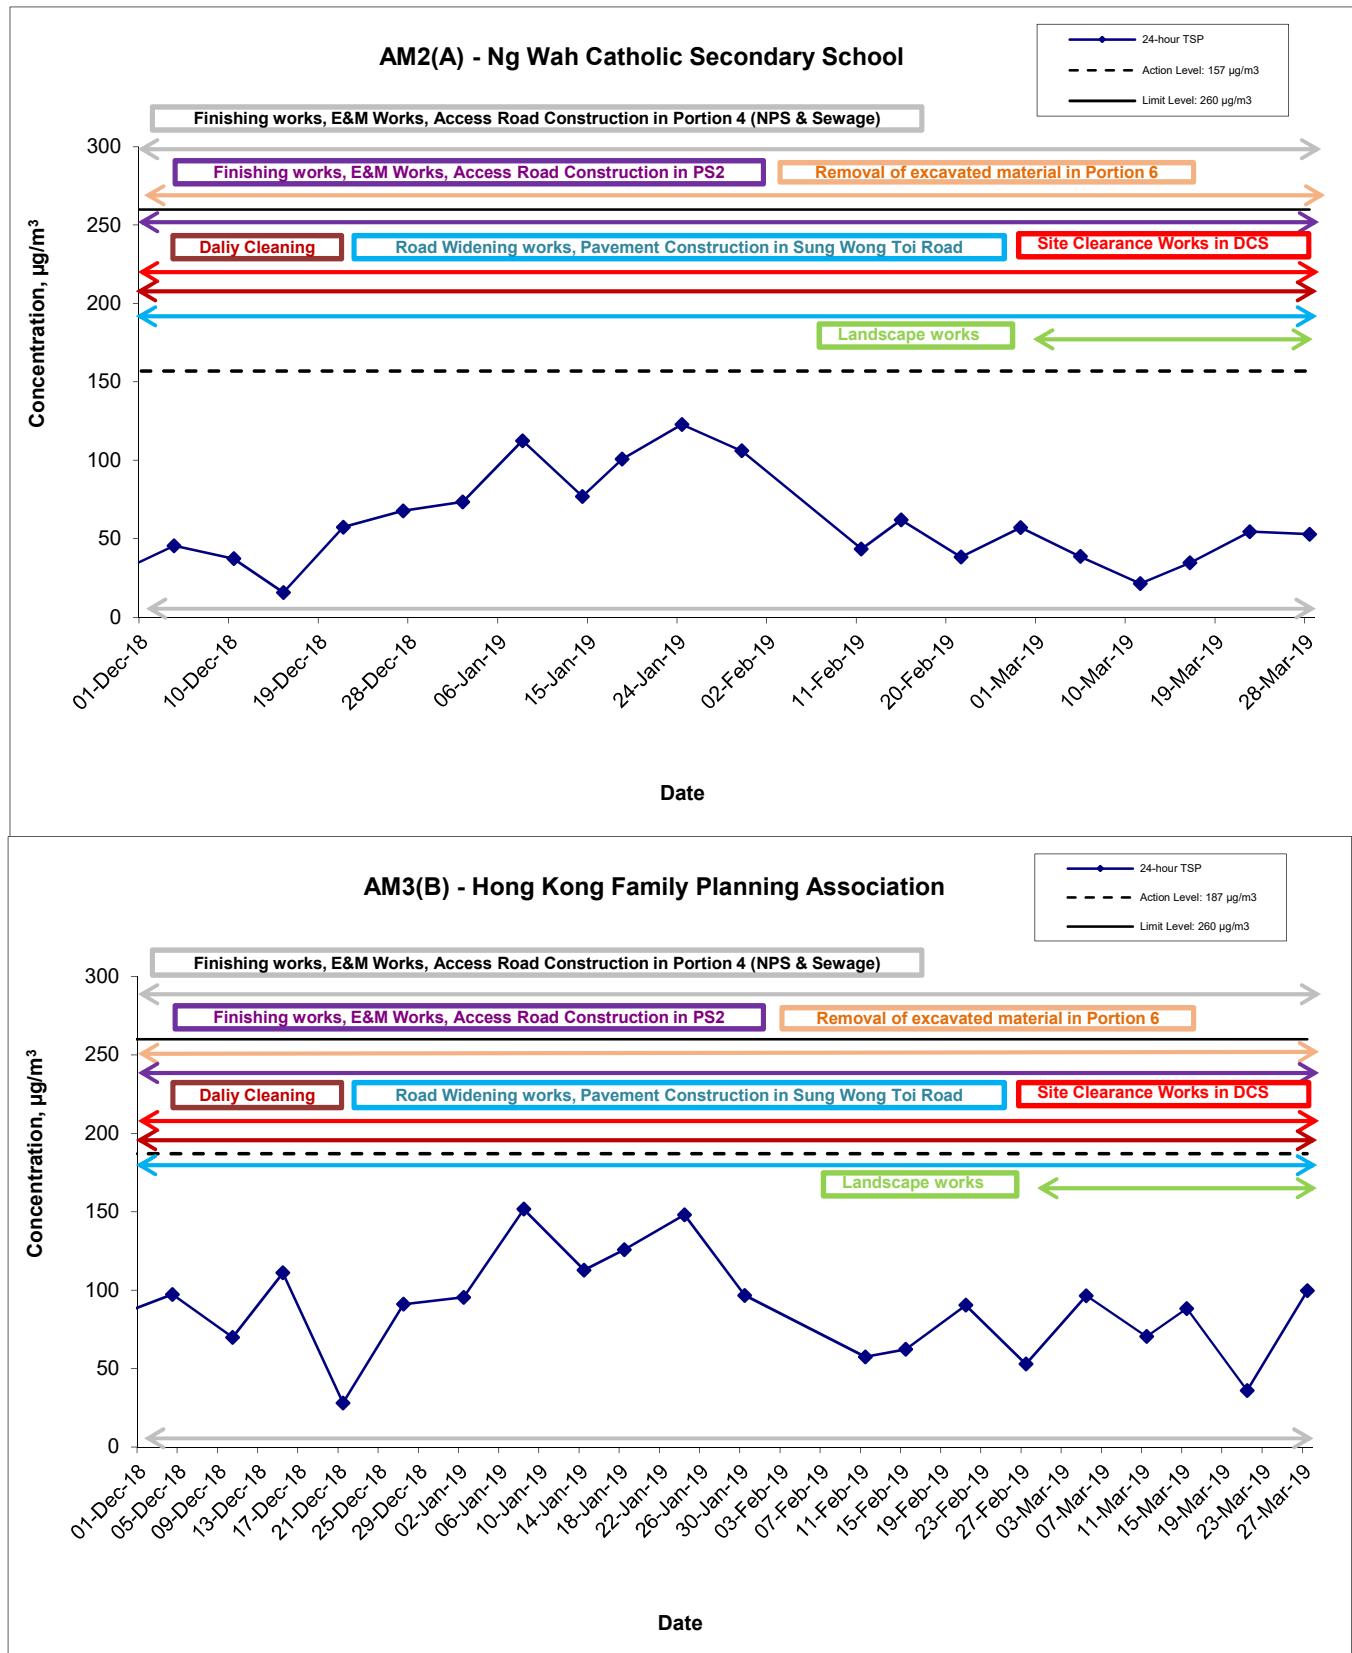
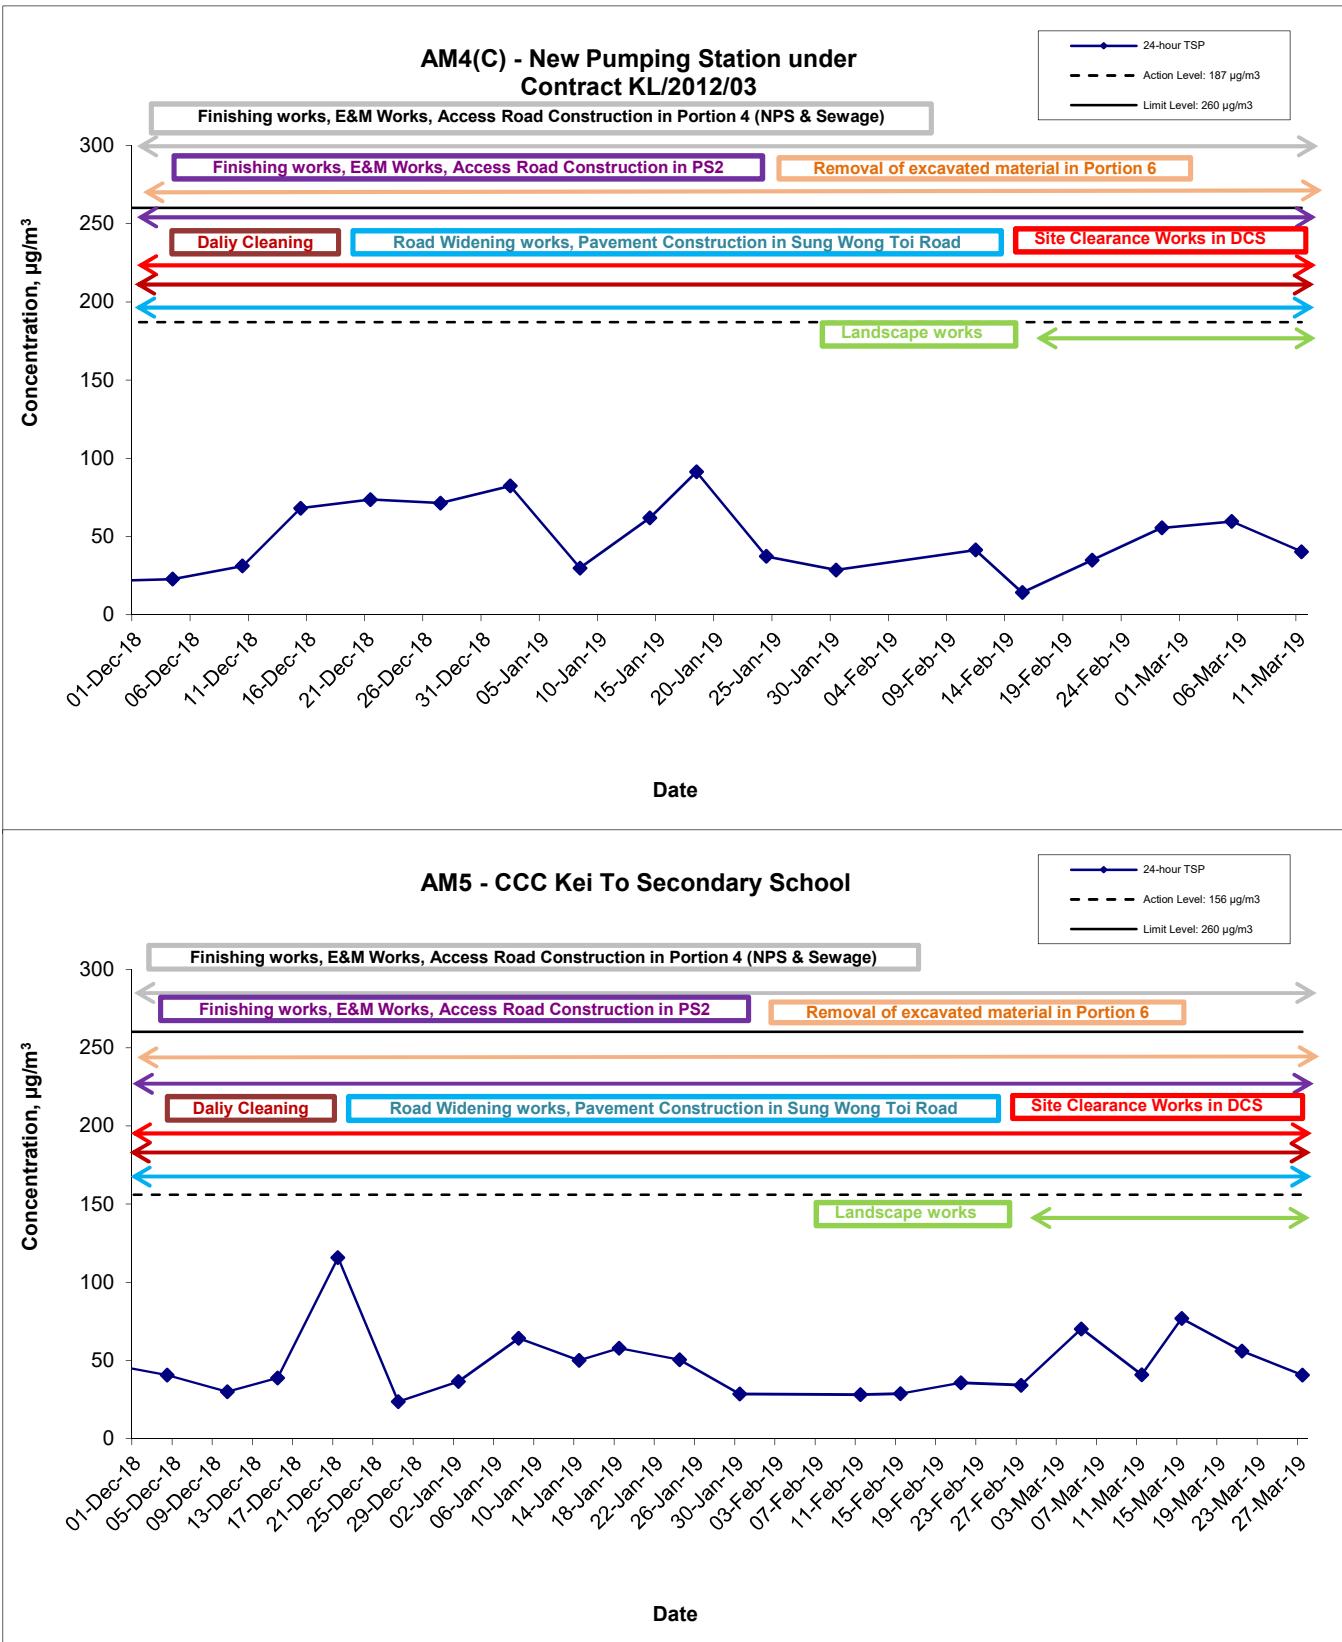
Title	Contract No. KL/2012/03 Kai Tak Development –Stage 4 Infrastructure at Former North Apron Area	Scale	Project	<b>WELLAB 雄力</b> consulting . testing . research
		N.T.S	No. MA13056	
Graphical Presentation of 24-hour TSP Monitoring Results	Date Mar 19	Appendix F

24-hr TSP monitoring at AM4(C) on 15, 21 and 27 March was cancelled due to power failure.

### 24-hr TSP Concentration Levels

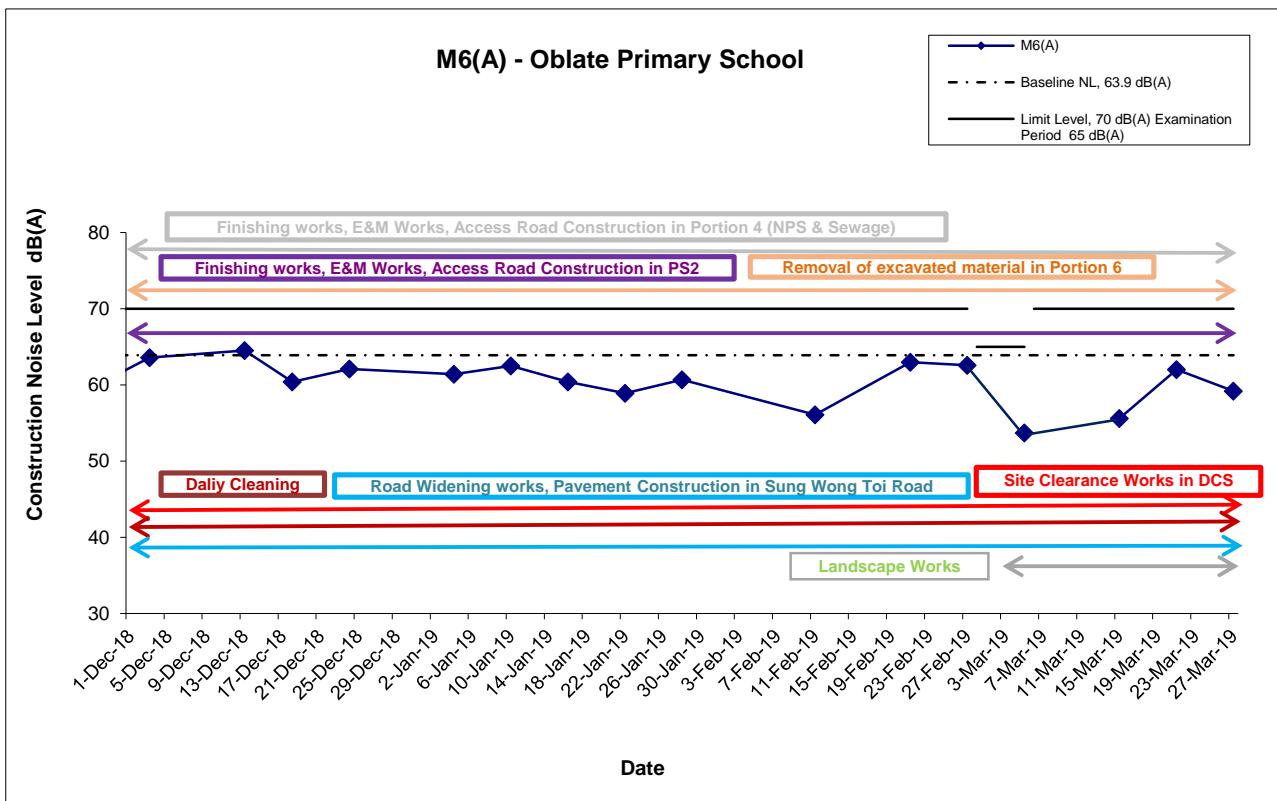
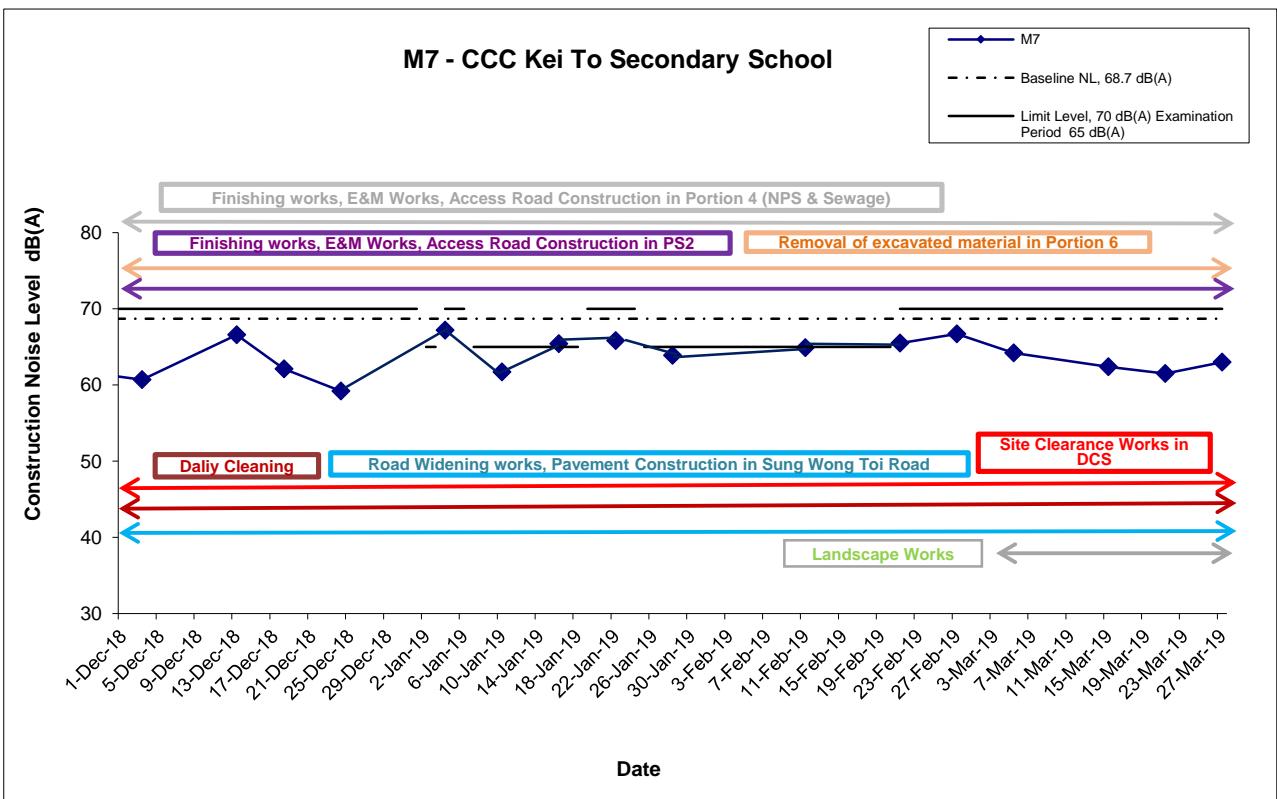
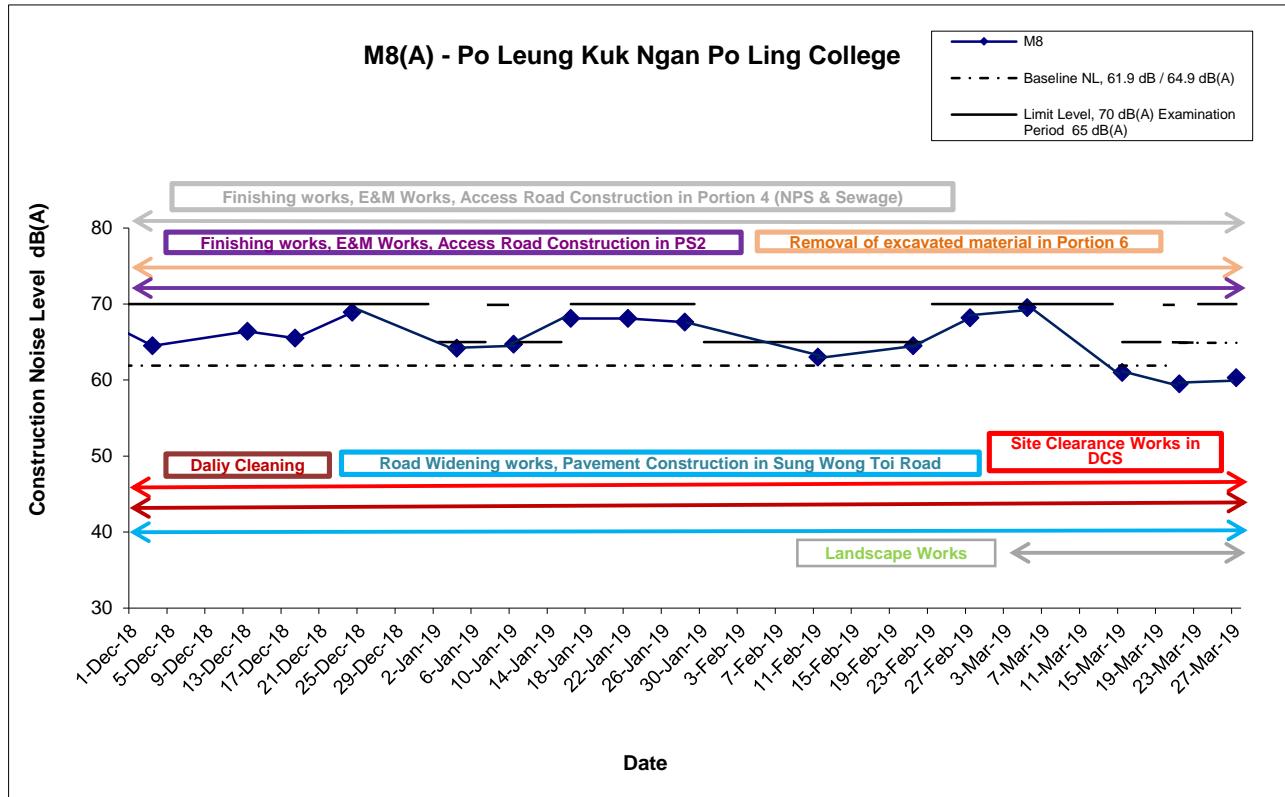
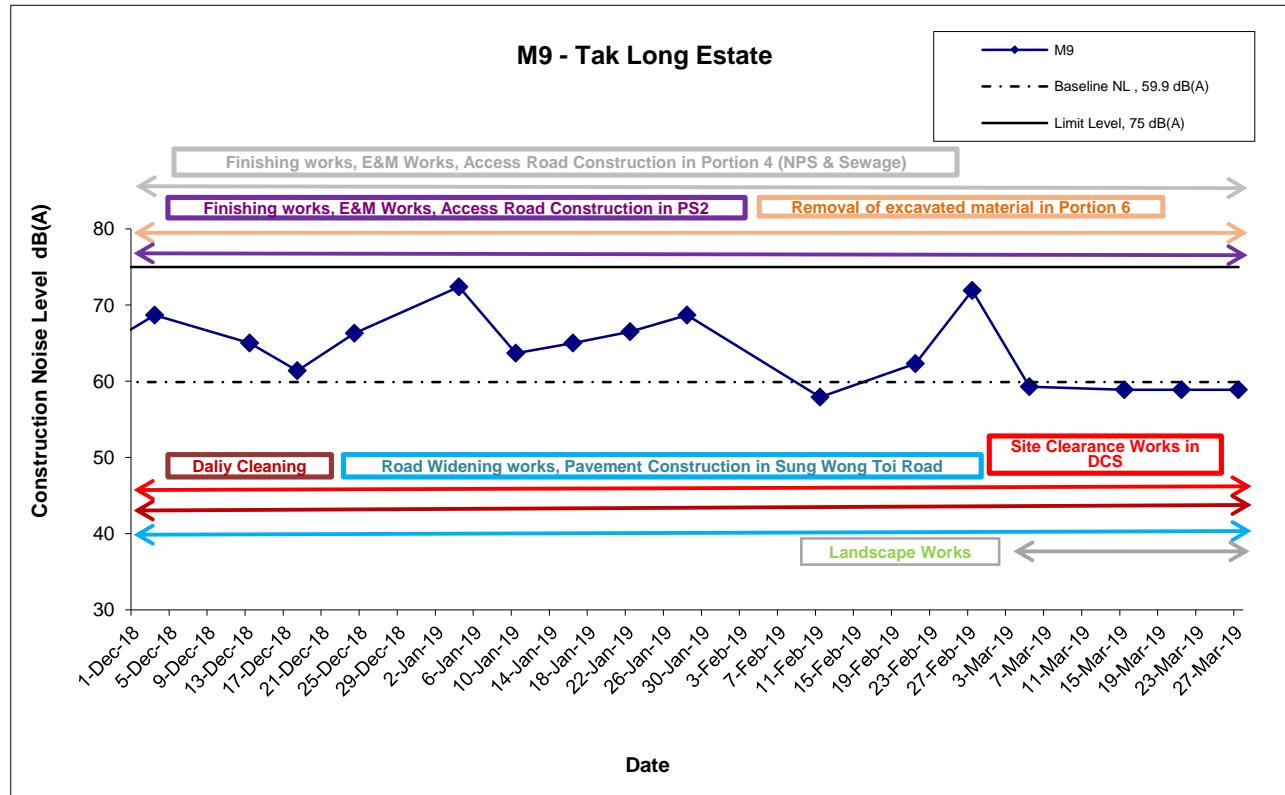
Title Kai Tak Development – Stage 4 Infrastructure at Former North Apron Area Graphical Presentation of Construction Noise Monitoring Results	Contract No. KL/2012/03	Scale N.T.S	Project No. MA13056	<b>WELLAB</b> 雄力 consulting . testing . research
		Date Mar 19	Appendix G

Remarks: The construction noise levels in the Tables in Appendix G were adopted for plotting the graphs

The construction noise levels in the Tables in Appendix G were adopted for plotting the graphs  
 The baseline reference noise level of M8(A) was adjusted with a correction of +3dB(A) as IEC agree the proposal for alternative position of M8 (remark as M8(A)) on 20 March 2019.
