13th CONSOLIDATED QUARTERLY EM&A REPORT

January 2020 – March 2020

EP No. : EP-337/2009 –
New Distributor Roads Serving the Planned Kai Tak
Development Area

Contract No. : KLN/2016/05 –
Independent Environmental Checker for
Contract No. KL/2015/02 Kai Tak Development –
Stage 5A Infrastructure at Former North Apron Area

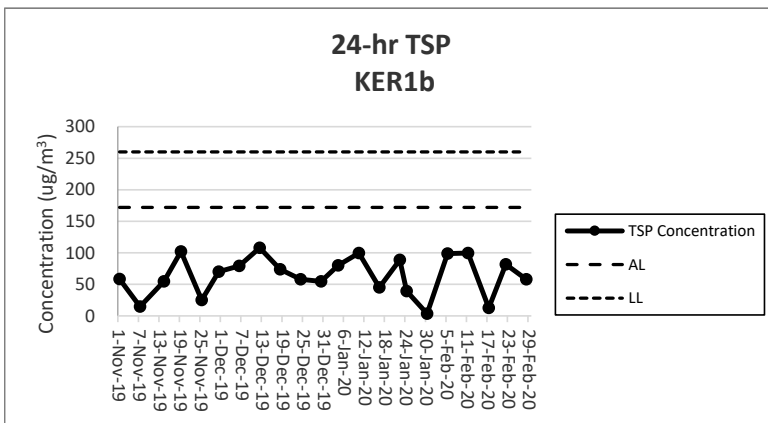
Graphical Presentation of Monitoring Data

- 1) The major activities being carried out on site during the reporting period can be referred to Section 1.3.1.
- 2) The weather conditions during monitoring in the reporting period was range from cloudy and fine.
- 3) Any other factors which might affect the monitoing results can be referred to Section 2.3.4.
- 4) 24-hr TSP monitoring was change to 14 November 2019 due to the traffic disturbance on 13 November 2019.

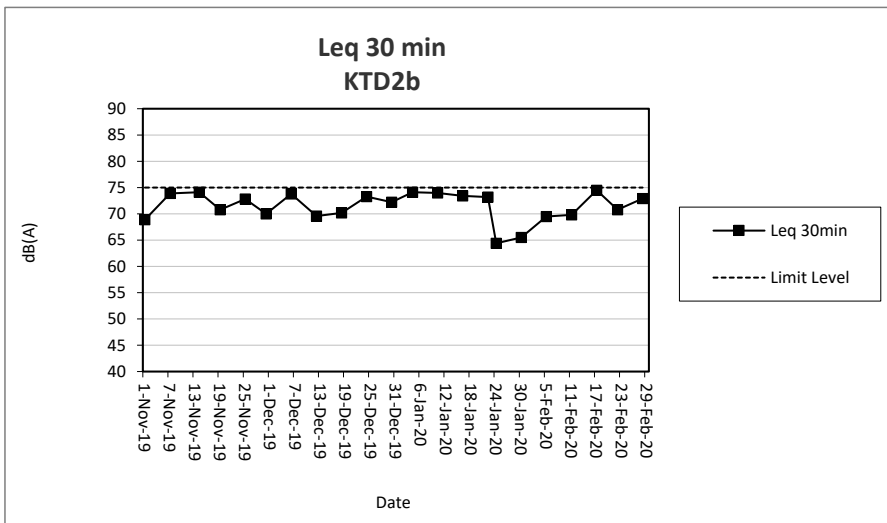
- 1) The major activities being carried out on site during the reporting period can be referred to Section 1.3.1.
- 2) The weather conditions during monitoring in the reporting period was ranged from cloudy and fine.
No raining or wind with speed over 5 m/s was observed during monitoring in the reporting period.
- 3) Any other factors which might affect the monitoring results can be referred to Section 2.3.4.
- 4) Impact noise monitoring was change to 14 November 2019 due to the traffic disturbance on 13 November 2019.

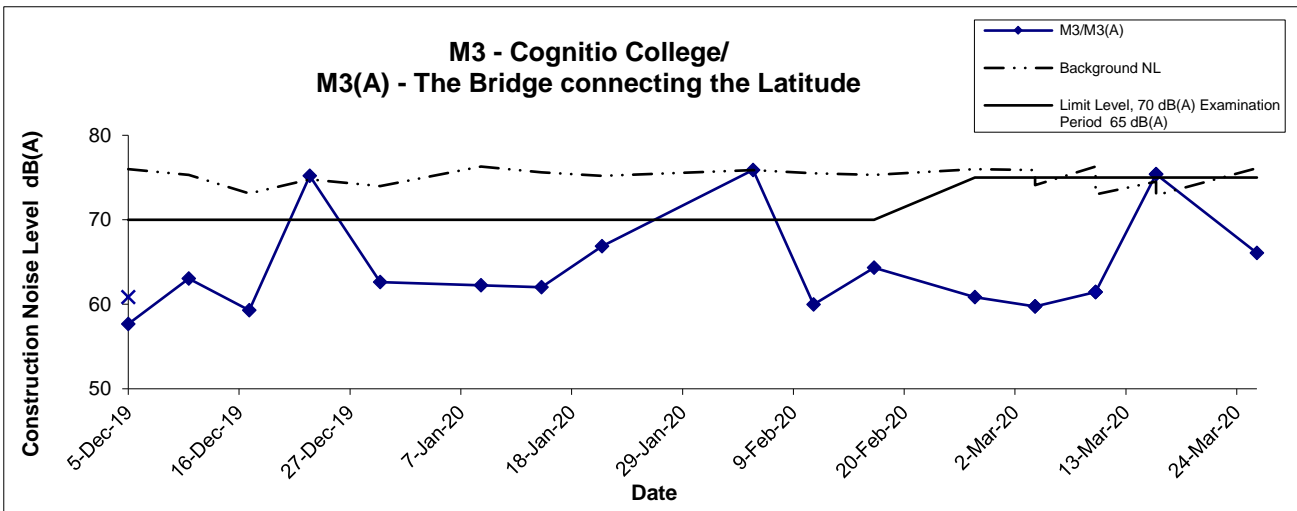
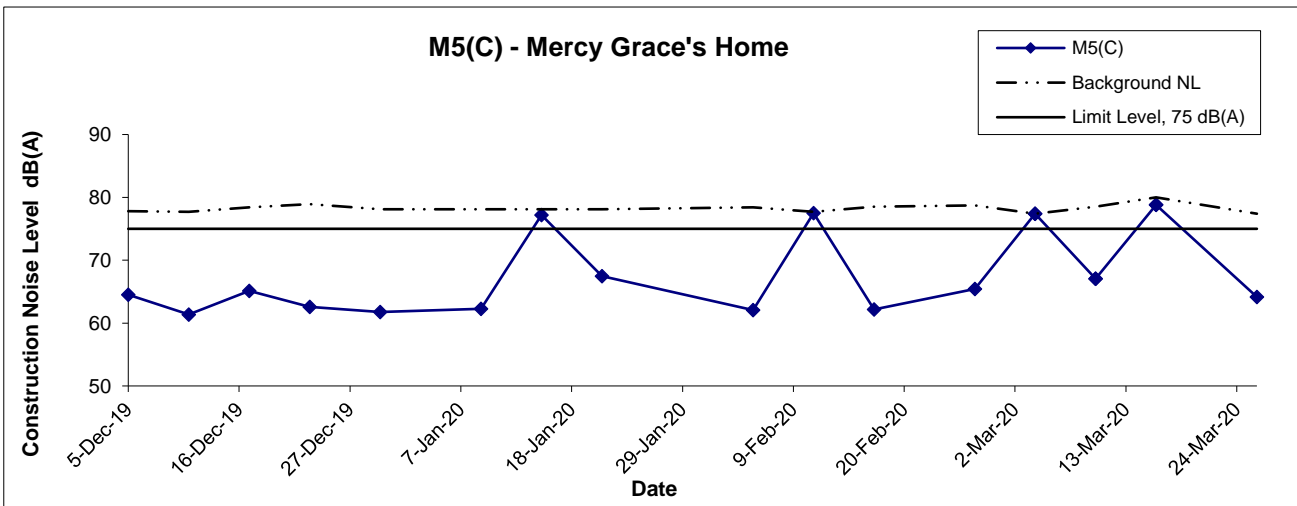
Noise Levels

Remarks: ^[1] The noise monitoring at M3(A) - The Bridge connecting the Latitude has been carried out for replacing monitoring station M3 on 27 February 2020.

Title Contract No. KLN/2016/04 Environmental Monitoring Works for Contract No. KL/2015/02 Kai Tak Development – Stage 5A Infrastructure at Former North Apron Area Graphical Presentation of Noise Monitoring Results	Scale N.T.S	Project No. MA16043	
		Appendix D
