EP-344/2009 – New Sewage Pumping Stations Serving KTD and
EP-337/2009 – New Distributor Roads Serving the Planned KTD

Contract No. KL/2010/03

Kai Tak Development - Stage 2 infrastructure works at north
apron area of Kai Tak Airport for residential development
and government, institution or community facilities

Monthly EM&A Report

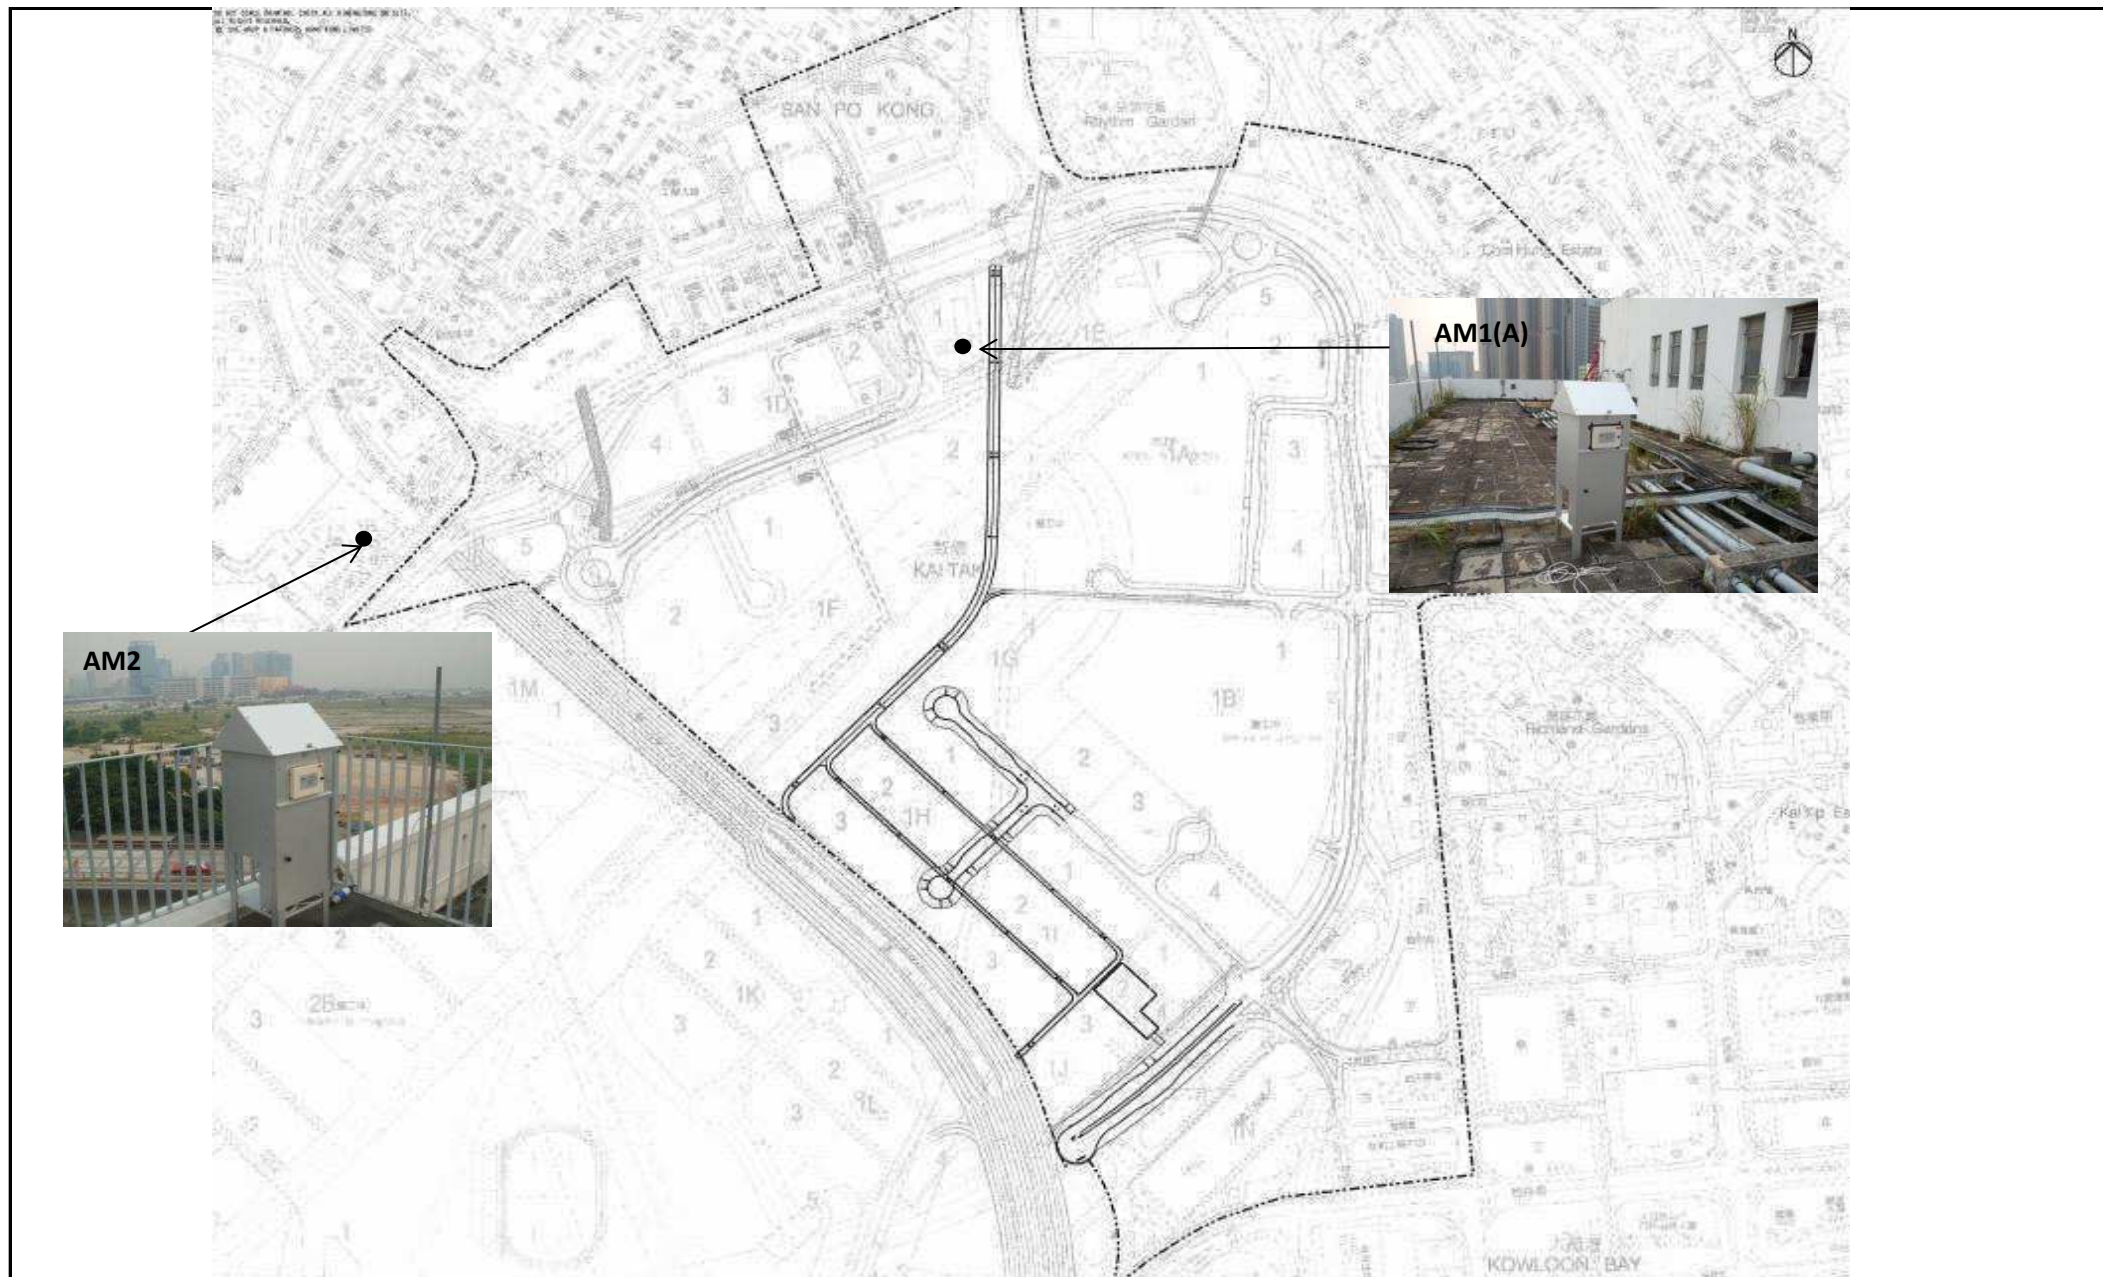
Title	EP-344/2009 – New Sewage Pumping Stations Serving KTD and EP-337/2009 – New Distributor Roads Serving the Planned KTD		Scale	N.T.S	Project No.	MA11038	CINOTECH
			Date	Nov 11	Figure	2

2. With reference to the same principle of EIA report of the Project, air quality monitoring stations within 500m and noise monitoring stations within 300m from the boundary of this Project are considered as relevant monitoring locations. In such regard, the relevant air quality and noise monitoring locations are tabulated in Table I (see Figure 2 and 3 for their locations).

Location of Air Quality Monitoring Stations

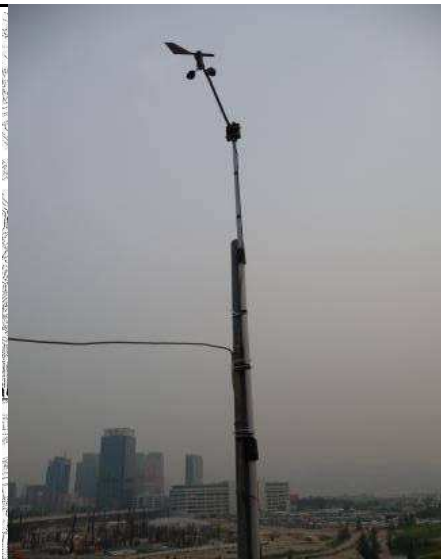
- 2.21 The air temperature, precipitation and the relative humidity data was obtained from Hong Kong Observatory where the wind speed and wind direction were recorded by the installed Wind Anemometer set at rooftop (about 9/F) of Kai Tak Operational Base. The location is shown in **Figure 4**. This weather information for the reporting month is summarized in **Appendix C**.

Wind Data Monitoring Equipment set at Kai Tak Operational Base

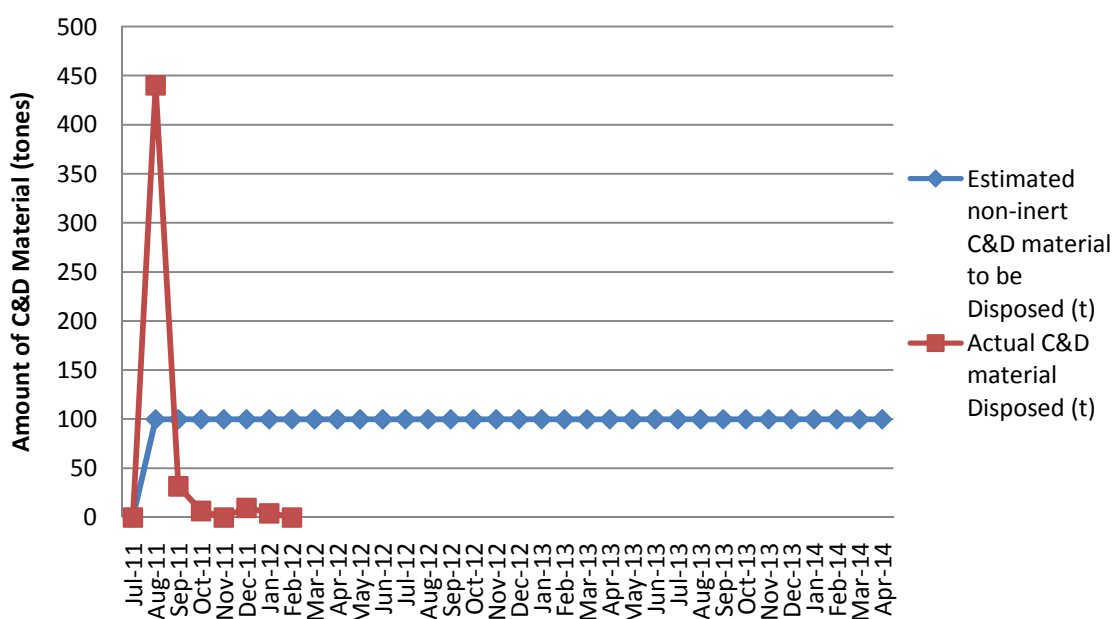
C&D Material Disposal

Note: No inert C&D materials will be disposed off the Site and all non-inert C&D materials will be disposed of at NENT.
