EP-344/2009 – New Sewage Pumping Stations Serving KTD and
EP-337/2009 – New Distributor Roads Serving the Planned KTD

Contract No. KL/2010/03

Kai Tak Development - Stage 2 infrastructure works at north
apron area of Kai Tak Airport for residential development
and government, institution or community facilities

Monthly EM&A Report

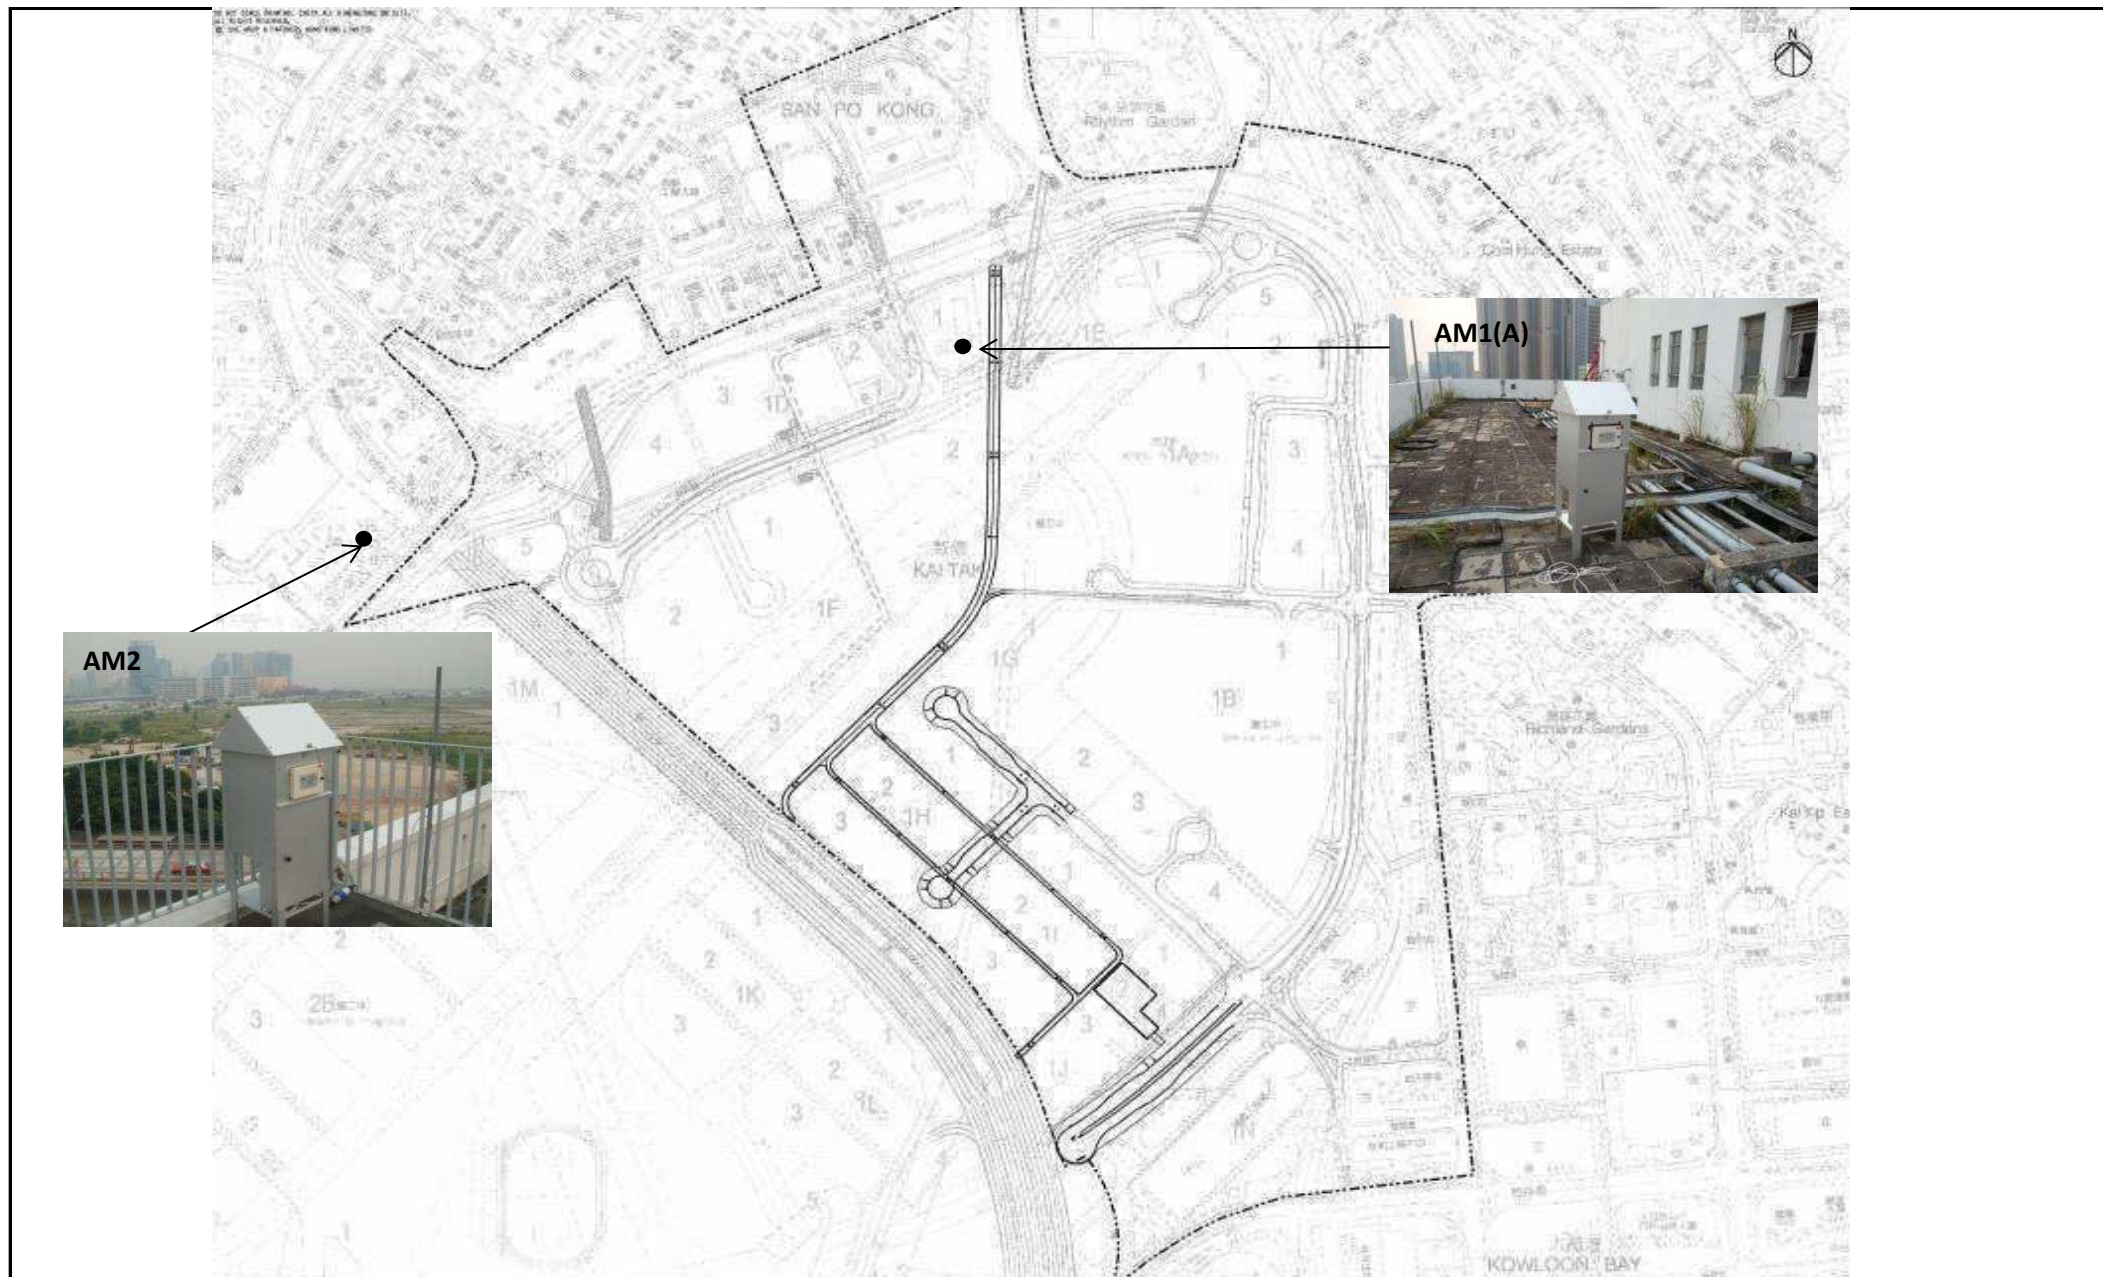
Title	EP-344/2009 – New Sewage Pumping Stations Serving KTD and EP-337/2009 – New Distributor Roads Serving the Planned KTD		Scale	N.T.S	Project No.	MA11038	CINOTECH
			Date	Nov 11	Figure	2

Location of Air Quality Monitoring Stations

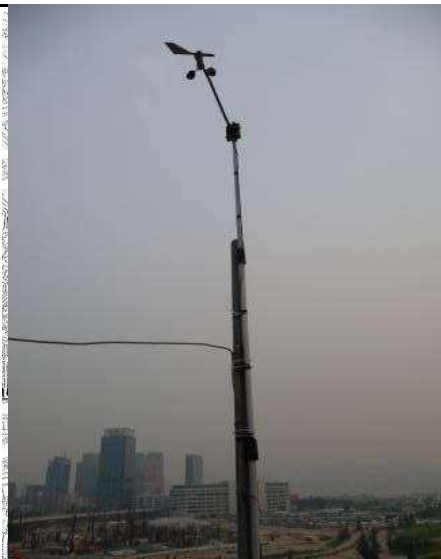
Title	EP-344/2009 – New Sewage Pumping Stations Serving KTD and EP-337/2009 – New Distributor Roads Serving the Planned KTD		Scale	N.T.S	Project No.	MA11038	CINOTECH
	Location of Wind Data Monitoring Equipment		Date	Nov 11	Figure	4

Wind Data Monitoring Equipment set at Kai Tak Operational Base

Anemometer Station from The Hong Kong Observatory

- 2.21 The air temperature, precipitation and the relative humidity data was obtained from Hong Kong Observatory where the wind speed and wind direction were recorded by the installed Wind Anemometer set at rooftop (about 9/F) of Kai Tak Operational Base. The location is shown in **Figure 4**. This weather information for the reporting month is summarized in **Appendix C**.

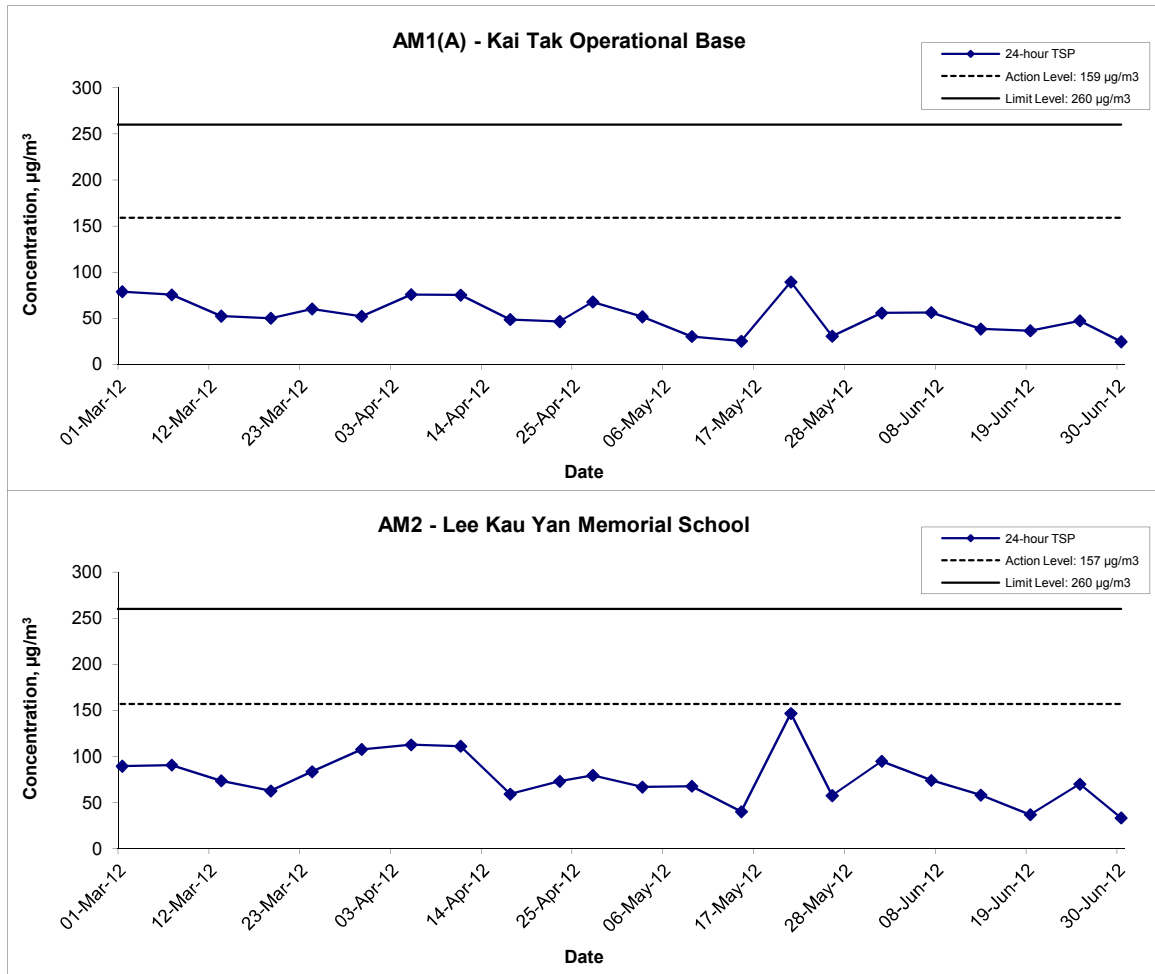
24-hr TSP Concentration Levels
