EP-344/2009 – New Sewage Pumping Stations Serving KTD and EP-337/2009 – New Distributor Roads Serving the Planned KTD

Contract No. KL/2010/03 Kai Tak Development - Stage 2 infrastructure works at north apron area of Kai Tak Airport for residential development and government, institution or community facilities

Monthly EM&A Report

September 2012

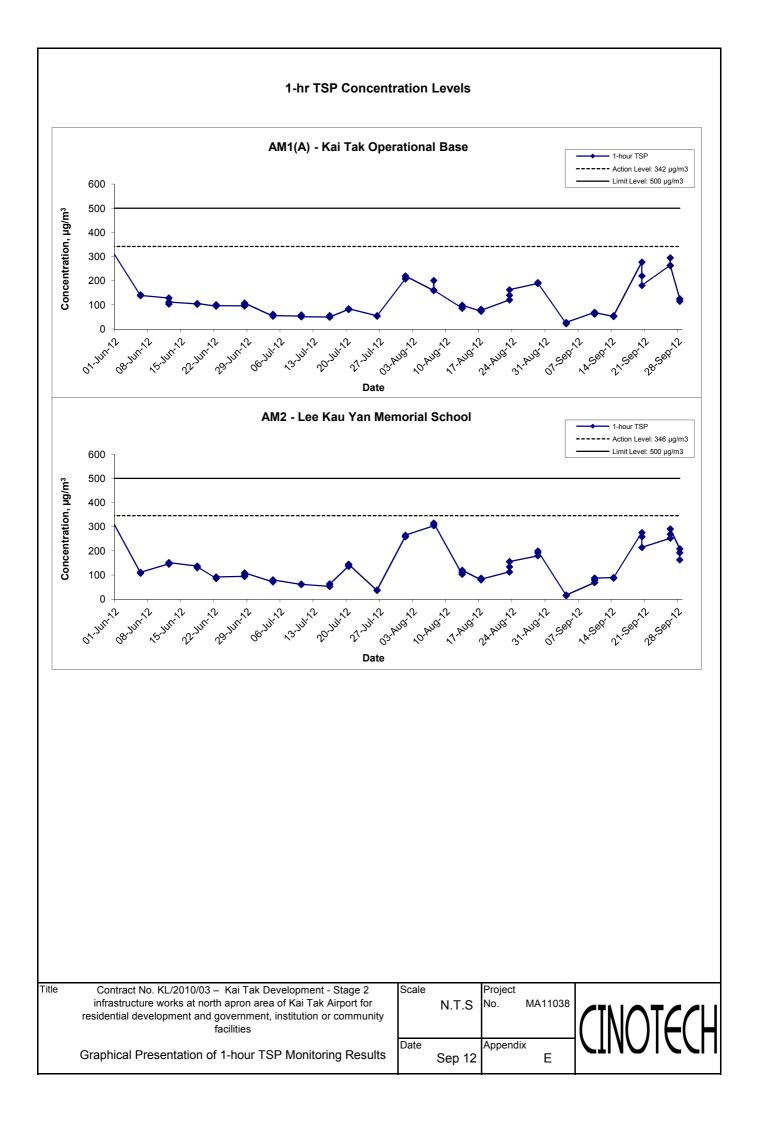
Appendix E - 1-hour TSP Monitoring Results

Location AM2 -	Lee Kau Yar	n Memorial Schoo	
Date	Time	Weather	Particulate Concentration (µg/m ³)
4-Sep-12	13:00	Cloudy	16.3
4-Sep-12	14:00	Cloudy	15.2
4-Sep-12	15:00	Cloudy	17.4
10-Sep-12	13:00	Sunny	69.2
10-Sep-12	14:00	Sunny	80.2
10-Sep-12	15:00	Sunny	87.5
14-Sep-12	13:00	Sunny	89.5
14-Sep-12	14:00	Sunny	87.7
14-Sep-12	15:00	Sunny	88.1
20-Sep-12	13:00	Cloudy	276.0
20-Sep-12	14:00	Cloudy	259.0
20-Sep-12	15:00	Cloudy	214.4
26-Sep-12	13:00	Cloudy	252.7
26-Sep-12	14:00	Cloudy	269.3
26-Sep-12	15:00	Cloudy	290.9
28-Sep-12	13:00	Sunny	208.7
28-Sep-12	14:00	Sunny	192.8
28-Sep-12	15:00	Sunny	163.6
		Average	148.8
		Maximum	290.9
		Minimum	15.2

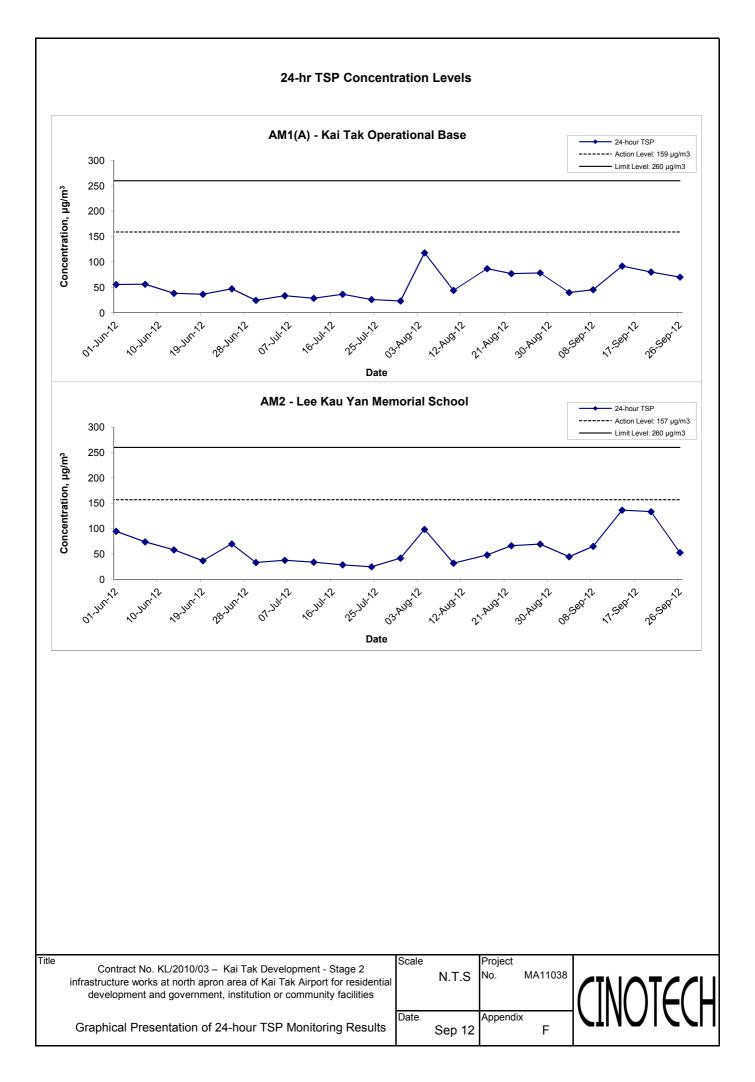
Appendix F - 24-hour TSP Monitoring Results

Start Date	Weather	Air	Atmospheric	Filter W	eight (g)	Particulate	Elaps	e Time	Sampling	Flow Rate	e (m ³ /min.)	Av. flow	Total vol.	Conc.
Start Date	Condition	Temp. (K)	Pressure, Pa (mmHg)	Initial	Final	weight (g)	Initial	Final	Time(hrs.)	Initial	Final	(m ³ /min)	(m ³)	(µg/m ³)
3-Sep-12	Cloudy	301.7	759.0	3.2368	3.3064	0.0696	3001.0	3025.0	24.0	1.21	1.21	1.21	1747.6	39.8
8-Sep-12	Sunny	302.1	761.9	3.2286	3.3080	0.0794	3025.0	3049.0	24.0	1.22	1.21	1.22	1749.6	45.4
14-Sep-12	Cloudy	298.7	760.1	3.2429	3.4043	0.1614	3049.0	3073.0	24.0	1.22	1.22	1.22	1756.5	91.9
20-Sep-12	Cloudy	299.9	761.8	3.1047	3.2456	0.1409	3073.0	3097.0	24.0	1.22	1.22	1.22	1755.2	80.3
26-Sep-12	Cloudy	301.2	758.6	3.1884	3.3109	0.1225	3097.0	3121.0	24.0	1.21	1.21	1.21	1743.1	70.3
													Min	39.8
													Max	91.9
													Average	65.5

Start Date	Weather	Air	Atmospheric	Filter W	eight (g)	Particulate	Elaps	e Time	Sampling	Flow Rate	e (m ³ /min.)	Av. flow	Total vol.	Conc.
Start Date	Condition	Temp. (K)	Pressure, Pa (mmHg)	Initial	Final	weight (g)	Initial	Final	Time(hrs.)	Initial	Final	(m ³ /min)	(m ³)	(µg/m ³)
3-Sep-12	Cloudy	301.7	759.0	3.2970	3.3748	0.0778	2905.0	2929.0	24.0	1.21	1.21	1.21	1744.1	44.6
8-Sep-12	Sunny	302.1	761.9	3.2414	3.3553	0.1139	2929.0	2953.0	24.0	1.21	1.21	1.21	1746.1	65.2
14-Sep-12	Cloudy	298.7	760.1	3.2691	3.5084	0.2393	2953.0	2977.0	24.0	1.22	1.22	1.22	1753.4	136.5
20-Sep-12	Cloudy	299.9	761.8	3.0888	3.3225	0.2337	2977.0	3001.0	24.0	1.22	1.22	1.22	1752.0	133.4
26-Sep-12	Cloudy	301.2	758.6	3.1886	3.2802	0.0916	3001.0	3025.0	24.0	1.21	1.21	1.21	1739.8	52.6
													Min	44.6
													Max	400 E

Max 136.5 Average 86.5

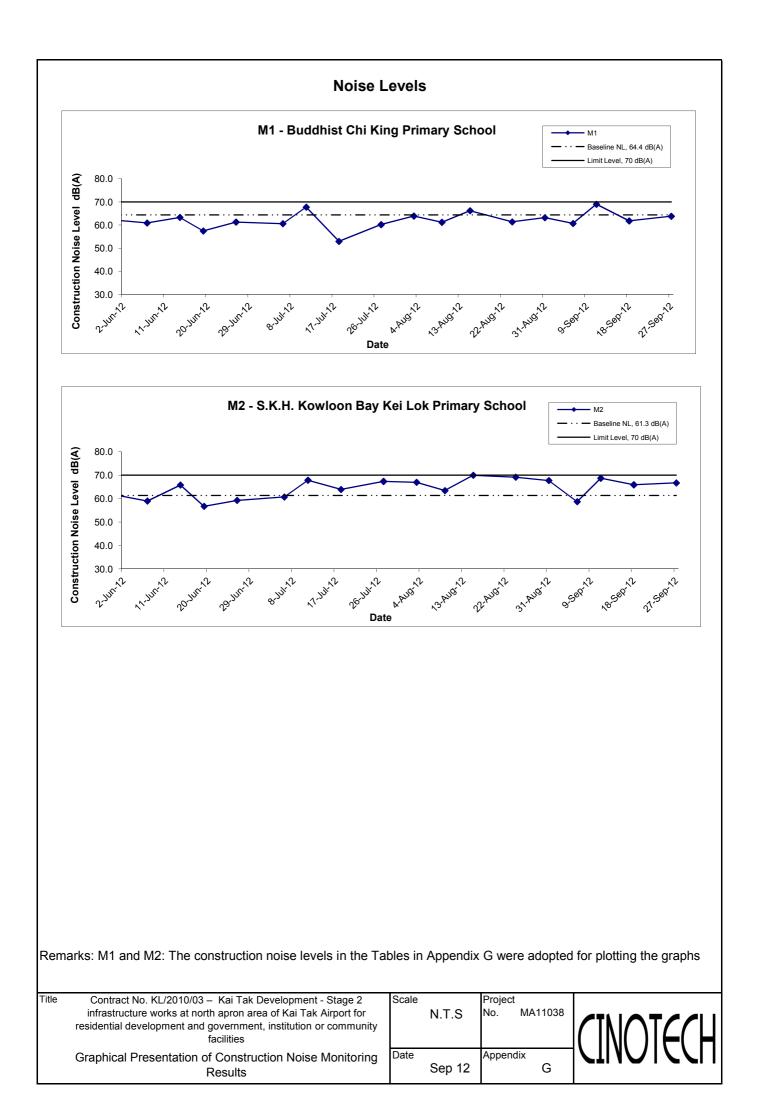
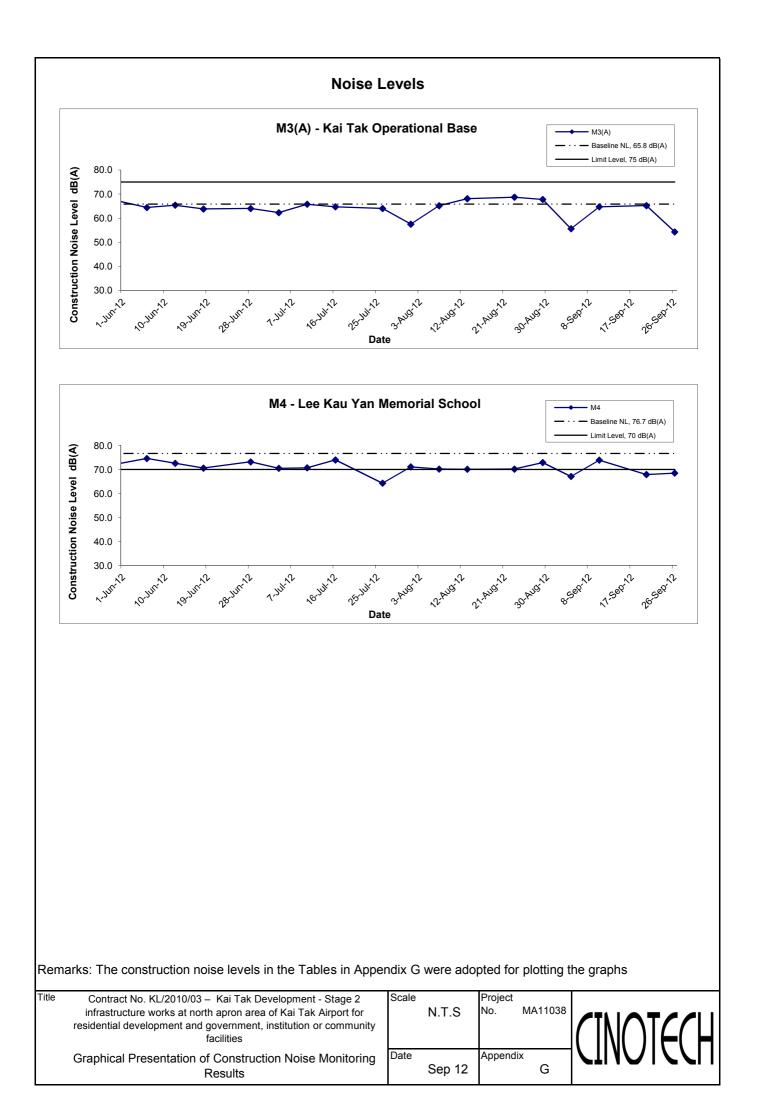
Appendix G - Noise Monitoring Results

Location M3(A	Location M3(A) - Kai Tak Operational Base											
				Unit: dB (A) (30-min)								
Date	Time	Weather	Measured Noise Level			Baseline Level	Construction Noise Level					
			L _{eq}	L ₁₀	L ₉₀	L _{eq}	L _{eq}					
4-Sep-12	14:20	Cloudy	66.2	69.9	62.5		55.6					
10-Sep-12	14:15	Sunny	68.3	71.9	64.2	65.8	64.7					
20-Sep-12	15:15	Cloudy	68.5	72.9	63.6	05.0	65.2					
26-Sep-12	13:00	Cloudy	66.1	72.0	63.3		54.3

Location M4 -	Location M4 - Lee Kau Yan Memorial School									
			Unit: dB (A) (30-min)							
Date	Time	Weather	Meas	sured Noise I	Level	Baseline Level	Construction Noise Level			
			L _{eq}	L ₁₀	L ₉₀	L _{eq}	L _{eq}			
4-Sep-12	13:00	Cloudy	67.1	69.9	64.1		67.1 Measured \leq Baseline			
10-Sep-12	13:00	Sunny	73.9	74.9	68.2	76.7	73.9 Measured \leq Baseline			
20-Sep-12	13:00	Cloudy	67.9	73.5	61.1	70.7	67.9 Measured \leq Baseline			
26-Sep-12	13:00	Cloudy	68.5	73.9	64.2		68.5 Measured \leq Baseline
