EP-344/2009 – New Sewage Pumping Stations Serving KTD and
EP-337/2009 – New Distributor Roads Serving the Planned KTD

Contract No. KL/2010/03

Kai Tak Development - Stage 2 infrastructure works at north
apron area of Kai Tak Airport for residential development
and government, institution or community facilities

Monthly EM&A Report

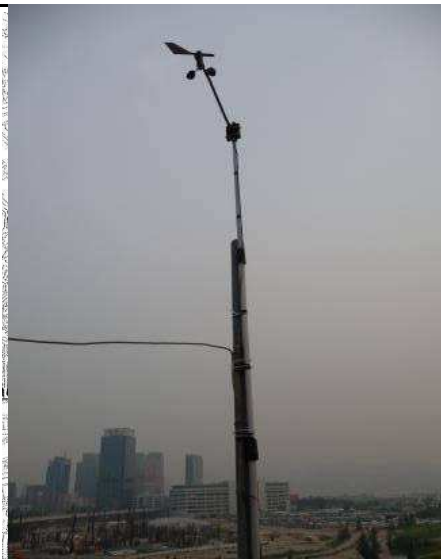
Title	EP-344/2009 – New Sewage Pumping Stations Serving KTD and EP-337/2009 – New Distributor Roads Serving the Planned KTD		Scale	N.T.S	Project No.	MA11038	CINOTECH
	Location of Wind Data Monitoring Equipment		Date	Nov 11	Figure	4

- 2.21 The air temperature, precipitation and the relative humidity data was obtained from Hong Kong Observatory where the wind speed and wind direction were recorded by the installed Wind Anemometer set at rooftop (about 9/F) of Kai Tak Operational Base. The location is shown in **Figure 4**. This weather information for the reporting month is summarized in **Appendix C**.

Wind Data Monitoring Equipment set at Kai Tak Operational Base

Anemometer Station from The Hong Kong Observatory
