EP-344/2009 – New Sewage Pumping Stations Serving KTD and
EP-337/2009 – New Distributor Roads Serving the Planned KTD

Contract No. KL/2010/03

Kai Tak Development - Stage 2 infrastructure works at north
apron area of Kai Tak Airport for residential development
and government, institution or community facilities

Monthly EM&A Report

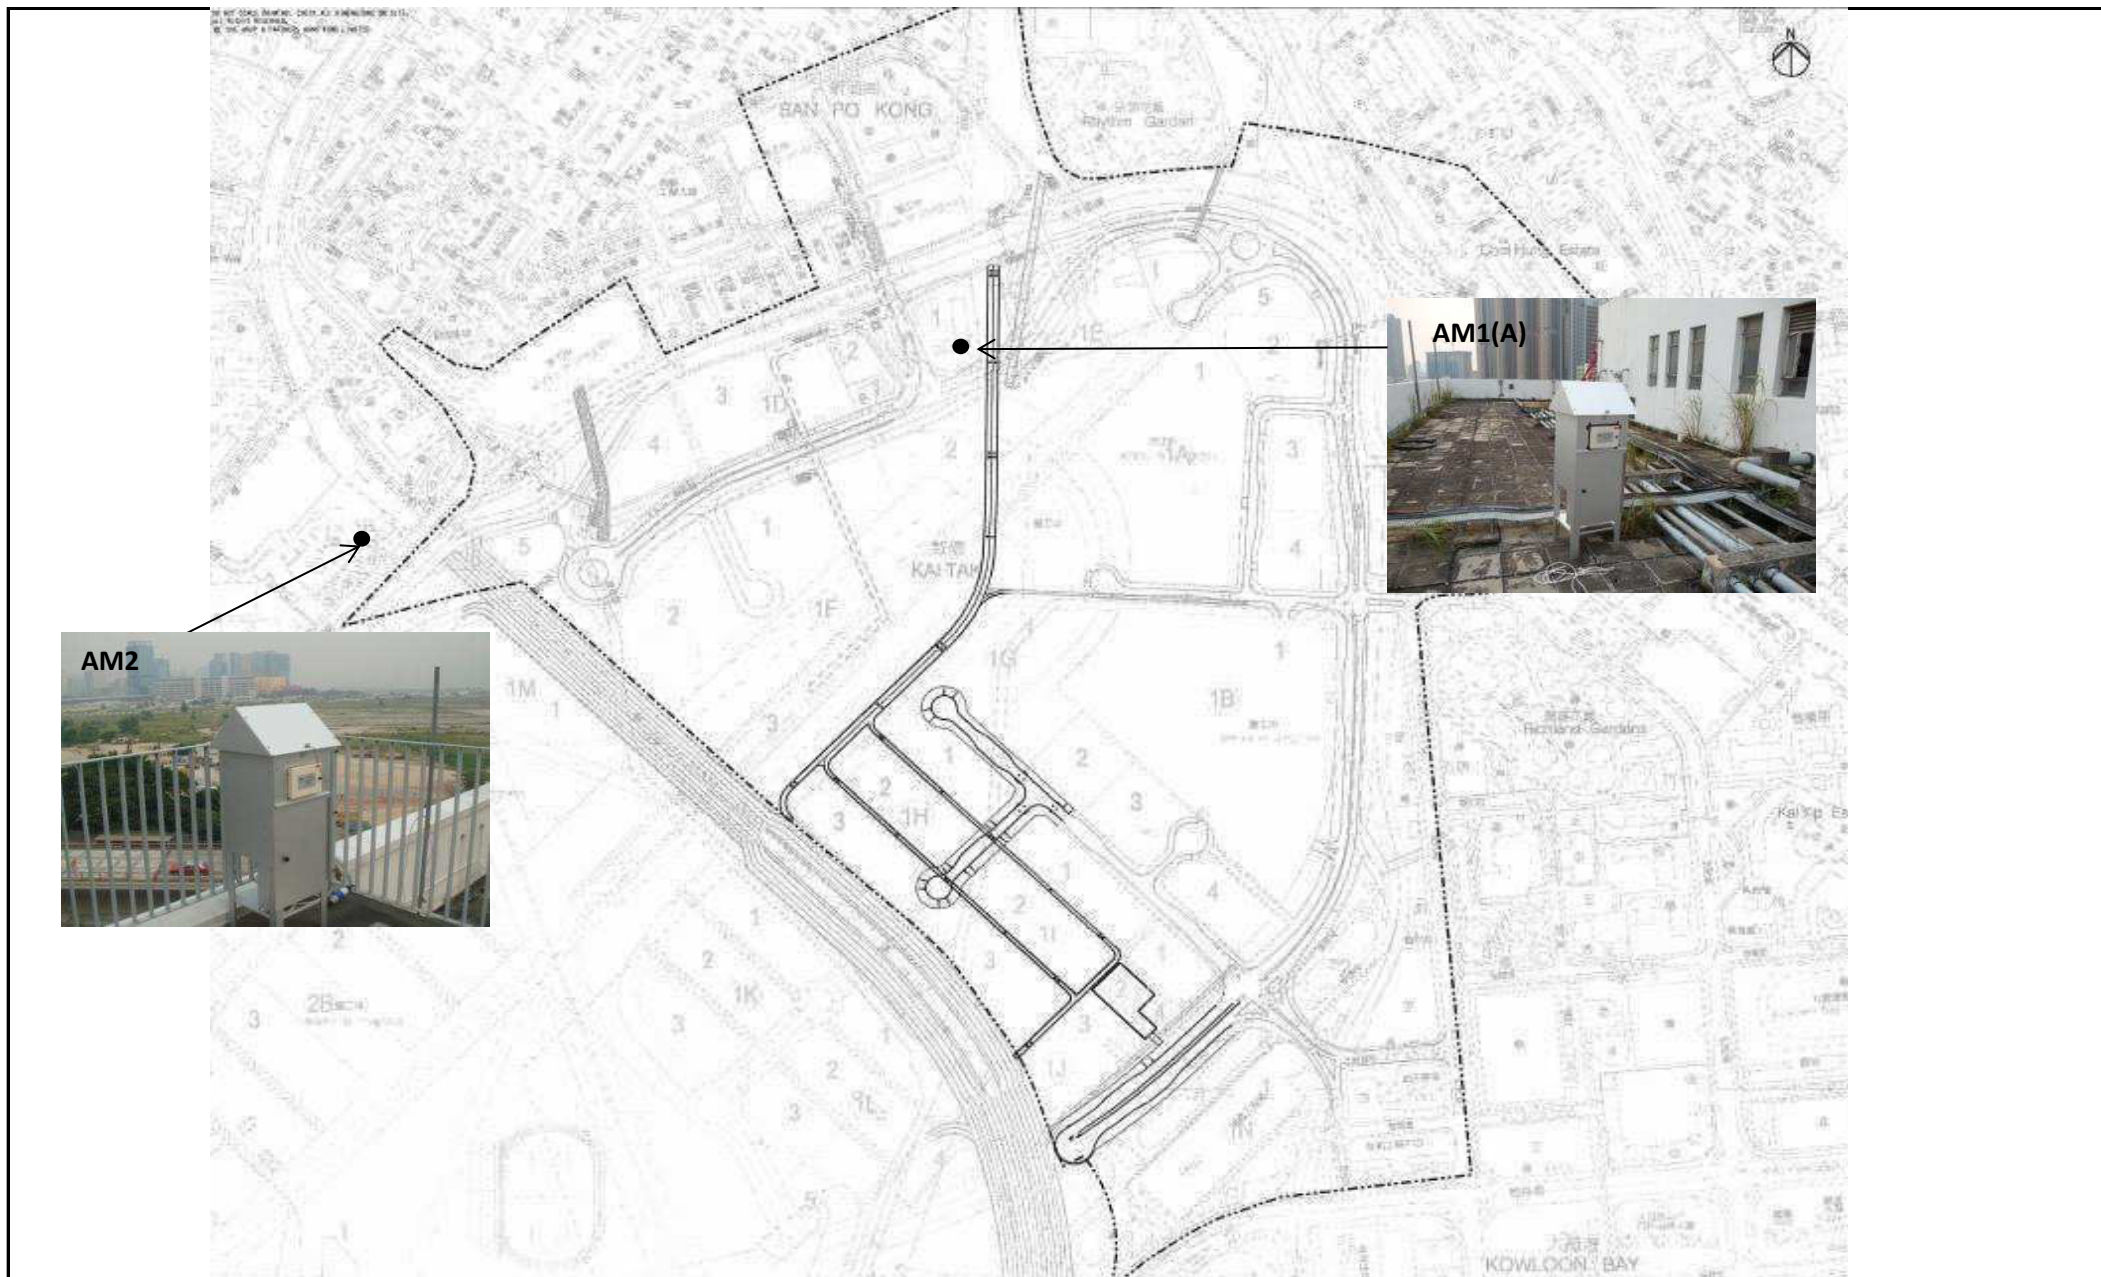
Title	EP-344/2009 – New Sewage Pumping Stations Serving KTD and EP-337/2009 – New Distributor Roads Serving the Planned KTD		Scale	N.T.S	Project No.	MA11038	CINOTECH
			Date	Nov 11	Figure	2

Location of Air Quality Monitoring Stations

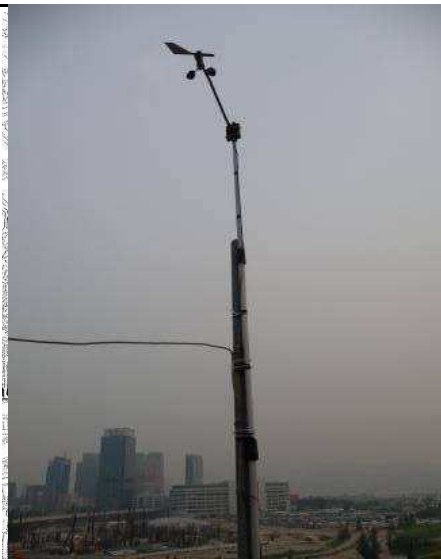
Wind Data Monitoring Equipment set at Kai Tak Operational Base

- 2.21 The air temperature, precipitation and the relative humidity data was obtained from Hong Kong Observatory where the wind speed and wind direction were recorded by the installed Wind Anemometer set at rooftop (about 9/F) of Kai Tak Operational Base. The location is shown in **Figure 4**. This weather information for the reporting month is summarized in **Appendix C**.
