EP-344/2009 – New Sewage Pumping Stations Serving KTD and
EP-337/2009 – New Distributor Roads Serving the Planned KTD

Contract No. KL/2010/03

Monthly EM&A Report

February 2013

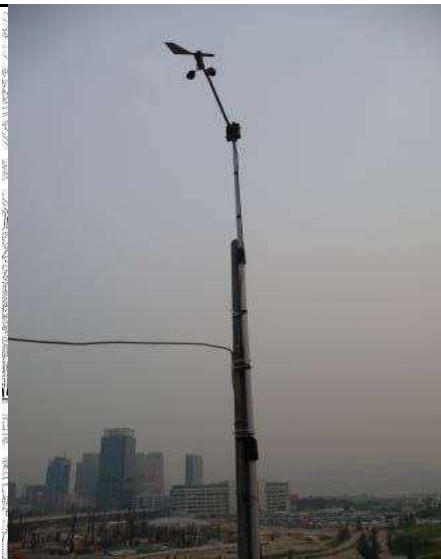
- 2.21 The air temperature, precipitation and the relative humidity data was obtained from Hong Kong Observatory where the wind speed and wind direction were recorded by the installed Wind Anemometer set at rooftop (about 9/F) of Kai Tak Operational Base. The location is shown in **Figure 4**. This weather information for the reporting month is summarized in **Appendix C**.

Wind Data Monitoring Equipment set at Kai Tak Operational Base

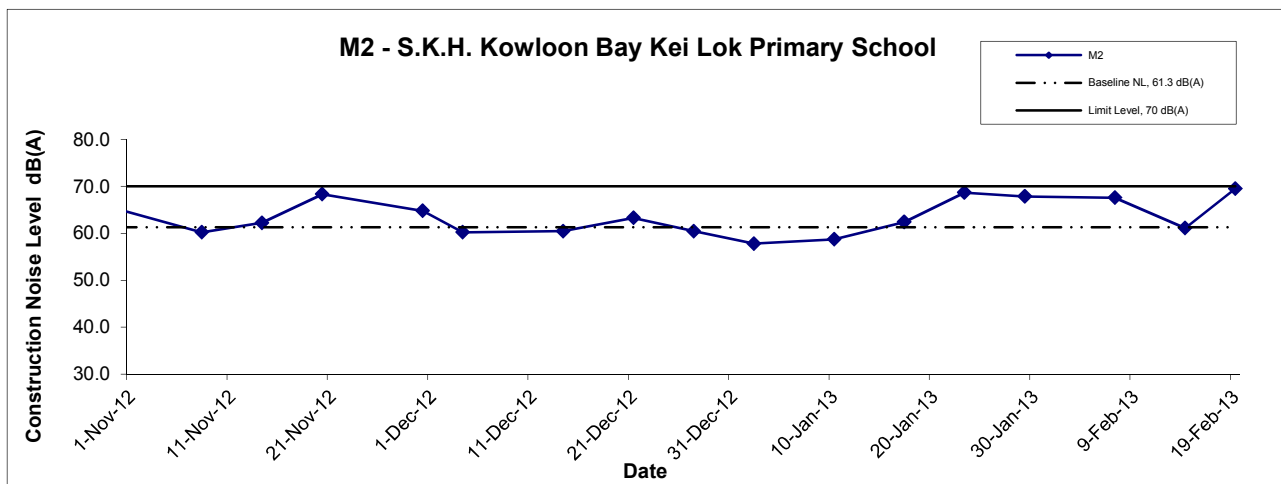
Title Contract No. KL/2010/03 – Kai Tak Development - Stage 2 infrastructure works at north apron area of Kai Tak Airport for residential development and government, institution or community facilities Graphical Presentation of Construction Noise Monitoring Results	Scale N.T.S	Project No. MA11038

Noise Levels

Remarks: M1 and M2: The construction noise levels in the Tables in Appendix G were adopted for plotting the graphs
