EP-344/2009 – New Sewage Pumping Stations Serving KTD and  
EP-337/2009 – New Distributor Roads Serving the Planned KTD

Contract No. KL/2010/03  
Kai Tak Development - Stage 2 infrastructure works at north  
apron area of Kai Tak Airport for residential development  
and government, institution or community facilities

Monthly EM&A Report

March 2013

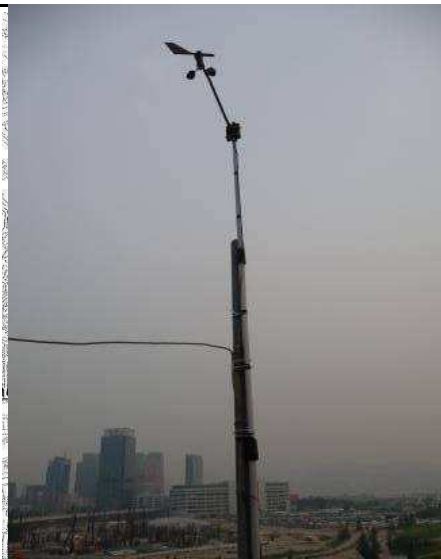
Wind Data Monitoring Equipment set at Kai Tak Operational Base

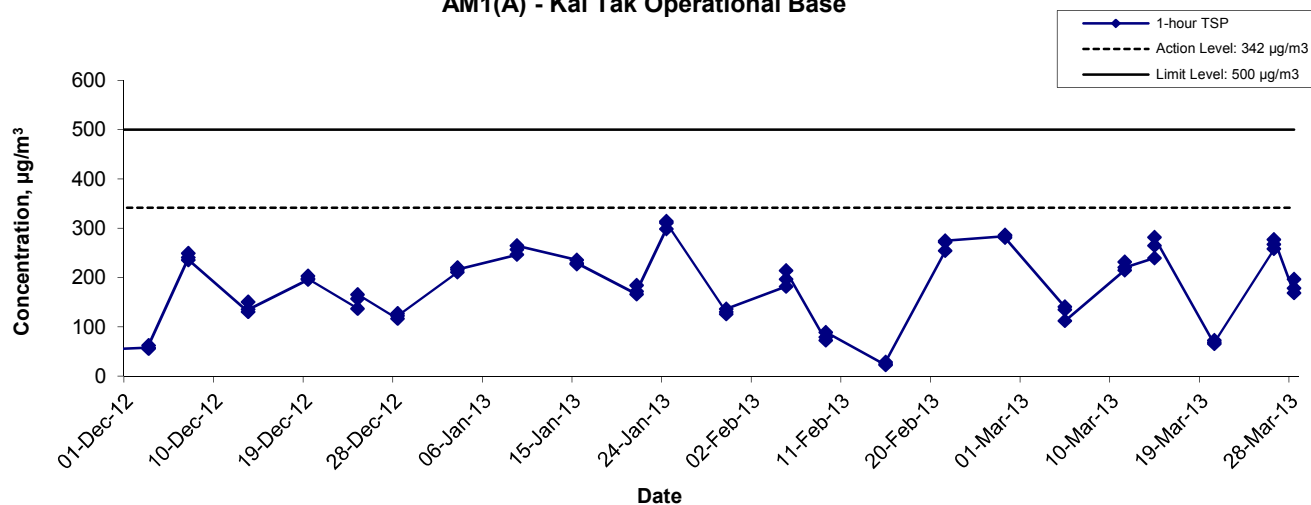
**AM1(A) - Kai Tak Operational Base**

Title	Contract No. KLN/2010/04	Scale	Project	CINOTECH
	Environmental Monitoring Works for Kai Tak Development	N.T.S	No. MA11038	
	Graphical Presentation of 1-hour TSP Monitoring Results	Date Mar 13	Appendix E

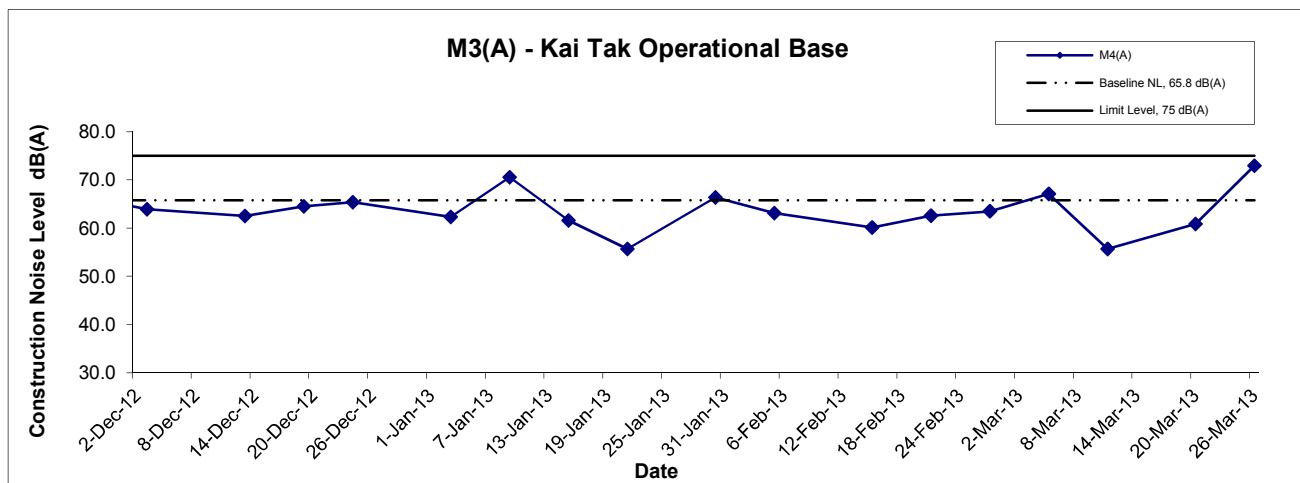
Remarks: M1 and M2: The construction noise levels in the Tables in Appendix G were adopted for plotting the graphs

<b>Title</b> Contract No. KLN/2010/04 Environmental Monitoring Works for Kai Tak Development Graphical Presentation of Construction Noise Monitoring Results	<b>Scale</b> N.T.S	<b>Project No.</b> MA11038	
	<b>Date</b> Mar 13	<b>Appendix</b> G
