# Civil Engineering and Development Department

**Contract No. KL/2010/03  
Kai Tak Development - Stage 2  
infrastructure works at north apron area of  
Kai Tak Airport for residential  
development and government, institution or  
community facilities**

Quarterly EM&A Report

November 2013 to January 2014

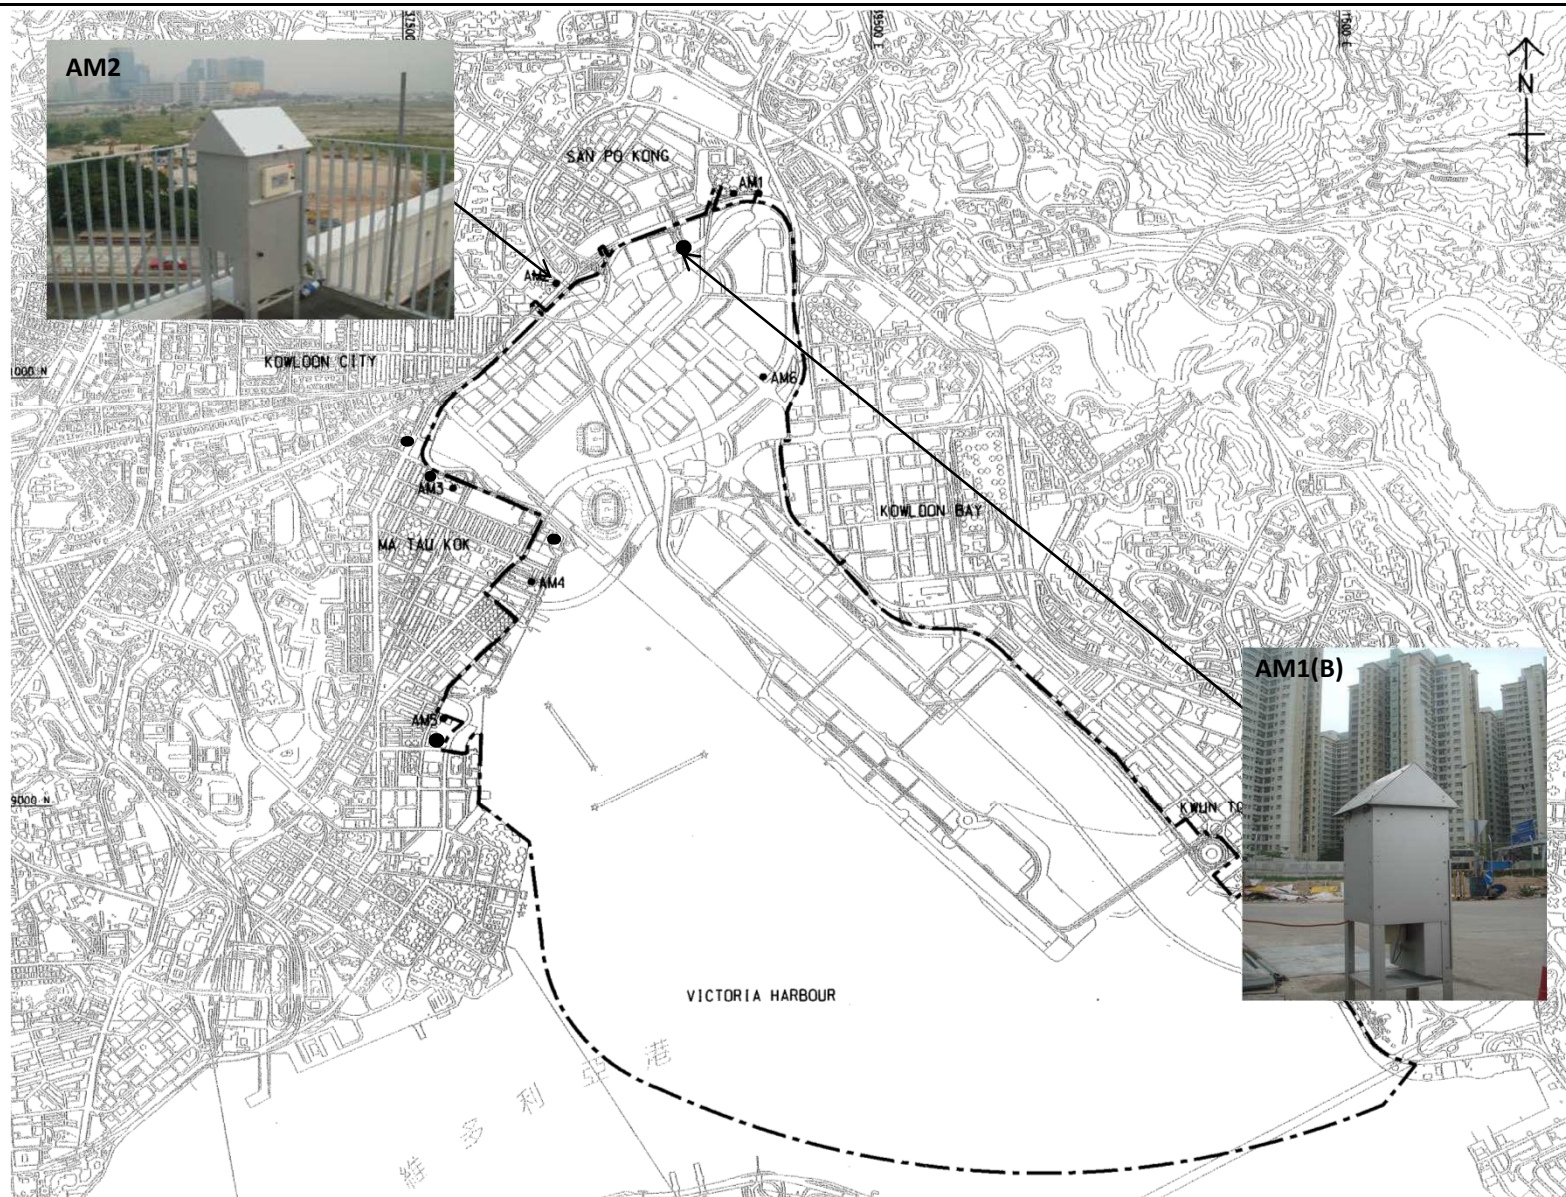
| | Location of Air Quality Monitoring Stations | Jul 13 | 2 | |

1. This is the 9<sup>th</sup> Quarterly Environmental Monitoring and Audit (EM&A) Report prepared by Cinotech Consultants Limited for the “Contract No. KL/2010/03 - Kai Tak Development - Stage 2 infrastructure works at north apron area of Kai Tak Airport for residential development and government, institution or community facilities” (hereinafter called “the Project”). This summary report presents the EM&A works performed in the period between November 2013 and January 2014.
2. With reference to the same principle of EIA report of the Project, air quality monitoring stations within 500m and noise monitoring stations within 300m from the boundary of this Project are considered as relevant monitoring locations. In such regard, the relevant air quality and noise monitoring locations are tabulated in **Table I** (see **Figure 2** and **3** for their locations).

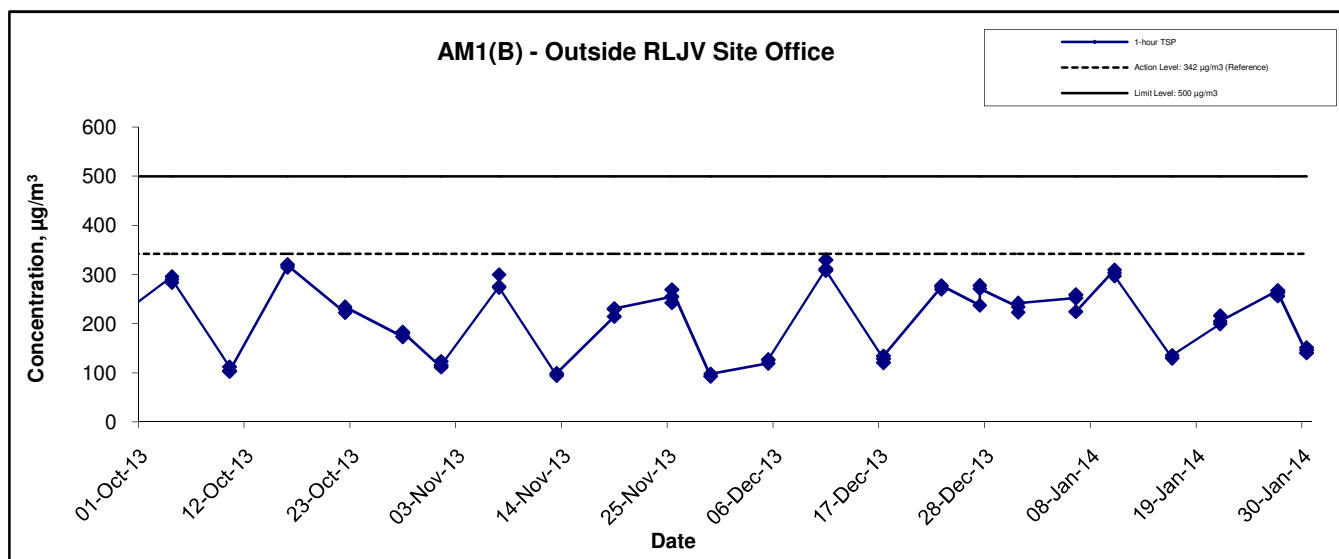
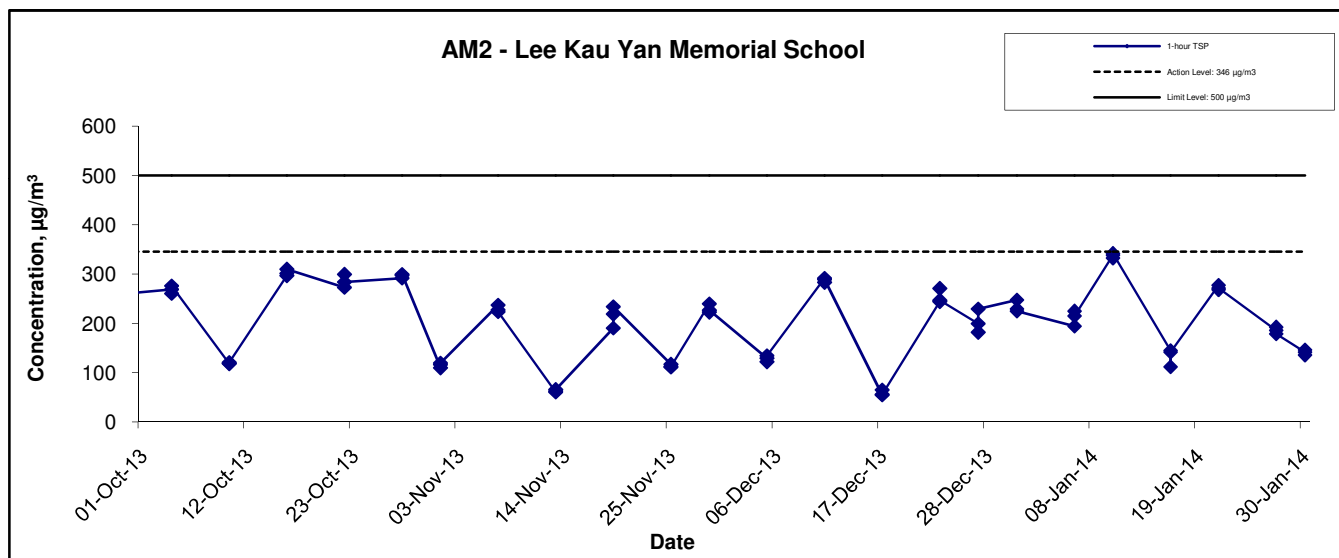
## 1-hr TSP Concentration Levels

7. All 1-hour TSP monitoring was conducted as scheduled in the reporting quarter. No Action/Limit Level exceedance was recorded.

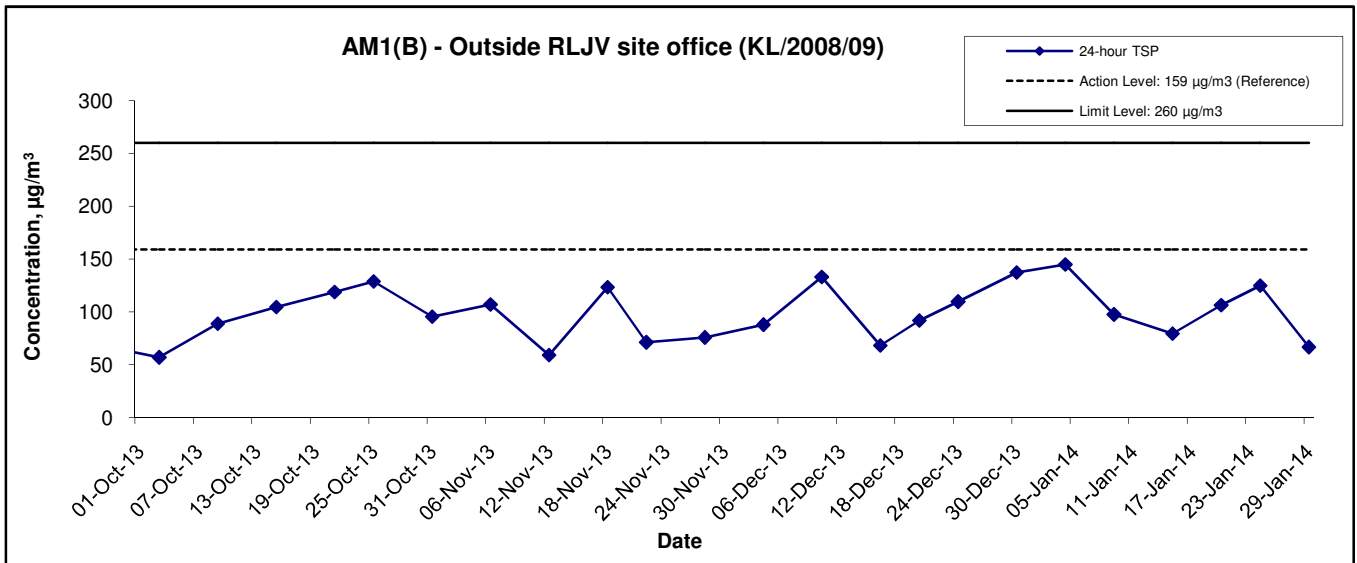
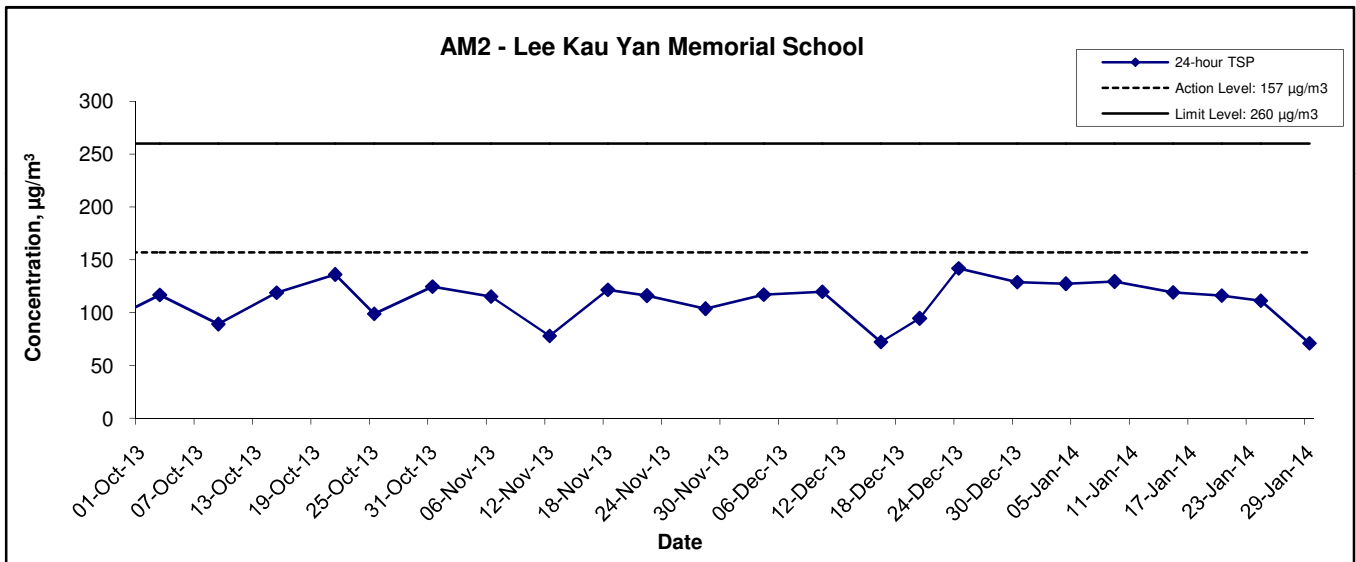
## 24-hr TSP Concentration Levels

8. All 24-hour TSP monitoring was conducted as scheduled in the reporting quarter. No Action/Limit Level exceedance was recorded

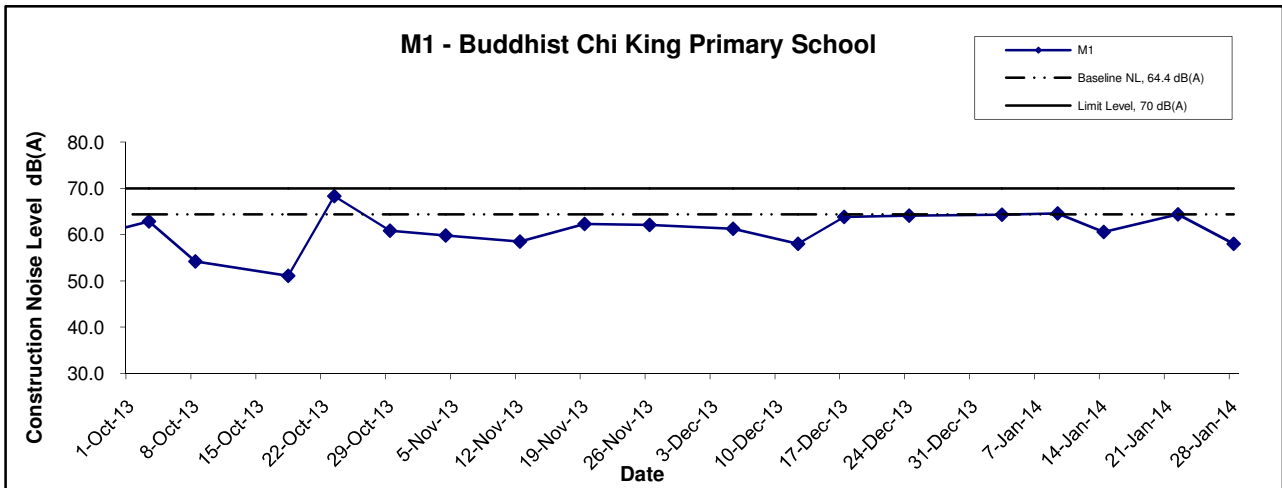
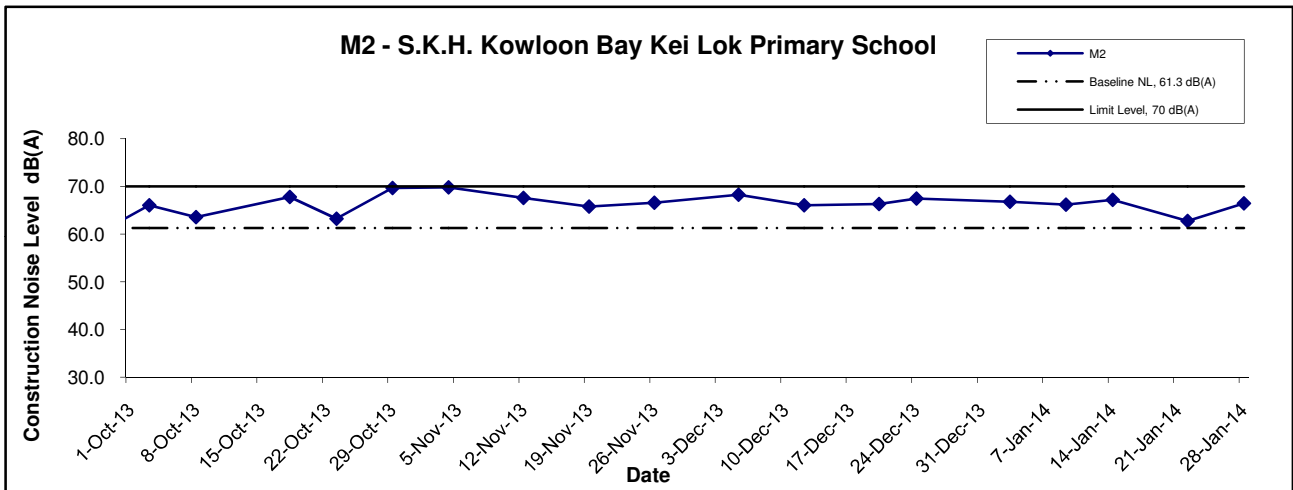
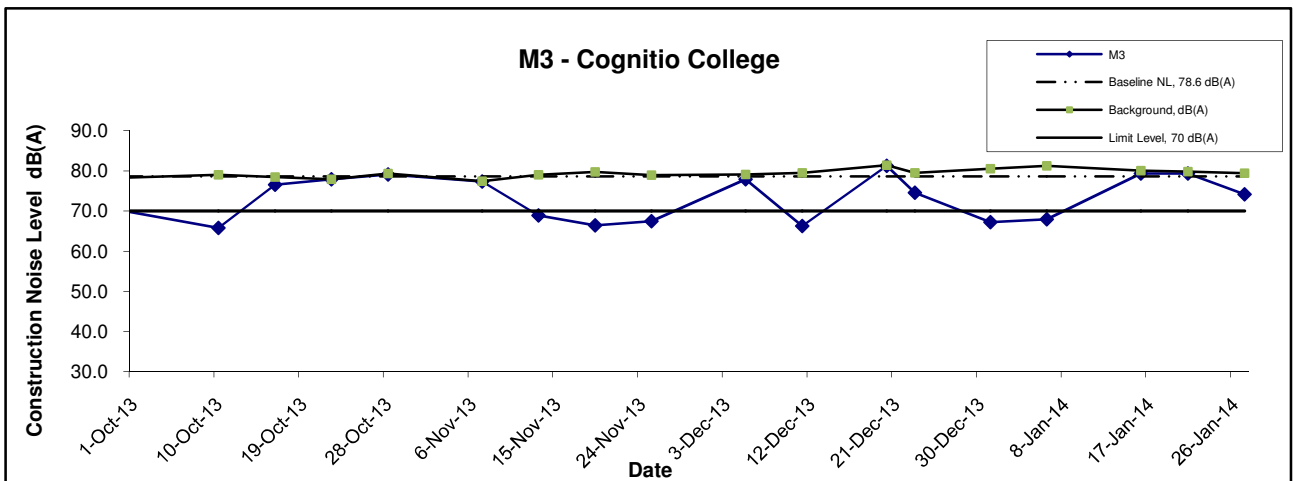
## Noise Levels

10. All construction noise monitoring was conducted as scheduled in the reporting quarter. 1 non-project related exceedances of Noise Limit level were recorded in December 2013. Details of the exceedance could be referred to **Section 3.9** of this report.

Remark: The measurement of Background Noise at M3 was started from 9 September 2013 for compliance checking of Noise Action/Limit Level.
