EP-344/2009 – New Sewage Pumping Stations Serving KTD and  
EP-337/2009 – New Distributor Roads Serving the Planned KTD

Contract No. KL/2010/03

Kai Tak Development - Stage 2 infrastructure works at north  
apron area of Kai Tak Airport for residential development  
and government, institution or community facilities

Monthly EM&A Report

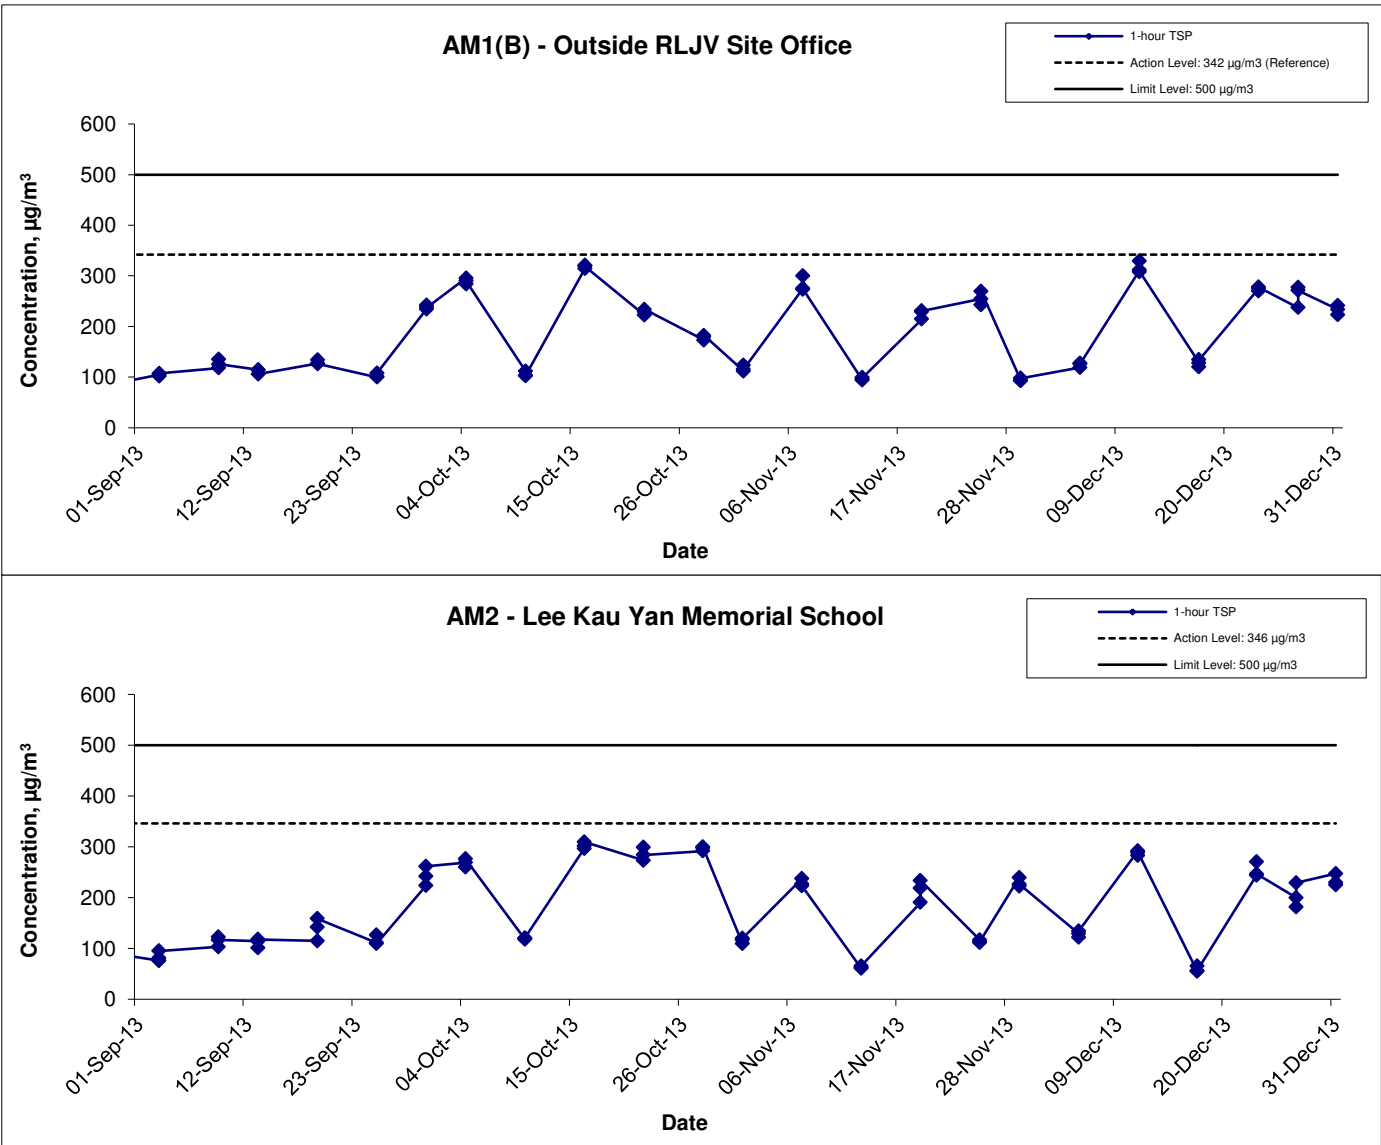
1-hr TSP Concentration Levels

Location AM2 - Lee Kau Yan Memorial School			
Date	Time	Weather	Particulate Concentration ( µg/m³)
5-Dec-13	9:00	Sunny	129.4
5-Dec-13	10:00	Sunny	122.1
5-Dec-13	11:00	Sunny	134.6
11-Dec-13	13:15	Cloudy	292.1
11-Dec-13	14:15	Cloudy	283.2
11-Dec-13	15:15	Cloudy	289.2
17-Dec-13	13:30	Cloudy	55.0
17-Dec-13	14:30	Cloudy	65.3
17-Dec-13	15:30	Cloudy	56.4
23-Dec-13	13:00	Sunny	244.1
23-Dec-13	14:00	Sunny	270.9
23-Dec-13	15:00	Sunny	246.7
27-Dec-13	13:00	Fine	199.9
27-Dec-13	14:00	Fine	181.9
27-Dec-13	15:00	Fine	229.5
31-Dec-13	13:00	Sunny	247.6
31-Dec-13	14:00	Sunny	229.7
31-Dec-13	15:00	Sunny	225.1
Average			194.6
Maximum			292.1
Minimum			55.0

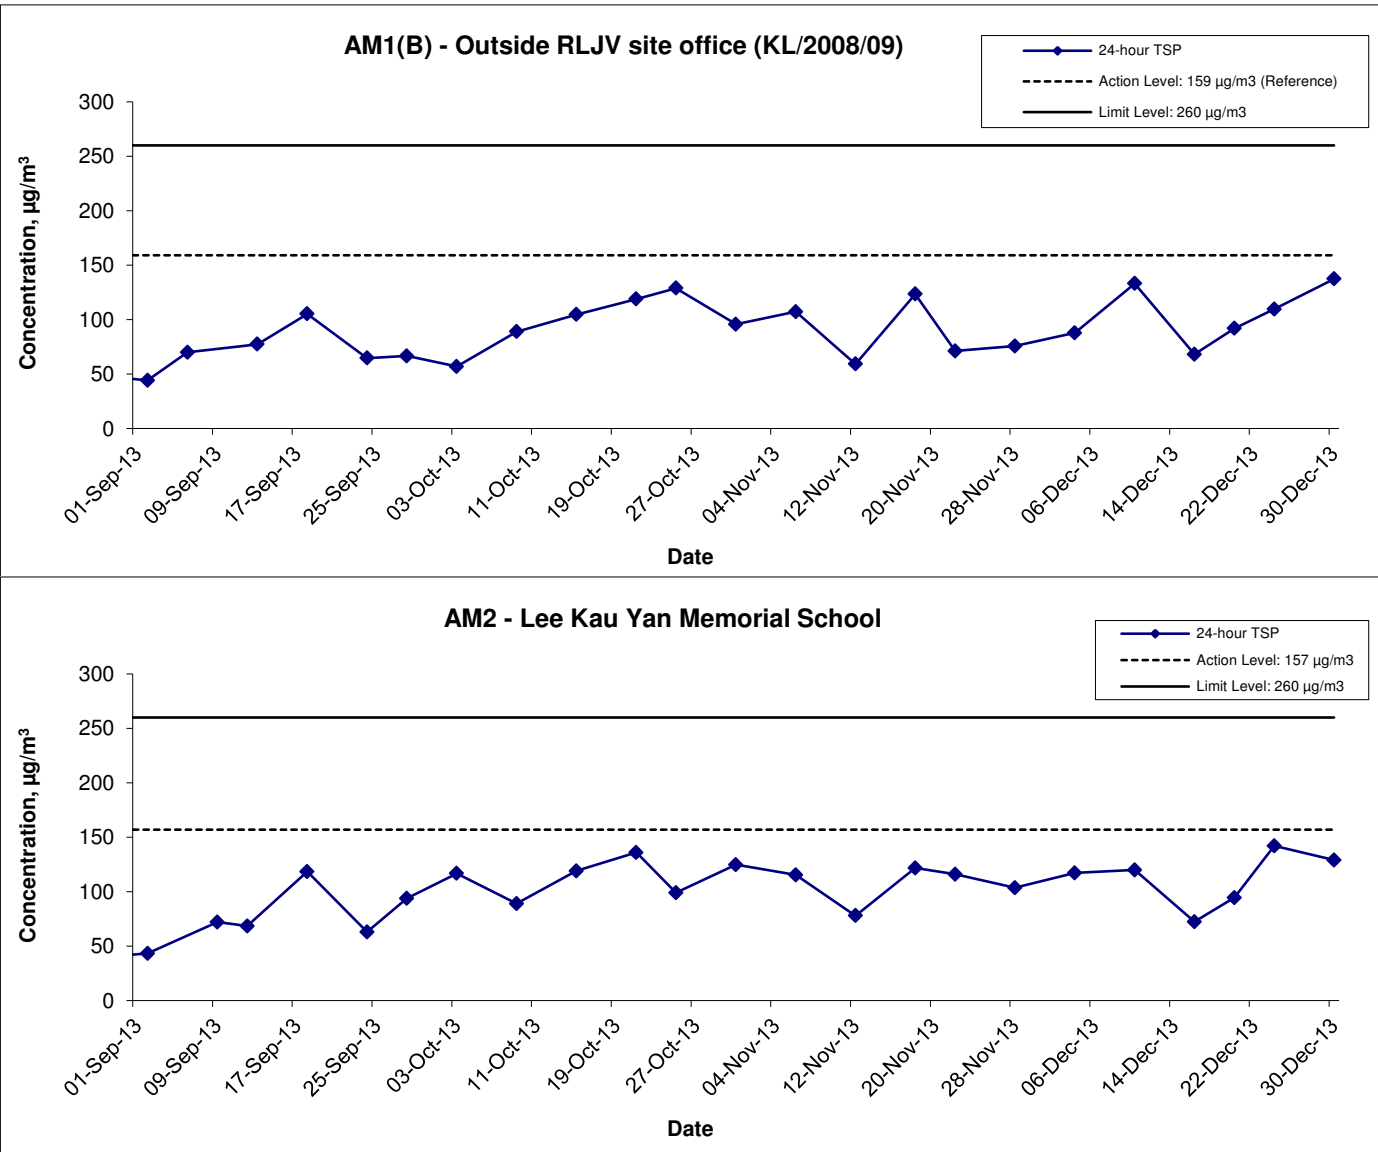
24-hr TSP Concentration Levels

Start Date	Weather Condition	Air Temp. (K)	Atmospheric Pressure, Pa (mmHg)	Filter Weight (g)		Particulate weight (g)	Elapse Time		Sampling Time(hrs.)	Flow Rate (m <sup>3</sup> /min.)		Av. flow (m <sup>3</sup> /min)	Total vol. (m <sup>3</sup> )	Conc. (µg/m <sup>3</sup> )
				Initial	Final		Initial	Final		Initial	Final			
4-Dec-13	Sunny	290.4	767.5	3.6288	3.8359	0.2071	12508.7	12532.7	24.0	1.23	1.23	1.23	1768.7	117.1
10-Dec-13	Sunny	290.3	764.9	3.6420	3.8537	0.2117	12532.7	12556.7	24.0	1.23	1.23	1.23	1766.3	119.9
16-Dec-13	Rainy	284.4	764.9	3.6038	3.7327	0.1289	12556.7	12580.7	24.0	1.24	1.24	1.24	1783.2	72.3
20-Dec-13	Sunny	284.3	771.2	3.5670	3.7362	0.1692	12580.7	12604.7	24.0	1.24	1.24	1.24	1790.2	94.5
24-Dec-13	Sunny	284.9	771.5	3.7131	3.9670	0.2539	12604.7	12628.7	24.0	1.24	1.24	1.24	1788.7	141.9
30-Dec-13	Sunny	283.3	771.2	3.6858	3.9170	0.2312	12628.7	12652.7	24.0	1.25	1.24	1.25	1793.1	128.9
													Min	72.3

Max	141.9
													Average	112.4
