EP-344/2009 – New Sewage Pumping Stations Serving KTD and  
EP-337/2009 – New Distributor Roads Serving the Planned KTD

Contract No. KL/2012/03  
Kai Tak Development –Stage 4 Infrastructure at  
Former North Apron Area

Monthly EM&A Report

March 2014

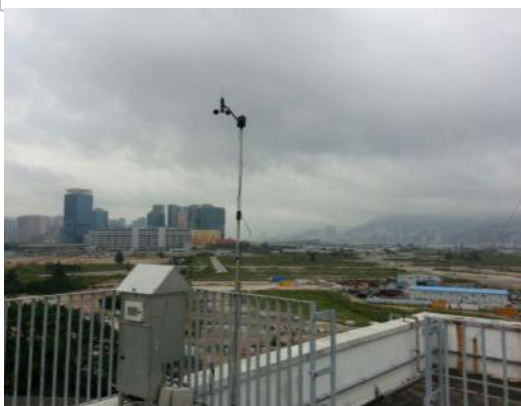
Wind Data Monitoring Equipment set at  
Lee Kau Yan Memorial School

Wind Monitoring Location	Northing	Easting
Lee Kau Yan Memorial School	821441.245	838153.917

- 2.21 The air temperature, precipitation and the relative humidity data was obtained from Hong Kong Observatory where the wind speed and wind direction were recorded by the installed Wind Anemometer set at rooftop (about 8/F) Lee Kau Yan Memorial School. The location is shown in **Figure 4**. This weather information for the reporting month is summarized in **Appendix C**.

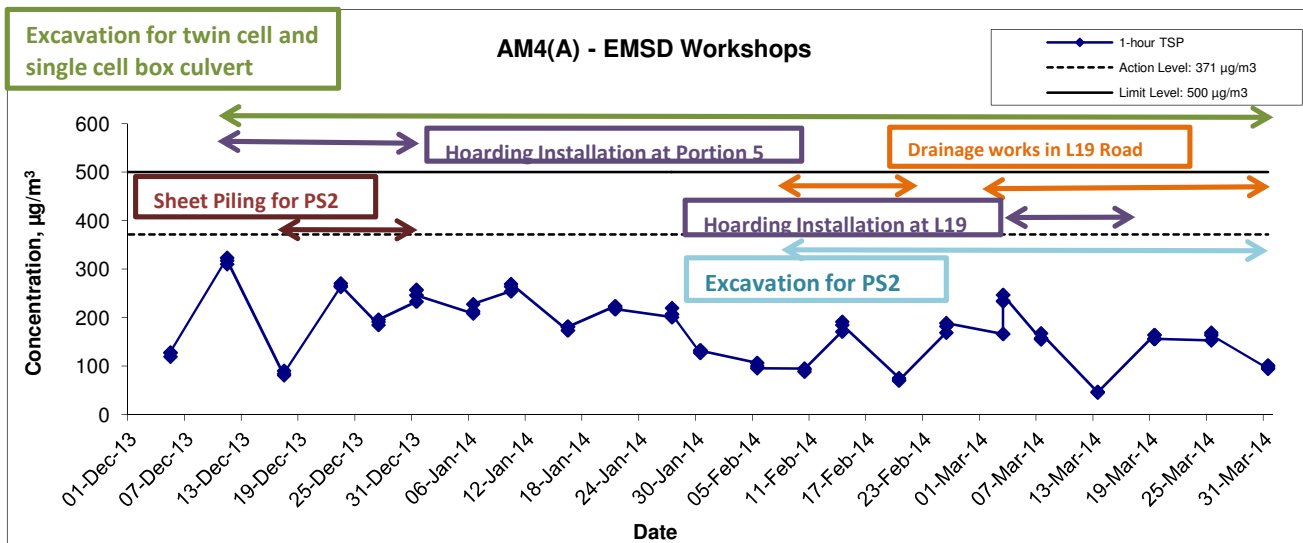
Title	Contract No. KL/2012/03 Kai Tak Development –Stage 4 Infrastructure at Former North Apron Area	Scale N.T.S	Project No. MA13056	CINOTECH
	Graphical Presentation of 1-hour TSP Monitoring Results	Date Mar 14	Appendix E

### 1-hr TSP Concentration Levels
