EP-344/2009 – New Sewage Pumping Stations Serving KTD and
EP-337/2009 – New Distributor Roads Serving the Planned KTD

Contract No. KL/2012/03
Kai Tak Development –Stage 4 Infrastructure at
Former North Apron Area

Monthly EM&A Report

May 2014

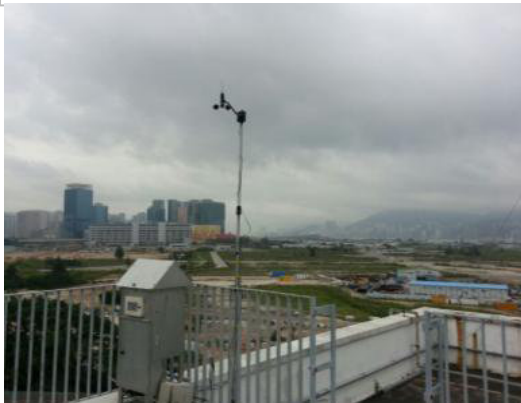
Wind Data Monitoring Equipment set at Lee Kau Yan Memorial School
