EP-344/2009 – New Sewage Pumping Stations Serving KTD and  
EP-337/2009 – New Distributor Roads Serving the Planned KTD

Contract No. KL/2012/03  
Kai Tak Development –Stage 4 Infrastructure at  
Former North Apron Area

Monthly EM&A Report

July 2014

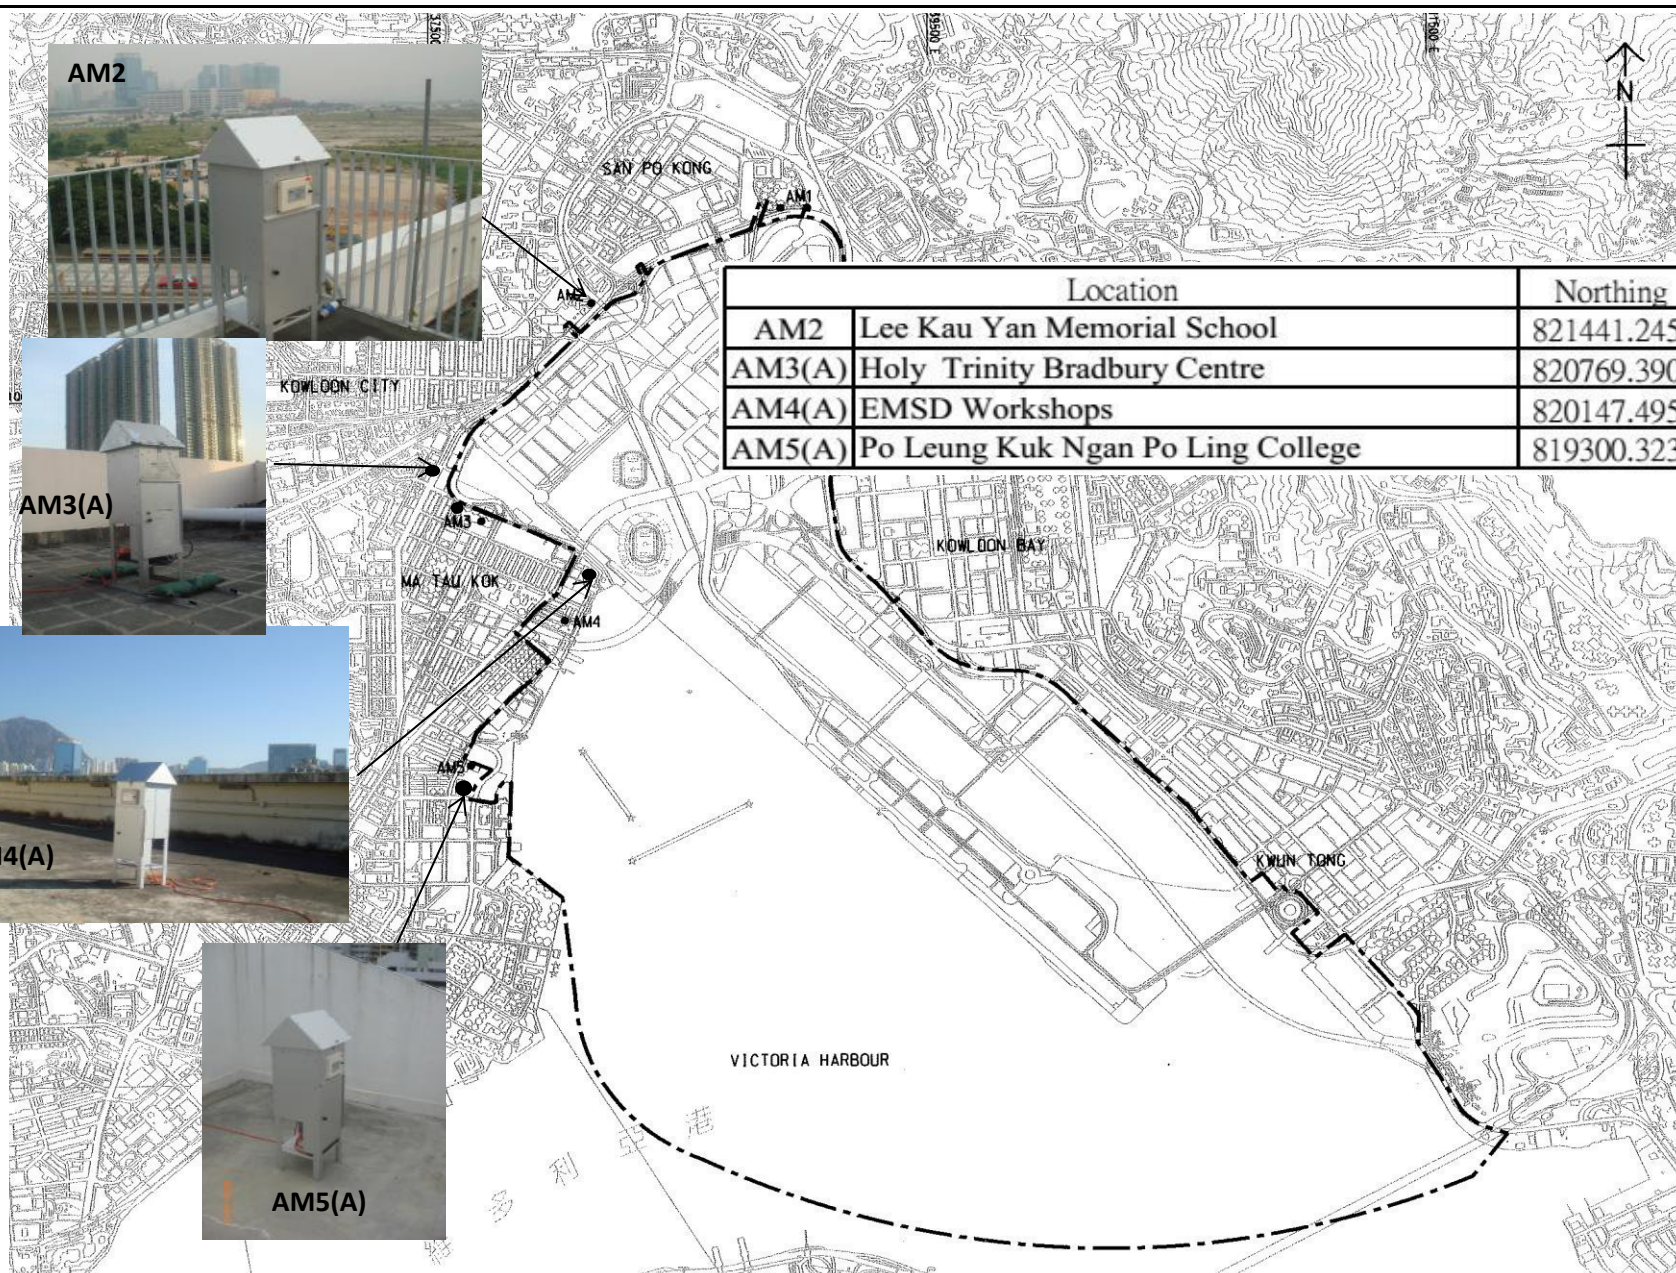
Scale	N.T.S	Project No.	MA13056
Date	Jan-14	Figure	2

Location		Northing	Easting
AM2	Lee Kau Yan Memorial School	821441.245	838153.917
AM3(A)	Holy Trinity Bradbury Centre	820769.390	837522.115
AM4(A)	EMSD Workshops	820147.495	838155.791
AM5(A)	Po Leung Kuk Ngan Po Ling College	819300.323	837659.613

Title Contract No. KL/2012/03  
 Kai Tak Development –Stage 4 Infrastructure at Former North Apron Area  
 Air Quality Monitoring Stations under this Project

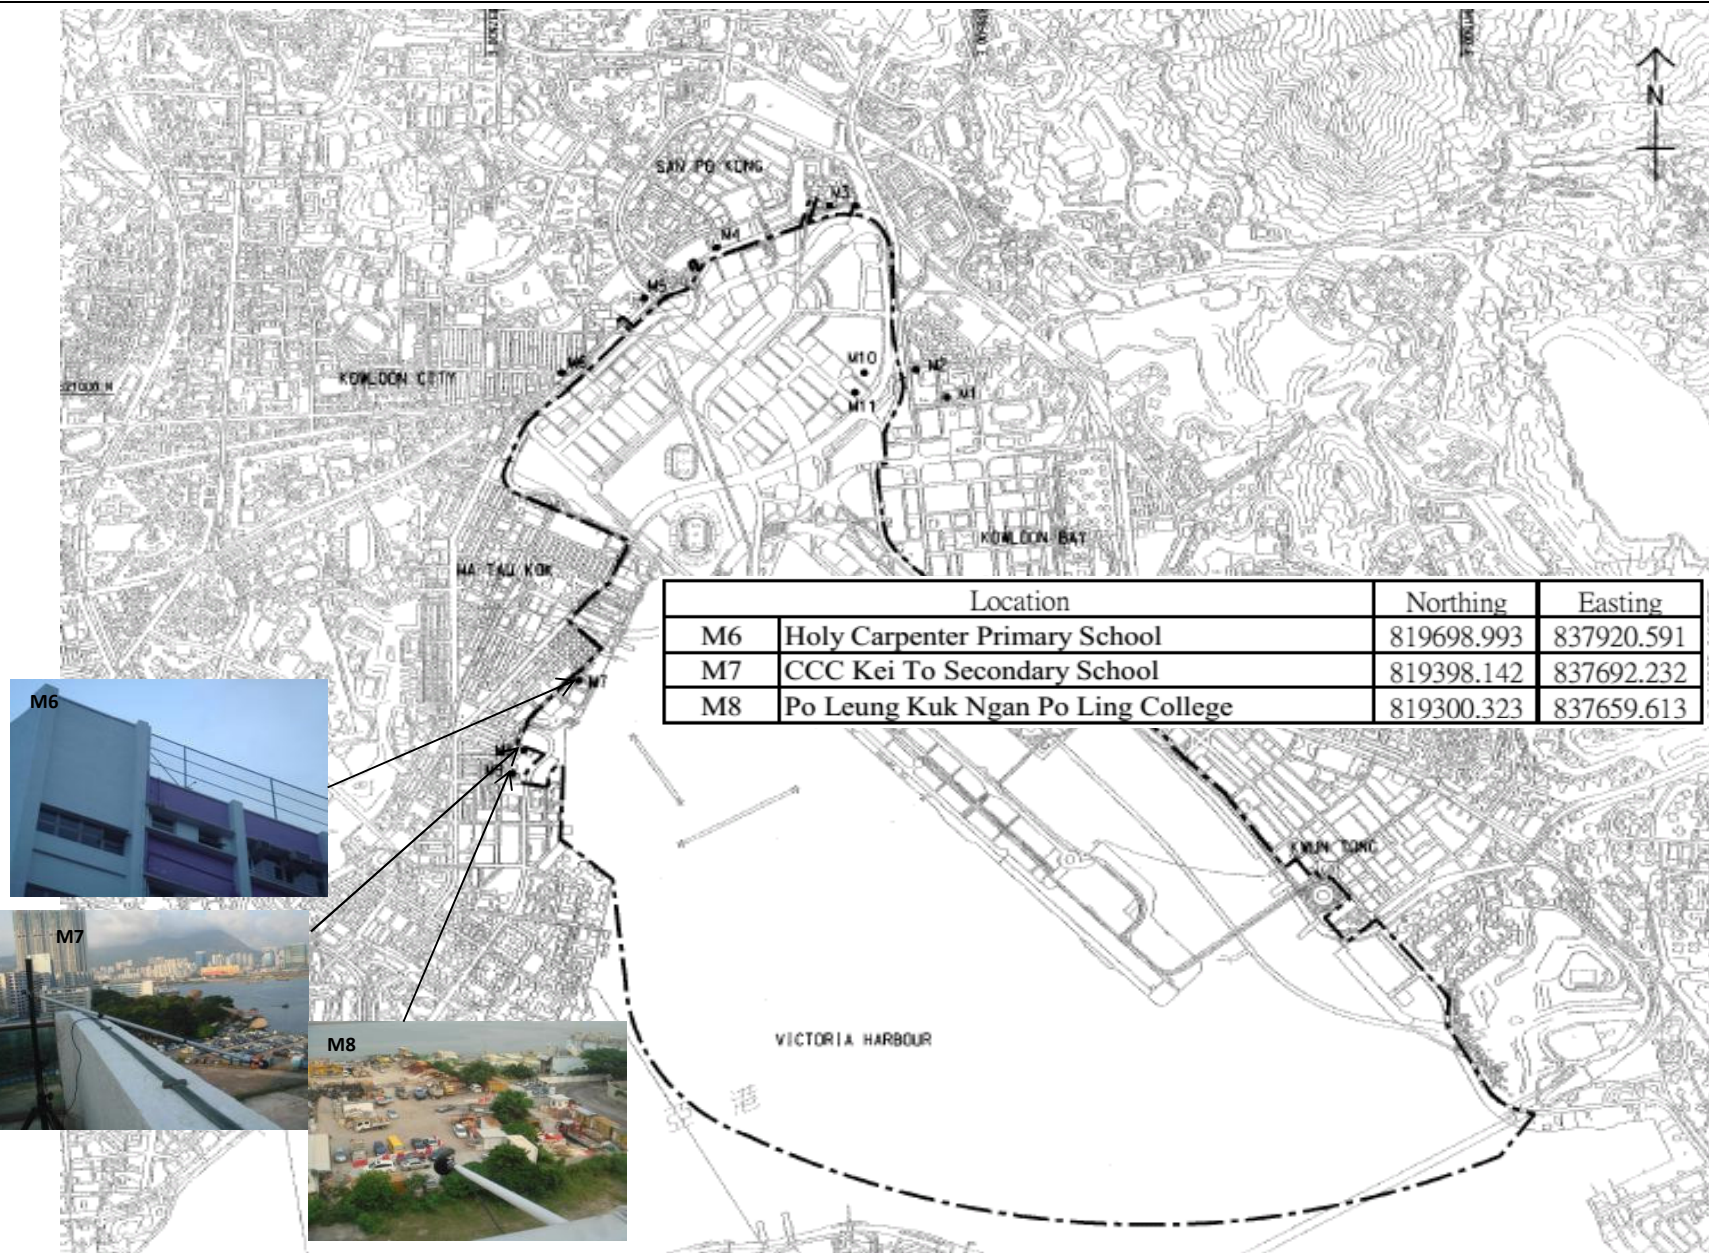
Scale	N.T.S	Project No.	MA13056
Date	Dec-13	Figure	3

Title Contract No. KL/2012/03  
 Kai Tak Development –Stage 4 Infrastructure at Former North Apron Area  
 Noise Monitoring Stations under this Project

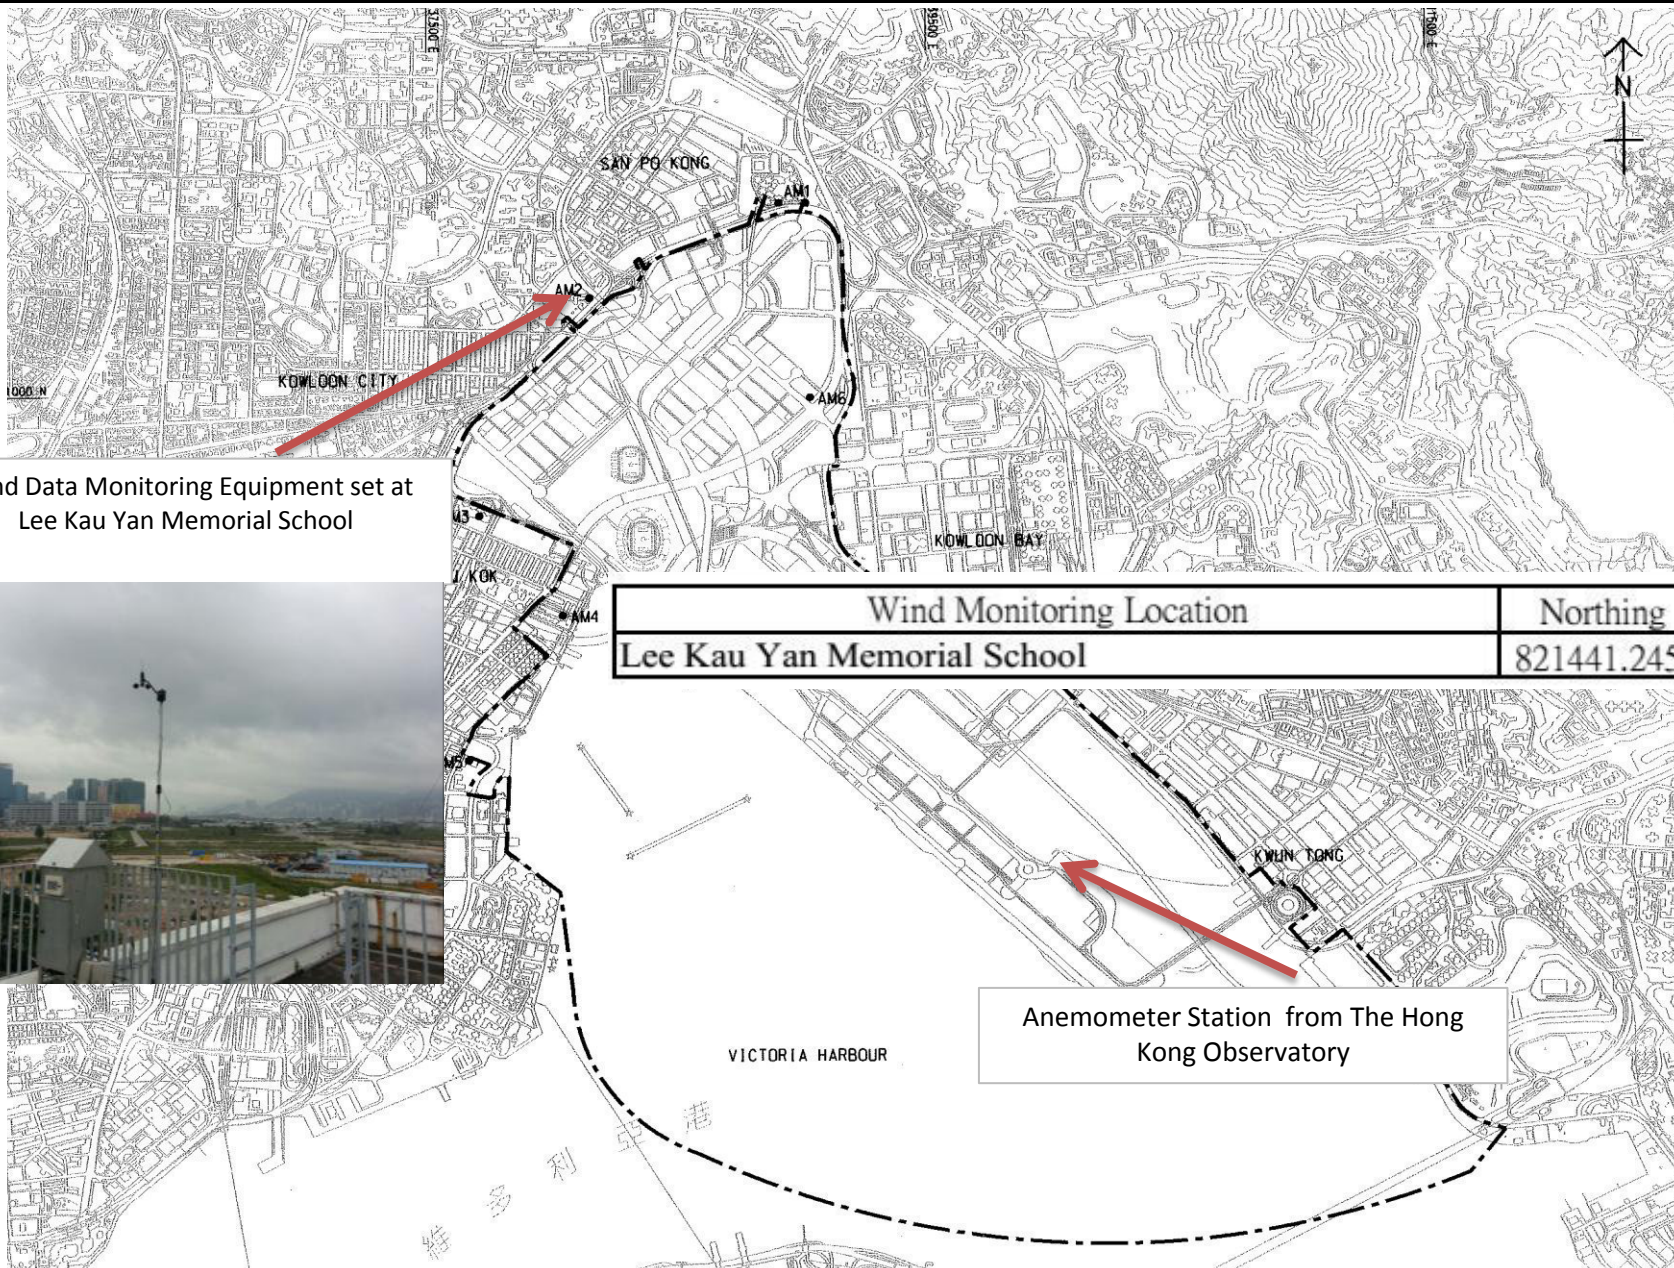
Scale	N.T.S	Project No.	MA13056
Date	Dec-13	Figure	4

Wind Data Monitoring Equipment set at  
Lee Kau Yan Memorial School

Wind Monitoring Location	Northing	Easting
Lee Kau Yan Memorial School	821441.245	838153.917

Anemometer Station from The Hong  
Kong Observatory

- 2.21 The air temperature, precipitation and the relative humidity data was obtained from Hong Kong Observatory where the wind speed and wind direction were recorded by the installed Wind Anemometer set at rooftop (about 8/F) Lee Kau Yan Memorial School. The location is shown in **Figure 4**. This weather information for the reporting month is summarized in **Appendix C**.

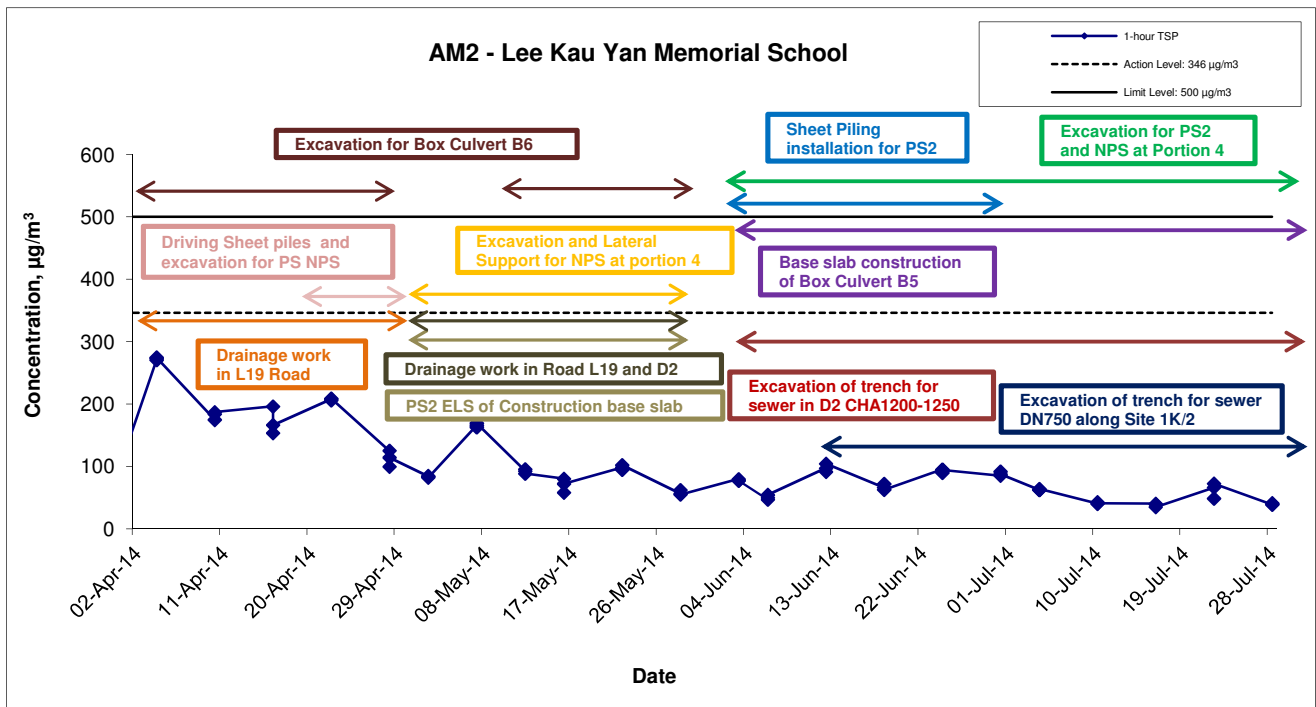
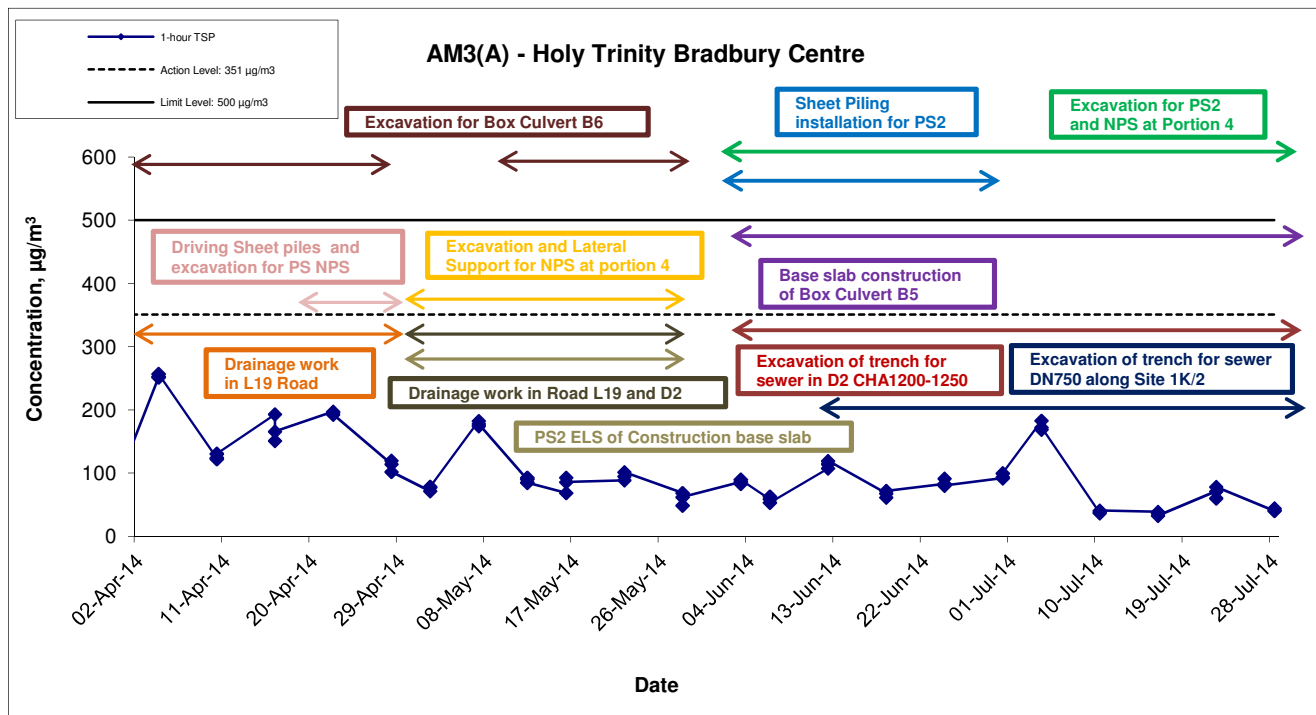
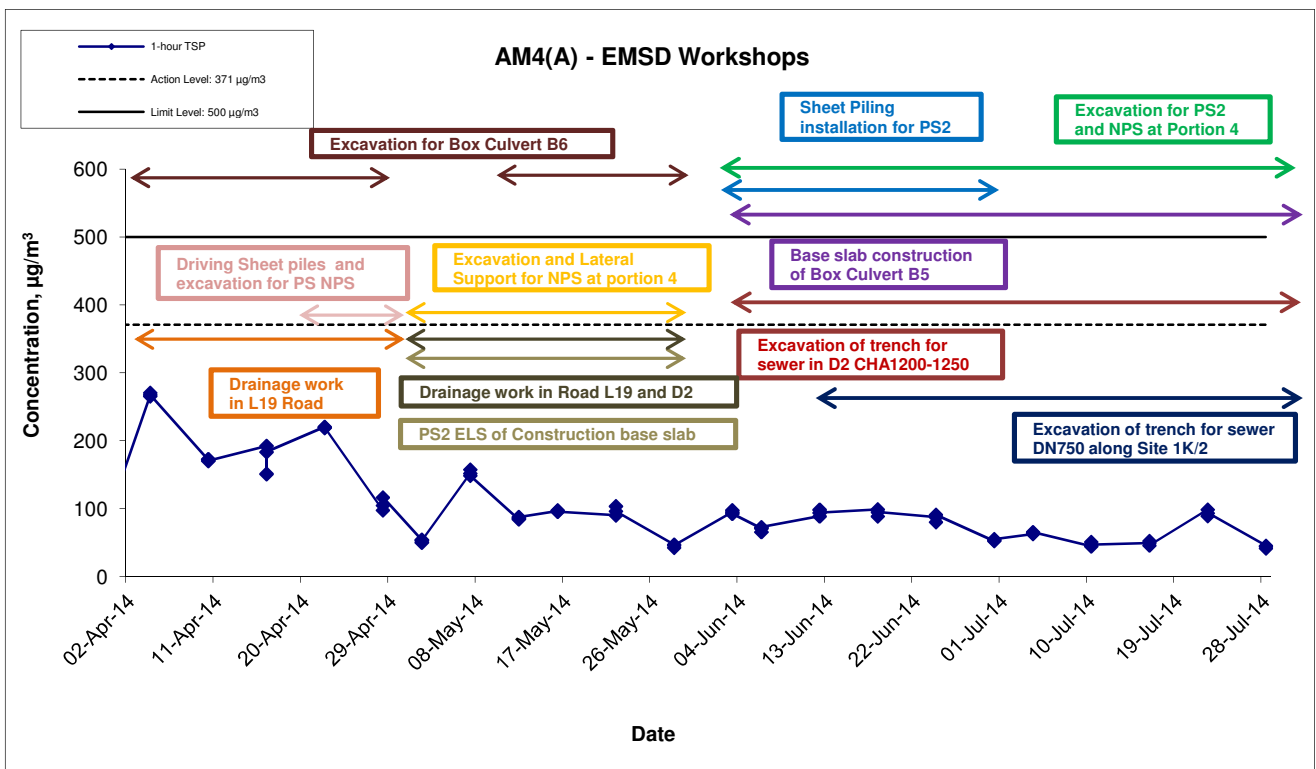
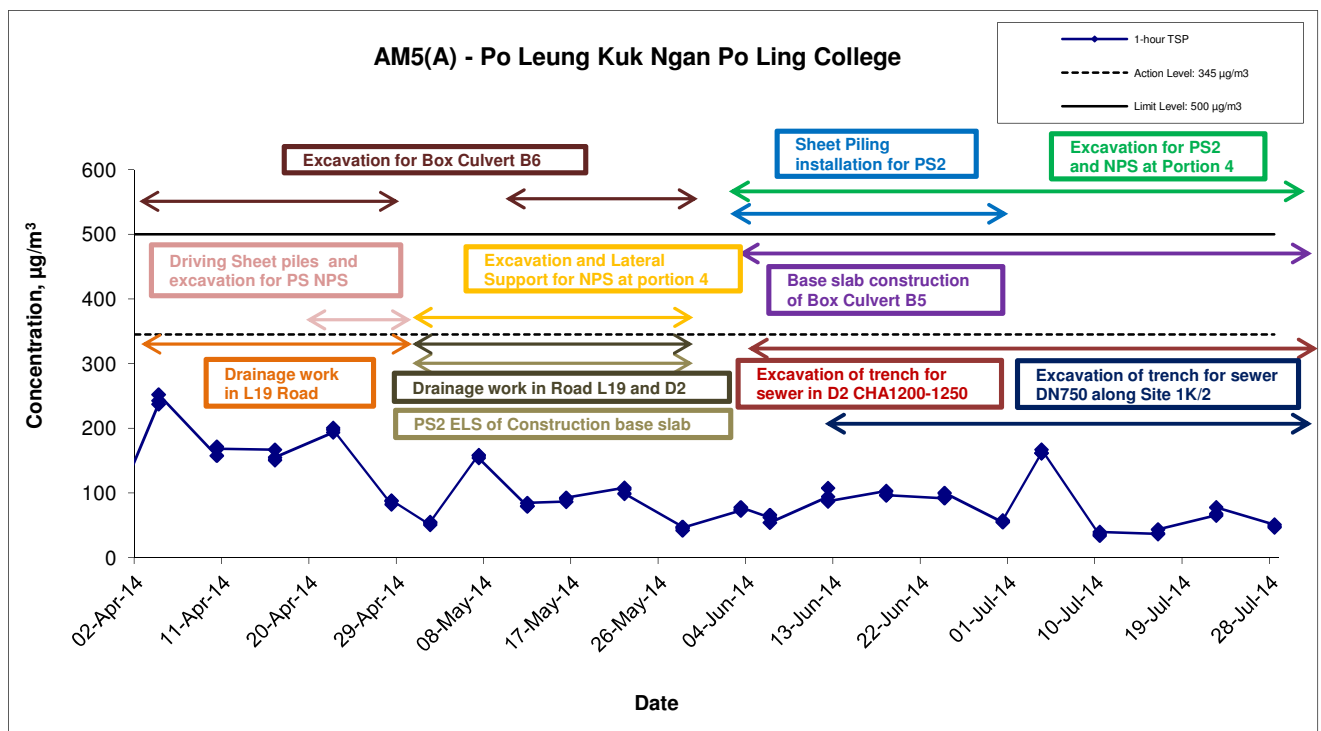
## 1-hr TSP Concentration Levels

<b>Title</b> Contract No. KL/2012/03 Kai Tak Development –Stage 4 Infrastructure at Former North Apron Area  Graphical Presentation of 1-hour TSP Monitoring Results	<b>Scale</b> N.T.S	<b>Project No.</b> MA13056	
	<b>Date</b> Jul 14	<b>Appendix</b> E

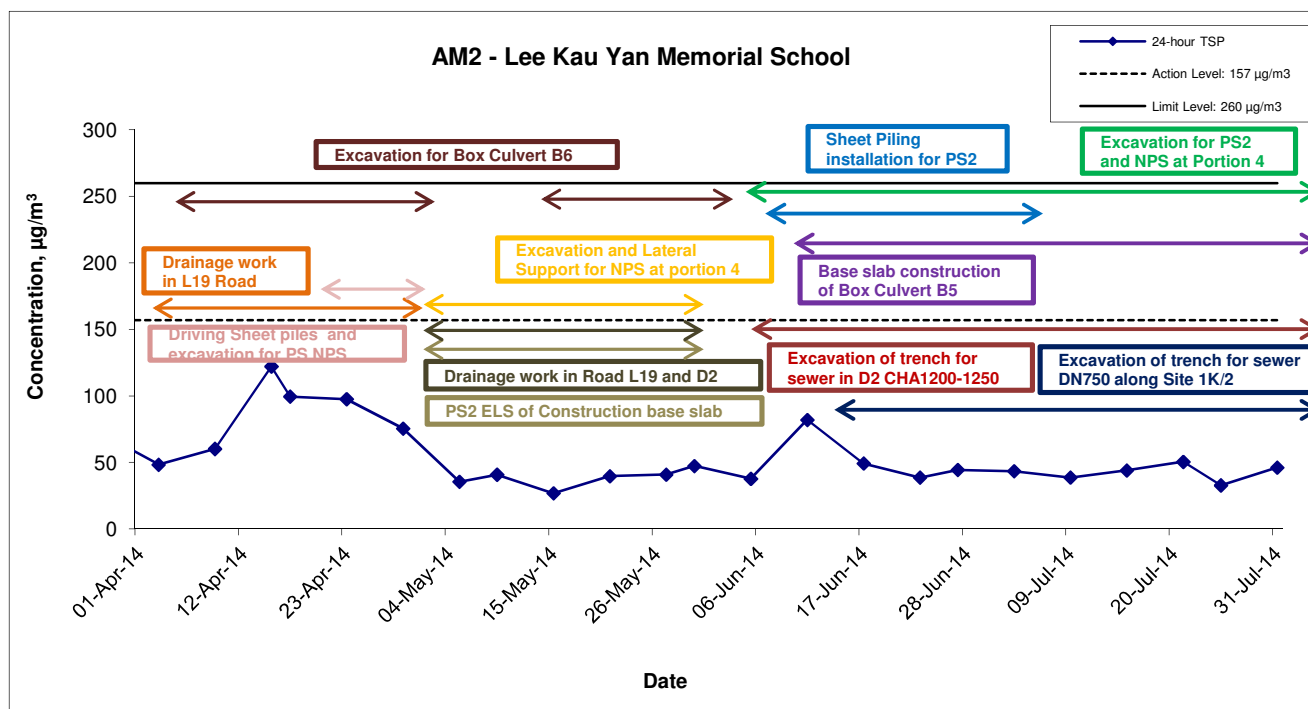
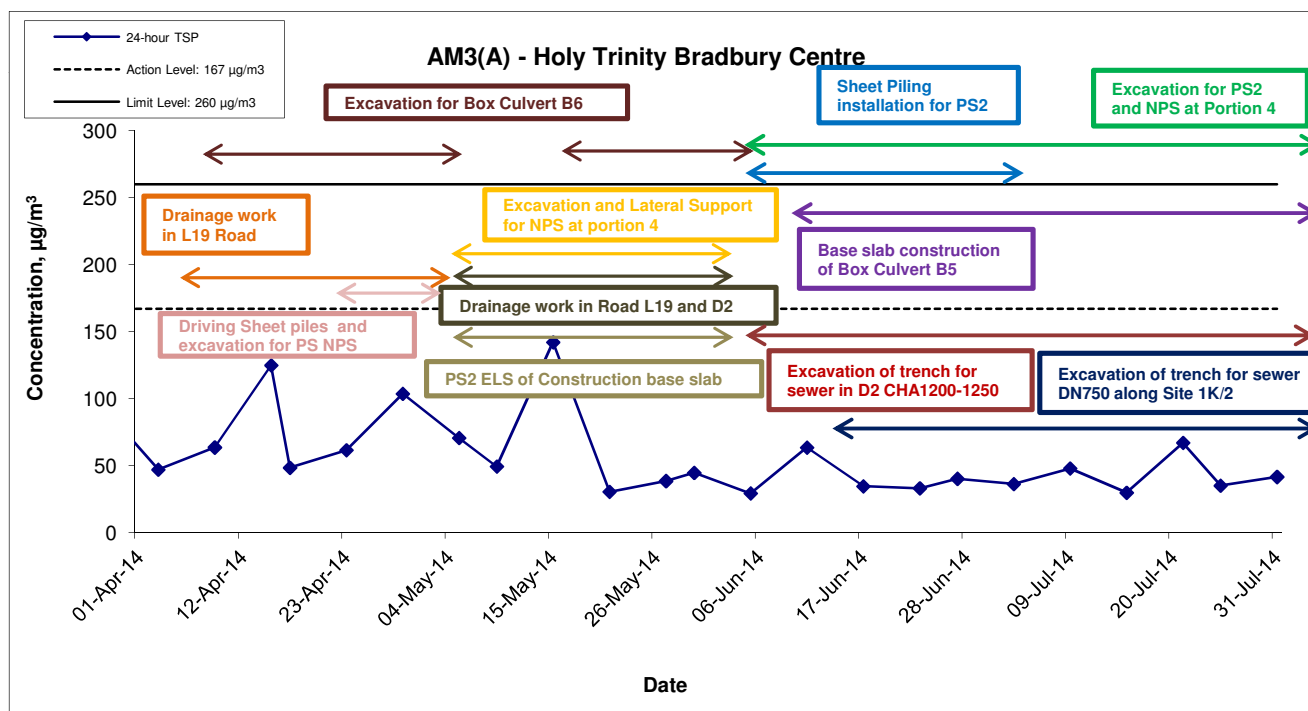
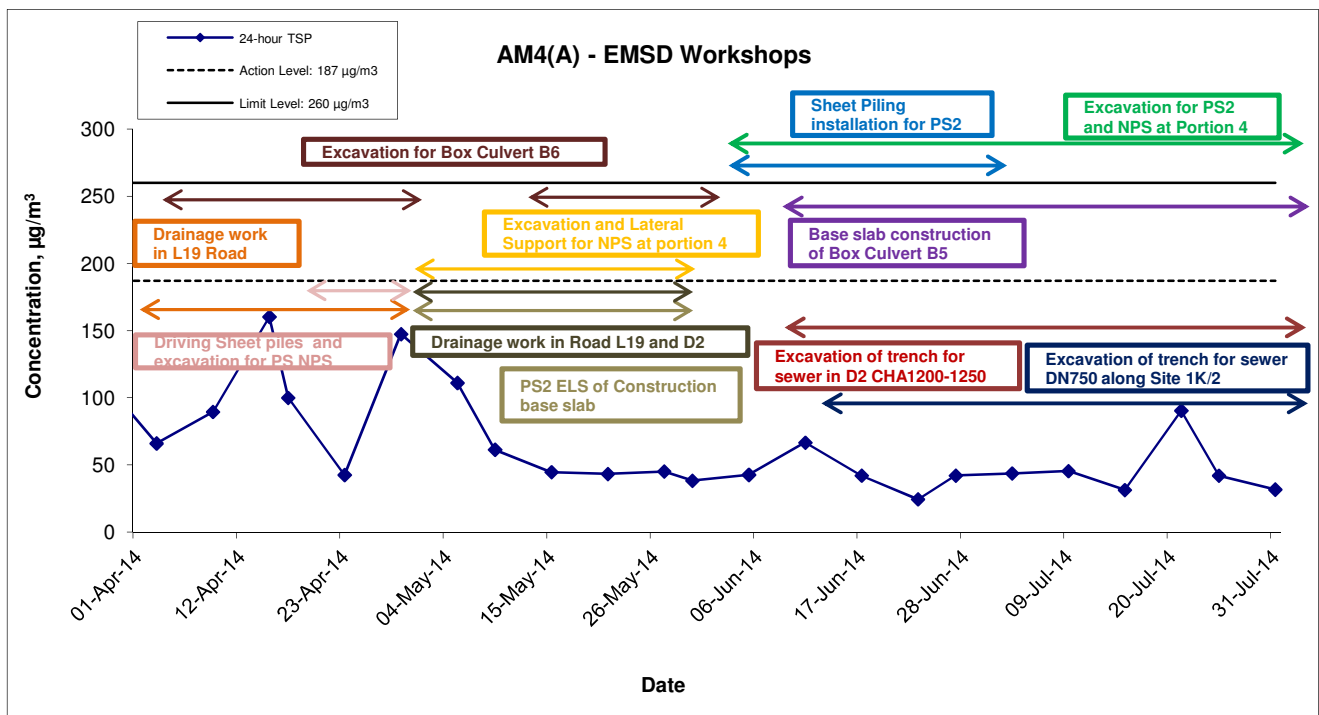
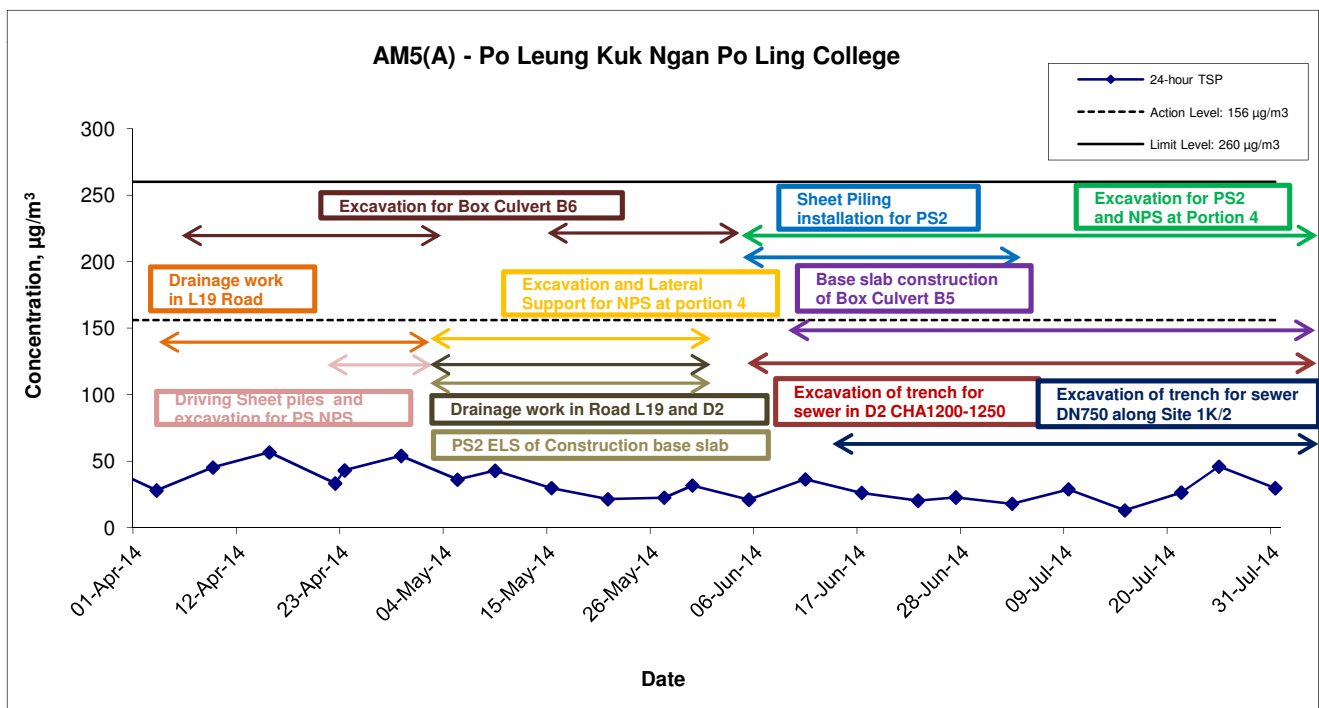
## 24-hr TSP Concentration Levels

<b>Title</b> Contract No. KL/2012/03 Kai Tak Development –Stage 4 Infrastructure at Former North Apron Area  Graphical Presentation of 24-hour TSP Monitoring Results	<b>Scale</b> N.T.S	<b>Project No.</b> MA13056	<div style="font-size: 48px; font-weight: bold; text-align: center;">CINOTECH</div>
	<b>Date</b> Jul 14	<b>Appendix</b> F

<b>Title</b> Contract No. KL/2012/03 Kai Tak Development –Stage 4 Infrastructure at Former North Apron Area  Graphical Presentation of 24-hour TSP Monitoring Results	<b>Scale</b> N.T.S	<b>Project No.</b> MA13056	
	<b>Date</b> Jul 14	<b>Appendix</b> F

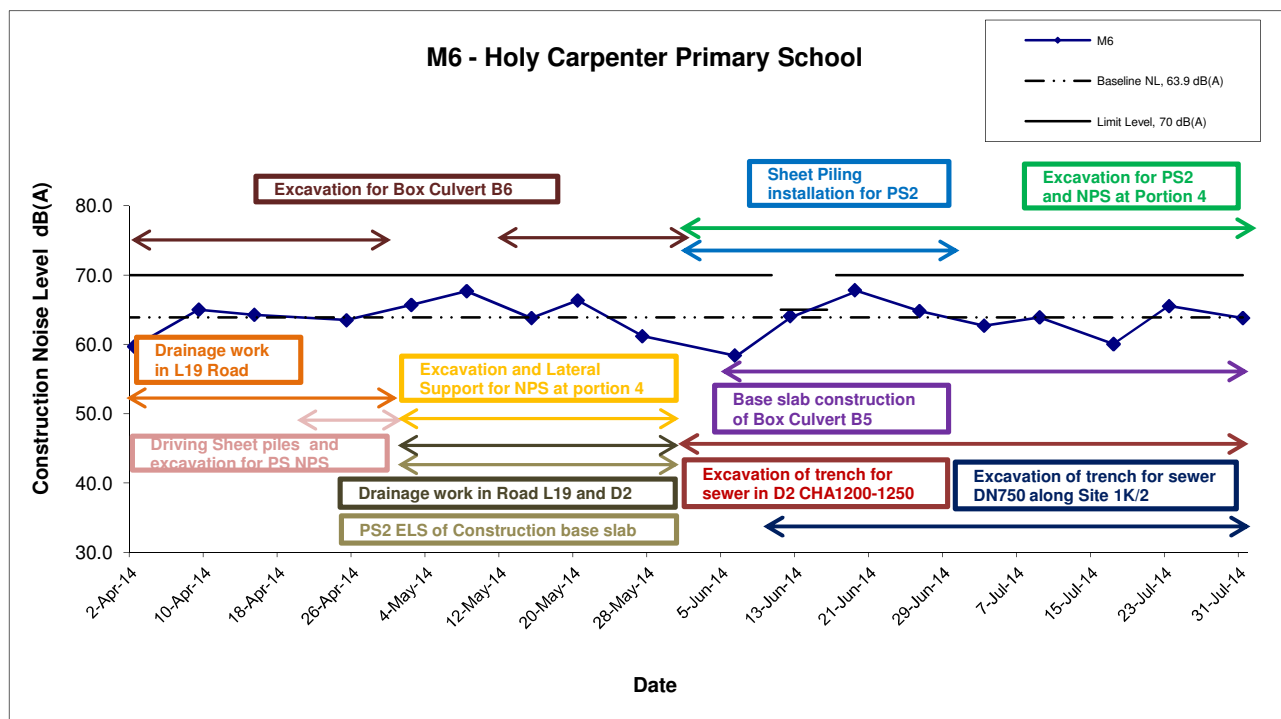
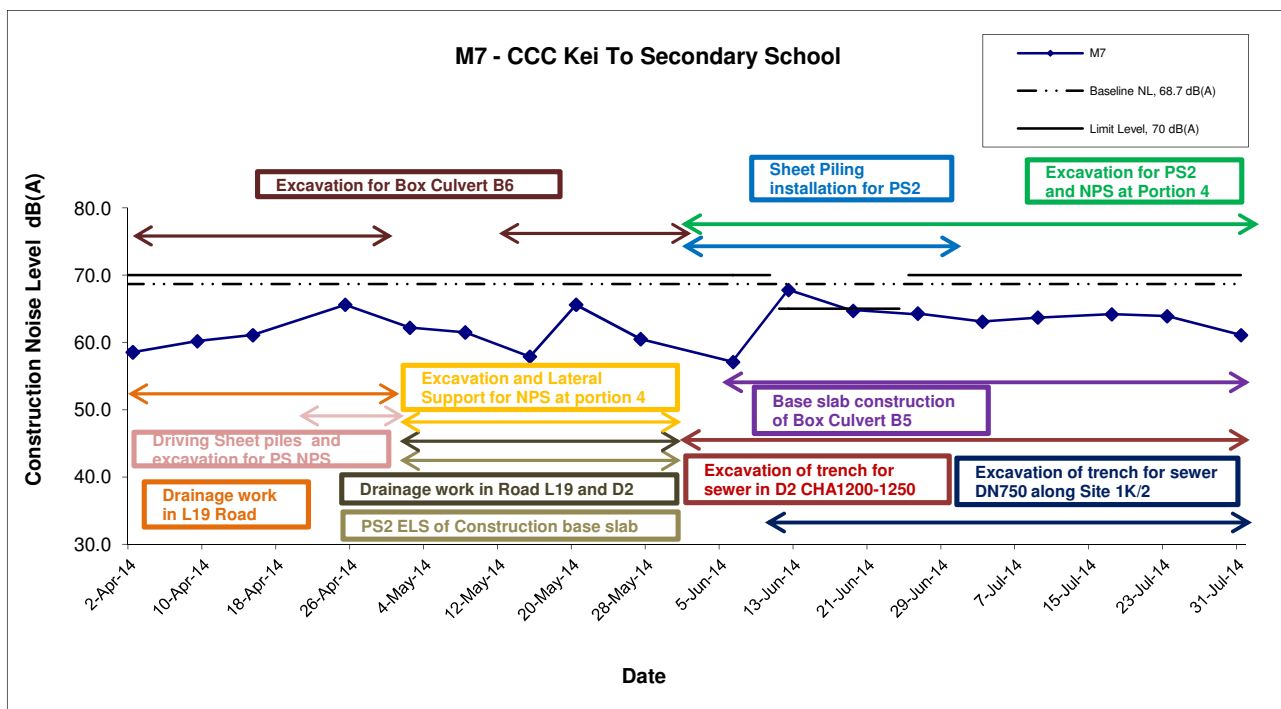
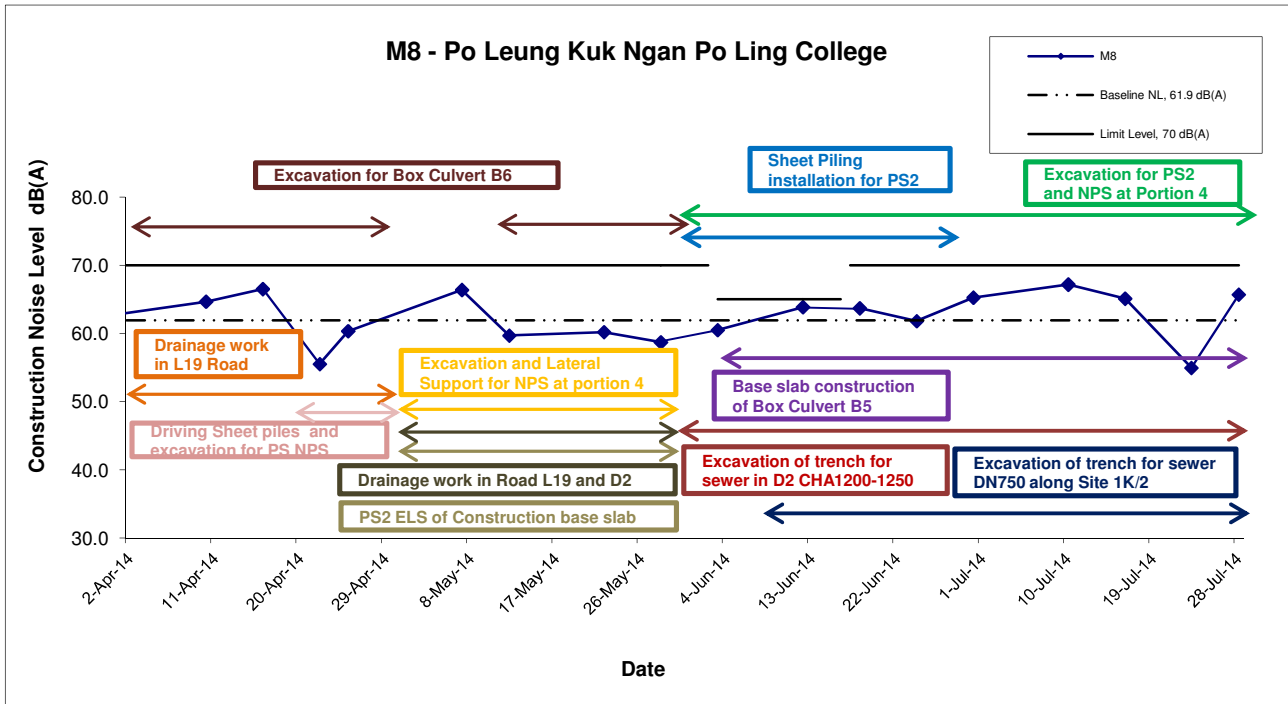
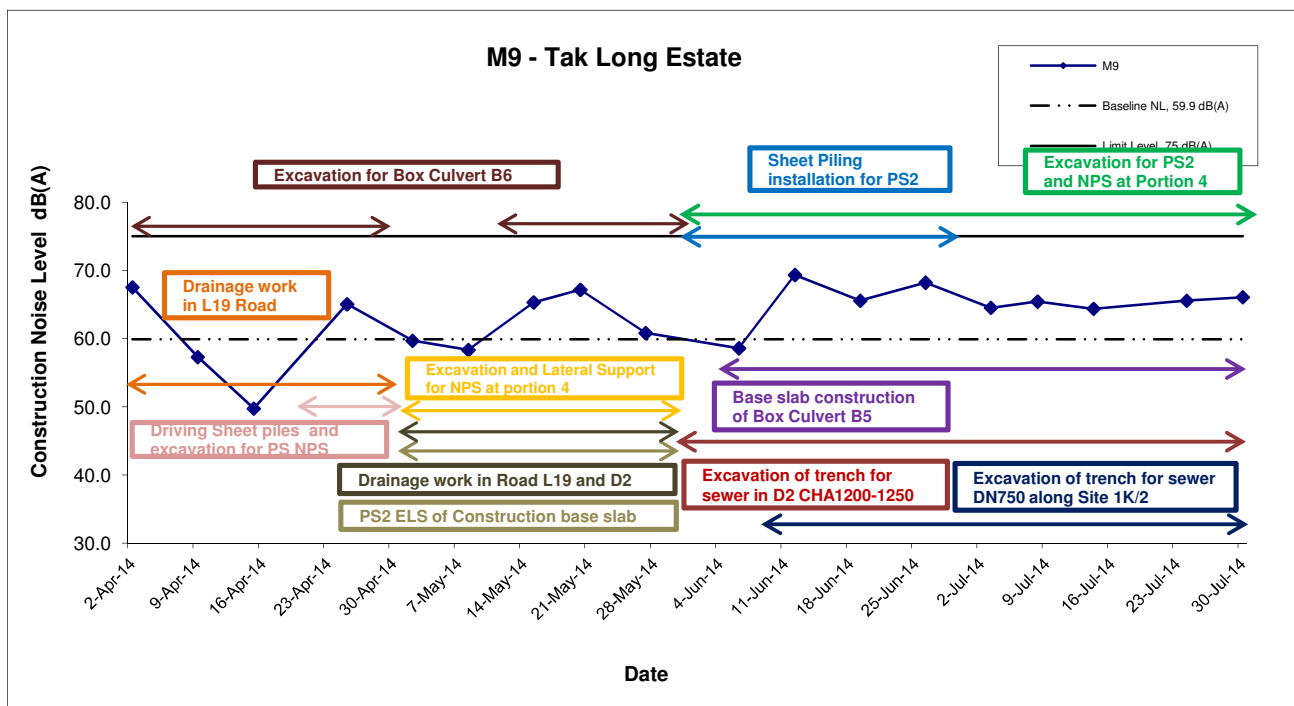
## Noise Levels

Remarks: The construction noise levels in the Tables in Appendix G were adopted for plotting the graphs

Title	Contract No. KL/2012/03		Scale	Project No.	CINOTECH
	Kai Tak Development –Stage 4 Infrastructure at Former North Apron Area		N.T.S	MA13056	
	Graphical Presentation of Construction Noise Monitoring Results		Date	Appendix	
			Jul 14	G

Title Contract No. KL/2012/03 Kai Tak Development –Stage 4 Infrastructure at Former North Apron Area Graphical Presentation of Construction Noise Monitoring Results	Scale	Project No.	CINOTECH
	N.T.S	MA13056	
	Date	Appendix	
	Jul 14	G
