EP-344/2009 – New Sewage Pumping Stations Serving KTD and
EP-337/2009 – New Distributor Roads Serving the Planned KTD

Contract No. KL/2012/03
Kai Tak Development –Stage 4 Infrastructure at
Former North Apron Area

Monthly EM&A Report

December 2014

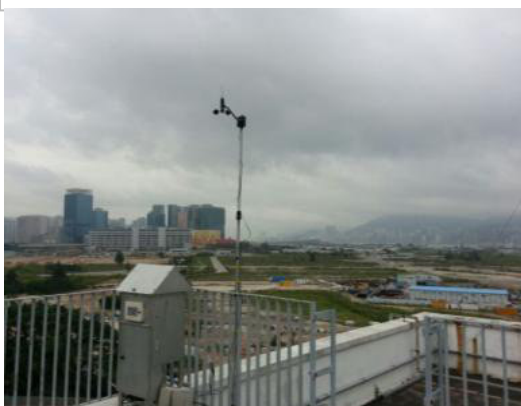
Wind Data Monitoring Equipment set at
Lee Kau Yan Memorial School

- 2.21 The air temperature, precipitation and the relative humidity data was obtained from Hong Kong Observatory where the wind speed and wind direction were recorded by the installed Wind Anemometer set at rooftop (about 8/F) Lee Kau Yan Memorial School. The location is shown in **Figure 4**. This weather information for the reporting month is summarized in **Appendix C**.

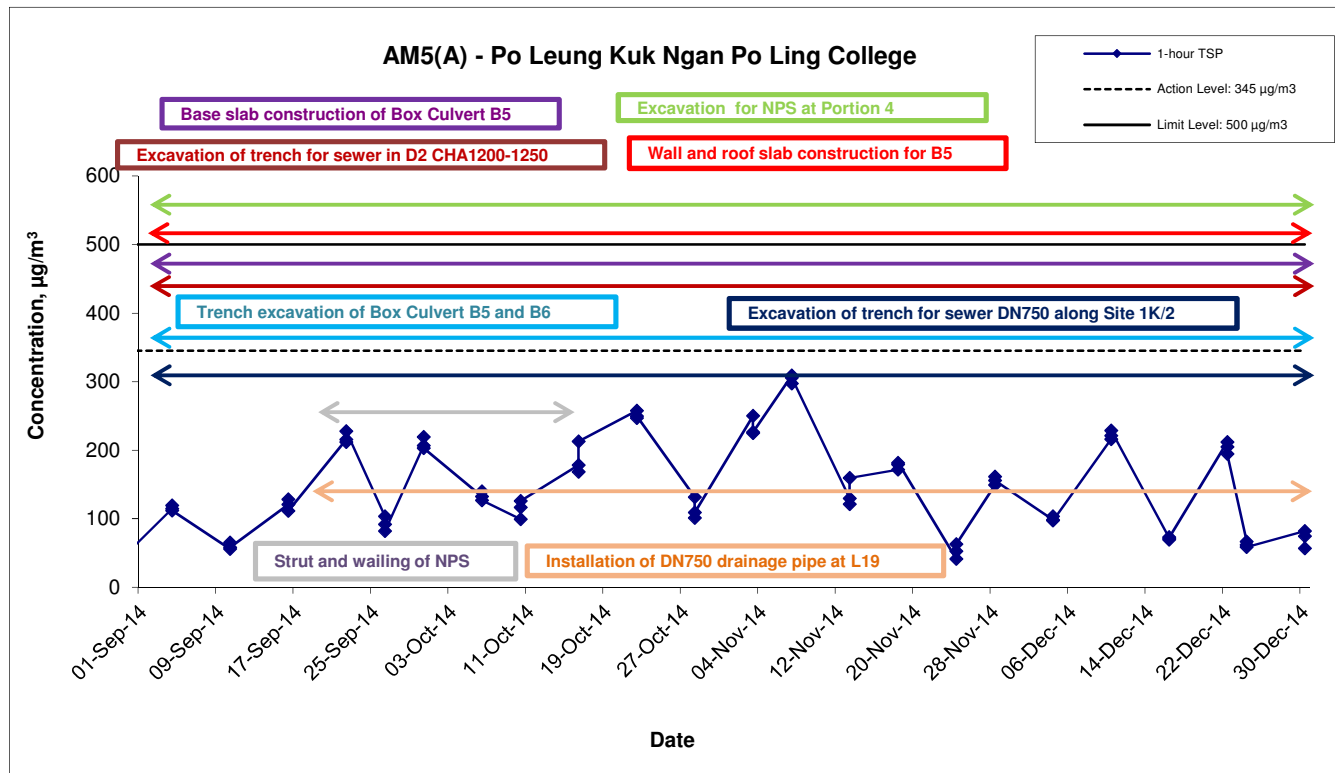
1-hr TSP Concentration Levels

Title	Contract No. KL/2012/03	Scale	Project No.	CINOTECH
	Kai Tak Development –Stage 4 Infrastructure at Former North Apron Area	N.T.S	MA13056	
	Graphical Presentation of 1-hour TSP Monitoring Results	Date	Appendix	
		Dec 14	E

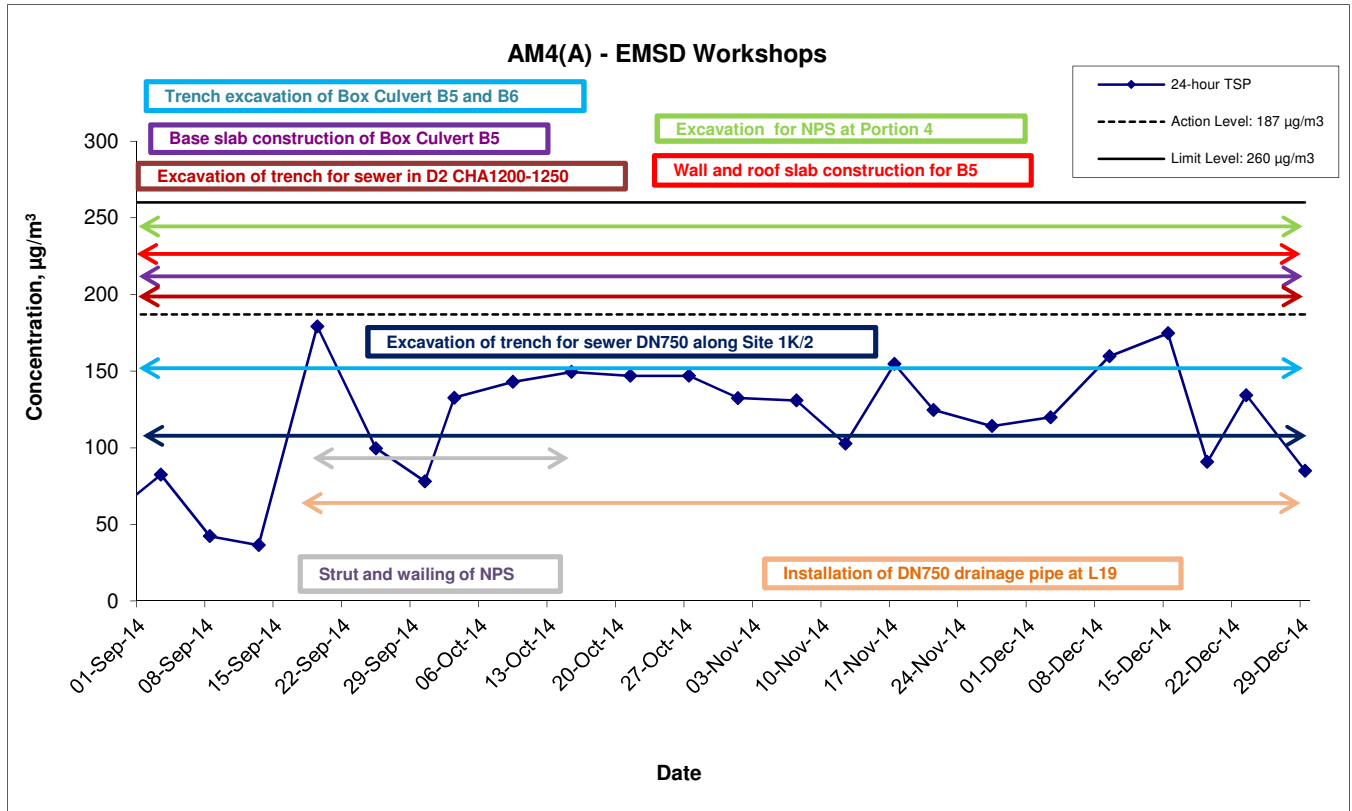
24-hr TSP Concentration Levels

Title Contract No. KL/2012/03 Kai Tak Development –Stage 4 Infrastructure at Former North Apron Area Graphical Presentation of 24-hour TSP Monitoring Results	Scale N.T.S	Project No. MA13056	
	Date Dec 14	Appendix F

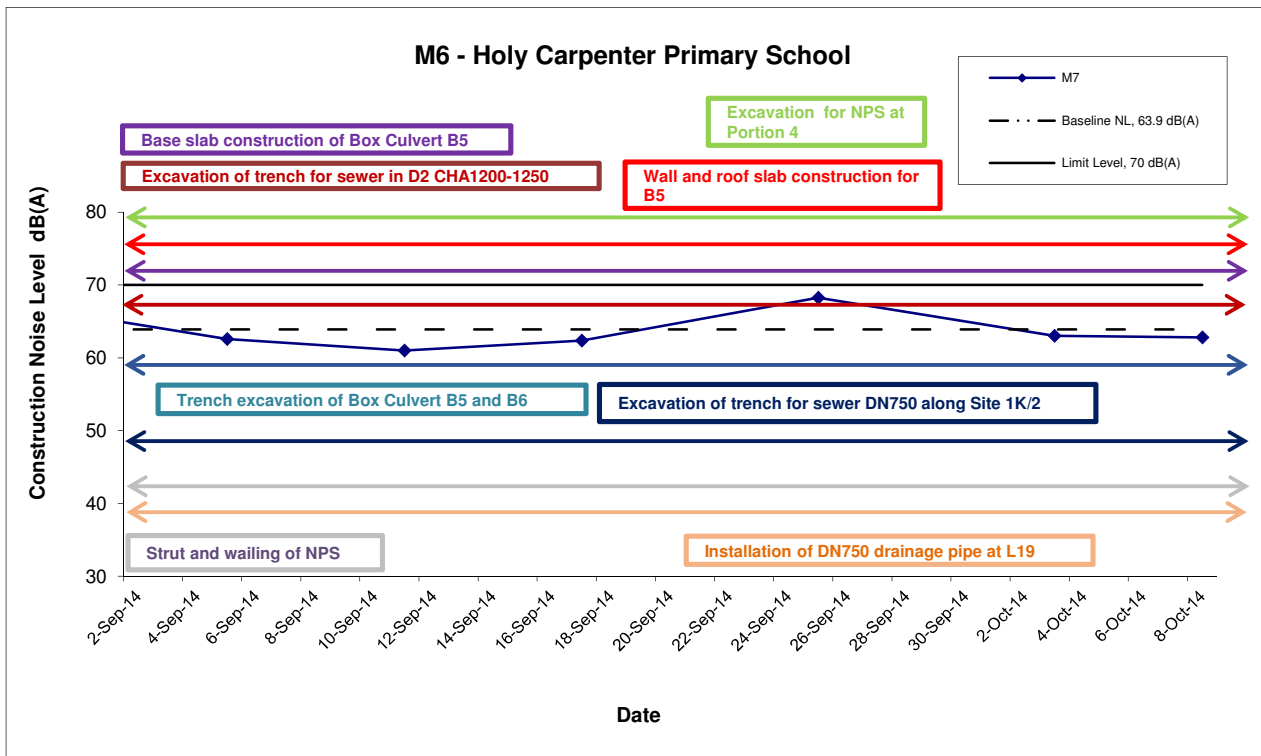
Noise Levels

Remarks: The construction noise levels in the Tables in Appendix G were adopted for plotting the graphs

Title Contract No. KL/2012/03 Kai Tak Development –Stage 4 Infrastructure at Former North Apron Area Graphical Presentation of Construction Noise Monitoring Results	Scale N.T.S	Project No. MA13056	CINOTECH
	Date Dec 14	Appendix G
